**INVESTIGATION OF VOIDS/CRACKING ON THE I-275 TWIN
BRIDGES OVER THE OHIO RIVER IN KENTON COUNTY
PHASE I**

| 4. Title and Subtitle Investigation of voids/cracking on the I-275 twin bridges over the Ohio River in Kenton County – Phase I | | 5. Report Date March 2008 | |

Final Report

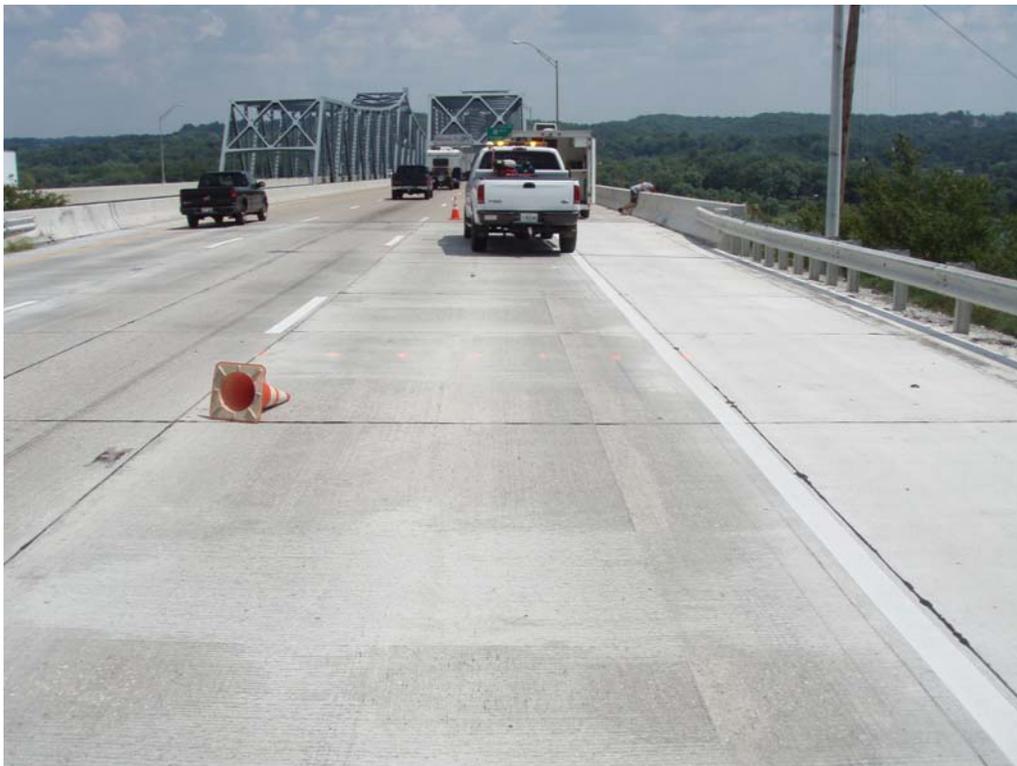
Figure 1 below identifies the approach slab that was scanned with a 900 Mhz. ground penetrating radar unit. As noted above, this area was scanned to identify potential voids beneath the concrete pavement. Figure 2 below details the proximity of possible voids seen beneath the pavement structure. It is estimated that the void sizes beneath the pavement structure would be on the order of one to two inches in depth, and if necessary could be filled with cement grout. At the time of the inspection there did not appear to be any differential settlement between the lanes or other pavement distress in the void area. Figure 3 below displays two radar scans from the approach slab area. The highlighted red area in the top picture of Figure 3 displays the possible void space beneath the concrete surface, the bottom picture of Figure 3 displays an area without voids beneath the pavement. There were no voids detected adjacent to the armored edge.

Figure 1: Bridge approach, scanned with GPR

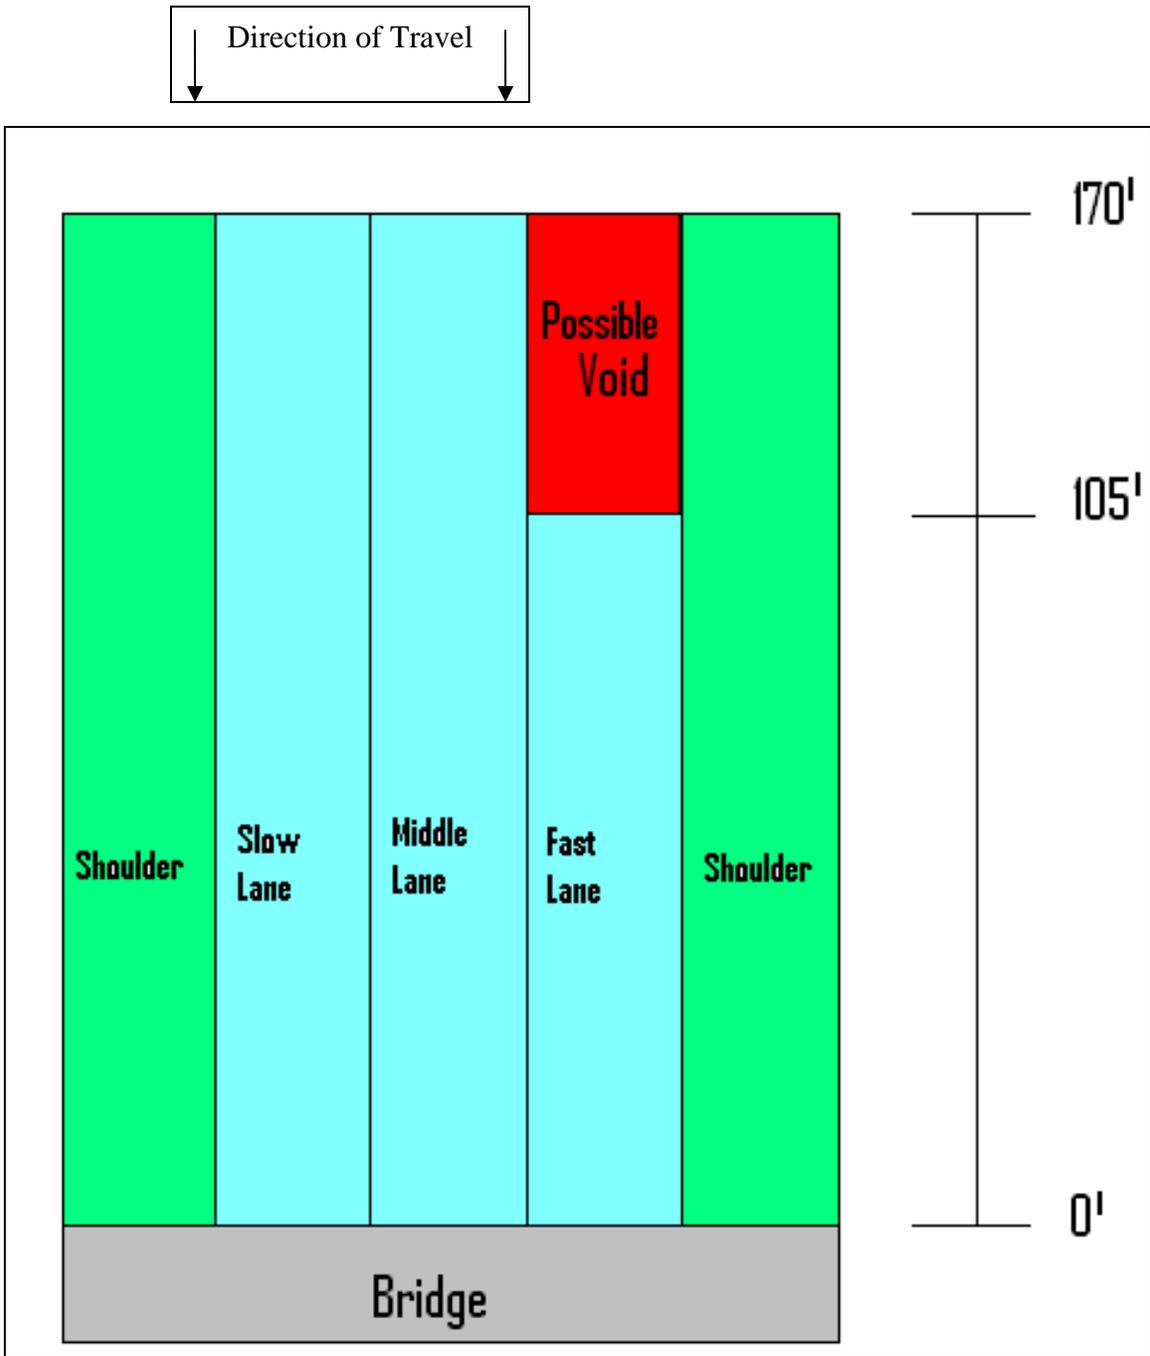
Figure 2: Void area under approach slab

A possible void approximately 1-2 inches in depth resides under the approach slab approximately 105 feet before the bridge abutment in the fast lane. It is recommended that this section be filled with cement grout. The camera inspection beneath the pier cap/concrete beam indicates that approximately 447 cubic feet of material has been displaced. It is suggested that the void space be filled with either cement grout or crushed aggregate. It is also recommended that the water eroding around the side of the abutment wall be diverted away from the bridge embankment.

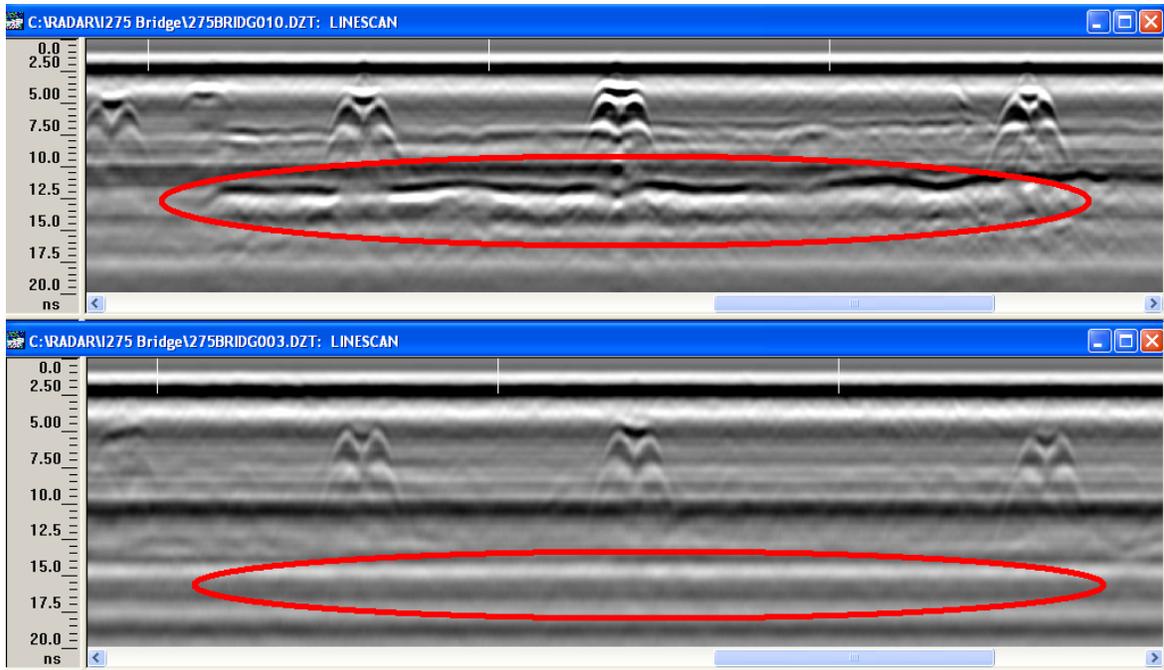
Figure 3: Void space under concrete pavement with GPR

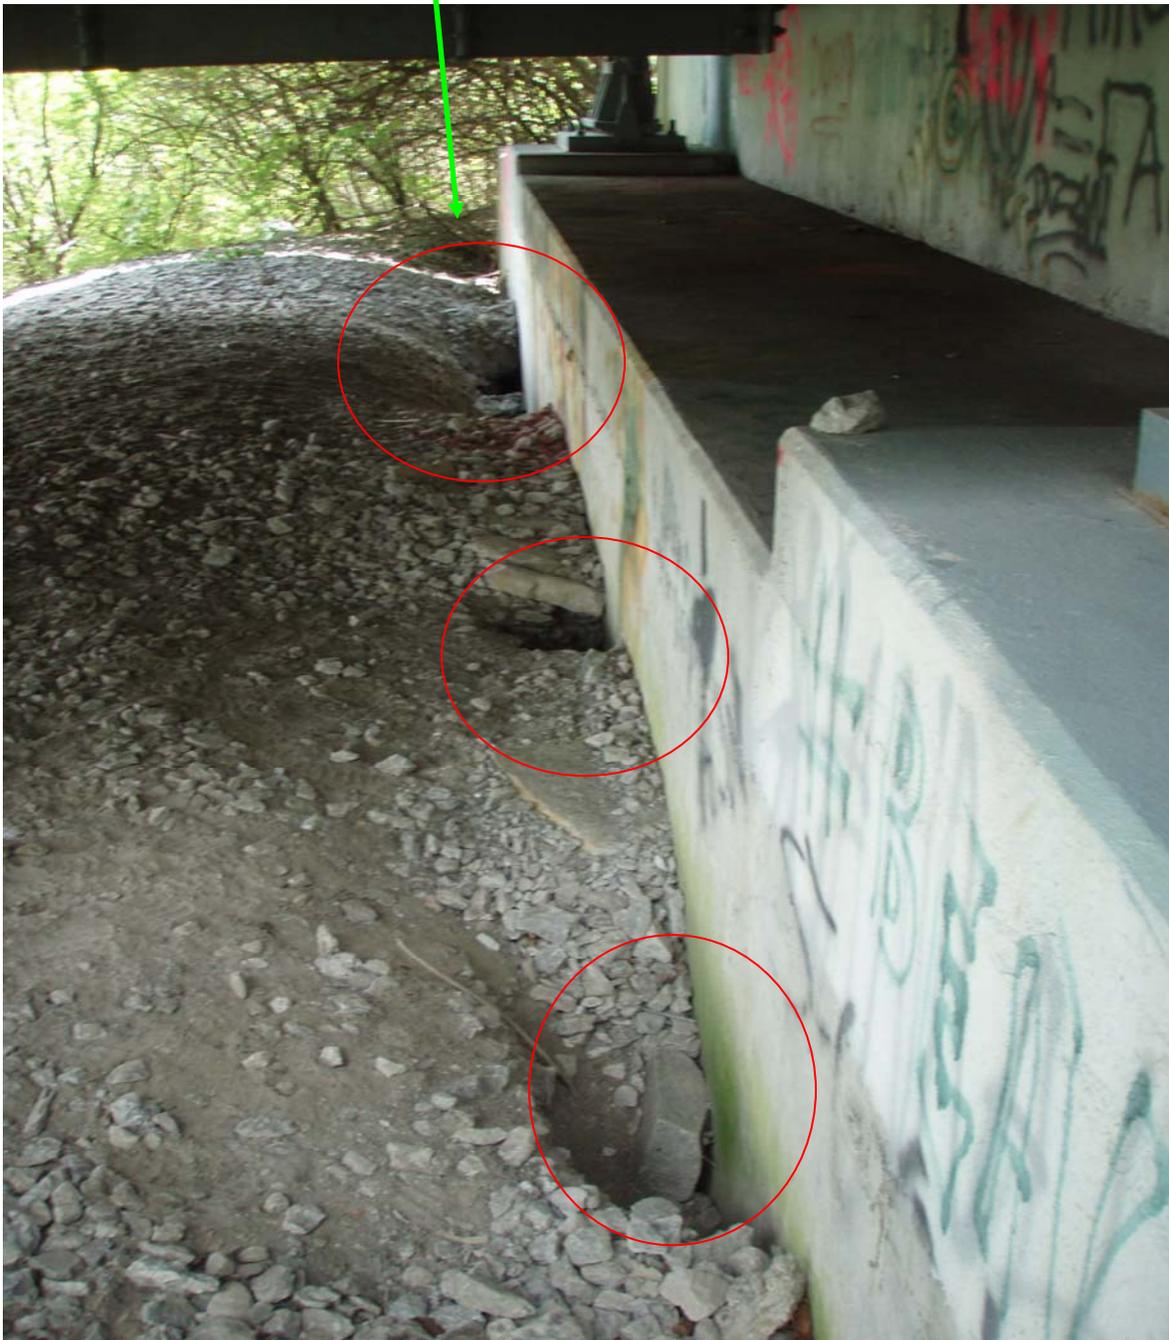
A visual inspection of the void space beneath the pier cap/concrete beam was conducted with a video inspection camera. Figures 4 and 5 below identifies the void space from the ground surface in front of the pier cap. Figure 4 also displays where water is eroding around the side of the abutment wall which can be corrected by diverting the water, from the roadway, away from the bridge embankment. Figure 6 displays the void space underneath the pier cap/concrete beam (video files contained on the attached DVD displays the inspection of the interior void space).

Water eroding around the side of abutment wall

Figure 4: Exterior abutment wall with voids

indicated that the fill material does not directly support the beam itself. However for precautionary measures of further eroding/settling of the embankment material beneath the pier cap/concrete beam it is suggested that the void space be filled with either cement grout or crushed aggregate. It is also imperative that the water eroding around the side of the abutment wall be diverted away from the bridge embankment.

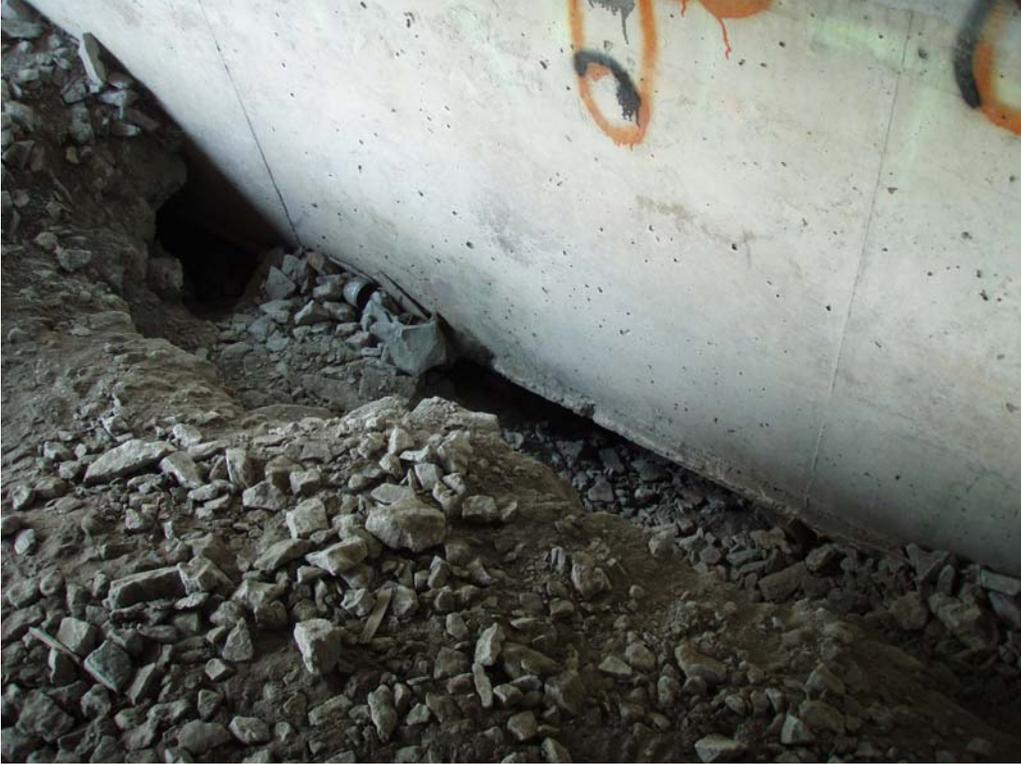
Figure 5: Exterior abutment wall with void spaces

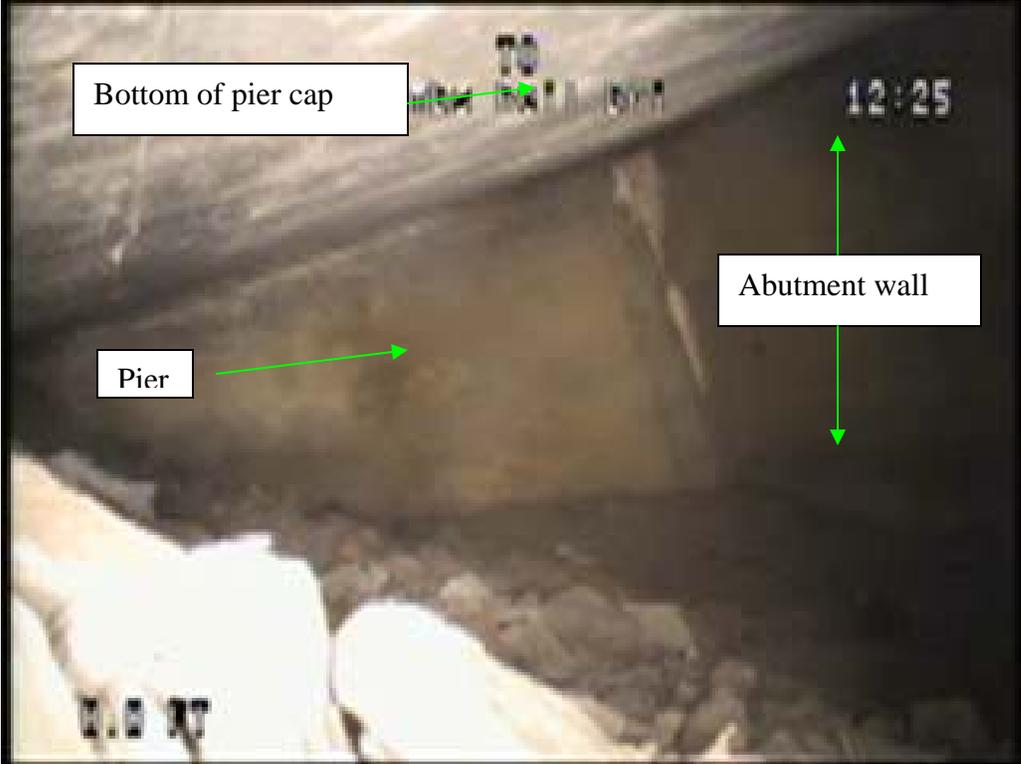
Figure 6: Void space beneath pier cap/concrete beam

It is speculated that the void space beneath the pier cap/concrete beam is isolated from the approach slab. It also appears that the void space may have been created due to deep foundation settlement of the embankment fill and/or poor compaction of fill material beneath the pier cap during construction. During field observations it was apparent that vibrations from the vehicles crossing the bridge were evident in the embankment. It is suggested that further field testing with accelerometers should be conducted to quantify the amount of vibrations experienced in the field. At this time it is suggested that the void be filled with either cement grout material or crushed aggregate i.e.: 57's.

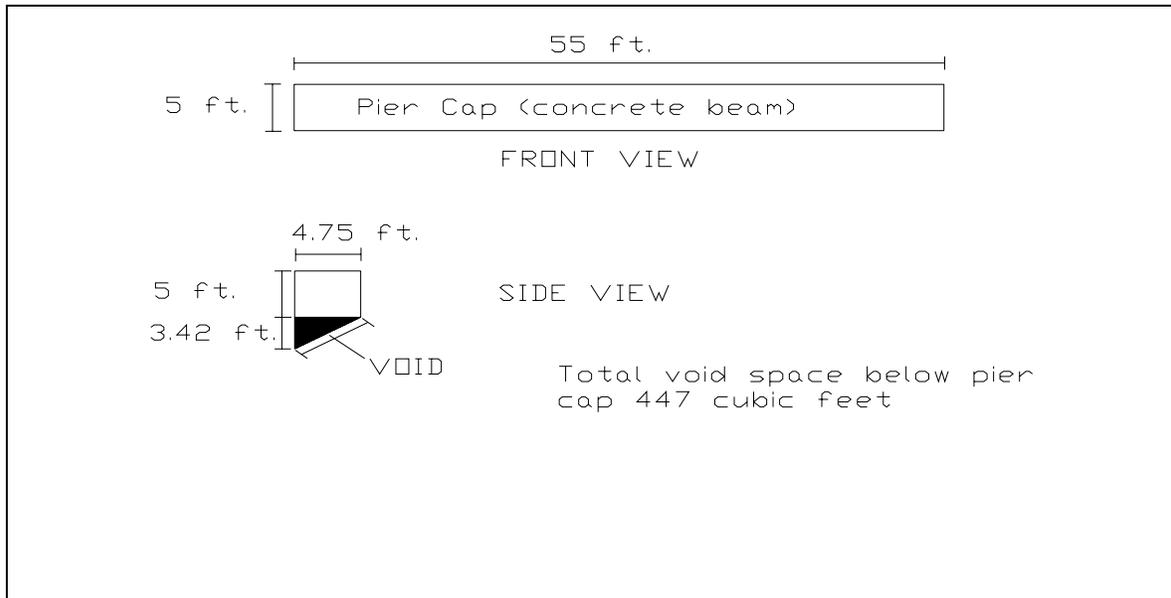
After the video inspection was complete, field measurements were taken of the interior void space that extended the entire length of the pier cap/concrete beam. The approximate volume of the void beneath the pier cap/concrete beam at the time of inspection was approximately 447 cubic feet (Figure7).

Figure 7: Estimated void space
