EXPERIMENTAL CONCRETE COATING APPLICATION ON THE MEDIAN BARRIER OF I-65 IN LOUISVILLE

**Research Report
KTC-08-20/FR155-06-1F**

**Experimental Concrete Coating Application on the
Median Barrier of I 65 in Louisville**

June 2008

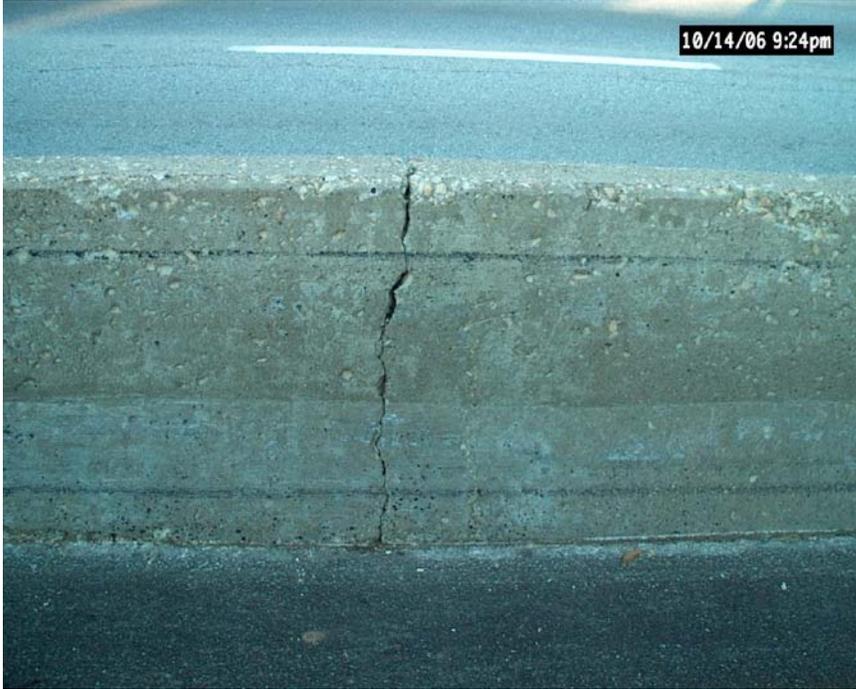
Painting operations began during the second weekend of October, 2006. On Friday, October 13, before the subcontractor began his work, KTC and KYTC personnel identified areas containing cracks, spalled concrete, exposed reinforced steel and pre-existing patched areas (Figures 5-8). Those areas were noted for reference in future inspections.

Figure 5. A typical pre-existing crack in the median barrier.

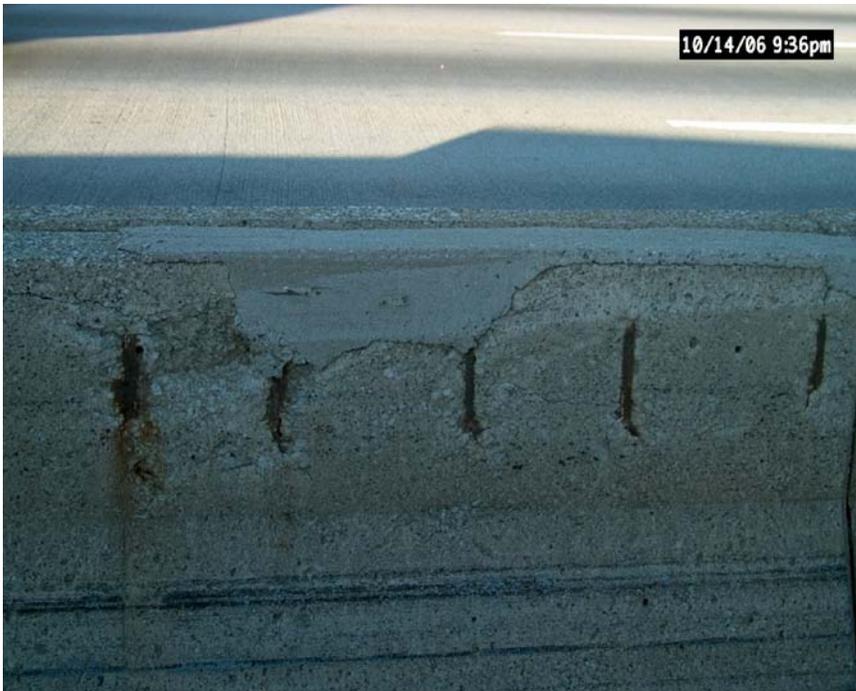
Figure 6. Exposed corroded reinforcing steel in the median barrier. Note the patch which was applied prior to this project.

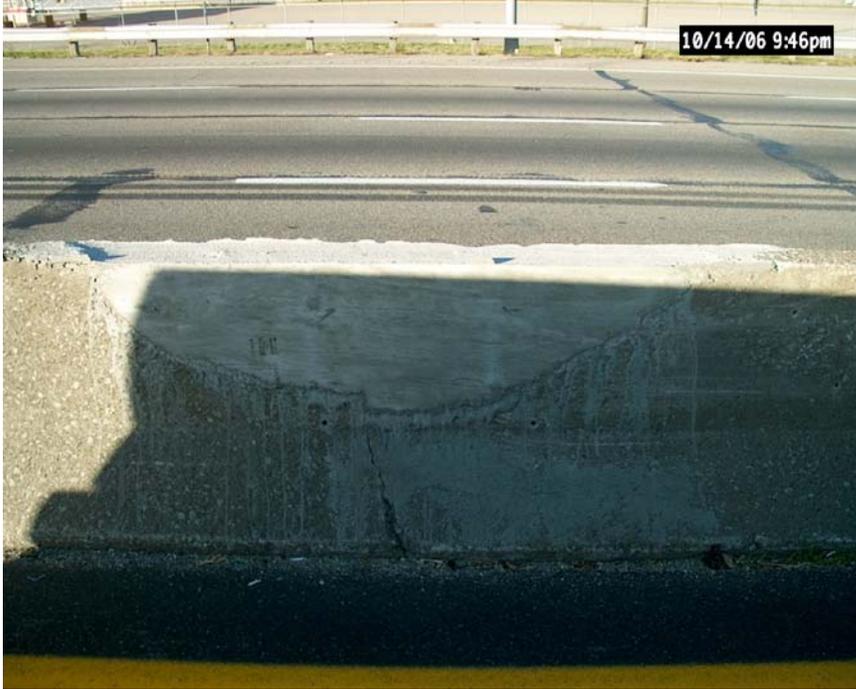
Figure 7. A previously patched area on the median barrier.

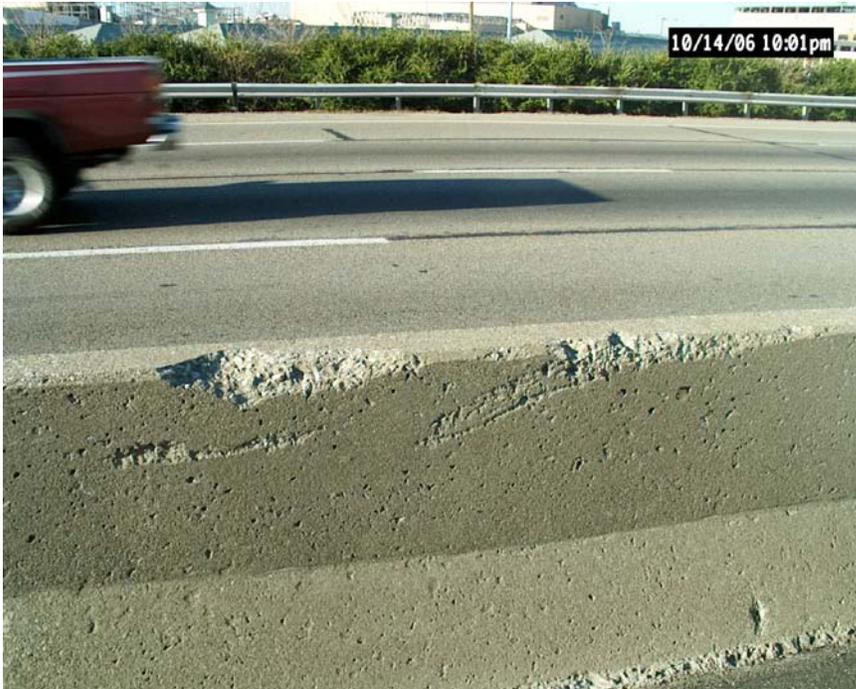
Figure 8. Existing impact damage on the median barrier.

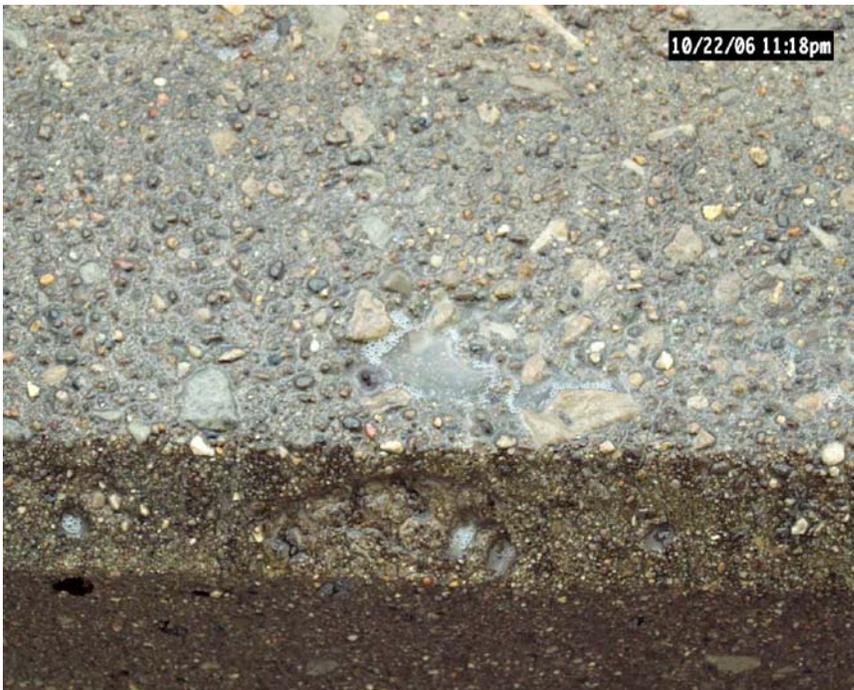
Figure 16. The prime coat settling and ponding on the crevices in the concrete.

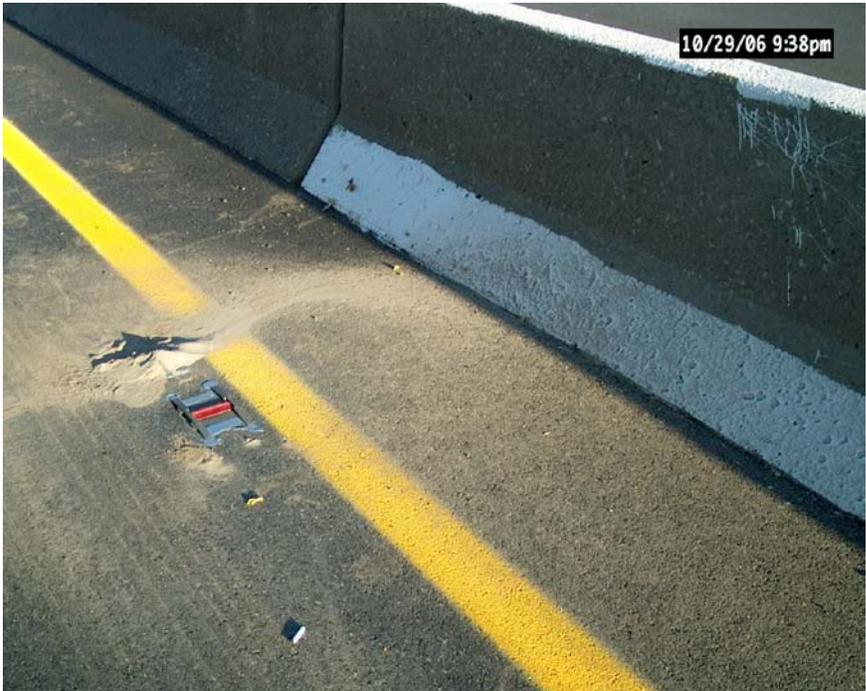
Several times during the project, cleaning and painting operations were delayed by the paving work. Consequently, the painting subcontractor would have to return to previously washed and/or painted areas and rinse the median walls to remove accumulated dust and grime that resulted from the paving work (Figures 19 & 20).

Figure 18. A picture showing a reflector that had been installed and the dirt that was blown onto the painted area of the barrier wall.

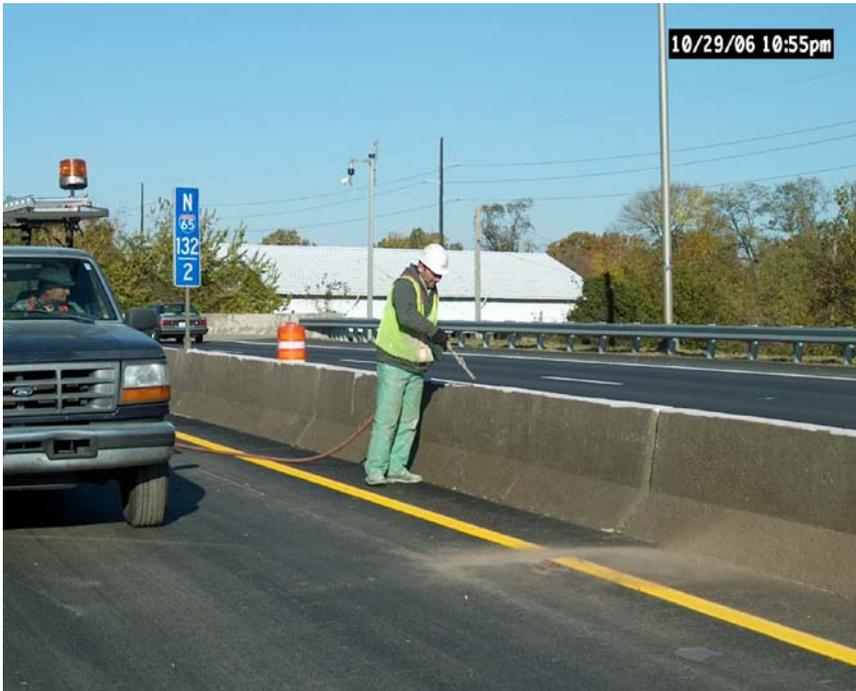
Figure 19. A worker using compressed air to remove dirt and dust from the top of the median barrier.

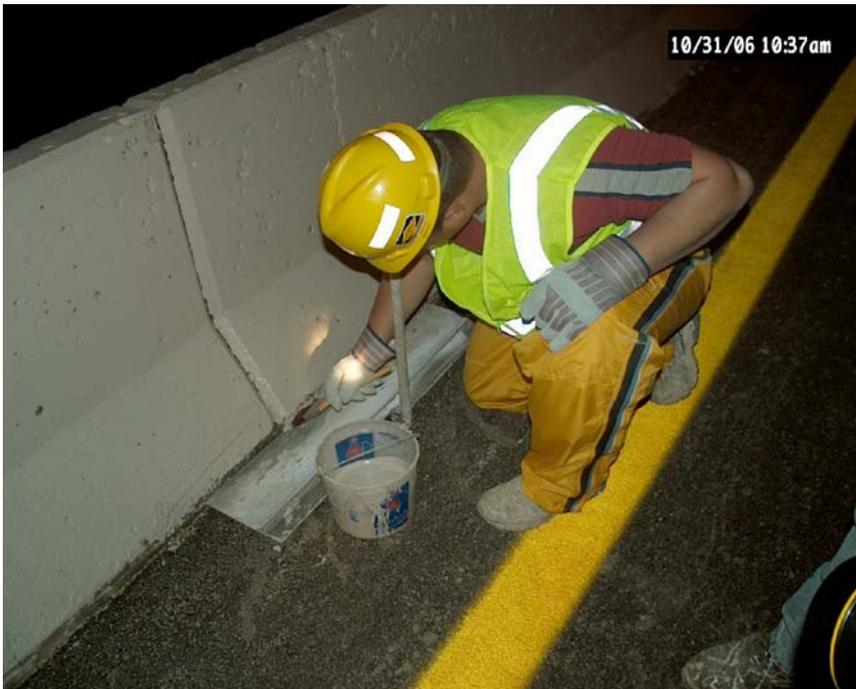
Figure 26. A painter doing touch up work along the base of the median barrier.

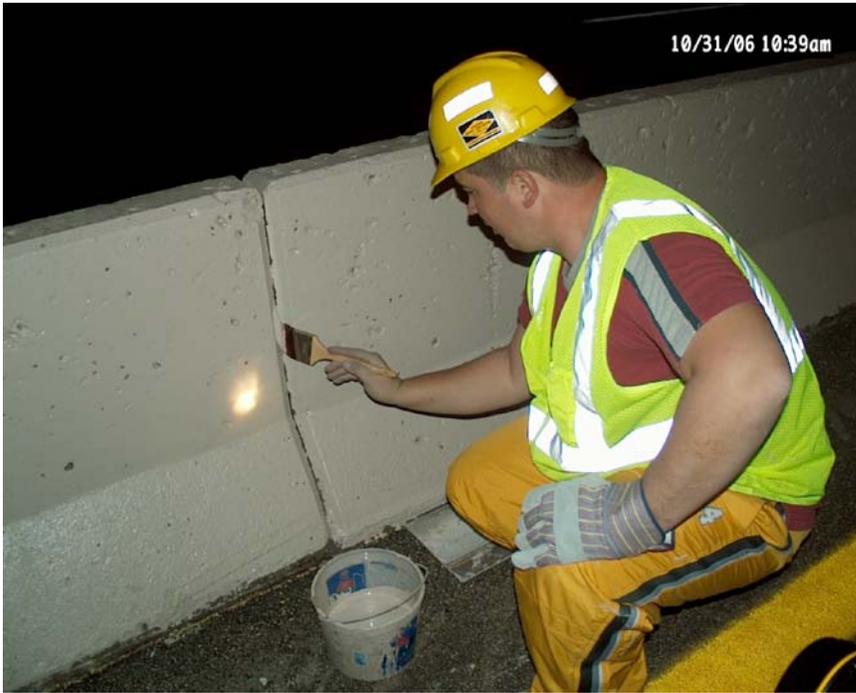
Figure 27. A painter performing touch up work at the barrier joints.
