**THREE-CABLE
MEDIAN BARRIER
FINAL REPORT**

#OR-RD-99-03

Brett Sposito, E.I.T.

Sam Johnston, P.E.

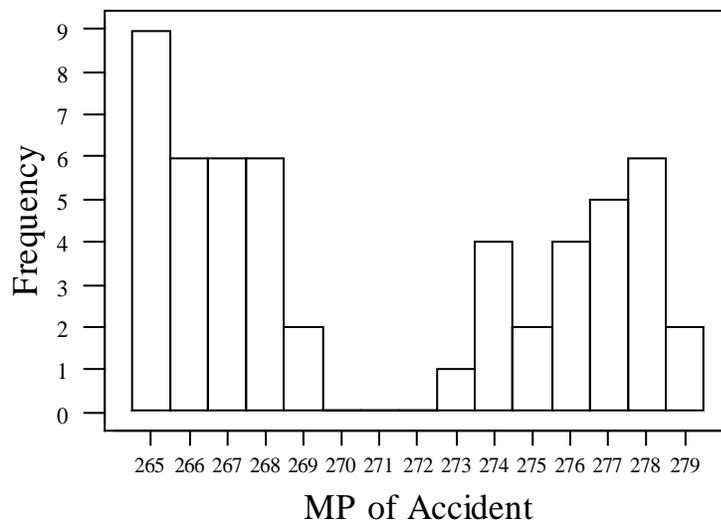
Figure 3.1: Impacts on the cable median barrier by MP

The cable median barrier has been hit 53 times from December 1996 through March 1998, or about once every nine days, based on the repair records. The frequency and location of the impacts are shown in Figure 3.1. No cable barrier was installed between MP 268.81 and 273.21. The accident rate for the cable barrier, 40 per year, is much higher than the historical accident rate of 1.0 per year. The most likely explanation for the increase in accidents is vehicles that drove into the median prior to the barrier installation, and reentered the roadway without incident, are now impacting the cable system. So, the total number of vehicles entering the median was not captured in previous accident history.

Once the system is installed, repair locations should be tracked as per Figure 3.1 in order to identify possible roadway design problems.

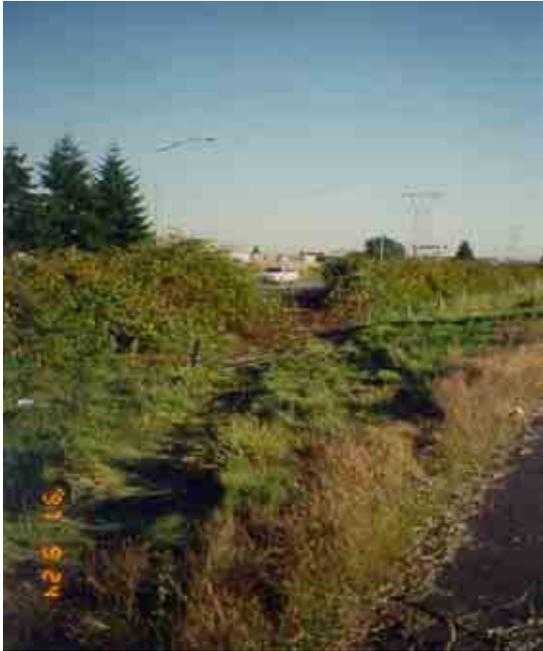
Figure 3.2: Semi-truck crossover through cable median barrier

On September 23, 1997, the only median crossover impacting the barrier occurred. A semi-truck went through the median barrier, dragged the cables across the opposing traffic lanes, hitting a GMC Yukon. The driver of the Yukon suffered minor injuries. The semi-truck driver suffered from a seizure before crossing through the median. As stated in Section 2.3, none of the barrier options are designed to stop these larger vehicles, as it is not cost effective.

Figures 3.2-3.4 document the path of the semi-truck crossover. Figures 3.5-3.10 document the results of the semi-truck crossing through the cable median barrier system, as well as, the energy dissipation characteristics of the system components.

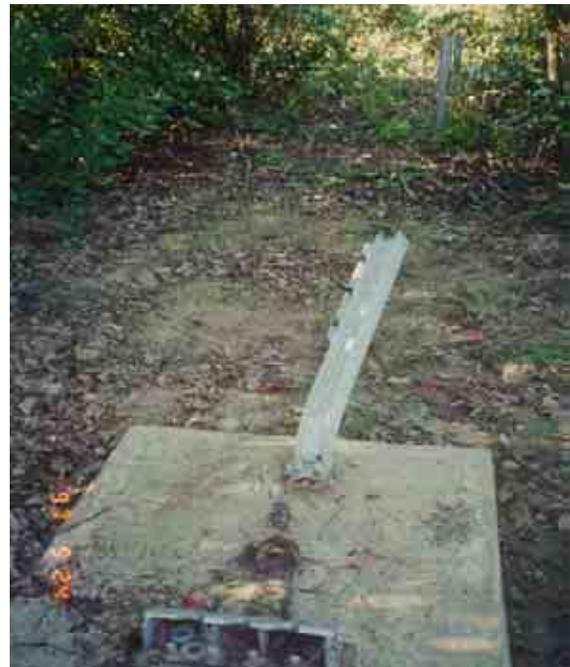
Figure 3.5: Energy dissipation-cable release from breakaway anchor angle and anchor post bracket (north end)

As shown in Figures 3.2-3.10, significant barrier damage may occur with any single hit. So far, there has not been a cross-median accident in a location where the barrier needs repair work. Even so, consideration should be given to the risk of cross-median accidents where the barrier is damaged.

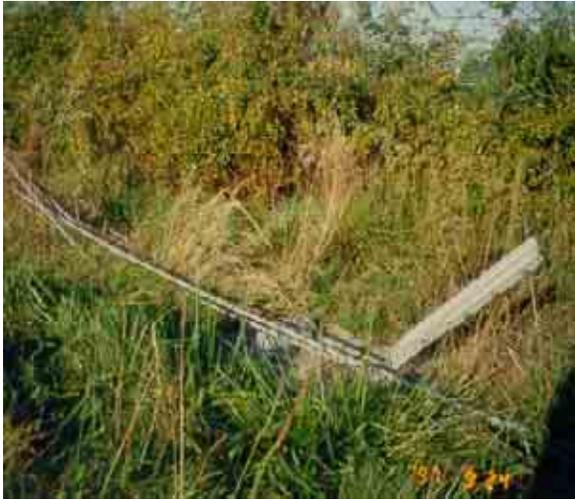
Figure 3.6: Energy dissipation-cable release from breakaway anchor angle and anchor post bracket (south end)

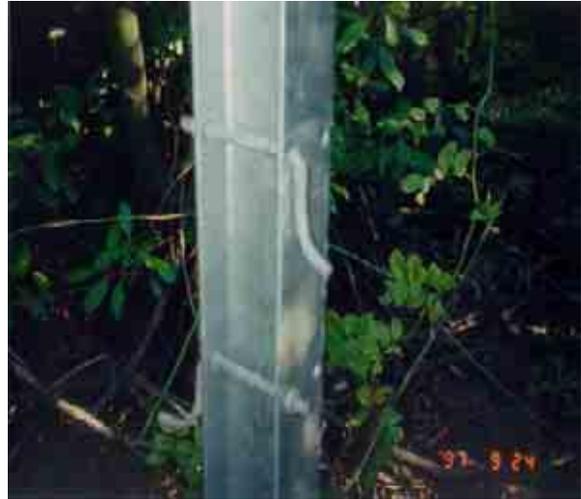
Figure 3.7: Energy dissipation-cable release from round bend hook bolts

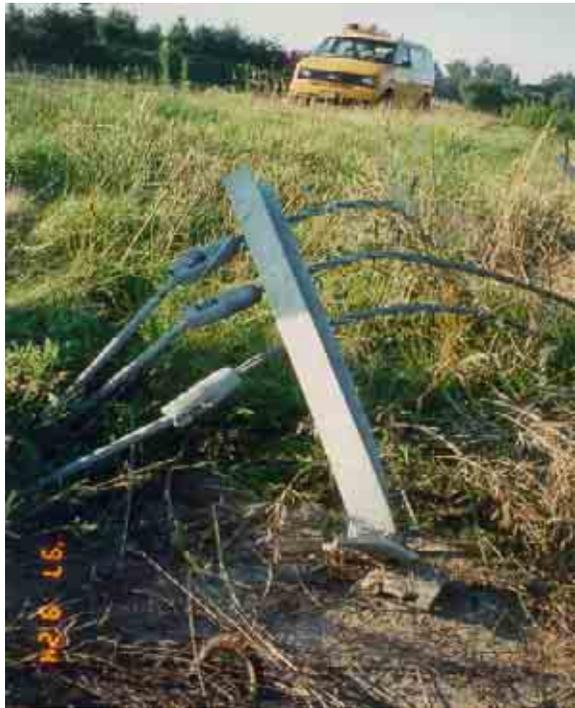
Figure 3.8: Energy dissipation-cable release from breakaway anchor angle and anchor post slip base failure

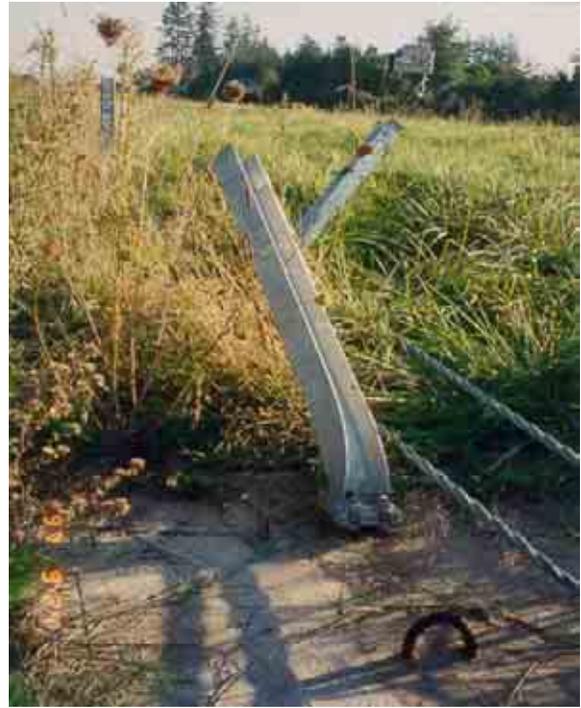
Figure 3.9: Energy dissipation-weak-post bending

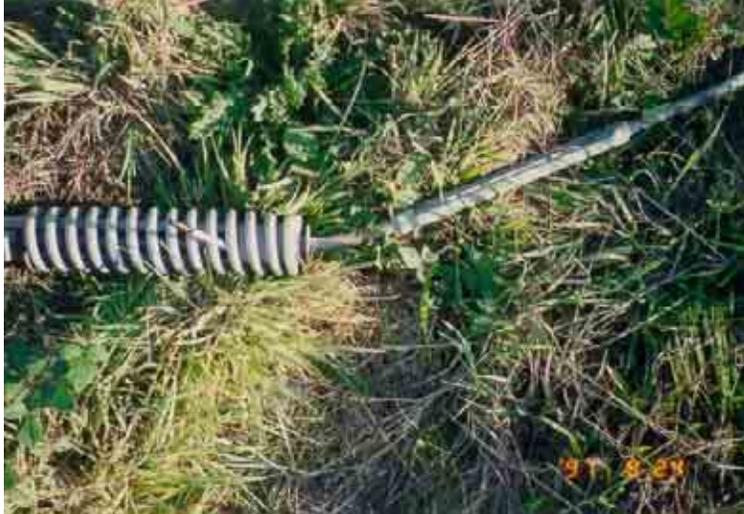
Figure 3.10: Energy dissipation-spring cable turnbuckle deformation
