**TWO-RAIL STEEL-BACKED  
TIMBER GUARDRAIL SYSTEM**

**Crown Point Highway  
Multnomah County, Oregon**

**Final Report**

**OREGON EXPERIMENTAL  
FEATURE PROJECT #OR92-03**

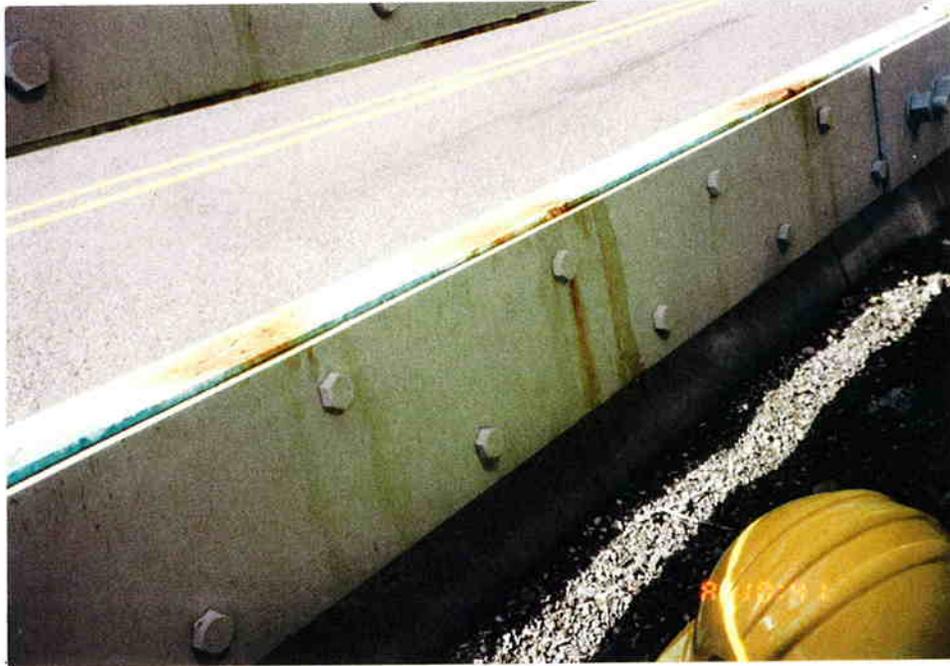
the guardrail. One section of the guardrail consists of 58 guardrail posts, of which 37 (64%) had visible signs of the galvanized steel corroding (3). This was a good representative section of the guardrail. The corrosion was caused by the leaching preservative, whereby the ammonia carrier of the preservative attacked the zinc galvanizing of the steel hardware.

**Figure 4.1: Corroded Hardware in Contact with ACZA, 1992**

Although corrosion has occurred, it is minor and at this time will not affect the satisfactory performance of the guardrail.

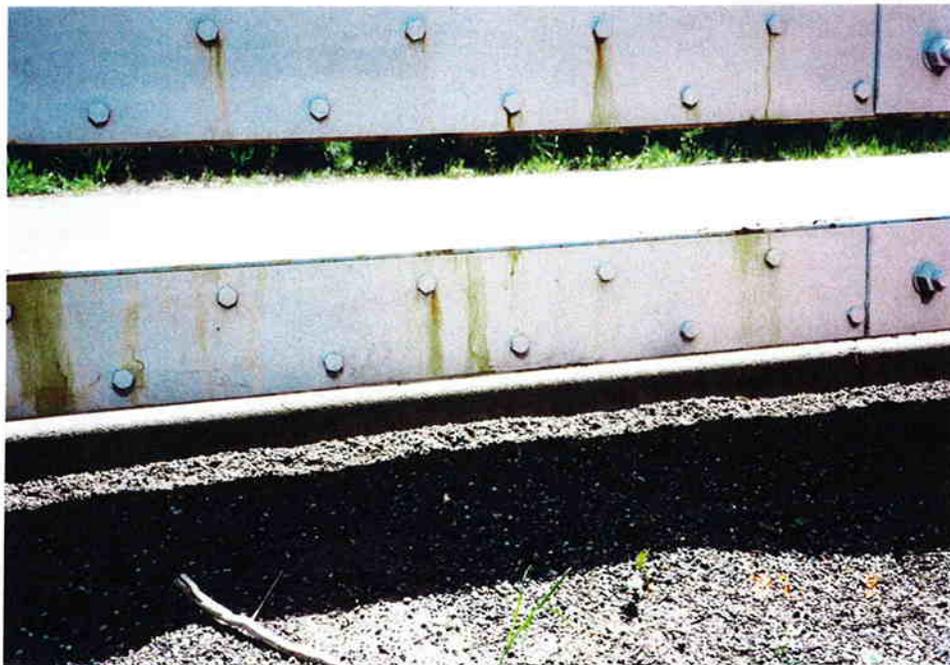
A second site visit was conducted on April 22, 1994, approximately two years after installation. There appeared to be minimal change in the discoloration of the guardrail and the corrosion of the hardware since the 1992 site visit, indicating that the leaching of the preservative has ceased. This is supported by photographs taken during the second inspection.

**Figure 4.2: Corroded Hardware in Contact with ACZA, 1994**

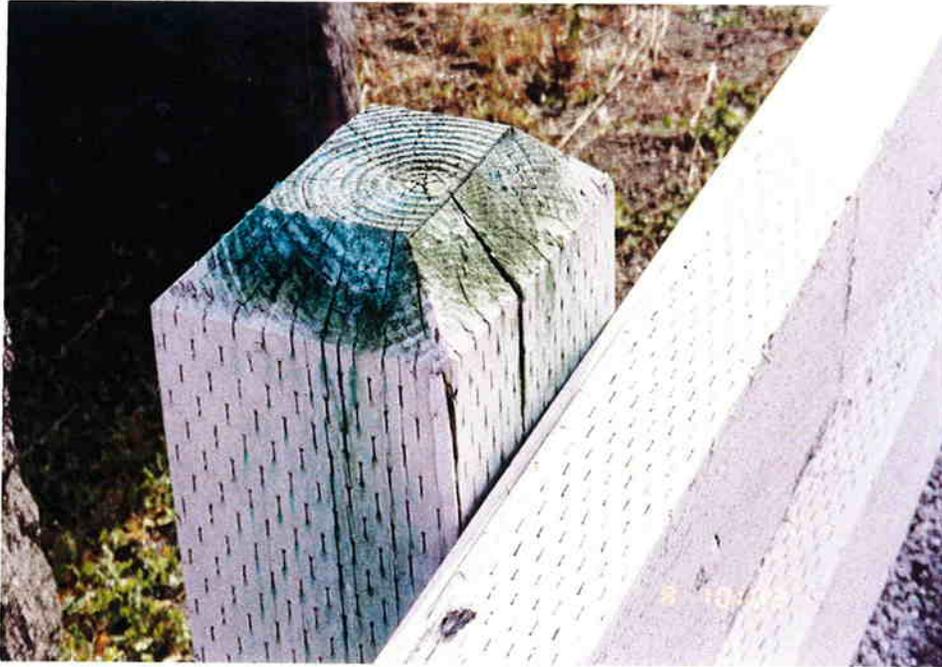
Figures 4.3 and 4.4 show the end grain section of a guardrail post. The photo shows the prominent discoloration and the flaking and peeling of the paint, which occurred on the tops of the posts, where the preservative did the majority of leaching.

**Figure 4.3: Typical Post Showing Discoloration and Peeling, 1992**

Prior to repainting the guardrail, the guardrail should be pressure washed to remove chipped or flaking paint and residue. Spot sanding may also be necessary at some locations. A sealant primer should be applied to the guardrail to reduce the risk of further bleeding and need for repainting. The sealant should be compatible with the wood preservative and the paint and be approved by the ODOT Structural Coating Quality Coordinator.

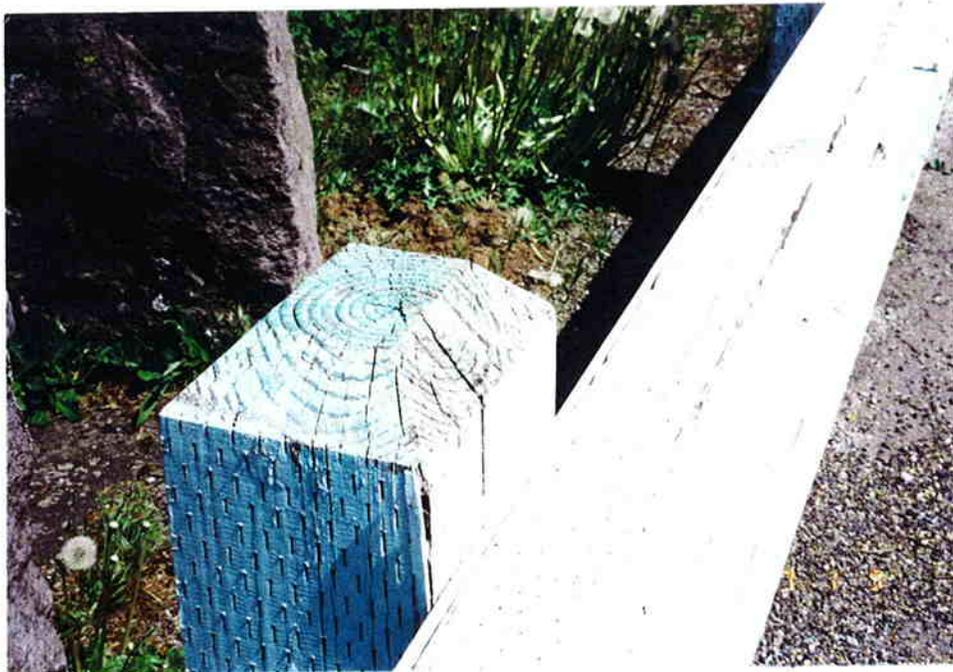
**Figure 4.4: Typical Post Showing Discoloration and Peeling, 1994**

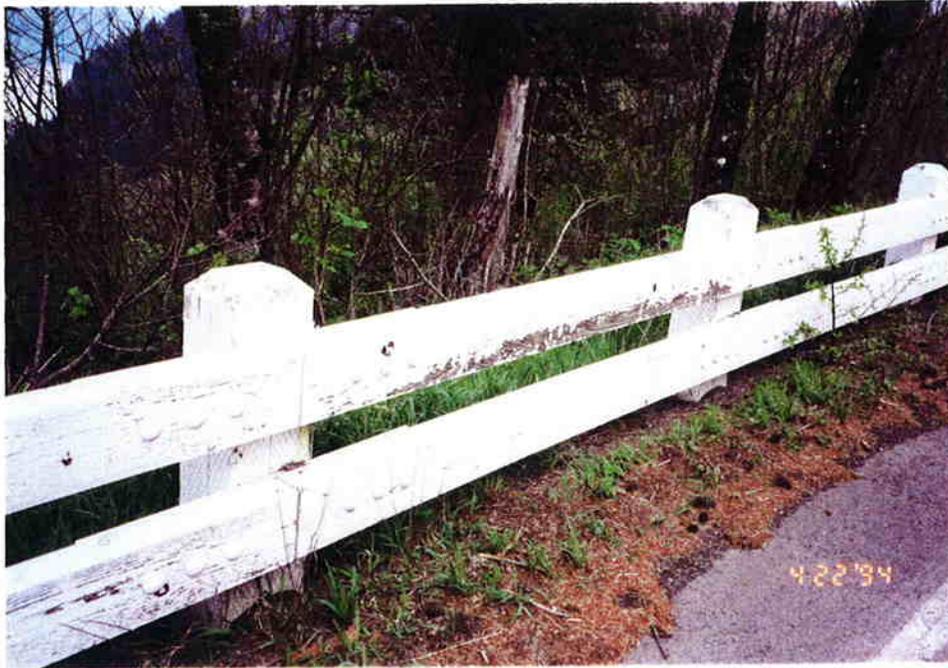
The peeling paint noted on the first site visit was much worse upon the second site visit. As noted above, the worst damage is at the tops of the posts, but the rails are now being affected as well. Figure 4.5 shows peeling on a typical section of rail. The peeling paint may have been initiated by the leaching preservative. However, this behavior is typical of the weathering process of painted wood.

**Figure 4.5: Peeling Paint on Typical Section Two Years After Installation**

A latex paint comparable to the original Acrilite Latex 7000 paint should be used to repaint the guardrail. The estimated cost of this process, including sealant and paint, will initially be \$11.50/linear meter (\$3.50/linear foot) of guardrail. The cost will decrease to \$10.50/linear meter (\$3.20/linear foot) after the first maintenance painting since the sealant only needs to be applied once. This maintenance process will need to be repeated approximately every five years.
