EXPERIMENTAL FEATURES CONSTRUCTION-REPORT

SERB GUARDRAIL
IN-SERVICE EVALUATION
OR 88-02

S. Ashland to California State Line
F.A.P. IR-5-1(113)00
Jackson County

OREGON STATE HIGHWAY DIVISION
Materials and Research Section
Salem, Or 97310

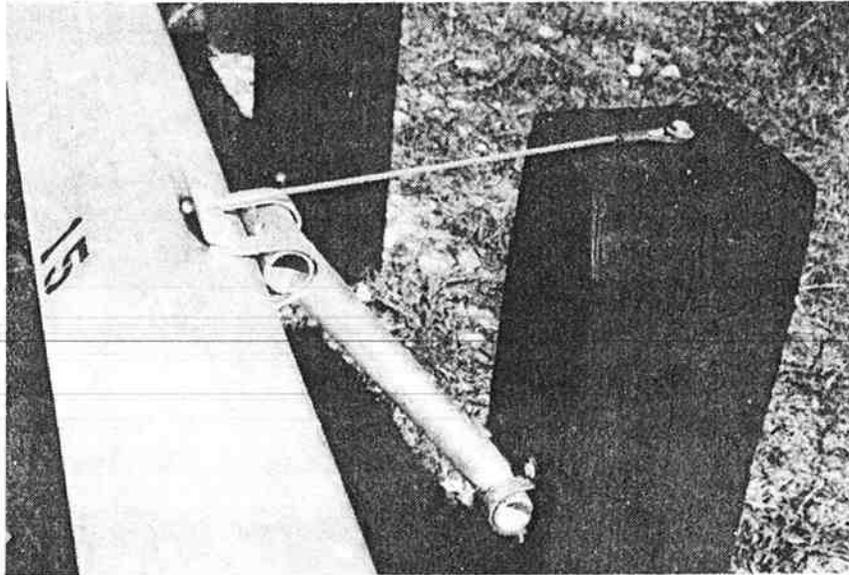
(Photo 2, pivot bars and support cables)

Pivot bars and support cables (as shown in photo no. 2) attach the SERB rail to ground mounted wooden posts. The pivot bars and support cables allow the rail to deflect backward and upward, and then return to its original position. This allows the vehicle to follow the upward motion and provides for a smooth redirection as shown in diagram two.

The Project Manager recommends that the support cable be mounted to the back of the post with a notched plate to hold the cable. Presently the lag screw is mounted in the top center of the post and will come loose if the post cracks.

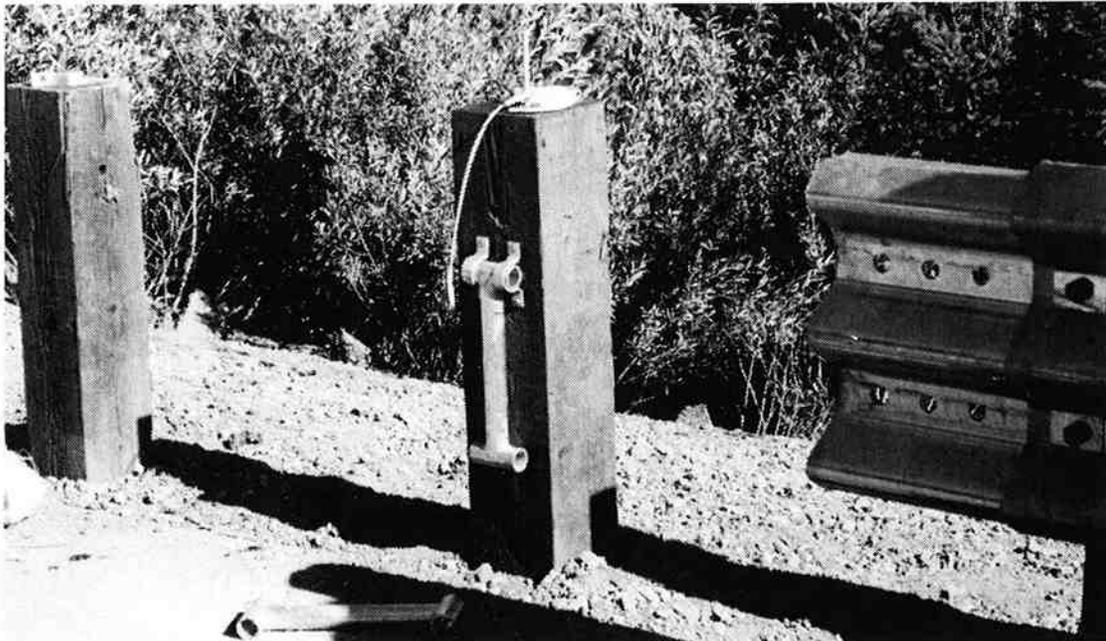
(Photo 3 internal splice)

Each SERB rail section is 24', 11 1/2" long. An internal splice, (a 24" piece of rail that slides inside each sections end) is used to connect these sections. Photo number 3 shows the internal splice and how it fits inside of the thriebeam rail.

The workers performing this installation found the SERB rail to be heavy and cumbersome to work with. Often the internal splice section had to be hammered into position. To prevent the galvanizing from being damaged extra care was required.

One major concern is how to repair damaged sections of the SERB. Maintenance personnel see the internal splice design as a problem. In order to replace a section of the thriebeam rail, the complete rail may have to be unbolted section by section for several hundred feet on both sides of the damaged area. Another problem is that Maintenance does not have the right equipment to replace the 24', 11-1/2" long sections which are heavy and cumbersome to maneuver. It is believed that handling would be easier if 12'5" manufactured sections were used. In addition, the thriebeam sections are a specialty item and cost significantly more than conventional barrier rail.

All future installations should use the LAPP-SPLICE design as part of the original construction.

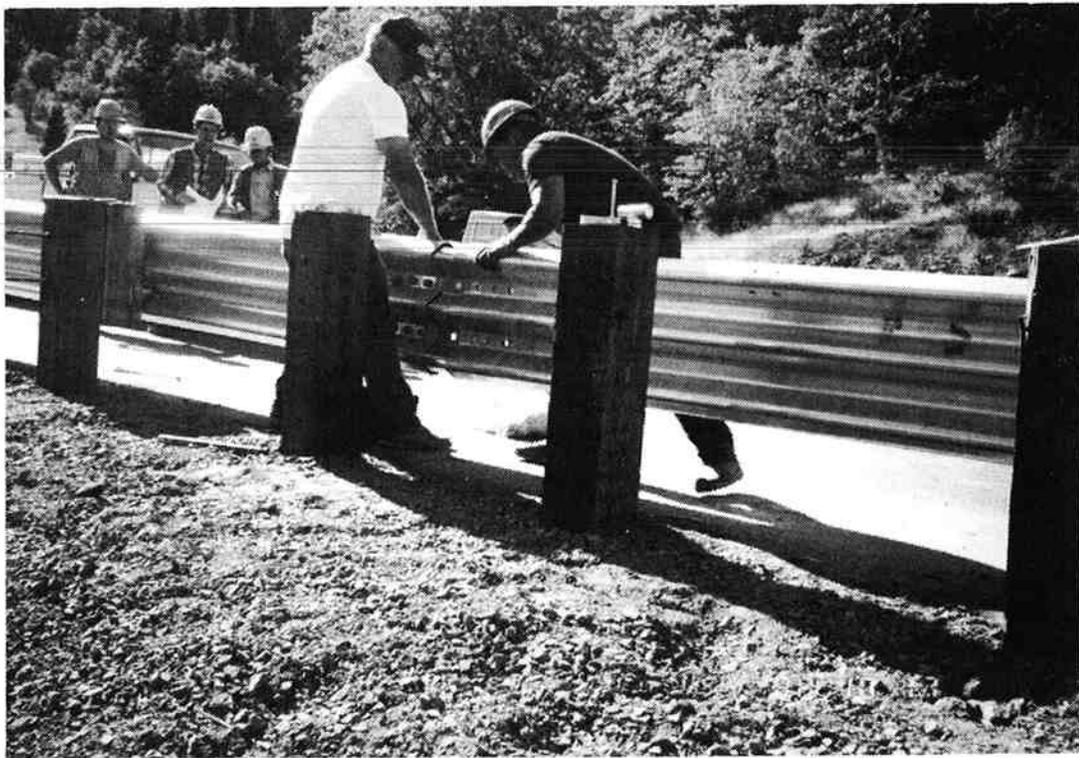
(Photo 4, rail slipped over the splice plates)

To install the splice the rail ends are wedged apart and slipped over the splice plates. Once over the splice the two rail sides come together and meet at the splice midsection as shown in photo number 4. Here they are fastened using six round fastening holes, three on the top and three on the bottom.

Oregon is not the only state that has found the SERB rail to be cumbersome to work with and to have difficulty with the internal splice during installation. According to the FHWA, Demonstration Project Division, other states who have installed the SERB rail have had these same experiences. This is because of the rail is stiff and heavy which makes it difficult to wedge apart to slip in the splice piece.

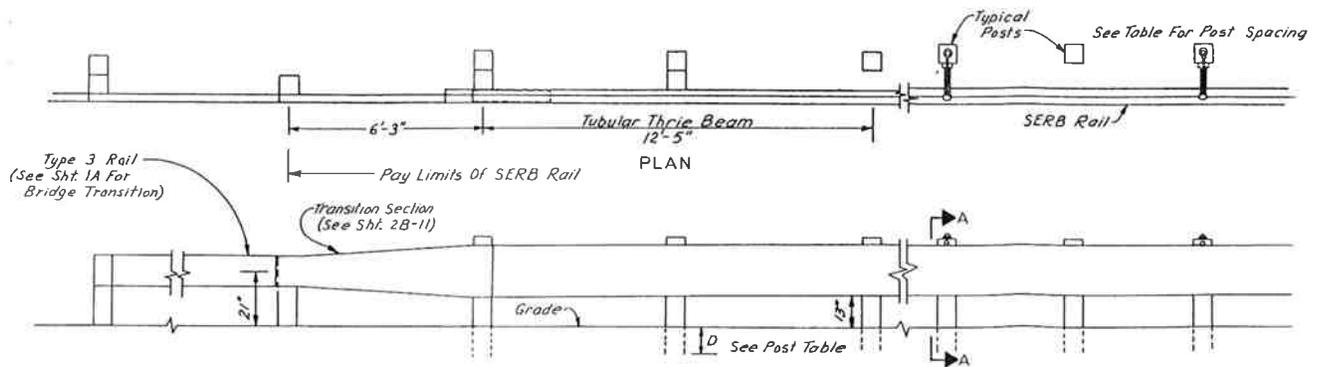
(Diagram 3 Rail Transition)

Transition back to the Type 2A and 3 rail and a bridge connection required some adjustments to fit smoothly. The concrete bridge rail that the thrie rail was to be bolted to was not high enough. So a Type 3 terminal connector was bolted to the bridge rail. It was then transitioned to the thrie rail and then to the SERB rail. Post placement also had to be tapered between SERB and Type 2A and 3 rail. This was necessary because the SERB rail posts are placed 6" farther, from the travel lanes, than the old type rail post.

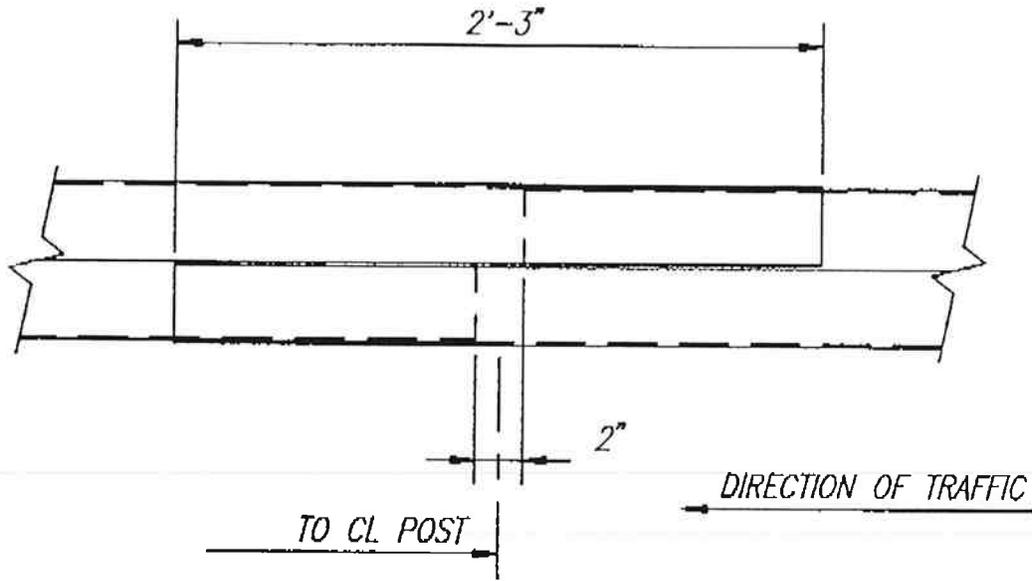
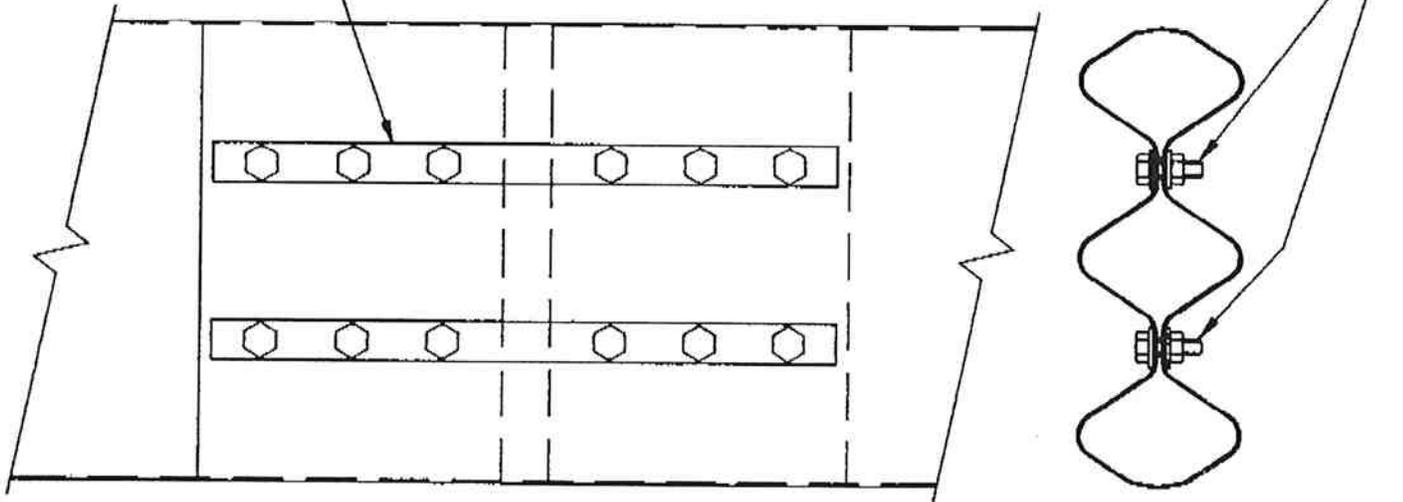
LAP ASSEMBLY
(TUBULAR THRIE BEAM)

The LAPP-SPLICE design is intended for use with new construction and has not been tested as a retrofit. Syro Steel representative, Chuck Norton, does not recommend using this design as a retrofit, although he says that it could be accomplished with some field fabrication. A diagram of this Lap Assembly Splice can be found in Appendix A. During repair the splice should be lapped in the direction of travel to minimize snagging.
