**CONCRETE BRIDGE DECKS
WITH ISOTROPIC REINFORCING**

SHORT TERM EVALUATION

**Final Report
OR-EF-99-06**

September 1998

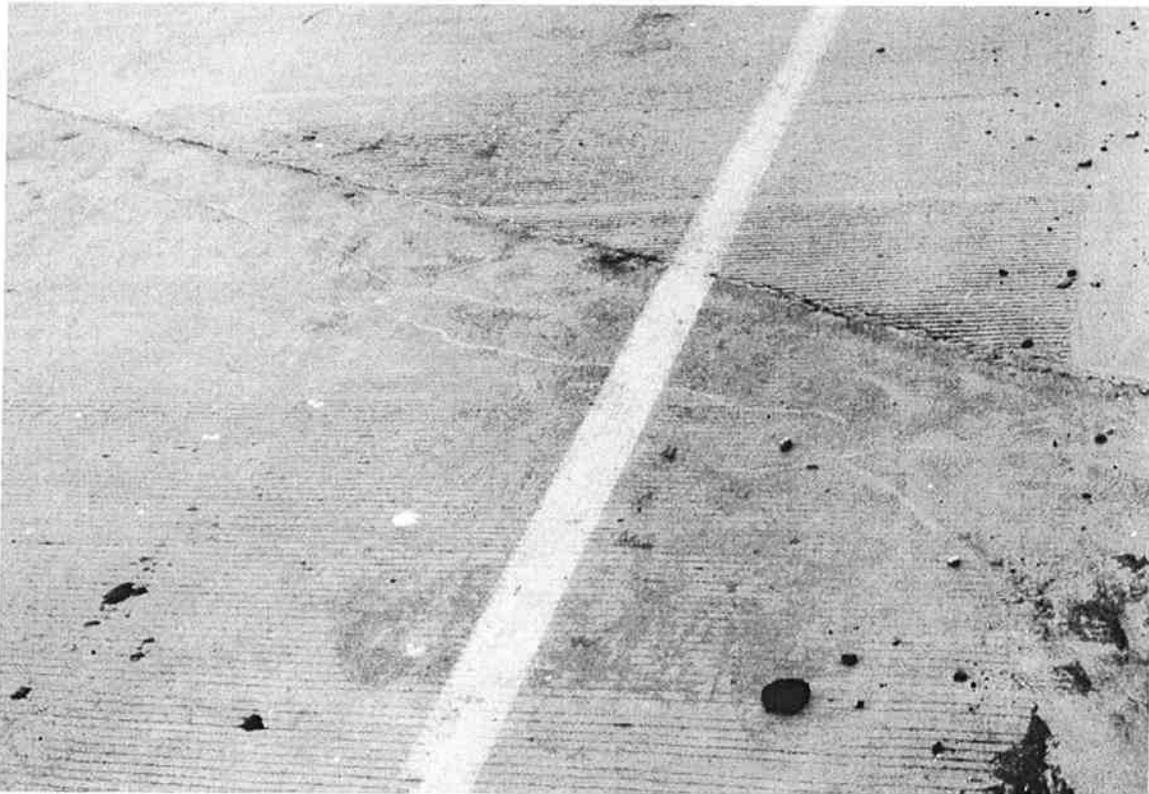
Some cracking near the bents was found and photographed, shown in Figure 3.1. Other cracking was also mentioned. However, a detailed crack map was not made, due to traffic on the southbound side and the contractor's equipment on the northbound side.

Figure 3.1: Cracks parallel to bents (April 1993).

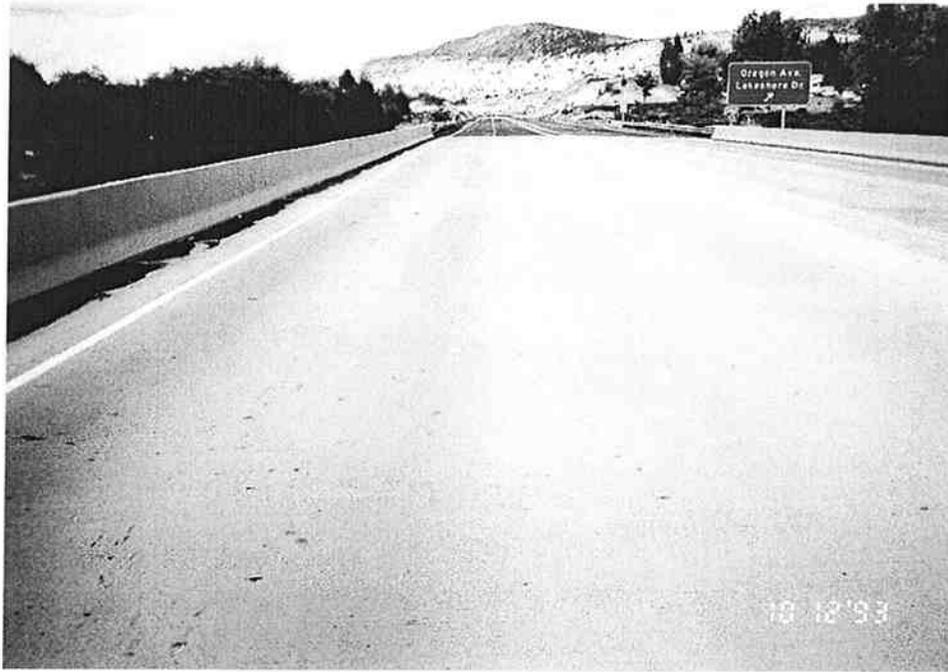
Several earthquakes and aftershocks occurred in the Klamath Falls area between September 1993 and October 1994 (Figure 3.2). Scattered transverse cracks on the southbound side were difficult to find in October 1993 (Figure 3.3). By October 1994, after the seismic activity subsided, transverse cracking had spread, making it easier to spot. Many of these cracks were sealed with methacrylate in late summer 1995. In Figure 3.4, the cracking severity is distorted by the sealant. Because detailed crack maps were not made, a correlation between seismic activity and cracking cannot be made.

Figure 3.3: Transverse cracking was not visible (October 1993).

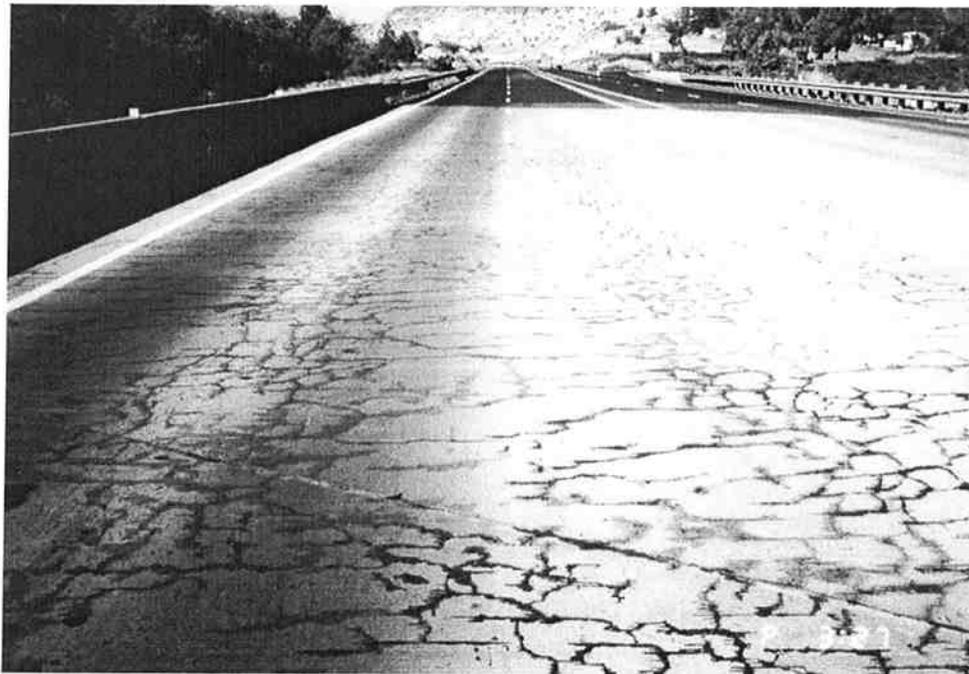
Figure 3.4: Sealed cracks in October 1995 distorted cracking severity.

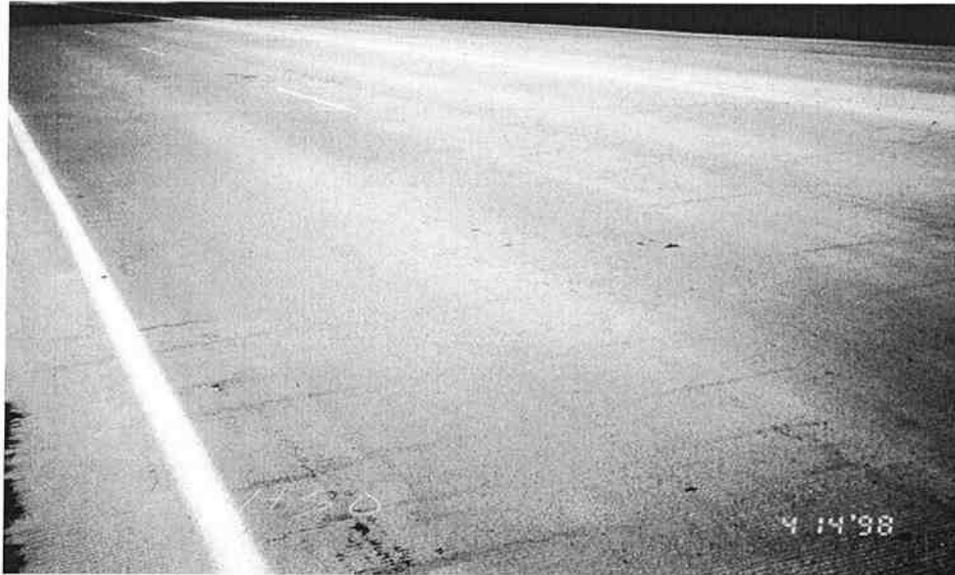
On April 14, 1998, a detailed survey of the deck was made. It included a crack map, photographs, and depth of cover for the reinforcing steel. Most of the cracks were difficult to find because the crack widths were very narrow. Cracks previously sealed with methacrylate were easier to spot. Some large cracks were found parallel to the bents. The bents on the USBR are at a skew angle of about sixty degrees (see crack map in Appendix A). Typical transverse cracking is shown in Figure 3.5, while cracking parallel to the bents is shown in Figure 3.6.

Figure 3.5: Typical transverse cracks (April 1998).

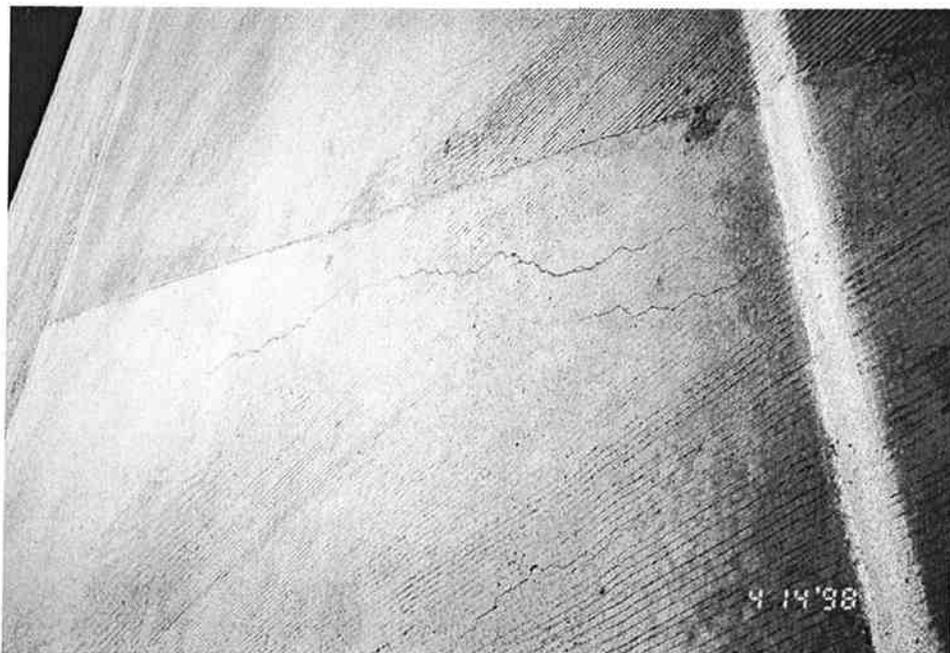
Figure 3.6: Small changes in transverse cracks parallel to bents (April 1998).

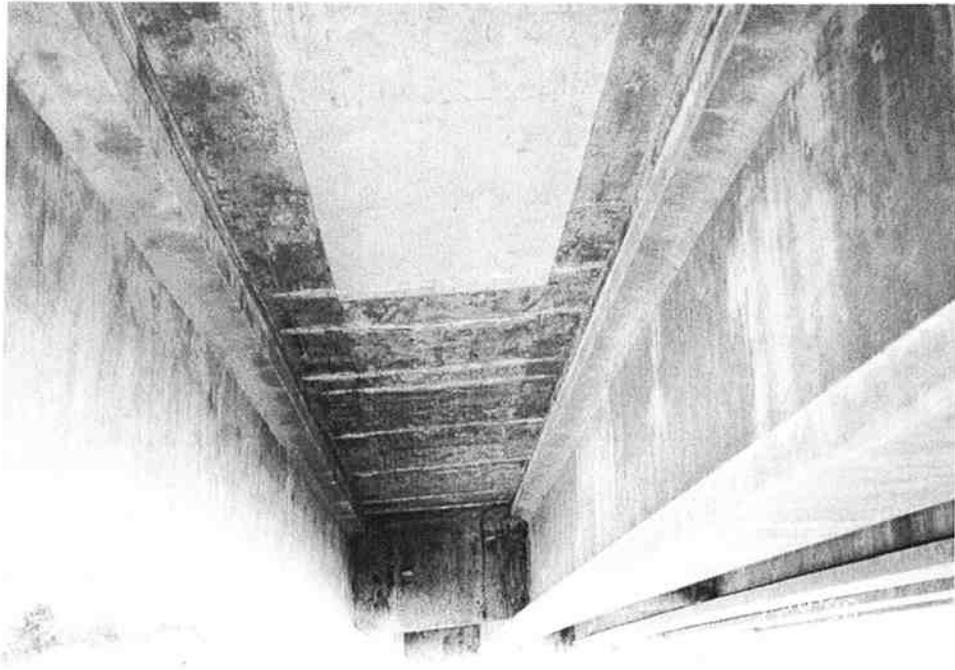
Although mapping cracks on the underside of the deck was not done because of the bridge height, photographs were taken. Most of the serious cracking was found near the east end on the bottoms of spans 8 through 11, as seen in Figure 3.8. Large transverse cracks with efflorescence were located near the diaphragms at center span. The taller columns near the west end did not have large visible cracks, as seen in Figure 3.9.

Figure 3.8: Transverse cracks were found on the bottom of the deck near center of span.

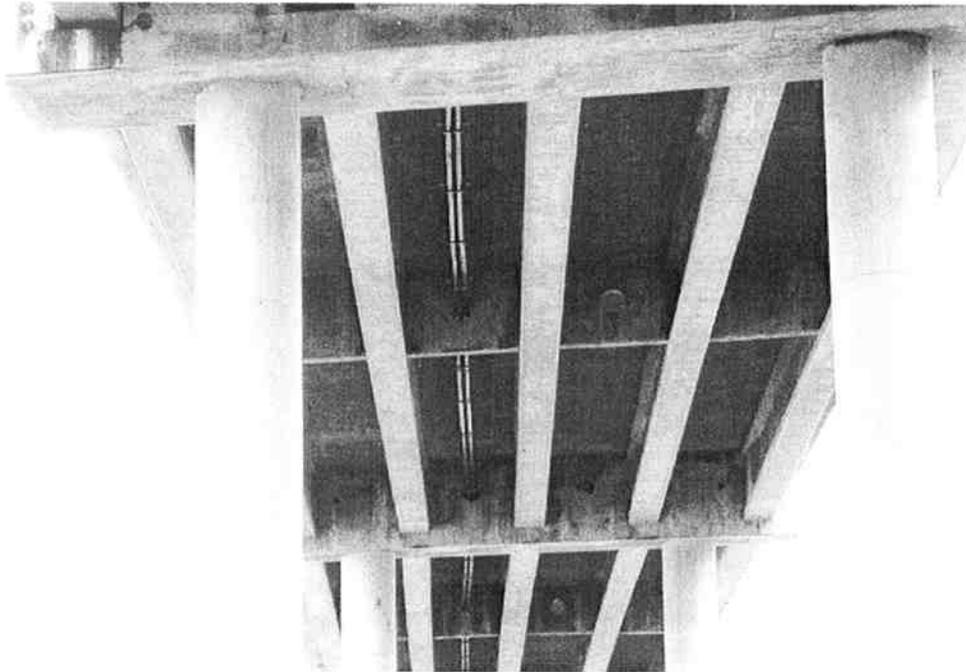
Figure 3.9: Transverse cracking is not found under the deck at the higher section of the structure.

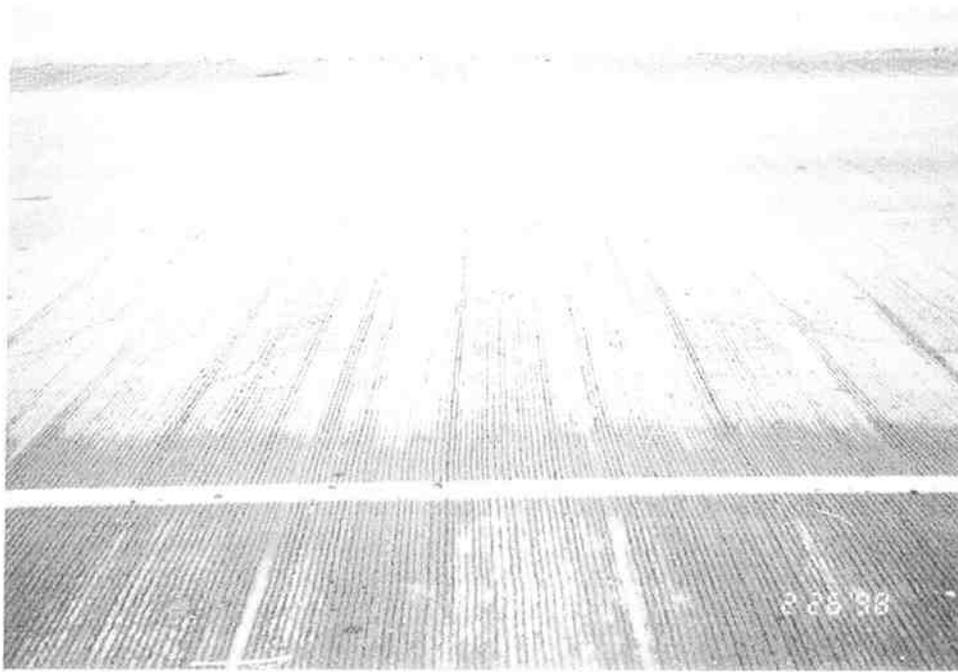
On February 26, 1998, the Research Unit, with the help of bridge designer Larry Bush and Region 2 Bridge Inspector Jeff Swanstrom, made a detailed inspection of the deck of Santiam Overflow No. 4. Both the top and bottom of the deck had transverse and longitudinal cracks, as shown in Figures 3.11 and 3.12. The bottom of the deck had large cracks, many even went through the deck. Stains on beams from water running through the cracks were found. A trench was also noted in the sand under the deck, apparently caused by water running from the surface through a large crack in the deck. Cracking on the underside of the deck was found over almost the entire surface with the frequency of cracking greater near the bents

Figure 3.11: Cracking on the top of the deck.

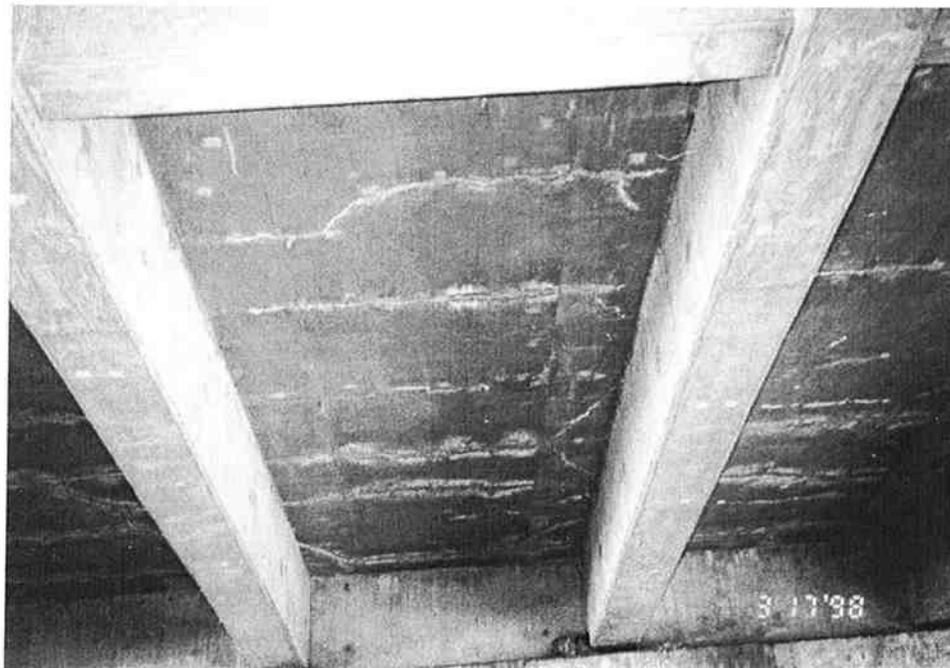
Figure 3.12: Cracks on the bottom of the deck were outlined by efflorescence stains.

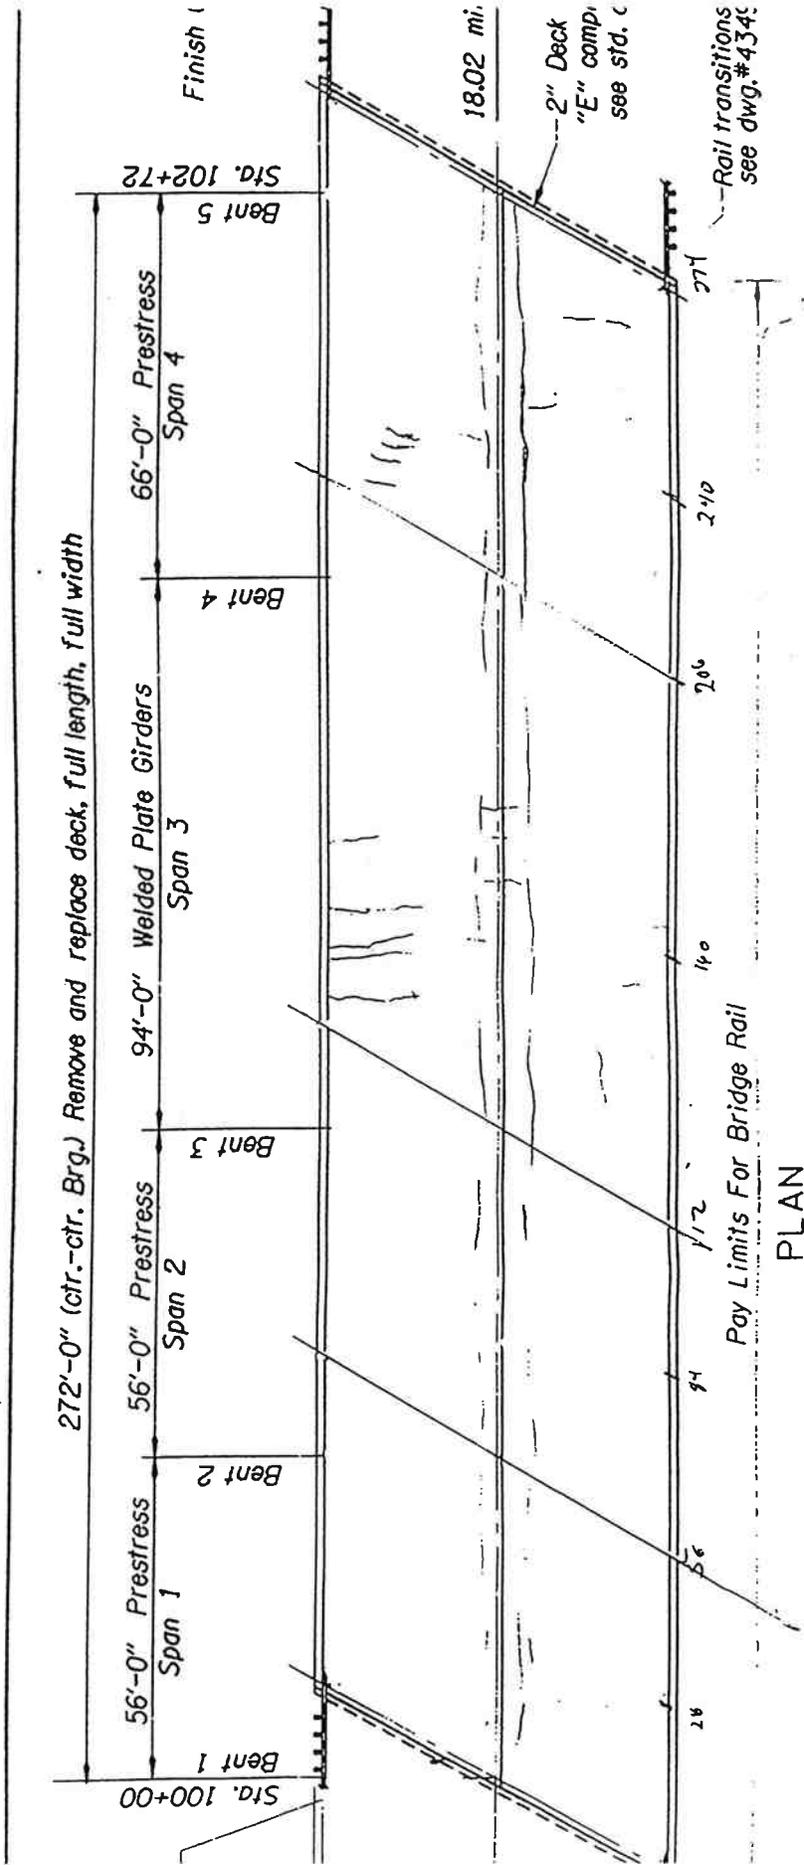
Bottom of USBR Deck as seen April 1998 through the top.
