**GEOSYNTHETIC MATERIALS
IN REFLECTIVE CRACK
PREVENTION**

Final Report

SR 537

July 2007

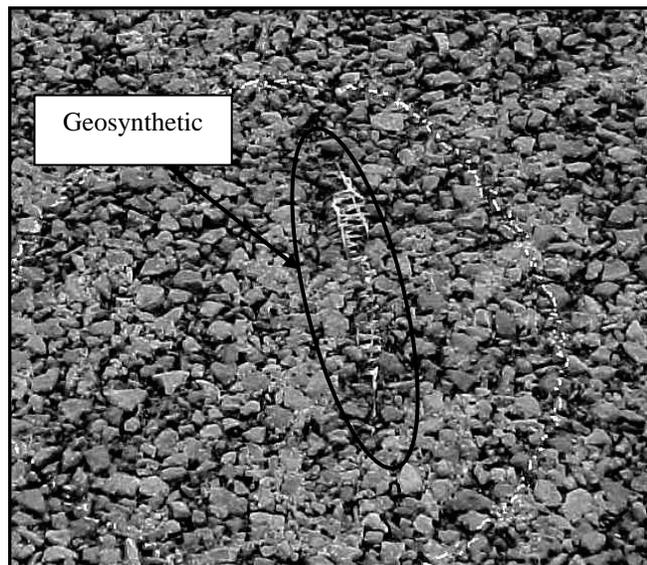
Figure 4.2: Glasgrid 8502® geosynthetic exposed at the surface

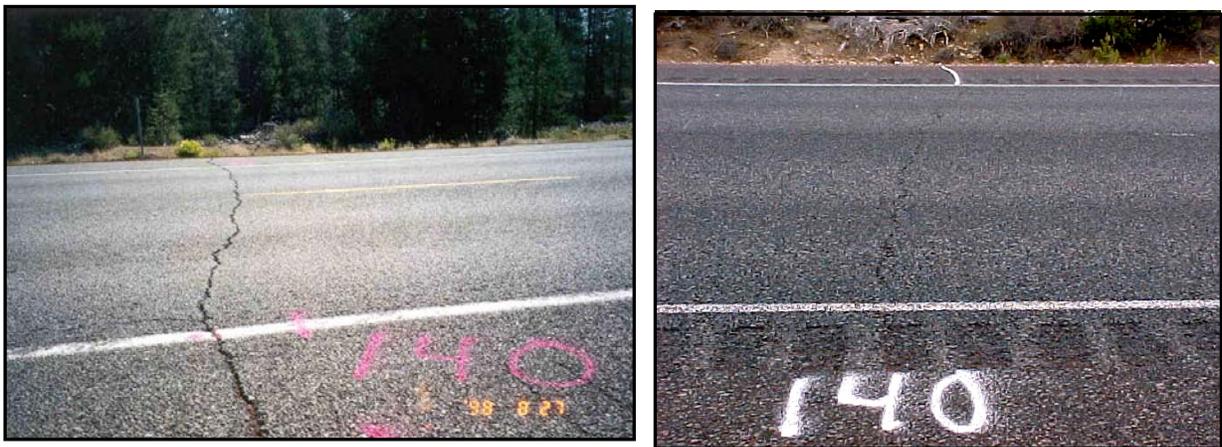
Observations were first made in 1999, one year after installation and construction, and continued once a year for eight years until May of 2007. By the end of the study, 132 of 140 transverse cracks had reflected through the pavement overlay (Figure 5.1) (Appendix A). By May of 2007 many of the cracks (99 total) had been filled and sealed over. A few cracks that had not appeared in 2006 such as control cracks 137 and 138 were sealed in 2007. It was assumed that because the cracks were filled, they were visible and thus were given a severity rating of low.

Figure 5.1: Photographic comparison of crack 140 shown before the overlay was constructed (pictured left) and the reflection of crack 140 through the overlay after construction (pictured right)

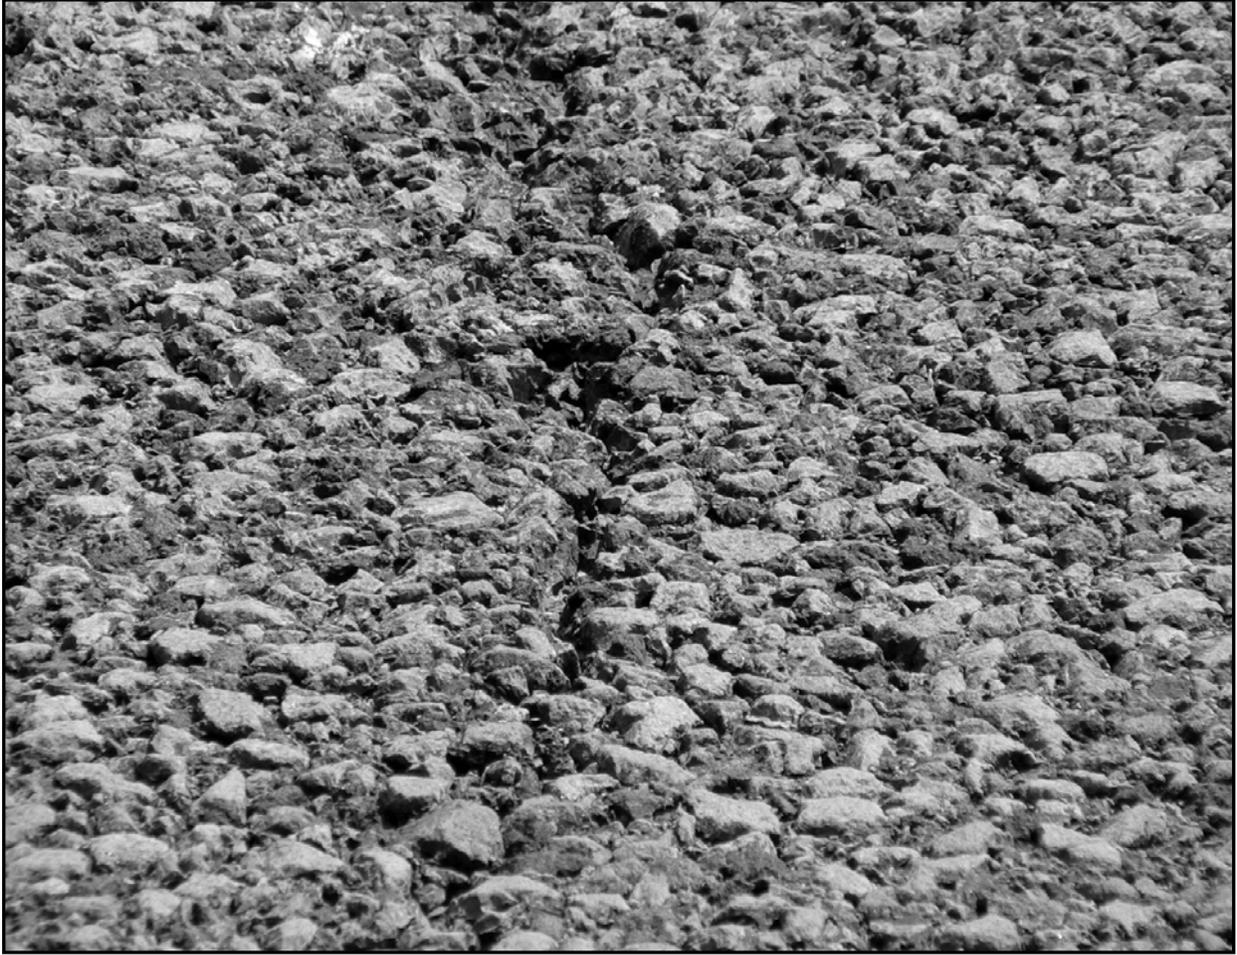
Starting in 2005, the geotextile products appear to fail rapidly, causing many cracks to reflect and overall crack severities to worsen (Figure 5.3). All test sections had cracks that reflected over 50 percent of their original length. The total number of cracks nearly doubled from 59 in 2004 to 110 in 2005. One factor that may have contributed to the worsening of road conditions in 2005, was the drop in average temperatures, with an extreme low temperature of -13 degrees. The last time the temperature dropped below -10 degrees was in 1998. Also, according to the Oregon Climate Service at Oregon State University, annual precipitation for 2005 (nearly 30in) exceeded average annual precipitation from 1998 to 2007 (24.7in). Both the decreased temperatures and the increased precipitation may have accelerated the deterioration of the roadway.

Figure 5.3: Close-up view of transverse crack reflecting through overlay

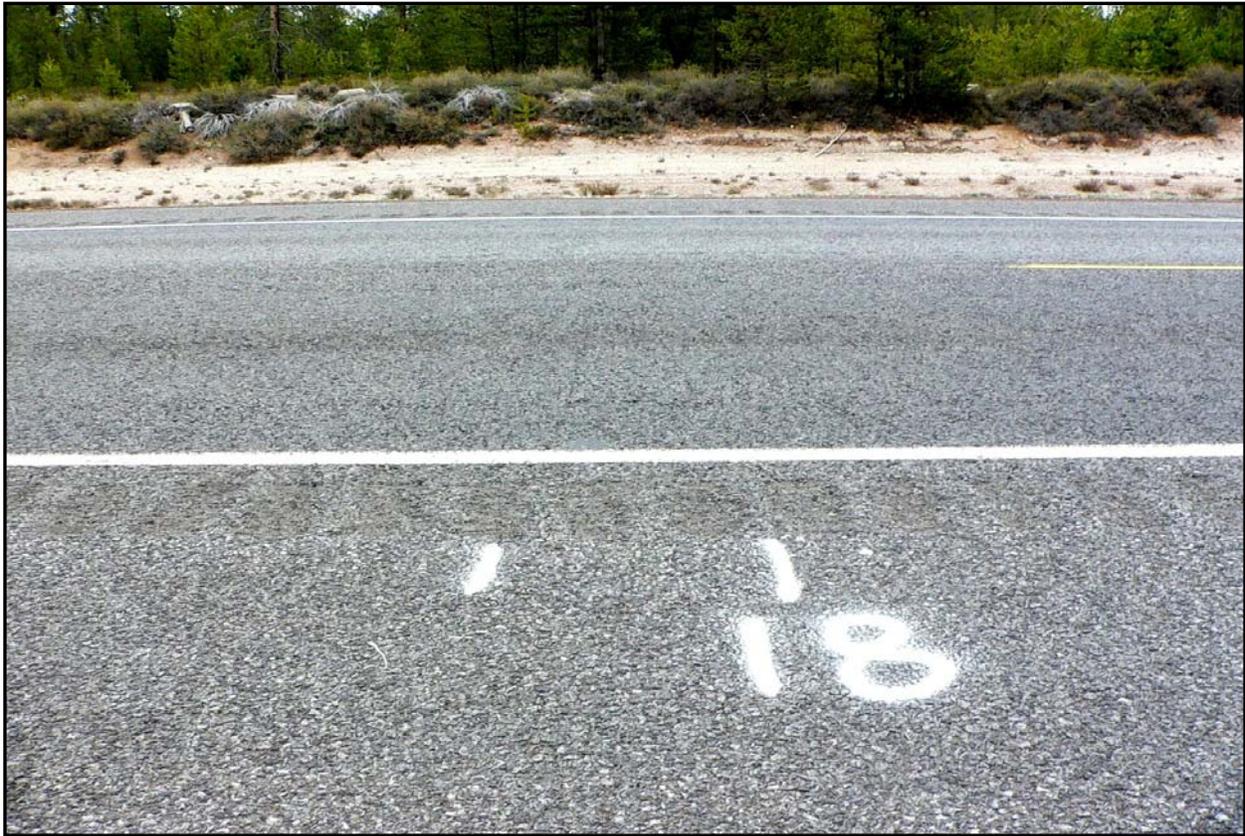
The best product in reducing reflective crack severity was Glasgrid 8502®. By 2007 all 20 transverse cracks had reflected through the overlay in the Glasgrid 8502® test section but 95

percent of them were of low severity and only one ranked as medium severity (Figure 6.1). The majority of low severity cracks were very narrow and were difficult to trace across the pavement (see Figure 6.1).

Figure 6.1: Example of a low severity crack in the Glasgrid 8502® test section
