Polymer Concrete Bridge Deck Overlays

**Deschutes River Bridge (Biggs)
and Maupin Bridge (Maupin)**

Final Report

July 1995

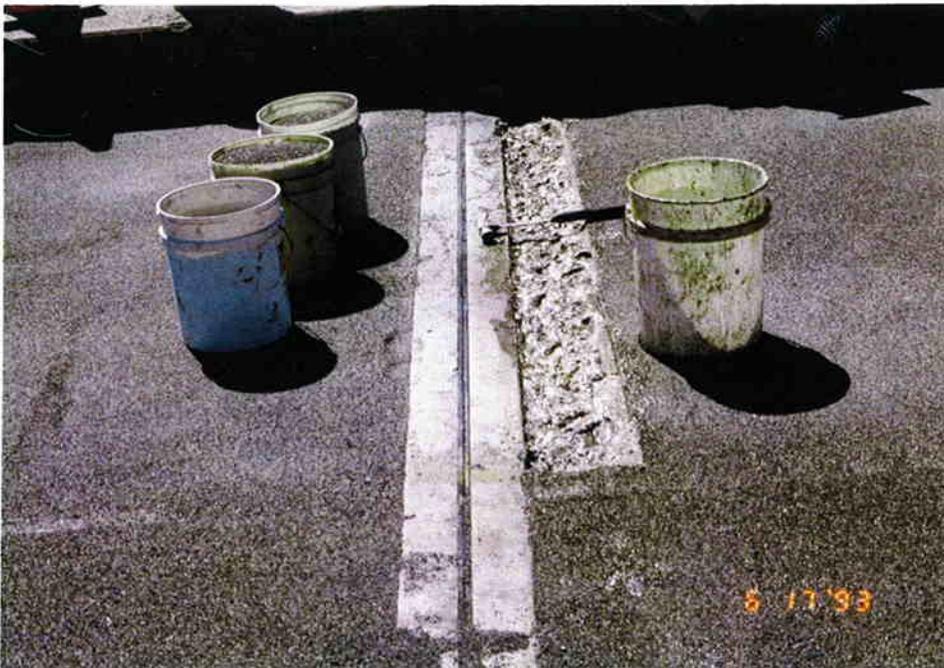
Rough spots were also created at the expansion joints. In the areas near the joints, the concrete had been chipped out more than 1/2-inch deep. Since the polymer only filled to 1/4-inch, a low area, 6 inches wide was left on both sides of the joint. More aggregate was added to some joints which caused ridges. Since this occurred on both sides of the armored joint, a bump was felt by motorists driving over it. The worst joint was repaired by making a cut line with a carbide saw, and then chipping the polymer concrete off. On the second joint application, more care was taken to "fill and feather" the depression by adding more polymer and rock by hand. This method had limited success and was not repeated.

Figure 4.2. Deck preparation adjacent to expansion joint.

- 3) Joint repair shall include the removal of material 12 to 18 inches on each side of the joint. Heavy shot blasting or diamond grinding shall be used for concrete removal around the joints. The material used to fill the joint shall be feathered in to provide a smooth riding surface.

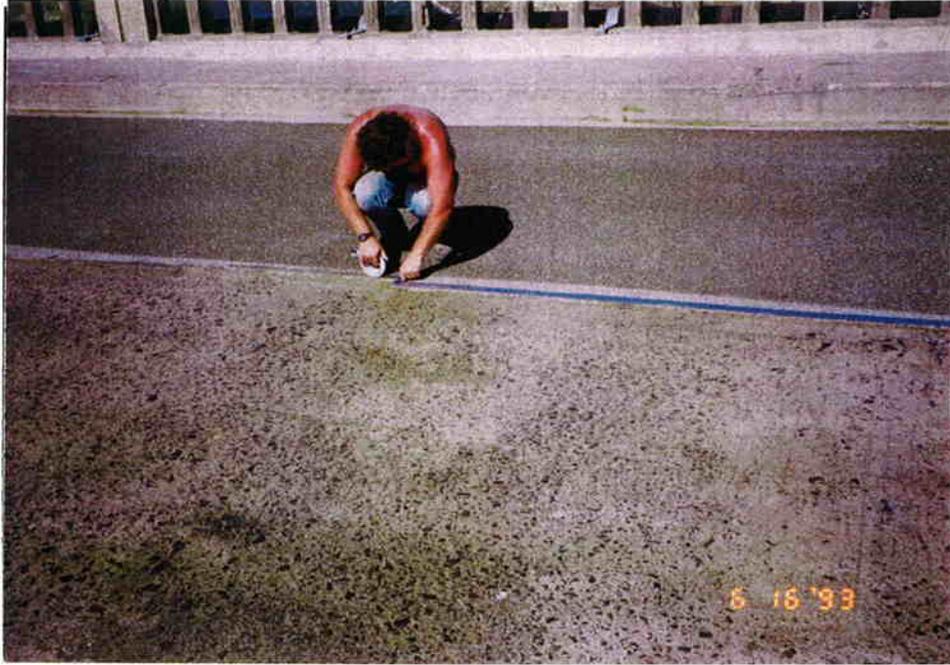
Figure 4.3. Duct tape application at overlay joint.

Duct tape placed over the finished lane edge to prevent an overlap coat of slurry mix could have caused the centerline delamination. Removing the tape weakened the joint and left a crack for water to seep beneath the mat.

- 8) If edge tape (duct tape) is used, it shall be removed as soon as possible. If the mix sets up, edge tape removal may cause delamination.
- 9) Gauge rakes shall be checked and hooks replaced frequently to maintain the specified minimum thickness of overlay.
- 10) The air and deck temperatures shall be monitored and the catalyst amount changed according to manufacturer's instructions.
- 11) Construction shall be planned to keep traffic off of the primed surface.

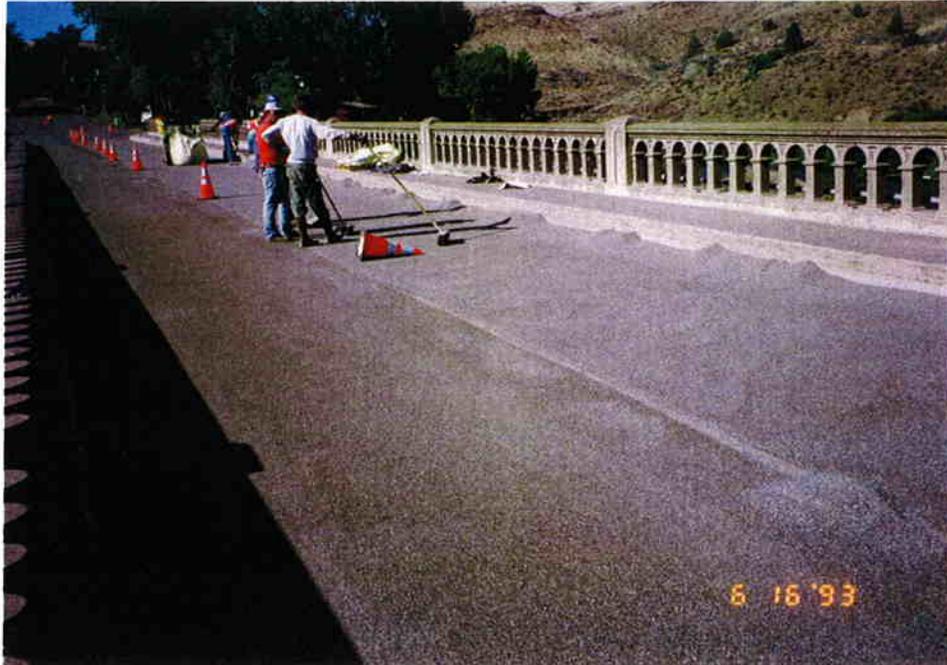
Figure 4.5. Excess aggregate on overlay at Maupin. Adjacent lane shows completed overlay.

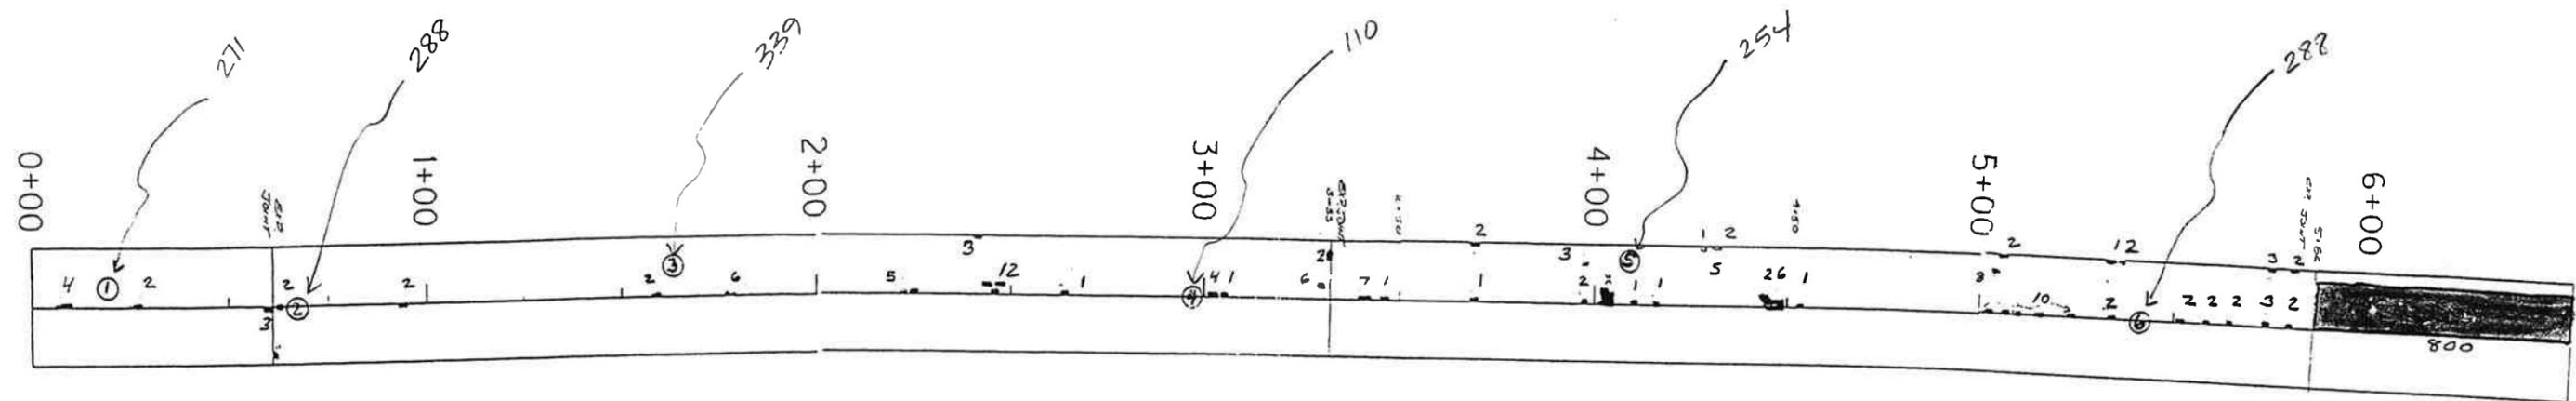
The entire deck surface was checked for delamination by the "sounding method" (ASTM D4580). Both hammer and heavy chain were used. The bad areas were plotted on a scale drawing of the bridge deck, Figure 6.1, for further evaluation. Small delaminated areas located along the curb and center lines were found across the entire deck. The largest delaminated area was found on the east end of the westbound lane. This distress section covers a total area of about 900 square feet.

The delamination discovered during chain drag tests was found along the curb and down the centerline. Deck preparation could be a cause of the delamination near the curb. Deck preparation along the curb was done by sand blasting since the shot blaster was not able to clean the surface adjacent to the curb because of the machine design. Because sand blasting is a manual operation, spots could have been missed or only done lightly which may have decreased the bond strength of the polymer concrete leading to delamination. The concrete substrate could also have been contaminated from material blowing off the sidewalk prior to primer application.

The 800 square feet where delamination was noted in the westbound lane at the east end of the bridge, was applied late in the day (using headlights from the pickups for light). Because of a shortage of material, the prime coat was placed too thin. This section was also opened to traffic sooner than other sections.

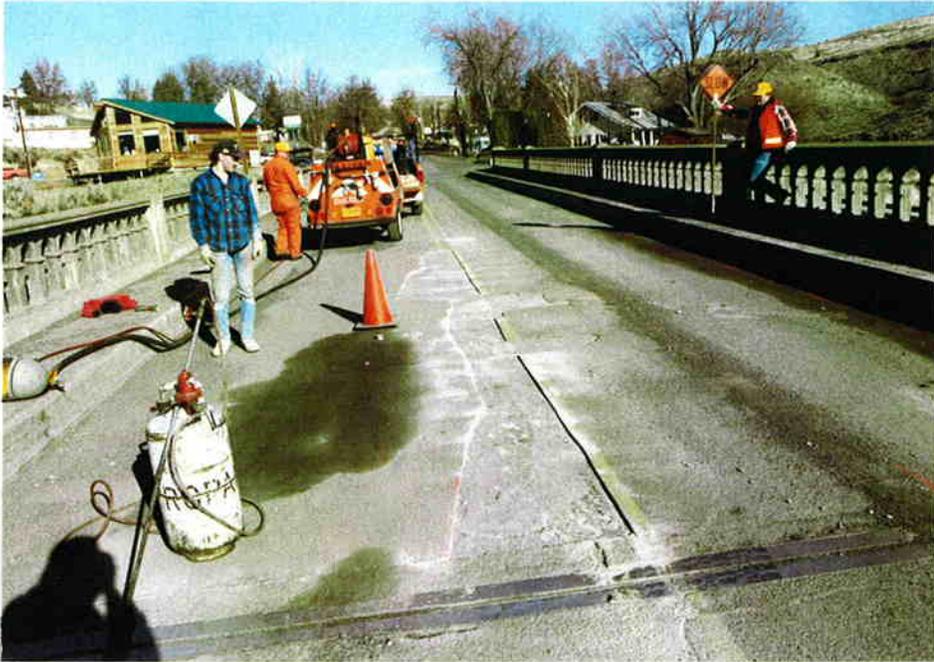
Figure 7.2: Delaminated Bridge Deck Prior to Overlay.

To investigate the repair of a delaminated area, a test patch using the polymer concrete was constructed. The area, near the center of the deck, was a 4 ft. by 20 ft. strip extending north from the expansion joint at Sta. 4+10. The deteriorated polymer concrete was cut on a straight edge with a carbide bladed circular saw to the depth of the original concrete. The overlay material was removed with a hammer and chisel. The material broke away in two-foot square sheets with a minimum of force being applied. No prime coat was visible on the deck; some was visible on the removed sheets. The exposed deck was wet and had to be dried with a torch before the new patch was applied. Figures 7.2 and 7.3 show the delaminated area prior to patching.
