**LATEX AND MICROSILICA
MODIFIED CONCRETE BRIDGE
DECK OVERLAYS IN OREGON**

Interim Report

SPR Project Number 5288

Oregon Department of Transportation

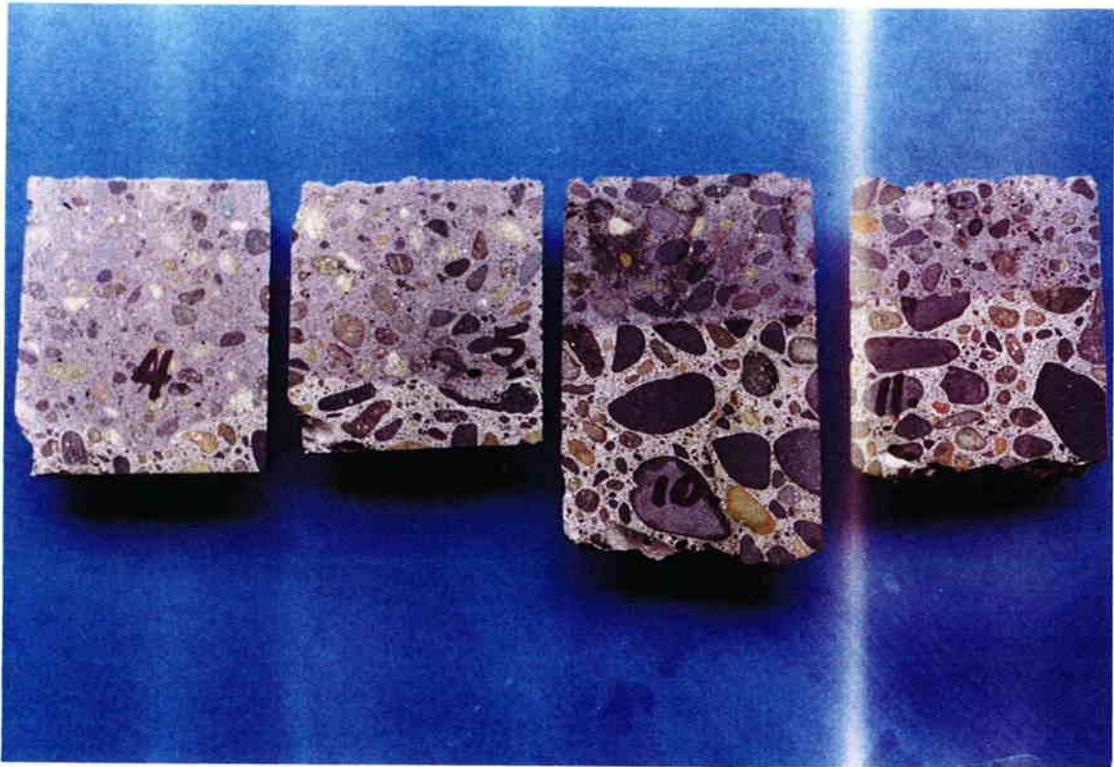
The interface or contact between the overlay and original concrete was characterized as being irregular, with about 1/4 to 3/8 in. (6 to 10 mm) of relief, and a zone of chalky, soft paste on top of the irregular surface. The paste within the light-colored contact zone contained fly ash, indicating that it was associated with the overlay mix at time of placement. Phenolphthalein applied to freshly broken surfaces did not indicate that the soft chalky material was carbonated. Some discontinuous shrinkage cracks were noted within the soft chalky zone but, when the samples were broken in the laboratory, bond strength along the contact appeared good. When Cores 4 and 5 were broken in the laboratory, other cut and polished sections showed the overlay to be well bonded to the original concrete. The surface region of the original deck concrete was free of microcracking in the paste as well as the aggregate particles in contact with the interface surface. Additional details of the petrographic examination are summarized in the attached Study Sheets contained in Appendix A.

Figure 2.1a. Cores 4, 5, 10, and 11 Cut and Polished for Examination.

- 1) The surface preparation procedure used on the original bridge deck represented by Cores 4 and 5 resulted in a relatively irregular surface with up to about 3/8 in. (10 mm) of relief. The procedure used in preparing the bridge deck surface represented by Cores 10 and 11 resulted in less relief but significant microcracking in the paste and fracturing of the aggregates just below the interface. The thin, light-colored chalky layer of paste above the interface contact in Cores 4 and 5 exhibited discontinuous microcracks; however, the bond quality or strength in all of the bridge deck overlays represented by these cores appeared high.

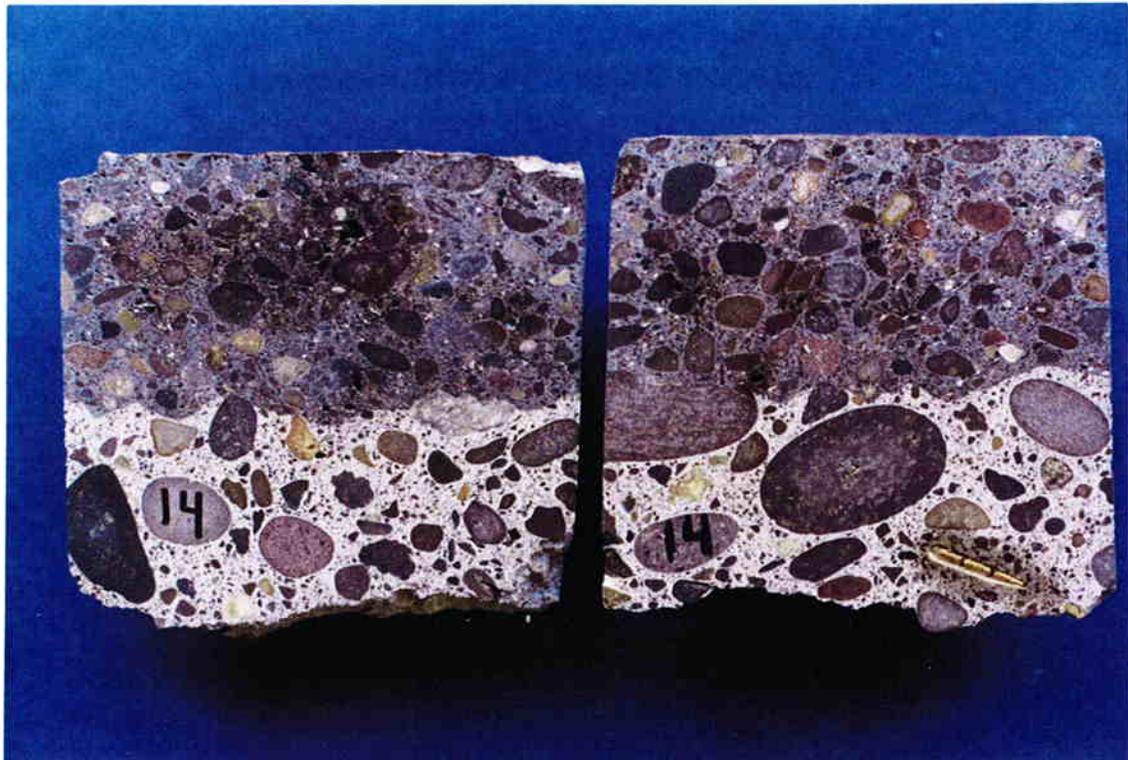
Figure 2.1b. Cut and Polished Section of Core 14.

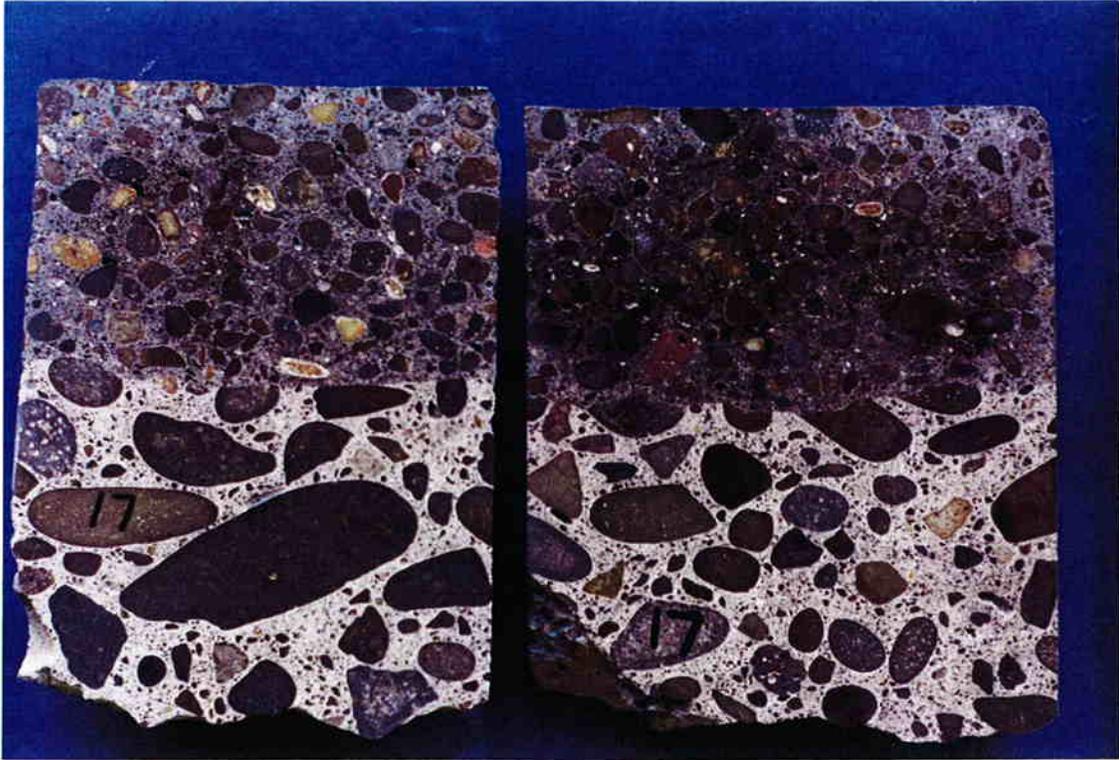
Figure 2.1c. Cut and Polished Section of Core 17.

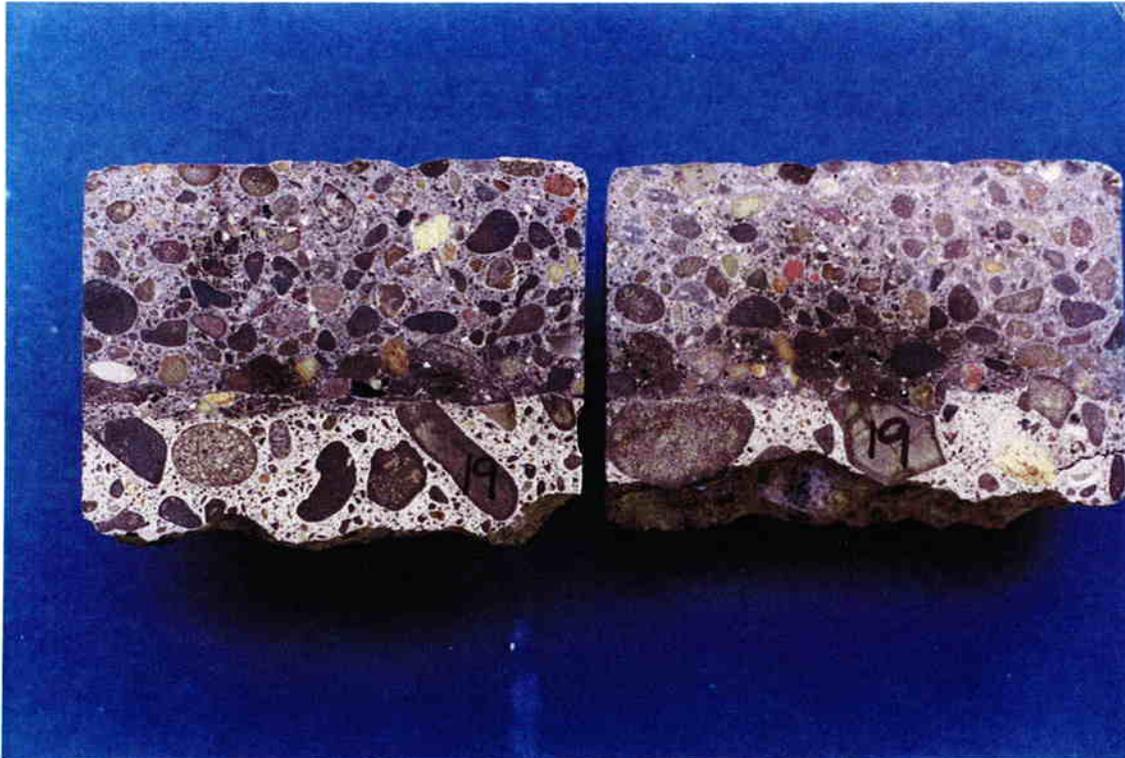
Figure 2.1d. Cut and Polished Section of Core 19.

Traces of alkali-silica gel were observed in the original underlying concrete portion of Cores 19 and 20. The interface zone between the overlay and original concrete in Core 19 exhibited significant fracturing of the original concrete and within the coarse aggregate particles adjacent to the contact surface.

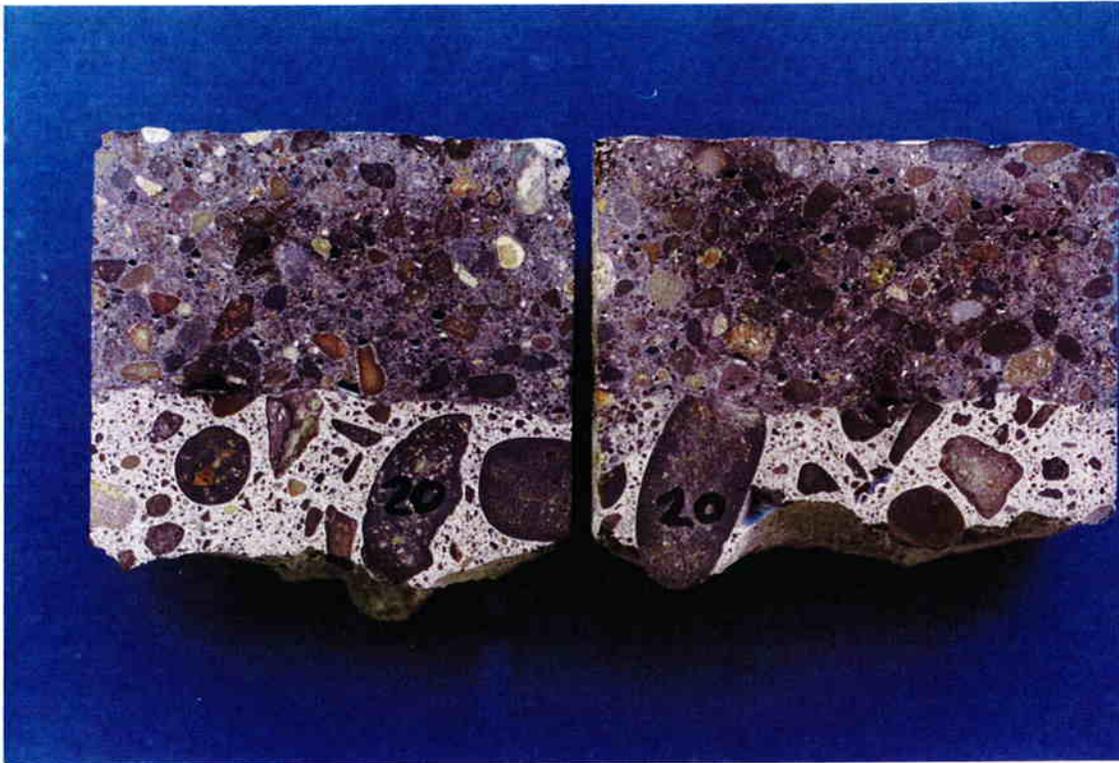
Figure 2.1e. Cut and Polished Section of Core 20.

However, Core 20 did not show severe cracking. Minor fractures were observed, but they were not as pronounced as observed in Core 19. The photomicrographs illustrate the microfracturing subparallel to the contact surface within the original concrete. As observed in all the cores, the overlay concrete did not exhibit fracturing parallel to the interface. Evidence of partially removed overlay concrete superimposed with newer overlay mix was detected in Core 19.

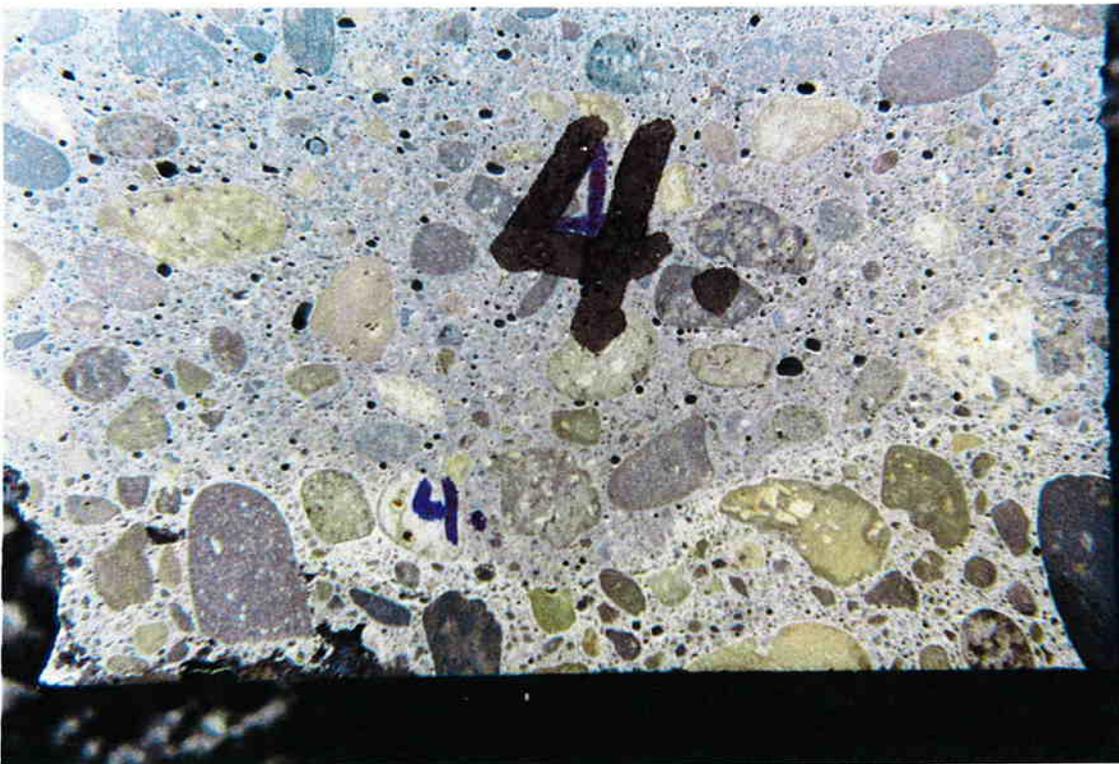
Figure 2.2. Close-Up View of Core 4 Showing the Overlay (Dark Concrete) in Contact with the Original Bridge Deck Concrete (Lighter Colored). Note fairly irregular contact surface. (Magnification about 2X.)

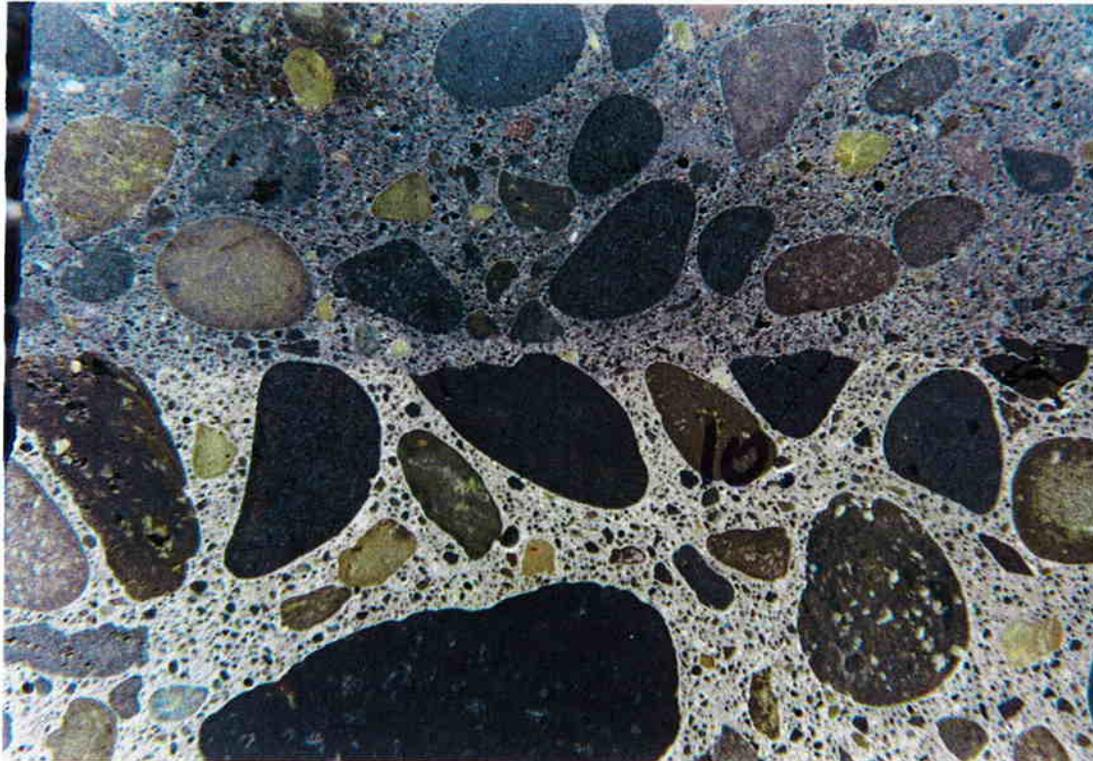
Figure 2.3. Close-Up of Core 10 Showing Interface Surface Between Overlay (Dark) Concrete and Original Deck Concrete (Lighter Colored).

The interface in Cores 10 and 11 was relatively even with a relief no greater than about 1/8 in. (3 mm). The interface or contact surface was clean and uniform in color. The bond strength between the overlay and the original concrete appeared high. However, the samples showed a significant number of microcracks in the paste and fractures within the aggregate in contact with the interface surface. One section of Core 11, when broken in the laboratory, showed some preference to fracturing horizontally within the original concrete 1/8 to 1/4 in. (3 to 6 mm) below the interface surface; however, the bond at the interface appeared excellent.

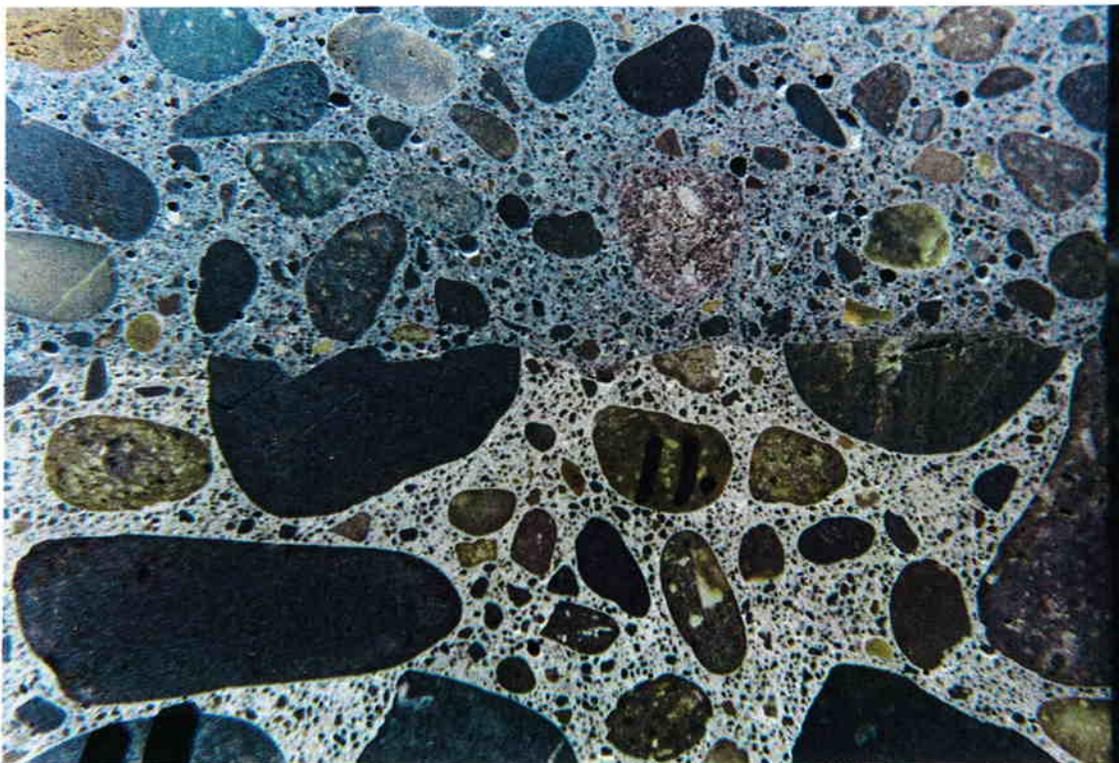
Figure 2.4. Close-Up of Core 11 Showing Interface Surface Between Overlay and Original Concrete.

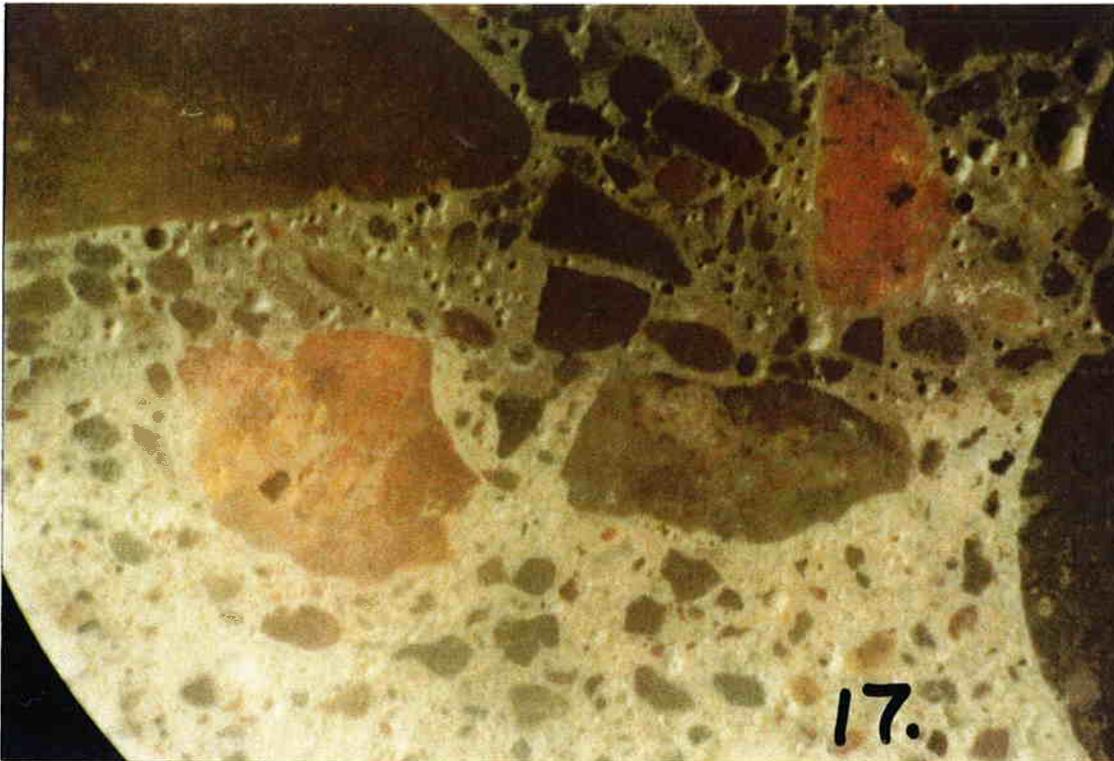
Figure 2.5. Close-Up View of Interface Surface Between Overlay and Original Concrete of Core 17. (Magnification about 10X.)

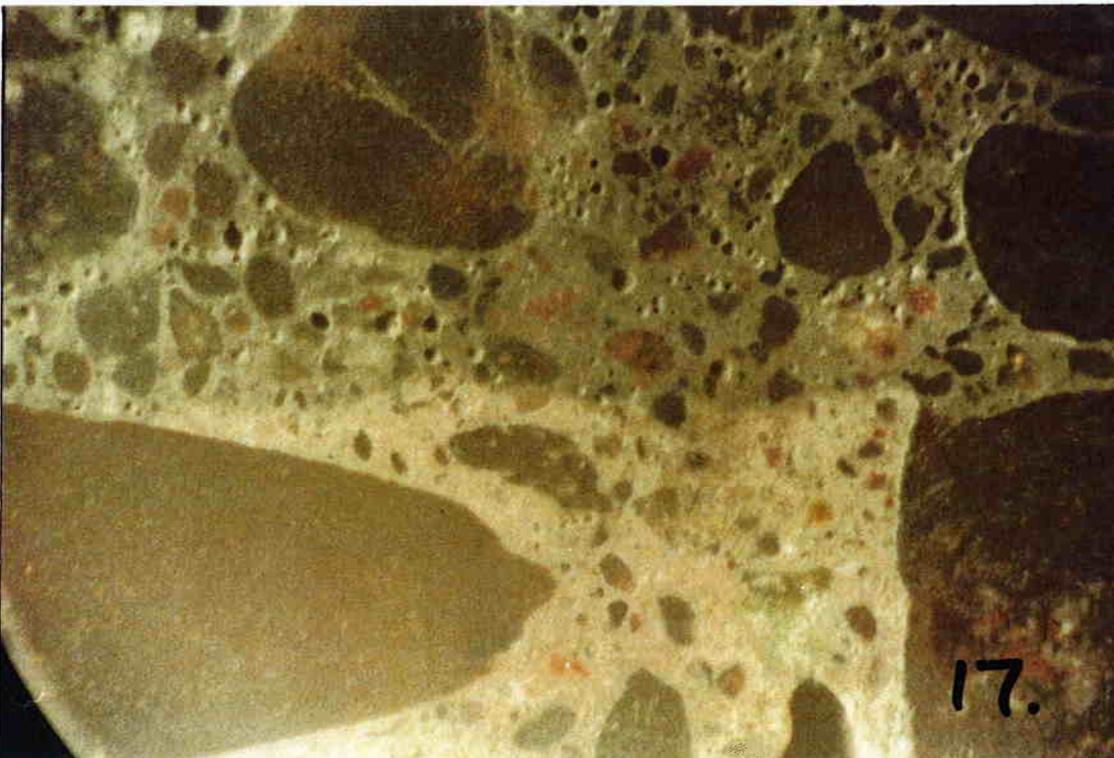
Figure 2.6. Close-Up of Core 17 Showing Contact Surface Between Overlay and Original Concrete. (Magnification about 10X.)

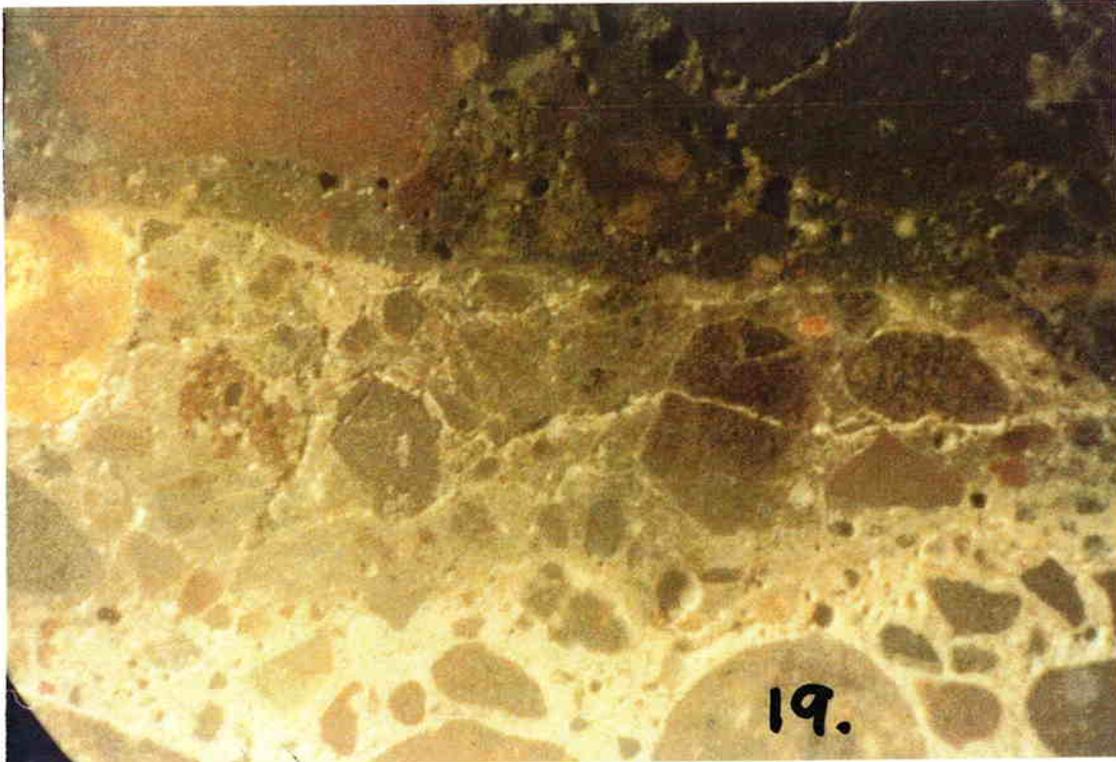
Figure 2.7. Close-Up View of Fracture Zone Associated with the Interface Between the Overlay and Original Concrete Observed in Core 19. (Magnification about 10X.)

- 3) The surface preparation used on the bridge decks represented by Cores 14, 17, and 20 removed original concrete with minimal "damage" which might influence long-term performance. However, Core 19 showed evidence that a previous overlay had been partially removed and superimposed with a more recent overlay. The partially removed overlay was severely fractured during its removal procedure. In addition, the original concrete observed in Core 19 had significant fracturing parallel to the contact interface. This observed fracturing could potentially affect long-term performance of the overlay represented by this core.

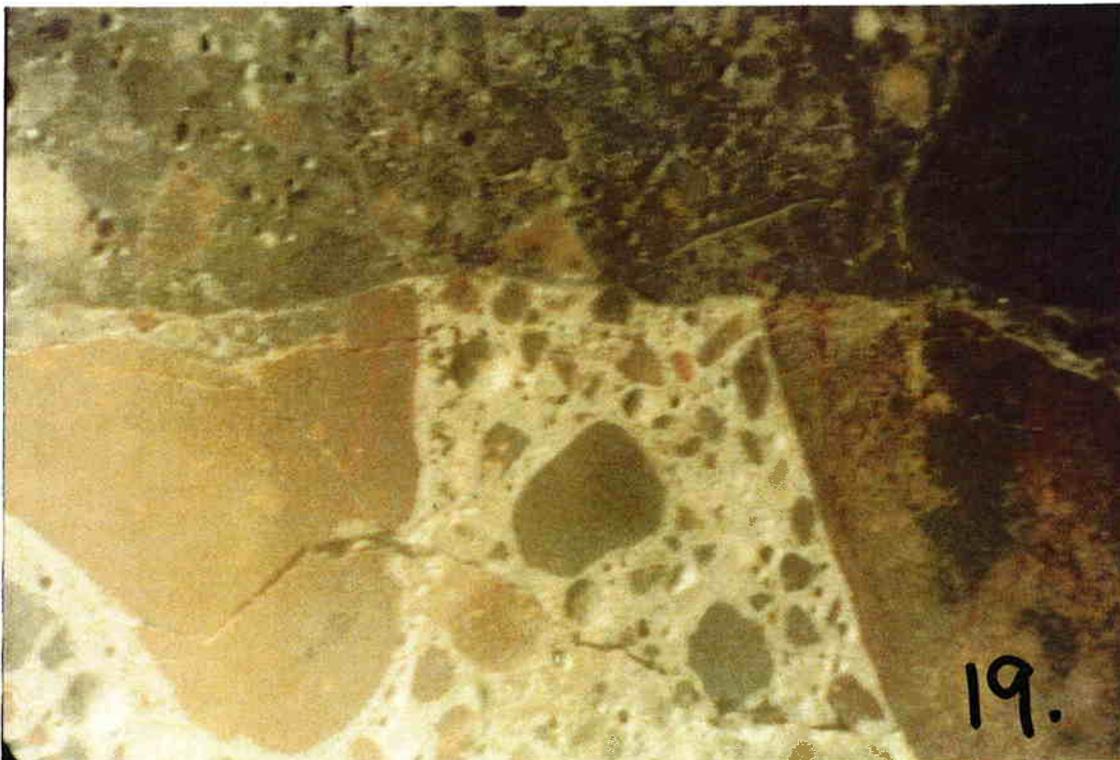
Figure 2.8. Another View of Core 19 Showing Fracturing Associated with the Contact Surface Between the Overlay and Original Concrete. (Magnification about 10X.)
