IMPROVING MATERIALS AND METHODS
FOR INSTALLING INDUCTIVE LOOP DETECTORS

FHWA-OR-RD 86-03
Final Report

OREGON DEPARTMENT OF TRANSPORTATION
Traffic Section
Salem, Oregon 97310

June 1986

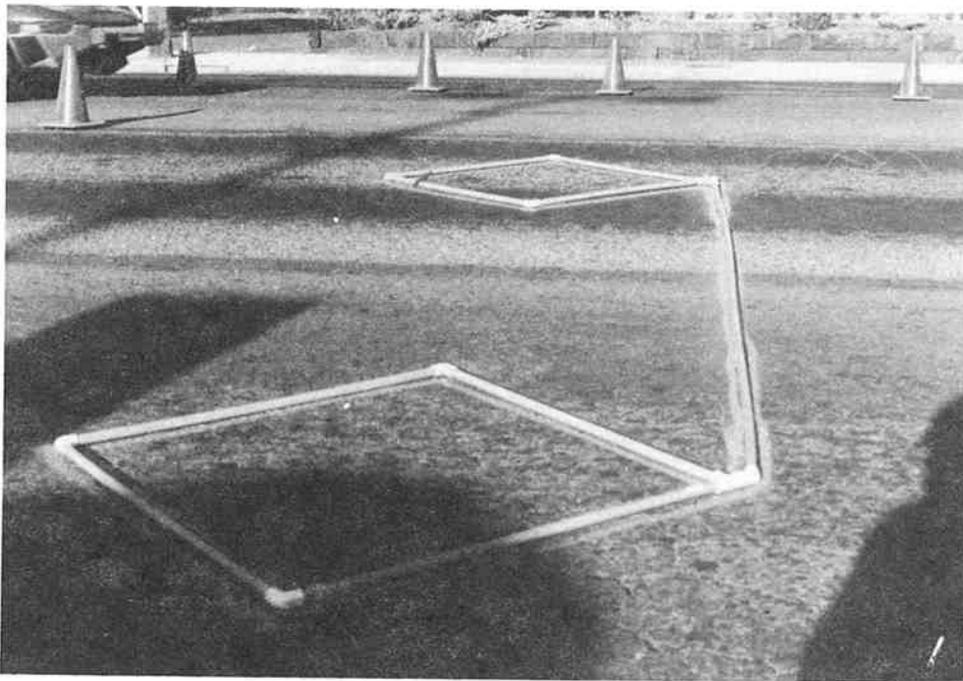
Picture 1: The preformed loop is laid out as a template and sprayed with aerosol paint. It is important to use the actual loop. This eliminates the possibility of small errors and distortions. It would be difficult to get an exact measure, either when forming the loops or laying out the pattern.

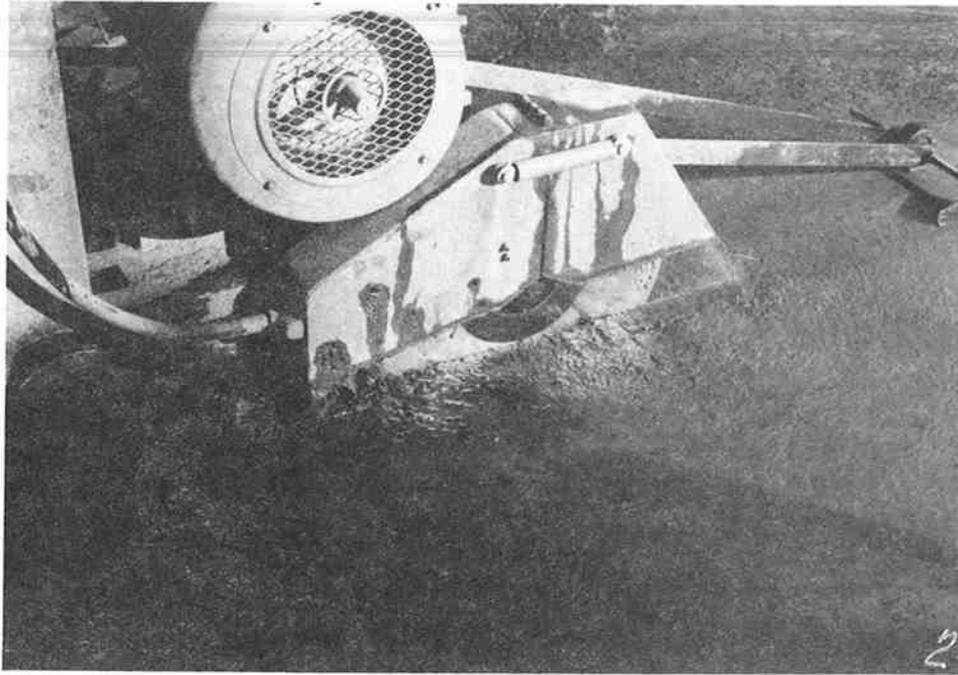
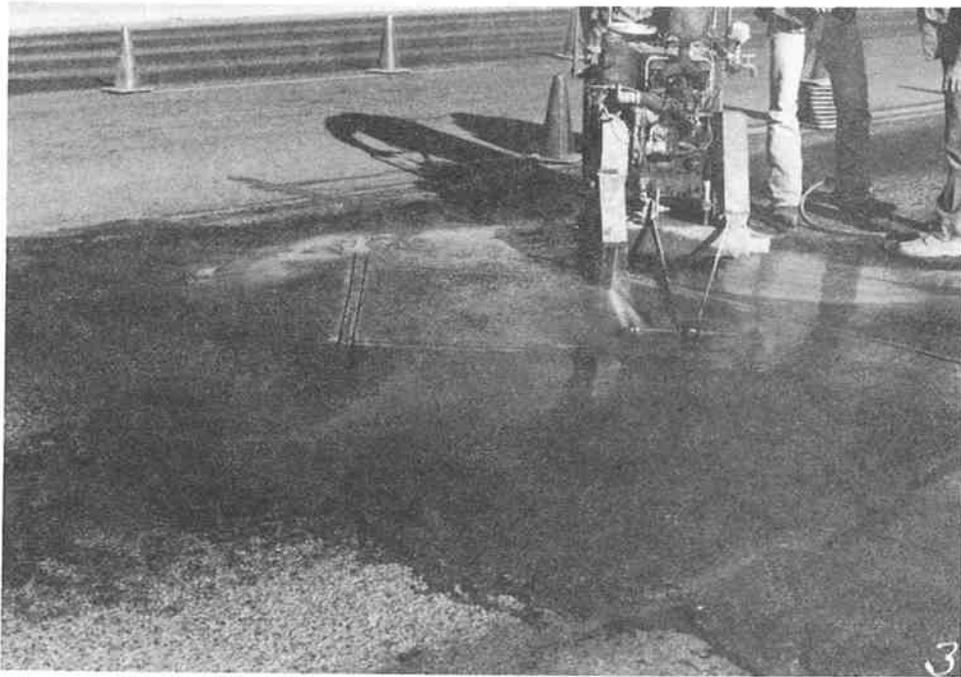
Picture 2: In order to obtain the extra depth required for the older pavement section, an 18" saw blade is used. The sawing machine is adjustable, and can be raised to a shallower depth as shown in Picture 3 .

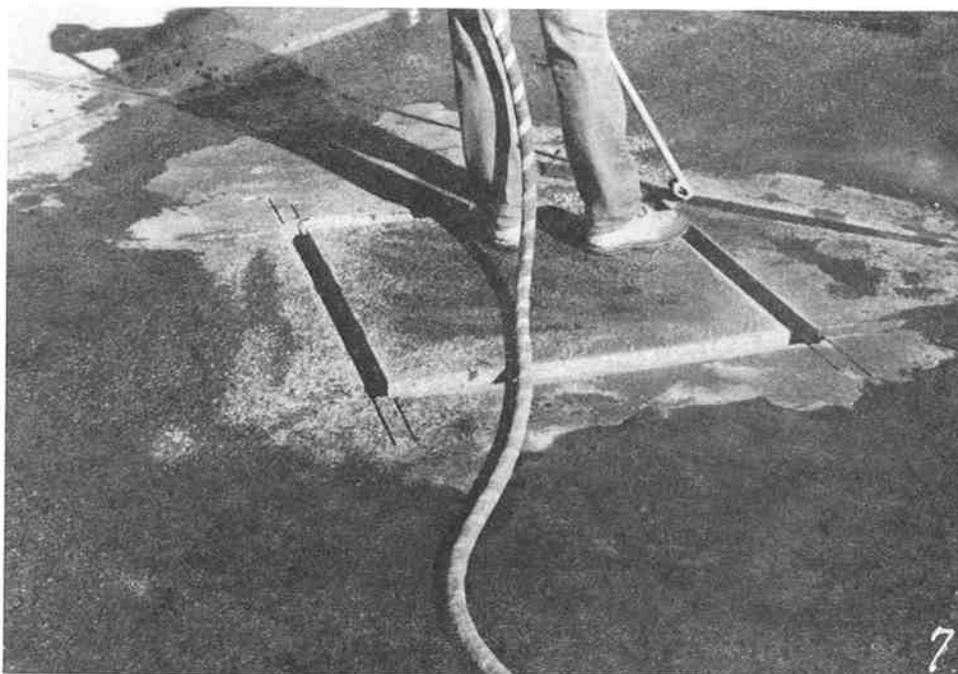
Picture 7: The trench and adjacent work area is thoroughly air dried. We find this step extremely important. It is the key to a good bond between the epoxy backfill, and the existing pavement. If the cut is not completely cleaned and dried, the epoxy will not bond. When the weather turns hot the pavement will expand, close in on the epoxy, and force the epoxy and loop wires up and out of the trench.

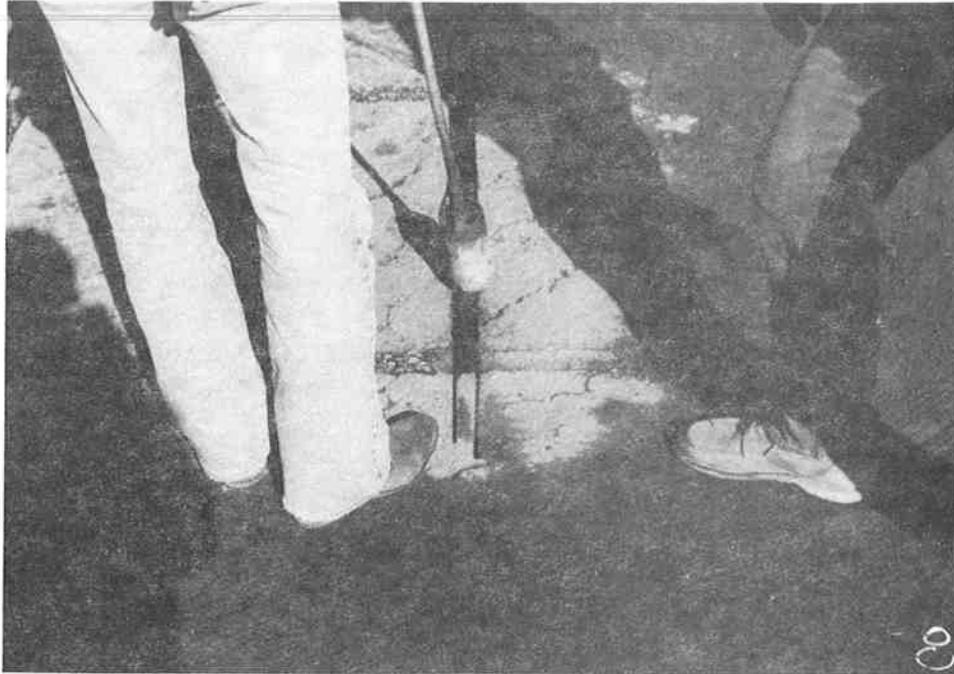
Picture 8: The old pavement is badly cracked and broken. It became necessary to dry the saw cut and the adjacent area with a gas torch.

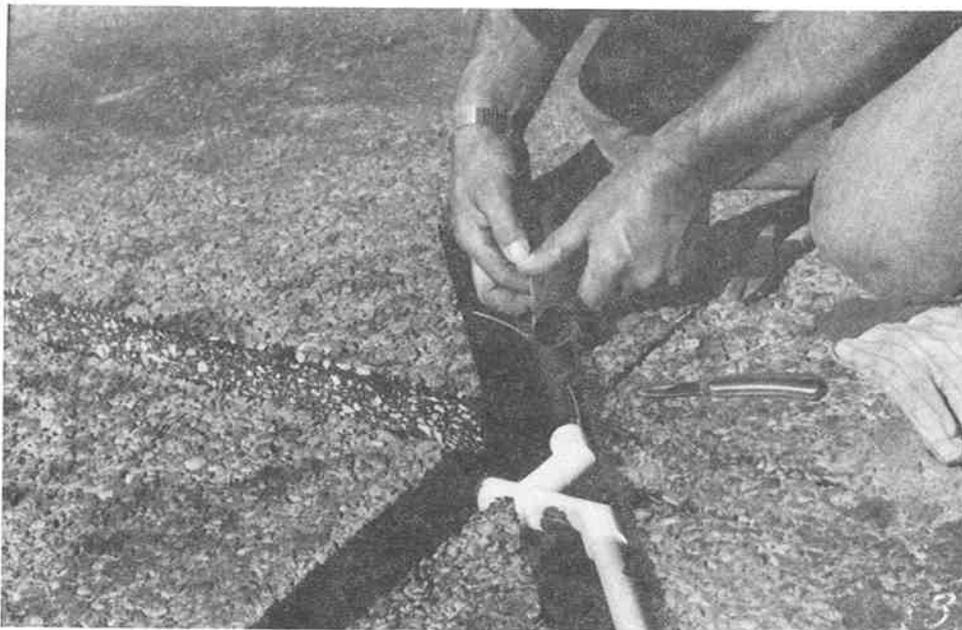
Picture 13: A large diameter heat shrink tubing is placed over the end of the conduit used to make the preformed loop. This turned out to be a problem and the sequence that follows involves two sets of loops. In the first, the heat shrink tubing was heated working away from the conduit. As it shrank, it began to slide off the conduit. In the second instance, the tubing was shrunk from the outer end towards the conduit. It also pulled away from the conduit, but not enough to endanger the seal.

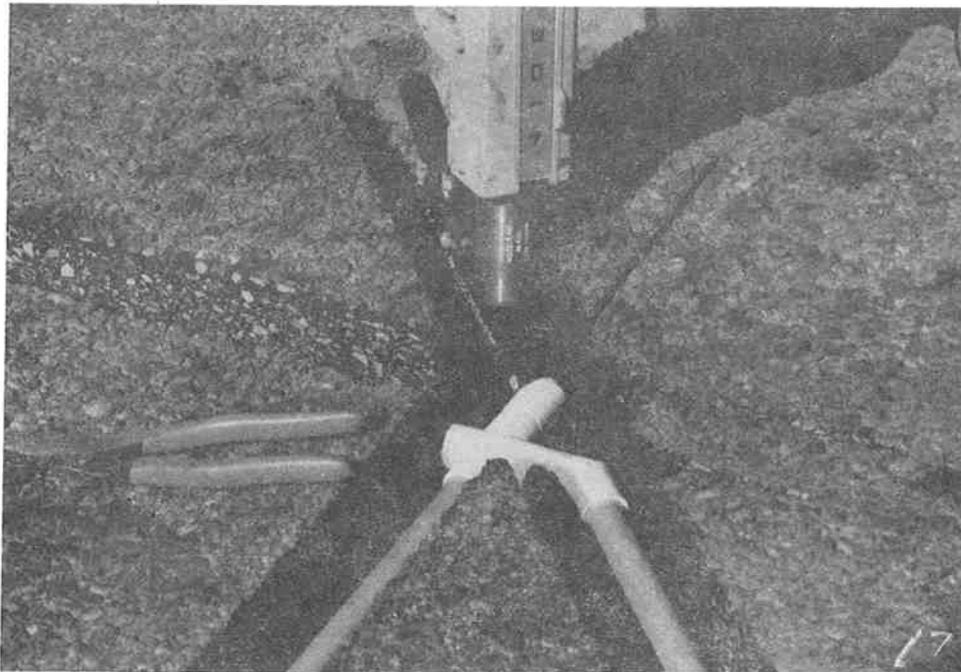
Picture 17: The larger sleeve is heated, working away from the conduit. This process had us a little worried.

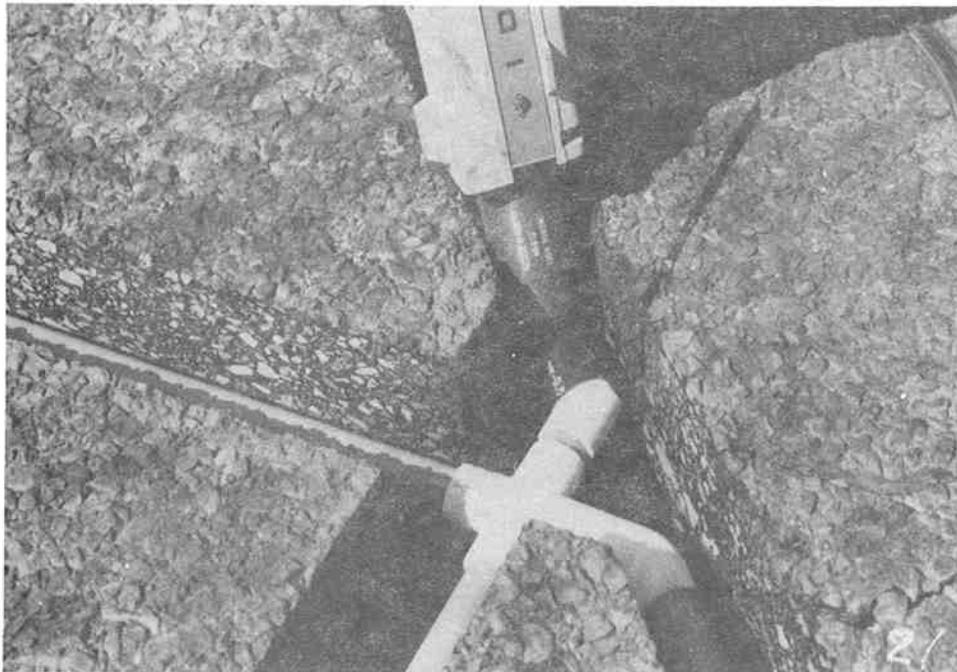
Pictures 21: The large sleeve has a better hold on the conduit, even though it did tend to slip a little.

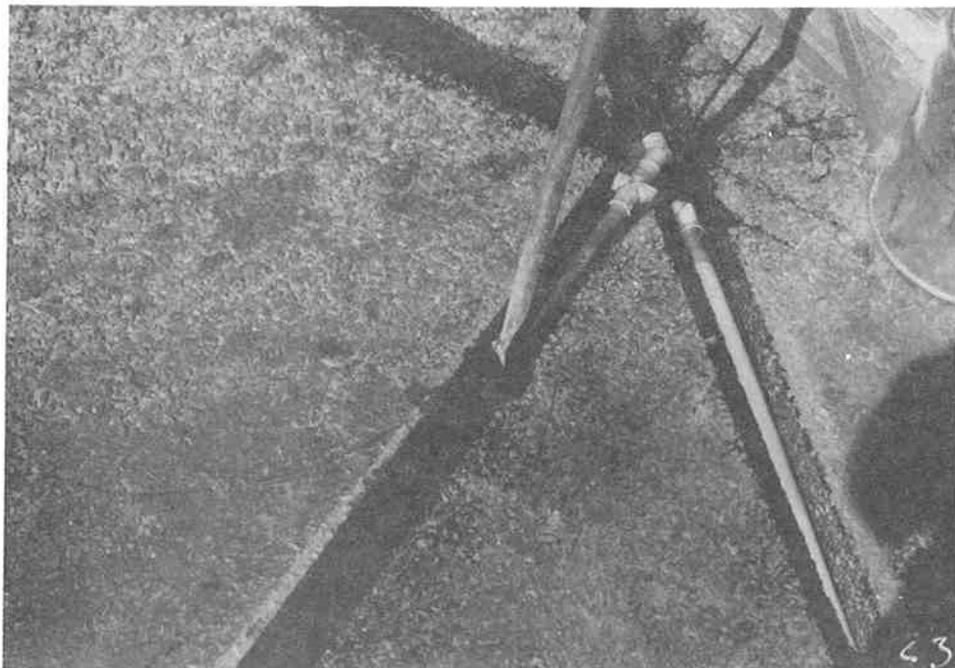
Picture 23: One unanticipated problem was encountered as the epoxy was placed in the saw cut. The conduit floated. This was countered by pouring just enough epoxy into the cut to catch the bottom of the conduit. After the epoxy set, it held the conduit in place in the bottom of the cut.

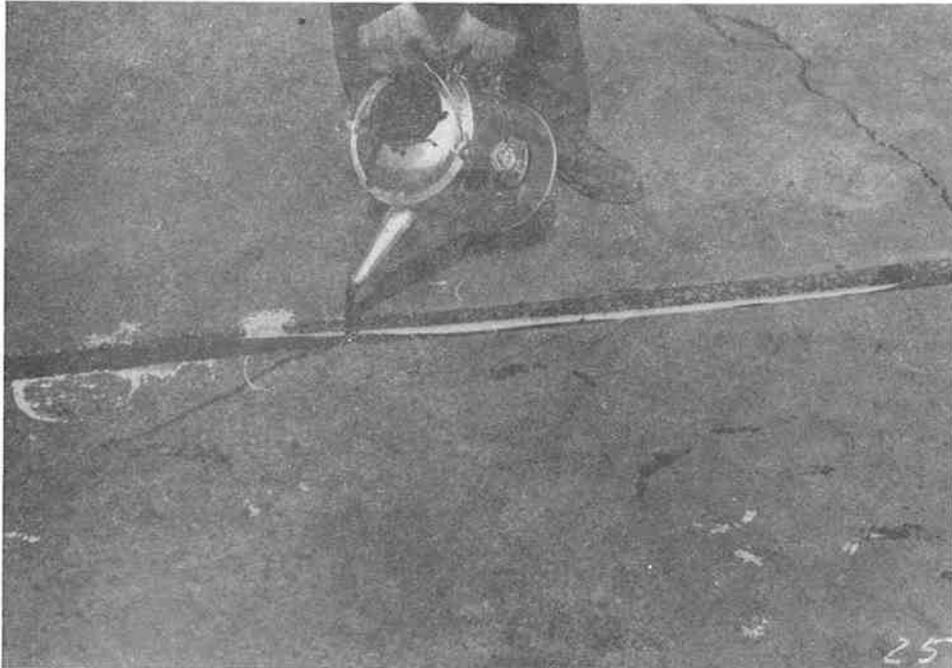
Picture 25: We experienced a shortage of black epoxy. This was countered by pouring grey epoxy into the bottom of the cut and covering it with black.

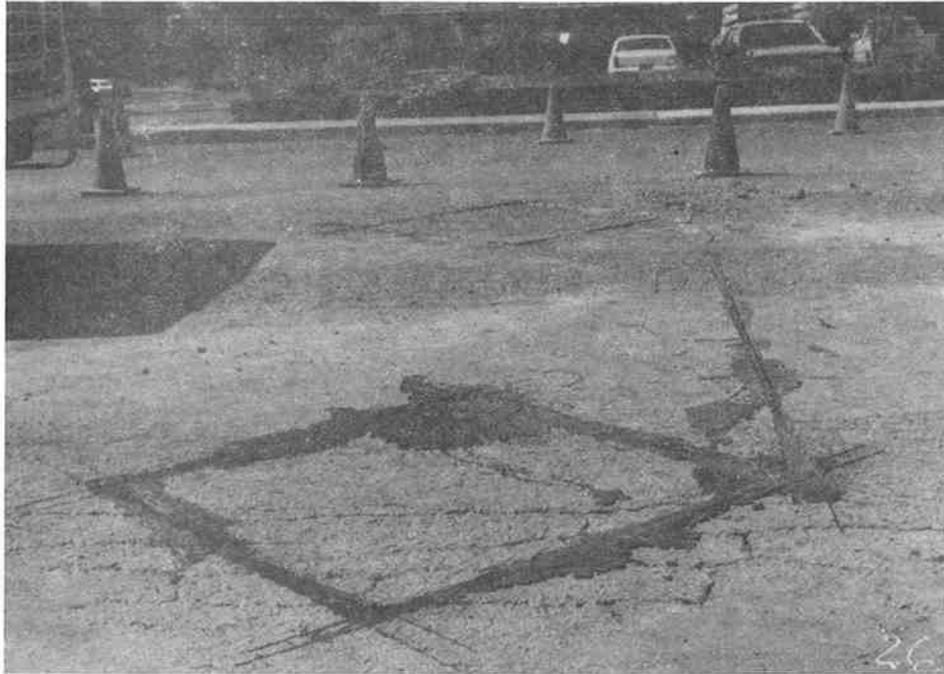
Picture 26: The completed installation. Notice the broken pavement in the foreground. This is the section scheduled to be ground out next year.

As of April, 1986 the preformed loop is still performing with no problems. In September, 1985 the grinding operation over the loop was completed and recycled asphalt mix was placed. Because of the high cost of epoxy, a fine A.C. mix is recommended for filling the saw slot. Also, the splice between the loop wires and loop lead-in cable would now be made according to our more recent design standard. This standard specifies that the splice be made in a junction box and not in a splice cut-out area.
