**EVALUATION OF GRIT-IMPREGNATED,
EPOXY COATED
PRESTRESSING STRAND
on
SOUTH SLOUGH (CHARLESTON)
BRIDGE
Bridge No. 1940G**

Construction Report

Experimental Features Project OR 89-06

**OREGON STATE HIGHWAY DIVISION
Materials and Research Section
Salem, Oregon 97310**

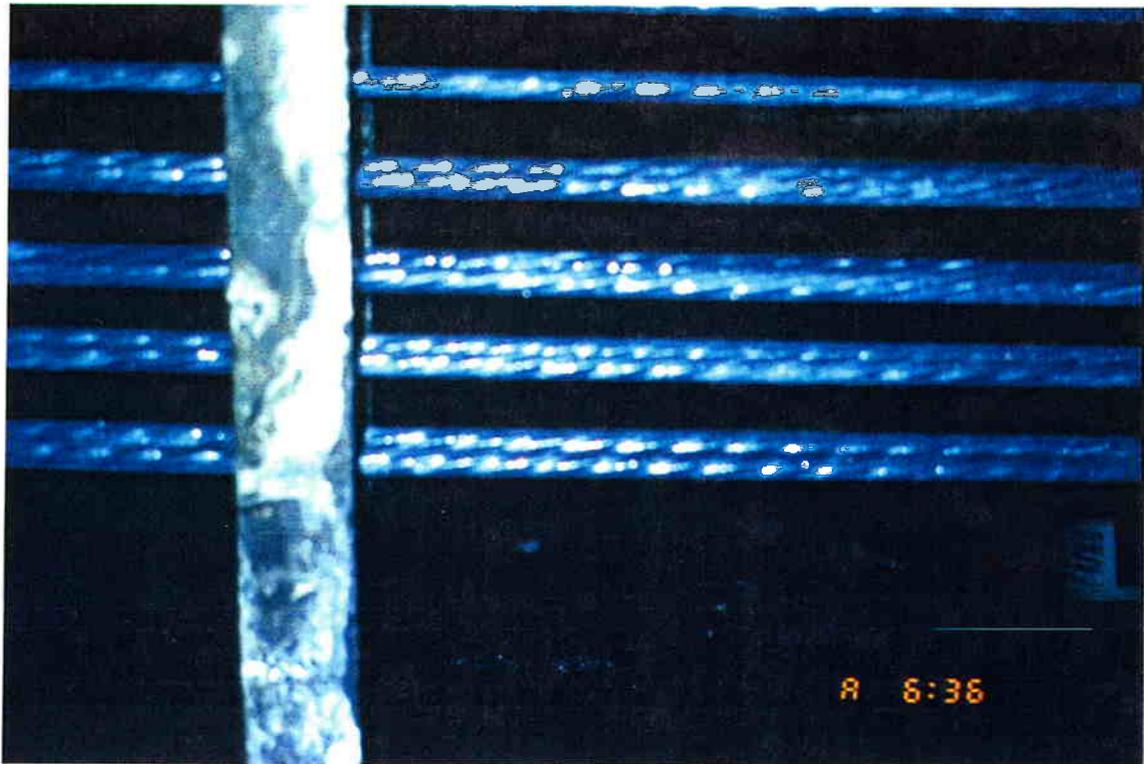
Figure 3.0 Strand Fastened to Tension Puller

The strand was hand-pulled from the coil, fed to the tension pullers, and secured (see figure 3.0). A total of 36 strands were placed, 18 were harped, and the other 18 were straight. The strands were tensioned using four 200-ton rams. An initial pull was made to even the tension on the strands. A second pull tensioned the strands to 103,000 psi. A third pull tensioned each

Inspection of the epoxy coating after the strand was placed and stressed revealed scrapes near the bridles and tie downs. These areas, along with other visible holidays, were patched with a dark blue 3M, epoxy patching paint, provided by Florida Wire & Iron.

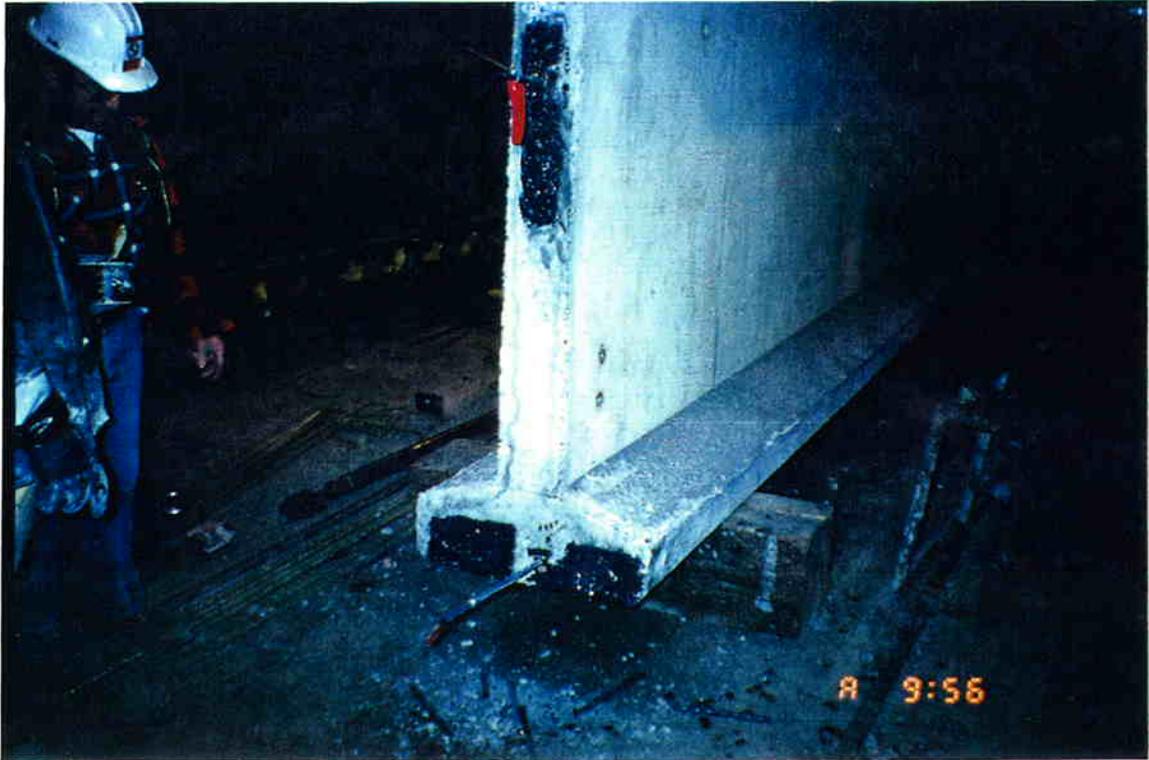
Figure 3.1 Reference Clamps

After the strands were cut, two reference clamps were mounted, one on a top strand and one on a bottom strand (see Figure 3.1). From these reference points, initial strand measurements were taken. While in storage at the plant, the first set of reference points were damaged. They were replaced and a new set of readings were taken. Both sets of readings can be found in Appendix A.

NOTE: The reference points had to be reset. The first set of reference points were damaged while in storage at the plant. Jim Ezzell replaced the reference points and made a new set of readings. These readings will be used for comparing future readings.

Clamps used for this study proved to be easily damaged, knocked off, and corrosive; therefore, a more reliable strand measuring system should be used on future studies.
