**GEOTEXTILE FABRICS UNDER AN
ASPHALT CONCRETE OVERLAY TO
RETARD REFLECTIVE CRACKING**

Construction Report

**Experimental Features
Project No. OR 91-03**

**East 39th Avenue - East 47th Avenue Section
East Burnside Street
City of Portland**

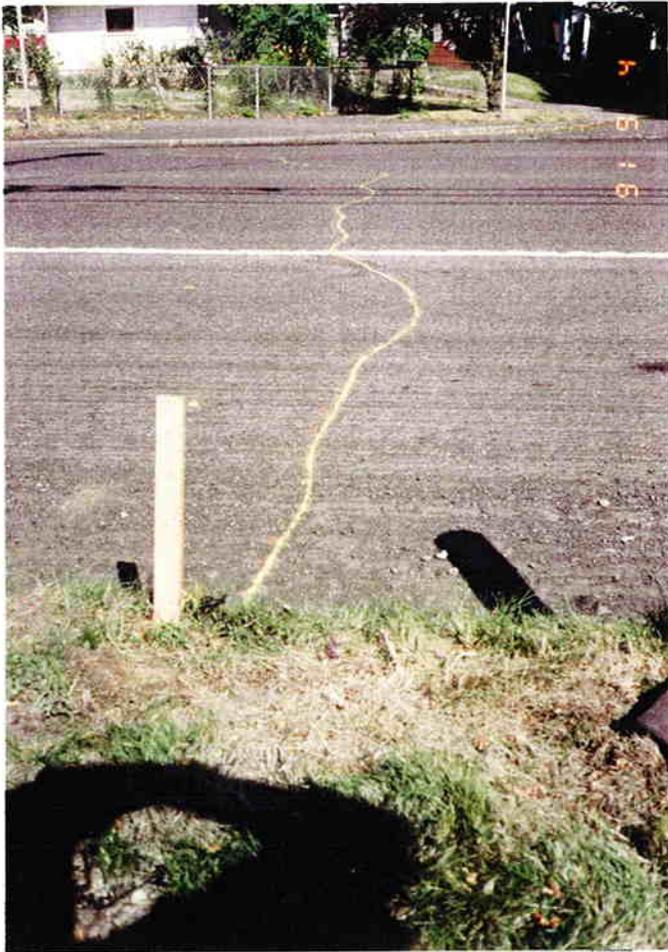
(a) Crack Number 2

Placing the Polyguard by removing the protective sheeting with the sticky side face up, then turning the fabric over did not work satisfactorily. When turning the second layer of fabric at crack #2, the fabric stuck to itself. It was extremely difficult to separate the material from itself so that it could be reset in its original position. The material was turned successfully on the second effort.

Figure A.1: Photographs of Crack Numbers 2 and 4 After Cold Planing

- 1) Polyguard NW-75 in two-foot wide rolls was substituted as Fabric 2 for Petrotac in three-foot wide rolls.
- 2) Polyguard was placed over crack #2 at 43rd Avenue in a three-foot wide width and a one-foot wide lap (double thickness) directly over the crack.

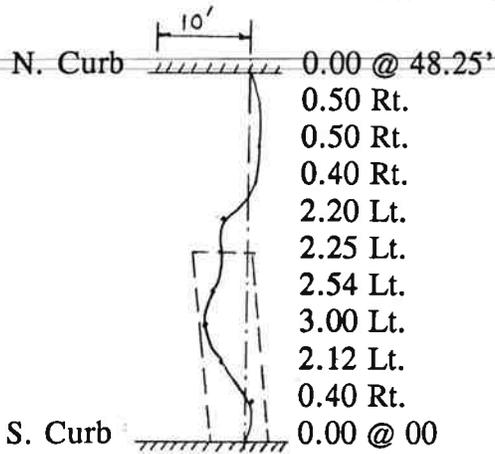
Crack #1, Fabric 1
E. of N.E. Meikle Pl.
Single layer of
5-foot wide Glasgrid

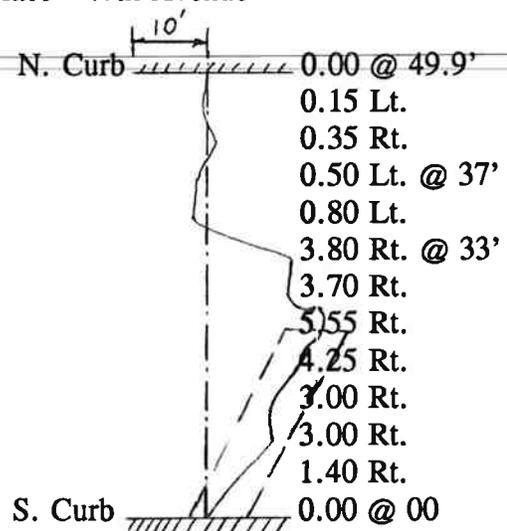
Crack #2, Fabric 2
W. of 43rd Avenue
Two sheets of 2-foot wide Polyguard
placed with 1-foot wide lap

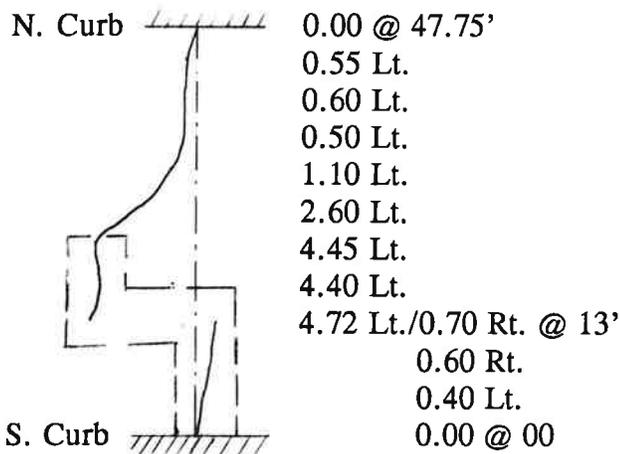
Crack #3, Fabric 1
E. of 43rd Avenue
Single layer of
5-foot wide Glasgrid

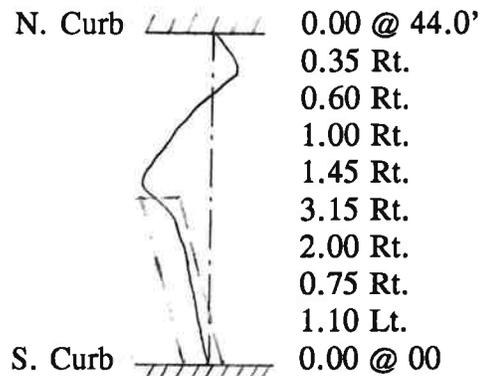
Crack #4, Fabric 2
W. of 47th Avenue
Single sheet of 2-foot wide
Polyguard

- 3) Polyguard was placed over crack #4, west of 47th Avenue, in a two-foot wide width (single thickness) directly over the crack.
- 4) Glasgrid pavement reinforcement was placed with no overlaps to a total width of twenty feet (4 widths of material) and to a length of 250 feet on the south side of Burnside Street between 44th Avenue and 45th Avenue.
