**STANDARDS FOR TIRE-BALE EROSION  
CONTROL AND BANK STABILIZATION  
PROJECTS: VALIDATION OF EXISTING  
PRACTICE AND IMPLEMENTATION**

Prepared by:  
New Mexico Institute of Mining & Technology  
Department of Mechanical Engineering  
Socorro, NM 87801

**Final Report NM08MNT-01**

SEPTEMBER, 2010

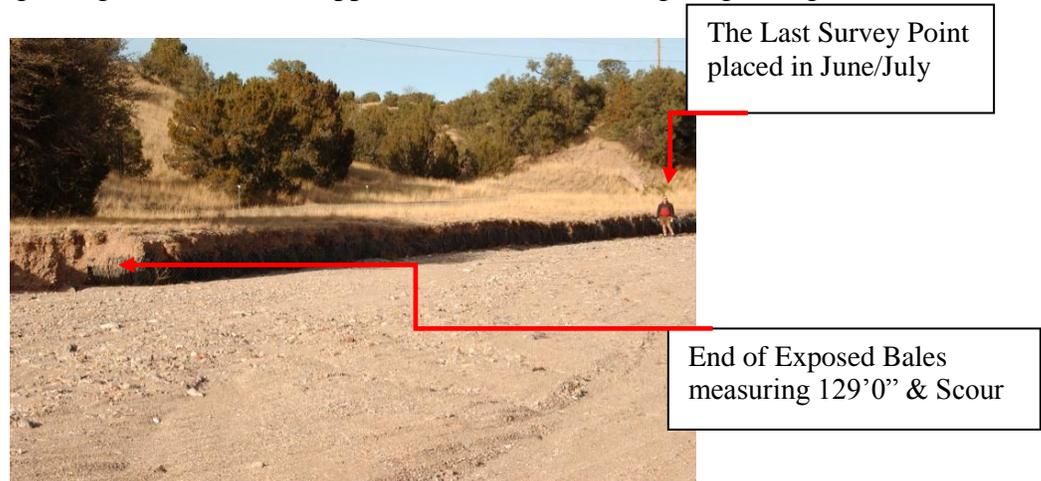
**FIGURE 14 Newly Exposed Bales @ NM 52 Mile Post 27.2**

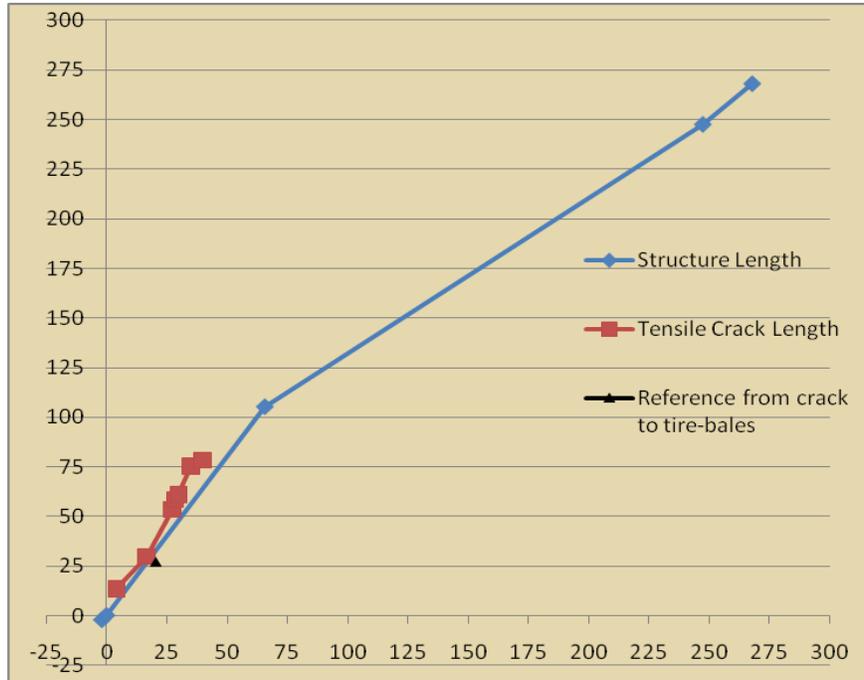
**FIGURE 17 Representation of Tensile Cracks above Tire-bale Structure MP 27.2**

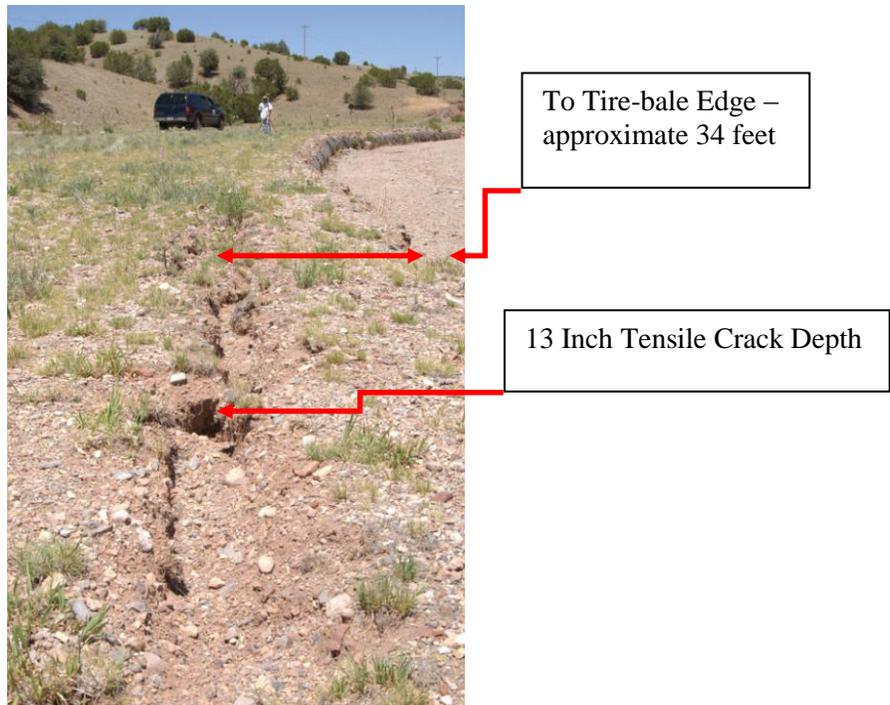
**FIGURE 18 Tensile Crack with 13 inch Depth MP 27.2**

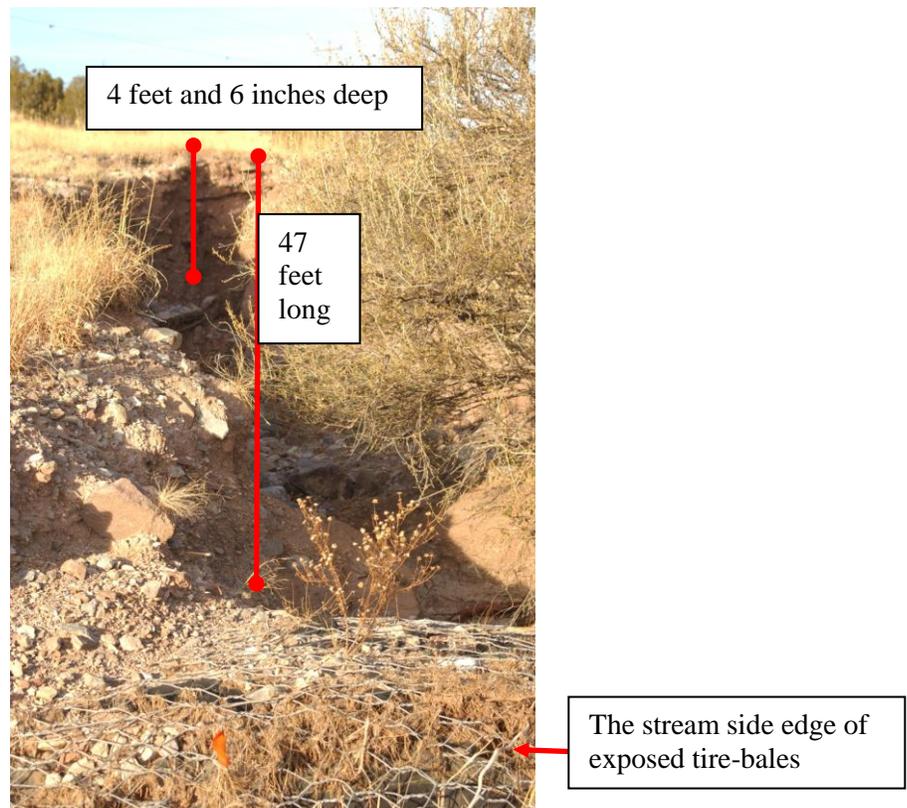
3. On December 20, 2008 milepost 26.7 had measurable areas of erosion at both ends of the structure with tire-bale exposure.
- At the beginning of the structure an erosion feature measured 47 feet long and 4 feet 6 inches deep with a varying width (Figure 19). This feature appeared to be formed as water flowed over the structure and the streambed. Two (2) tire-bales on the upstream side of the structure which are also located on the north end of the culvert are entirely exposed.
  - At the end of the structure a scour feature measured 12 feet long with varying width and depth (Figure 20). Again appears to be formed by water flow over the structure.

**FIGURE 19 Erosion Feature 47 feet long MP 26.7**

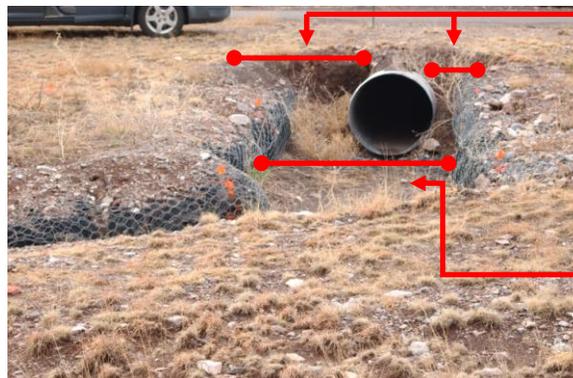
**FIGURE 21 Culvert at MP 26.7**

Scour measures maximum of 8 feet 2 inches from culvert mouth

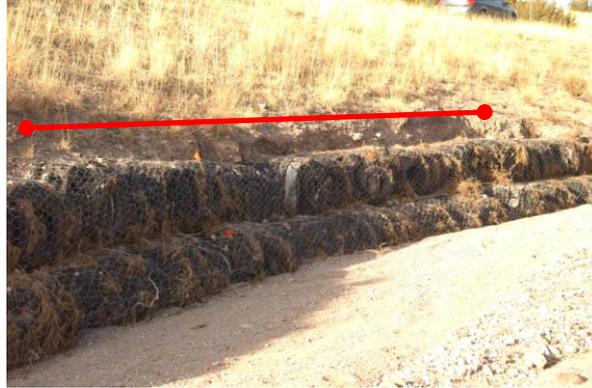
- Finally, 29 feet from the end of the structure there was 40 feet of exposed upper level tire-bales (Figure 22).
- On July 5, 2010 the erosion feature that appeared most changed was the one at the beginning of the structure. The length is approximately 93 feet long however the beginning of the depth of the feature begins at 47 feet. The length change had similarity to that of the tensile cracking occurring at milepost 27.5. The length change of the feature shows shallow erosion pattern moving toward the drop off into the 47 feet long feature. Capturing the photographic intricacies was not possible.

**FIGURE 22 40 feet of upper level exposure MP 26.7**

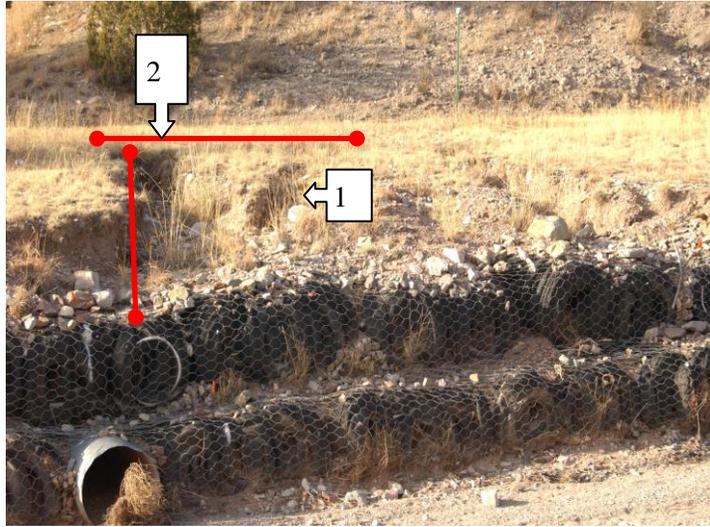
**FIGURE 23 Culvert Upper Level Erosion – December 2008 MP 27.75**

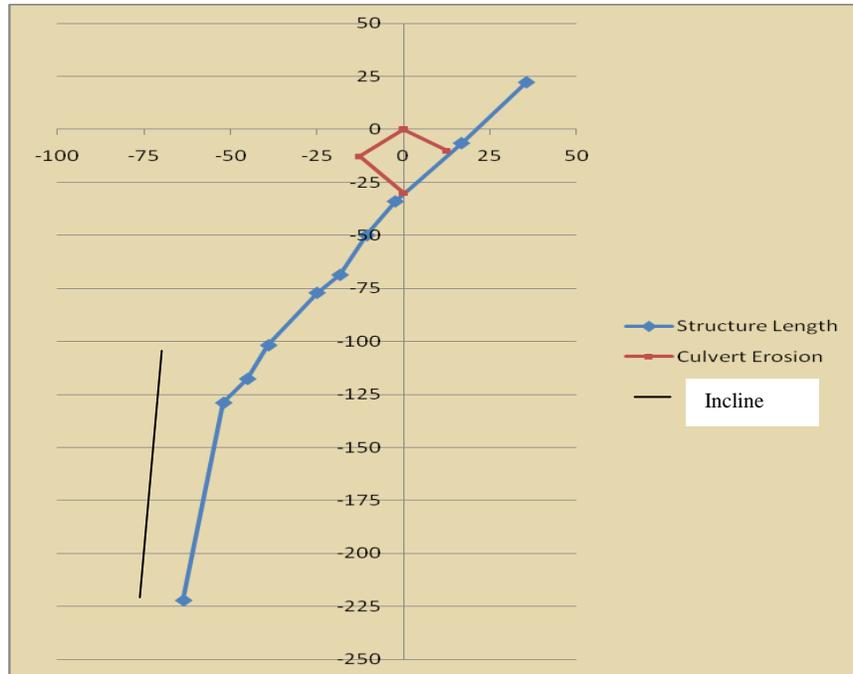
**FIGURE 26 Representation of Culvert Erosion above Tire-bale Structure MP 27.75**

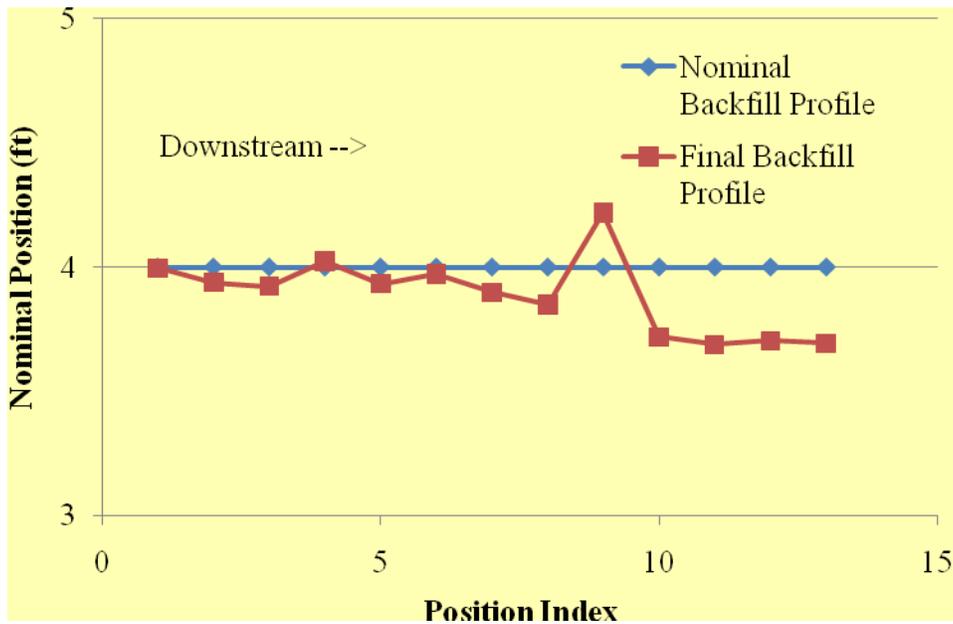
Figure 46 shows an obvious settlement trend, increasing in the downstream direction. The downstream portion of the structure is that in which tensile cracking was observed.

**FIGURE 46 NM 52 MM 26.7: Vertical displacement profile of the backfill survey points**

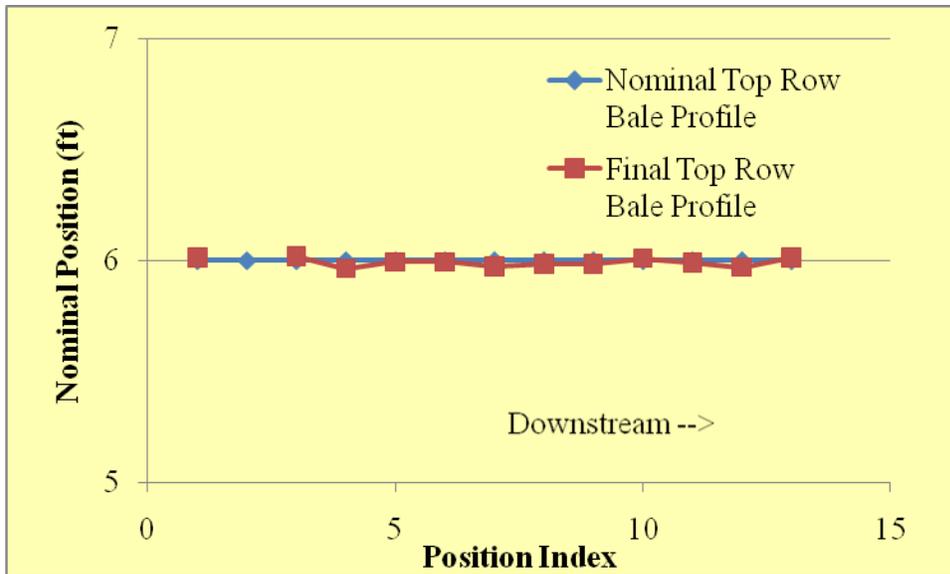
Figure 49 indicates a bit of ‘waviness’ is developing over time. There are three distinct settlement ‘wave’; this data corresponds to the inference made above of consolidation and settlement about the tire-bale structure.

**FIGURE 49 NM 52 MM 27.75: Vertical displacement profile of the top-row tire-bales**

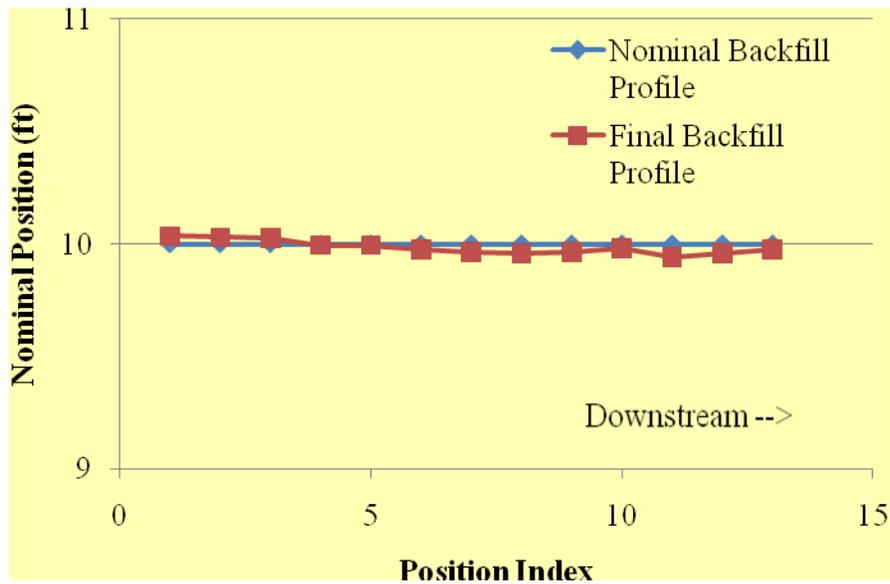
Figure 50 shows the vertical displacement profile of the backfill survey markers over the length of the tire-bale structure. A slight increase in height is seen in the upstream third of the structure, while settlement is seen in the downstream two-thirds. The uplift is very slight, and almost within the bounds of measurement error. If we assume that the uplift does exist, the best admissible explanation comes from the swelling of a local clay formation in the backfill, likely concentrated when native soil was removed for construction, and then replaced.

**FIGURE 50 NM 52 MM 27.75: Vertical displacement profile of the backfill survey points**

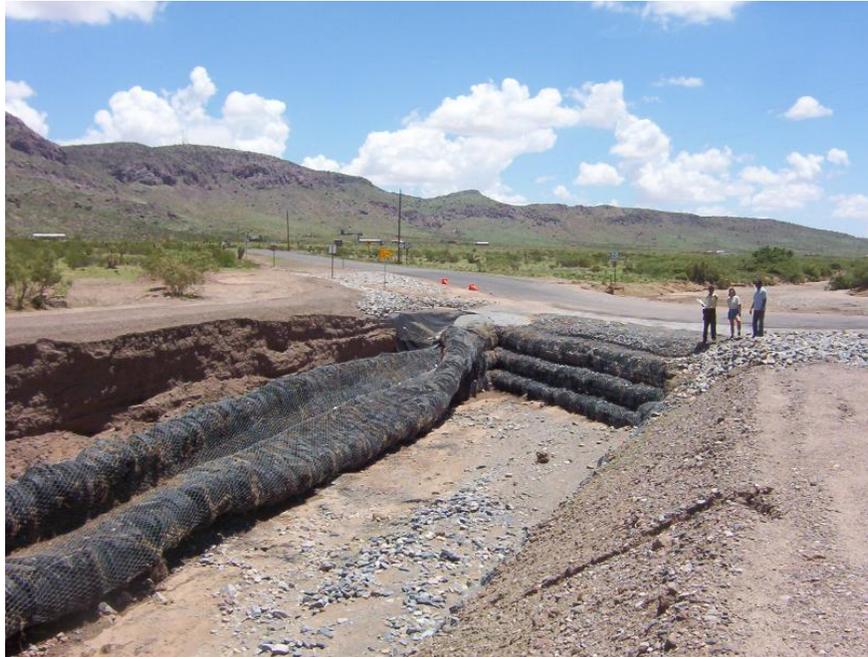
Figure 57, below, shows the structure after failure on July 21, 2008. The exact date of damage was unknown. It can be seen from the picture that the east wall of tire-bales had fallen into the channel, but remained intact due to the wire mesh. There was also a significant amount of debris in the basin, some of which was riprap from the western slope close to the road.

**FIGURE 57 NM-143 tire-bale structure as pictured on July 21, 2008**

The lesson of the failure of the NM 143 structure is that lateral anchors are a necessity for tire-bale structures used in erosion control applications. They cannot be built with sufficient moment resistance to resist hydrostatic pressure behind the structure, and there is no way to ensure the permanent exclusion of water through the life of the structure.

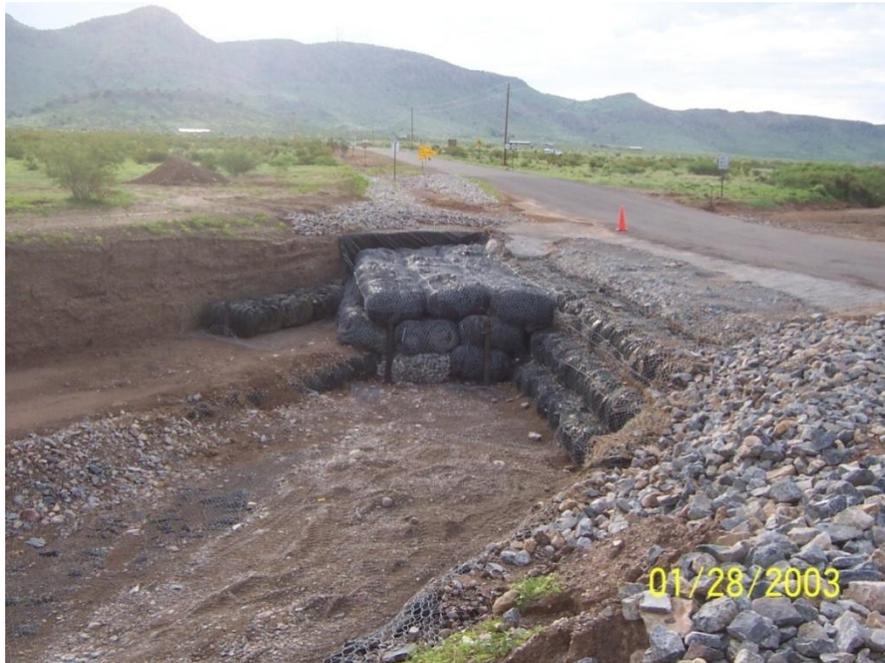
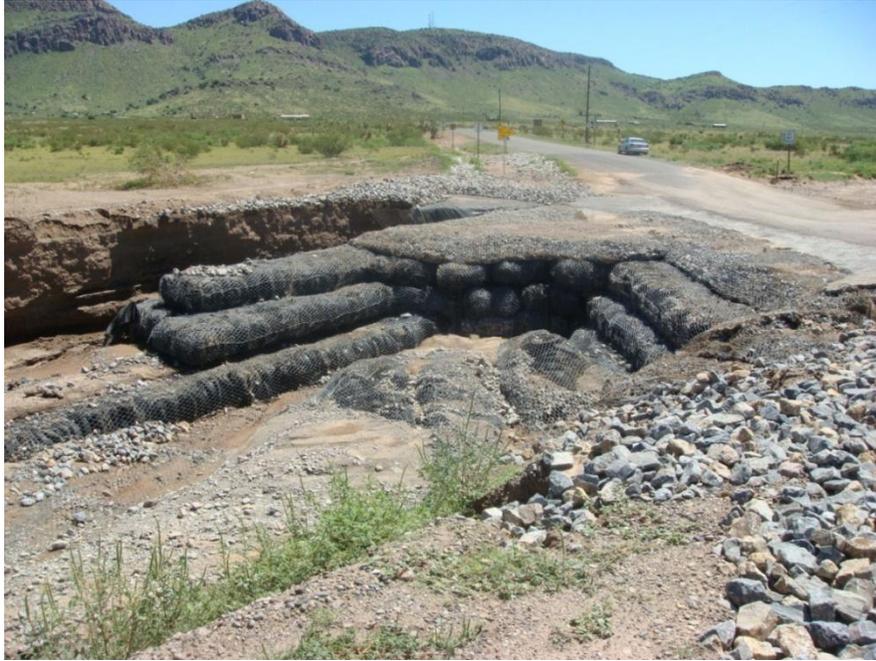
**FIGURE 58 August Reconstruction – Photo courtesy of NMDOT  
(date on photo is not accurate)**

**FIGURE 59 August Reconstruction – Photo courtesy of NMDOT**

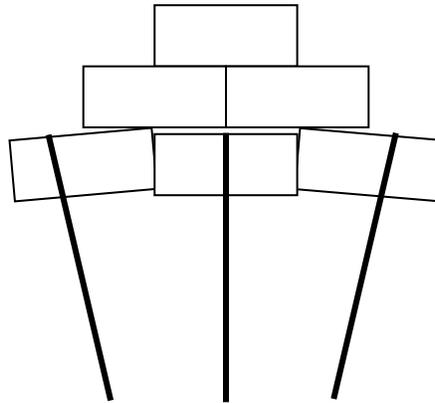
**FIGURE 79 Observed Tilting of the Tire-bales Located on the Outside Edge of the First Layer**

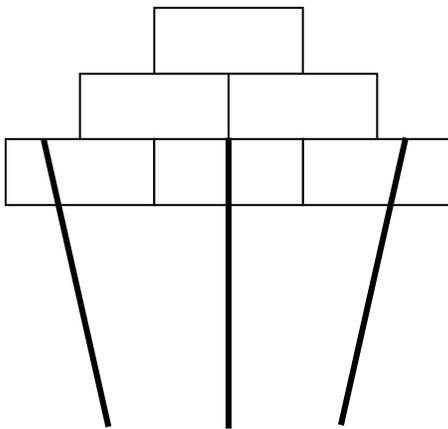
**FIGURE 80 Difference Between Specified and Constructed Pile Configuration for Head-cutting Structure**
