# Investigation of Early Distress in Wisconsin Rubblized Pavements

Investigation of Early Distress in  
Wisconsin Rubblized Pavements  
Research Study # WI-10-02

Report # WI-02-11

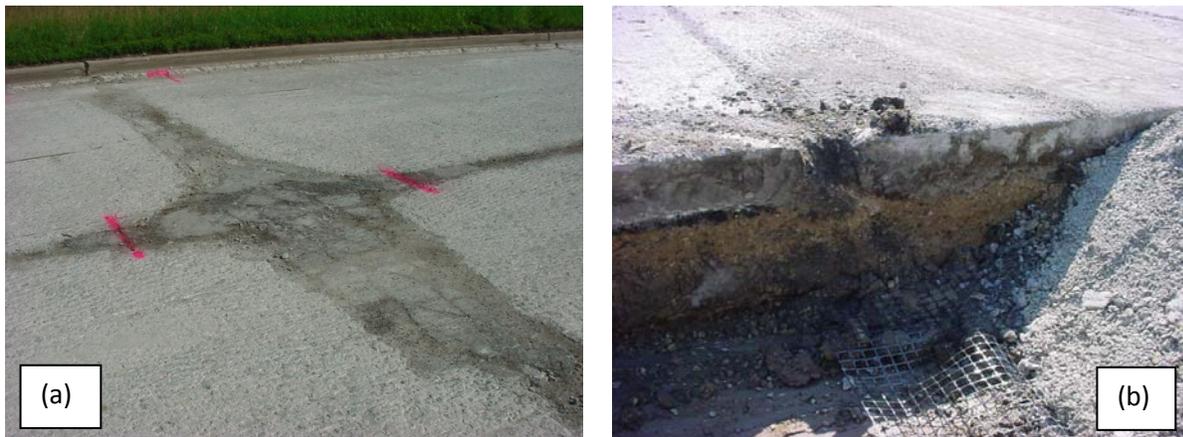
pavement after it was exposed, nor after it was test rolled. Former concrete pavement transverse joints were apparent, however, and water was observed seeping up through them the next day. It was concluded that the observed failures were a result of a weak, wet subgrade. Areas exhibiting failures were milled and patched, as addressing the subgrade issue would have been too extensive and costly a repair. [23]

A field review the following March (2011) noted similar issues, along with potholes in the HMA pavement. In one pothole, reinforcing mesh was observed on top of the rubblized layer.

Figure 3. Existing concrete pavement transverse joint on CTH E (a) after milling existing HMA overlay and (b) during repair with HES concrete prior to rubblization. [23]

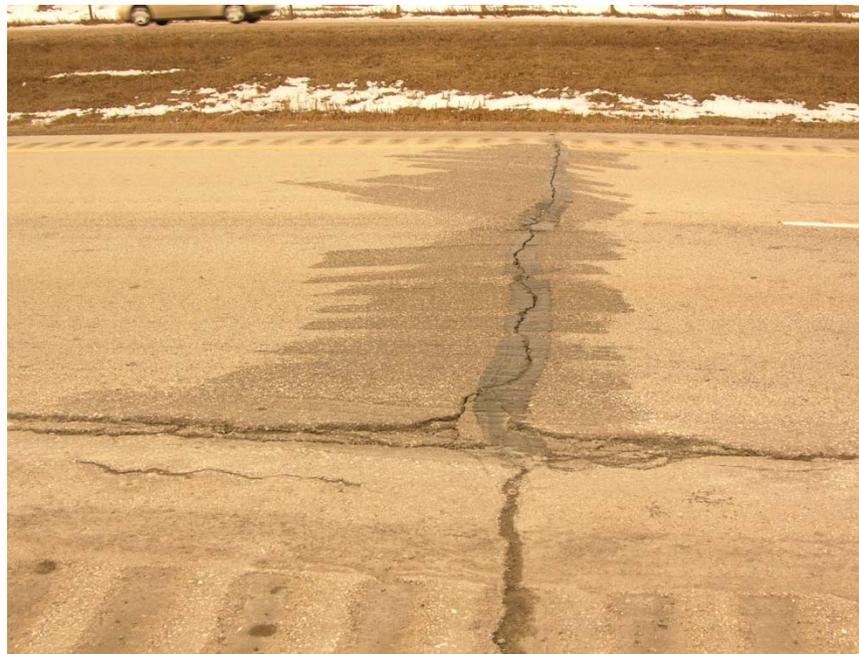
Field reviews were conducted in the spring of 2010 and 2011. Transverse cracks were present at the location of previous JRCPC joints (80-ft spacing). In 2010, cracks in the northern part of the project had not been sealed, and many were tented. Cracks in the southern portion had been sealed and were not tented. Tented areas were milled and sealed in 2010. In 2011, remaining cracks that had not been sealed were now tented. Cracks where sealant had ruptured were also tented, as shown in Figure 4.

Figure 4. Tented crack on USH 41, Brown County.

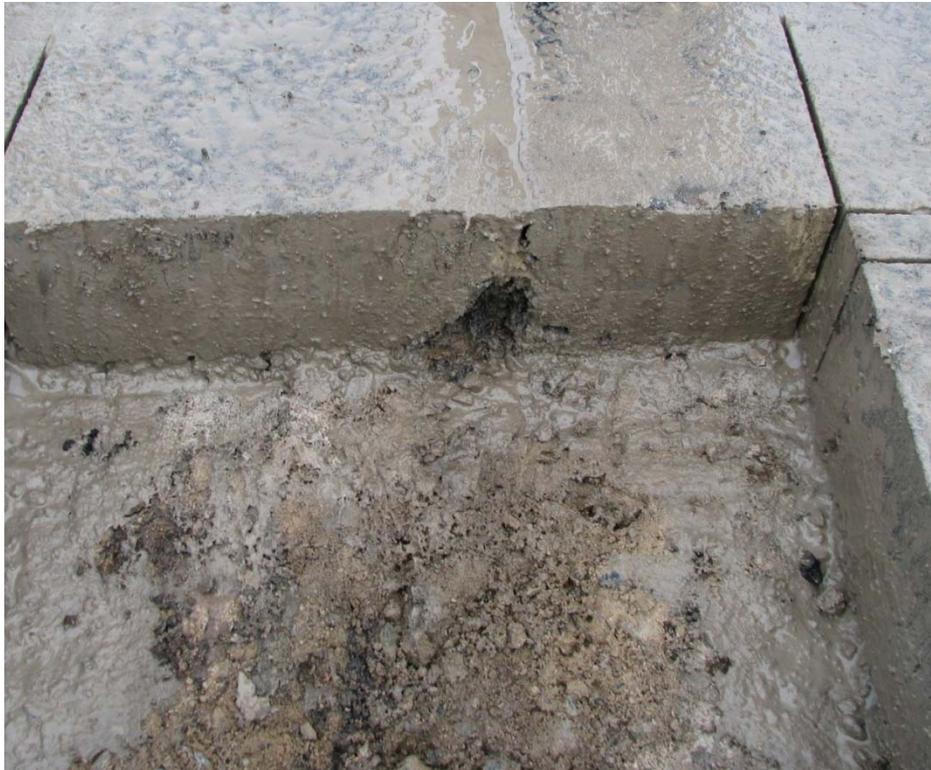
It was hypothesized that because the existing CRCP crack had not been obliterated during rubblization, reflective cracks propagated through the HMA layer. Water seeped through the open cracks and did not drain through the rubblized layer. During the winter months, this ponded water froze and expanded, resulting in tenting of the HMA cracks. Tenting settled during the spring thaw, but damage remained in the pavement. HMA cracks had been sealed in 2007, but excessive stress on the cracks caused them to open again.

The new pavement was surveyed in March 2011, when it was nearing one year old. Longitudinal joint distress was evident, likely caused by poor joint construction. Some transverse cracking was noted, and the ride was slightly "wobbly." It is likely that the same failure mechanism is occurring, as the former CRCP cracks were not repaired prior to repaving the roadway.

Figure 5. Removal of HMA pavement at transverse crack location to expose rubblized CRCP layer.
