# **Final Report**

## **Non-Destructive Bridge Testing With Advanced Micro-II Digital AE system**

### BRIDGE ON COAST GUARD BOULEVARD

The test bridge (Virginia Structure # 1809, Federal Structure ID # 21212), located on Route 164, falls on the stretch between the Cedar Lane and the Norfolk Road. The bridge was built in 1991. It was originally planned to cross over the Coast Guard Boulevard. Due to change in plans it currently crosses over the W. Norfolk Road and N&W R/R.

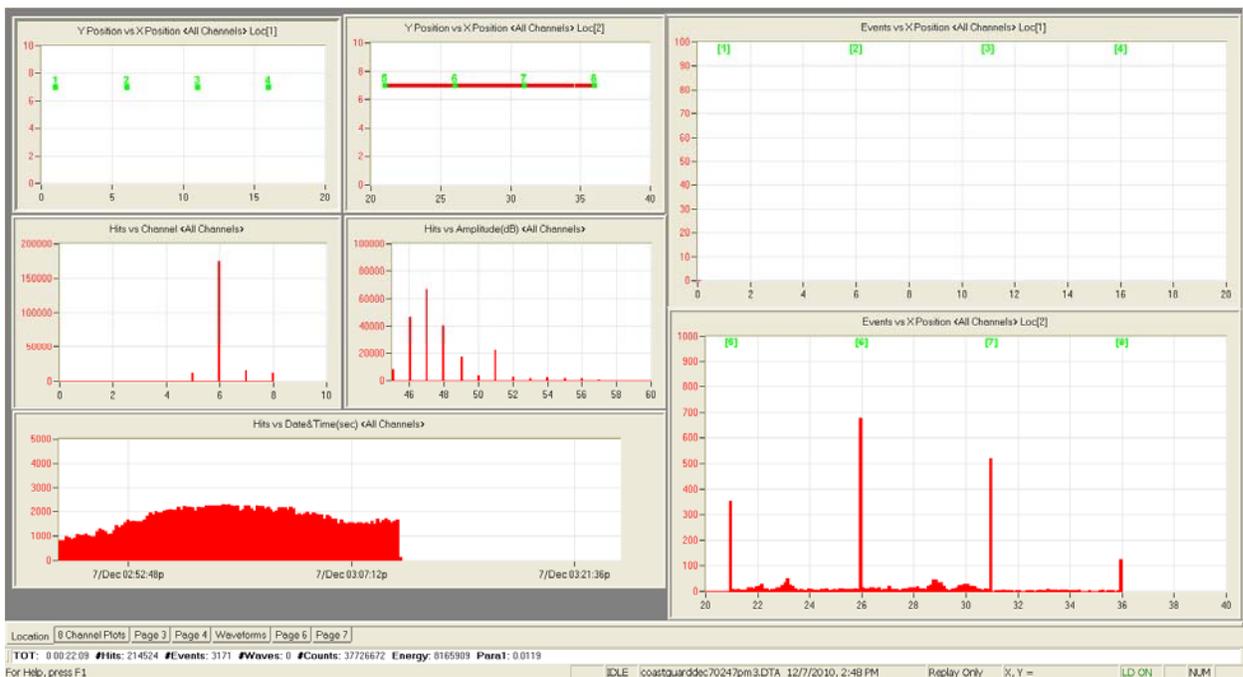
AE sensors respond only when there is an AE activity at locations in the vicinity of sensors. The Micro-II Digital 8 channel DAQ system records several parameters related with Acoustic Emission; namely, the number of AE hits, number of AE events, AE energy, AE duration, AE amplitude, AE rise time, AE absolute energy etc. The DAQ system also time stamps the AE event. A typical AE plot of the events of December 7, 2010 is shown in Figure 5. During this period of recording there was no train cargo traffic under the bridge but there was a regular traffic on the bridge. The sensors 1-4, were located outside of the south deck of the bridge and sensors 5 – 8 were located under the bridge (Table 1). It may be noted from Figure 5 that sensor 1-4, being located outside of the deck area on the bridge, show no AE response. This is an area unaffected by the load on the bridge.

Figure 5. Typical response from AE sensors December 7, 2010 for the sensor locations in Table 1. Sensors 1-4 do not show any response being located on the wall area outside of the bridge.

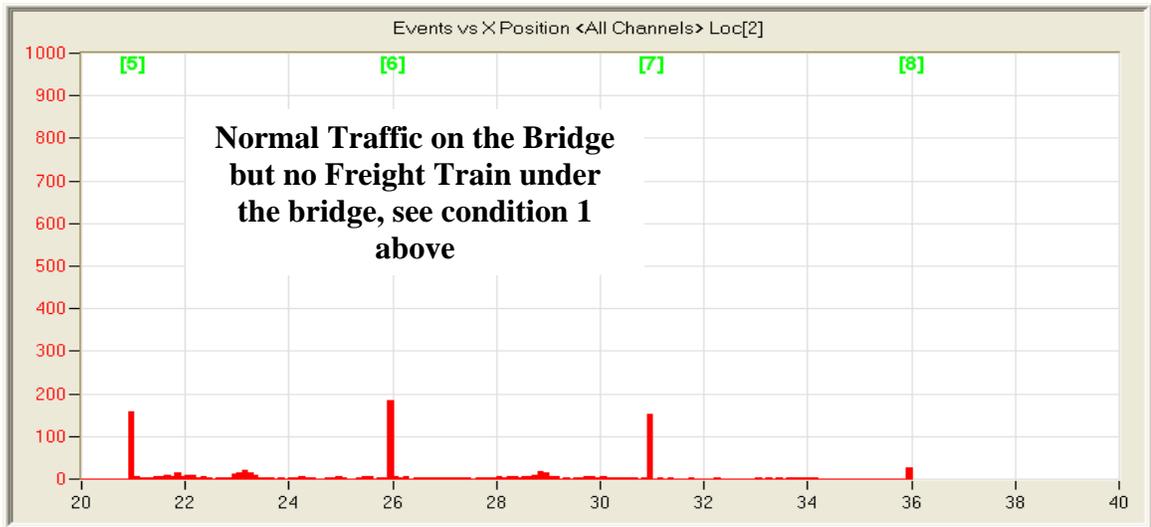
Figure 6 shows responses from sensors 5 – 8 for locations given in Table 1 for the traffic situation in item 1 above where AE events have been plotted against the sensor locations on the back wall. The cluster of events in the wall stretch between sensors 5 - 6 and between 6 -7 are from locations falling under the central steel girders in Figure 2. These AE events are resulted from the existing cracks in these regions.

Figure 6. AE responses from AE sensors 5 – 8 recorded on December 7, 2010 for the sensor locations in Table 1 for a regular traffic on the bridge and no freight train movement under the bridge.

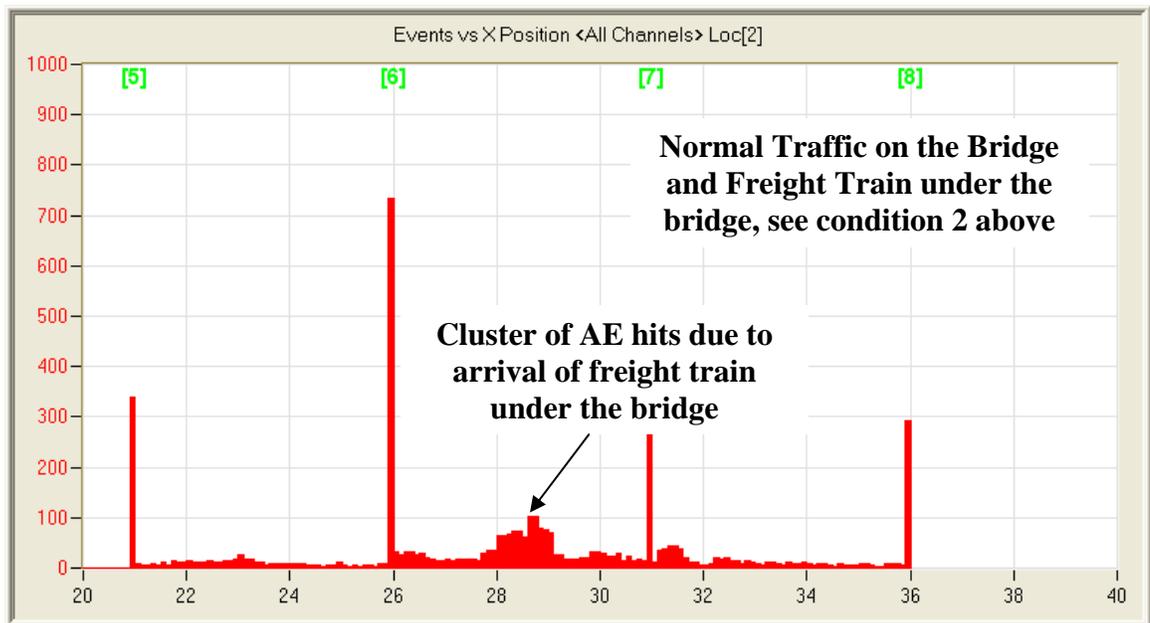
Figure 7 shows responses from sensors 5 – 8 for locations given in Table 1 for the traffic situation in item 2 above where AE events have been plotted against the sensor locations. The cluster of events in the wall stretch between sensors 5 - 6 and between 6 -7 are from locations falling under the central steel girders in Figure 2. These AE events are resulted from the existing cracks in these regions. Comparison of Figures 6 and 7 clearly demonstrates the effect of freight train movement on the AE activity in the wall. The effect is significant indicated by a large number of recorded hits, specifically in the sensor 6 - 7 stretch and in the vicinity of sensor 7 towards sensor 8.

Figure 7. AE responses from AE sensors 5 – 8 recorded on December 14, 2010 for the sensor locations in Table 1 for a regular traffic on the bridge and also freight train movement under the bridge.

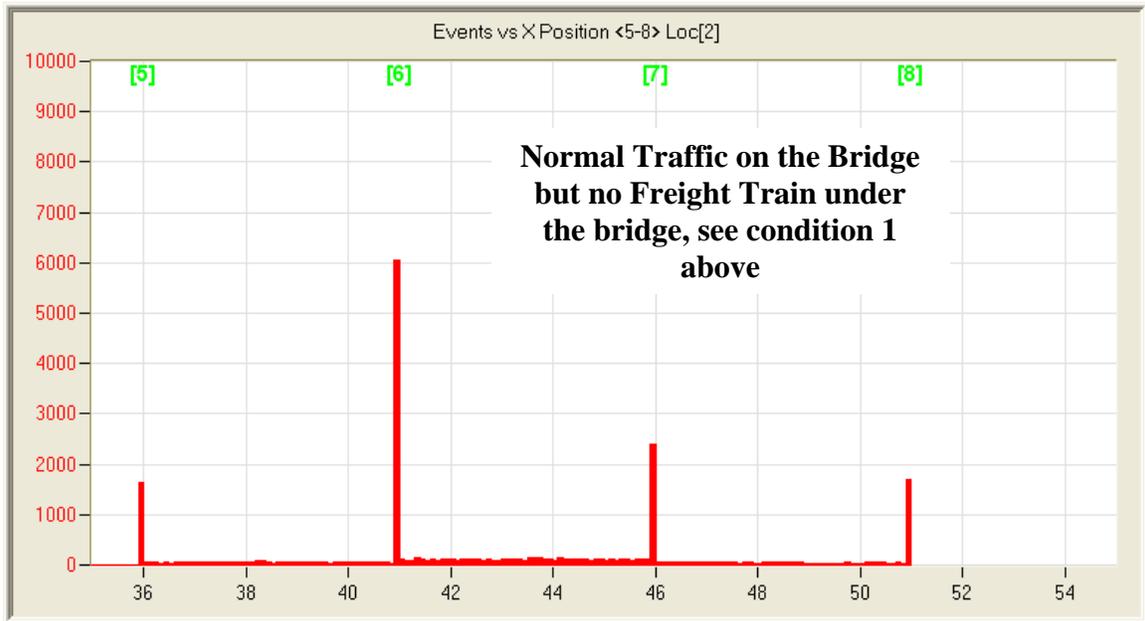
Figure 8 (a) shows installations of the relocated sensors (see Table 2 for locations) to cover the wall area between 16 feet – 51 feet. Considering the width of the back wall of the bridge as 54.5 feet, this relocation covers the entire width of the wall at 7.75 feet from the ground. The responses from sensors 5-8 in this configuration acquired on December 22, 2010 are demonstrated in Figure 9 in the absence of any freight movement under the bridge. However, when the freight train arrived on the same day, the data showed a significant change in AE activity shown in Figure 10. Figure 9 shows responses from sensors 5 – 8 for locations given in Table 2 for the traffic situation in item 1 above where AE events have been plotted against the sensor locations. Figure 10 shows the cluster of events in the wall stretch between sensors 5 - 6 and between 6 -7 are from locations falling around the central steel girders in Figure 2. The situation in Figure 10 corresponds to the condition of item 2 above where there is also the presence of train freight apart from the normal traffic on the bridge. These AE events are resulted from the existing cracks in these regions as well as generation/expansion of new cracks. Comparison of Figures 9 and 10 clearly demonstrates the effect of freight train movement on the AE activity in the wall. The effect is significant as indicated by a large number of recorded hits, specifically in the sensor 6 - 7 stretch and in the vicinity of sensor 7 towards sensor 8.

Figure 9. AE responses from AE sensors 5 – 8 recorded on December 22, 2010 for the sensor locations in Table 2 for a regular traffic on the bridge and no freight train movement under the bridge.

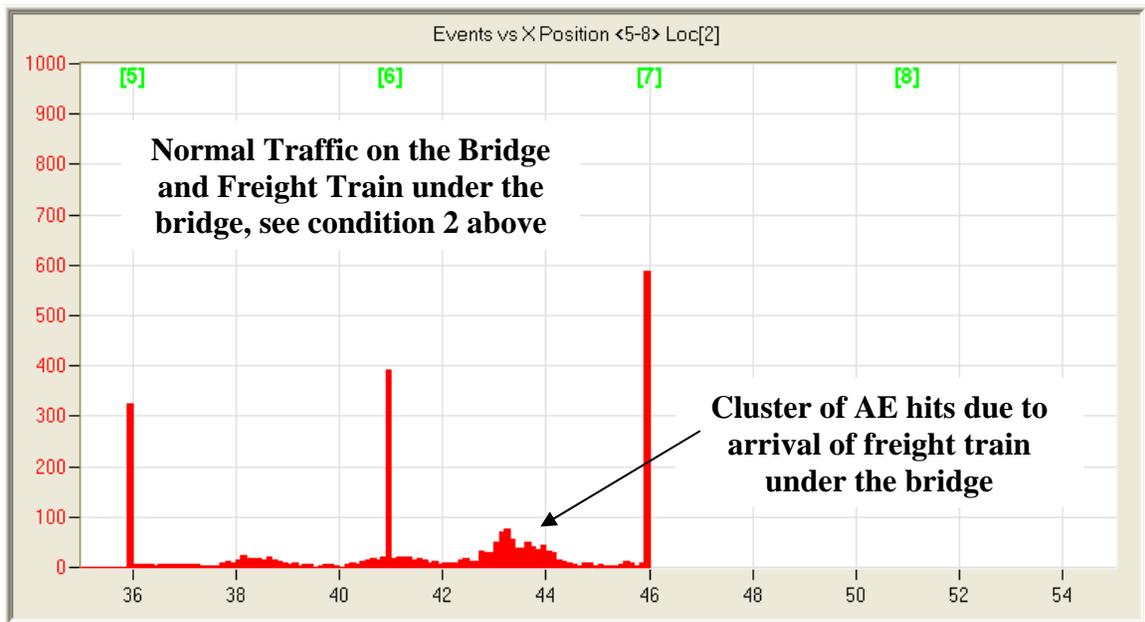
Figure 10. AE responses from AE sensors 5 – 8 recorded on December 22, 2010 for the sensor locations in Table 2 for a regular traffic on the bridge and also freight train movement under the bridge.

As shown in Figure 10, areas of significant AE activity have been found around locations of sensors 5-7. In order to focus on this area, AE sensors were redistributed to include vertical distance variations according to the location scheme of Table 3. In this scheme, sensors 3, 5 and 7 were relocated 32” higher than shown in Figure 8(a). The new scheme of sensor locations is shown in Figure 8(b). This redistribution allowed closer look around sensors 2, 4 and 6. The AE sensor locations and AE response from sensors in scheme of Table 3 is shown in Figure 13. Areas of high and low AE activity are clearly

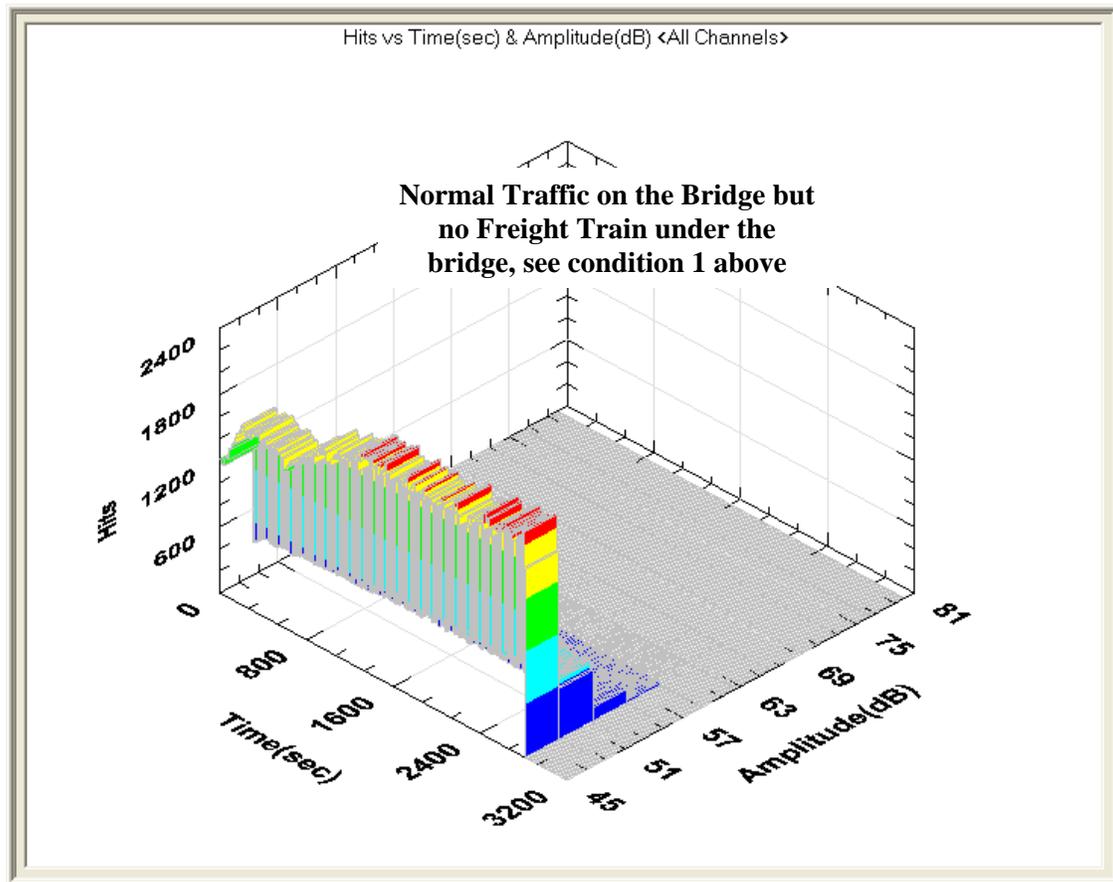
The data of Figures 9 and 10 for the absence and presence of the freight train component has further been analyzed to give a 3 D perspective in Figures 11 and 12, respectively. In 3D diagrams, the AE hits and their amplitudes have been plotted against the time of the hits being recorded at a given sensor. A “hump” of hits related to AE activity due to arrival of freight train in Figure 12 is absent in Figure 11.

Figure 11. 3D representation of responses from AE sensors 5 – 8 recorded on December 22, 2010 for the sensor locations in Table 2 for a regular traffic on the bridge and no freight train movement under the bridge.

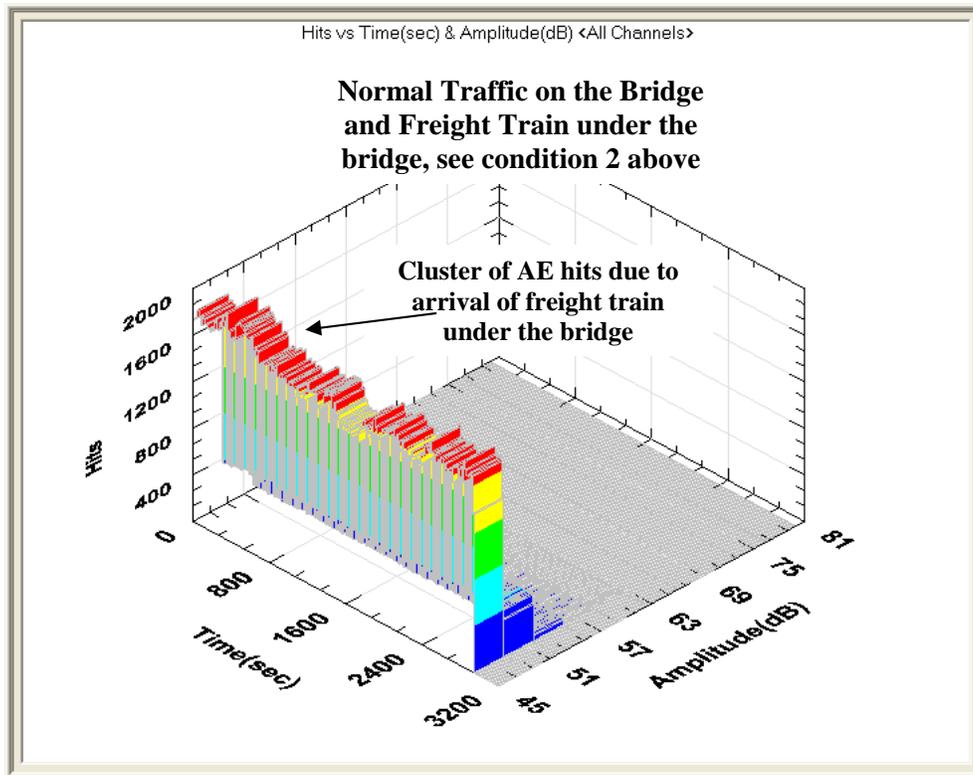
Figure 12. 3D representation of responses from AE sensors 5 – 8 recorded on December 22, 2010 for the sensor locations in Table 2 for a regular traffic on the bridge and also freight train movement under the bridge.

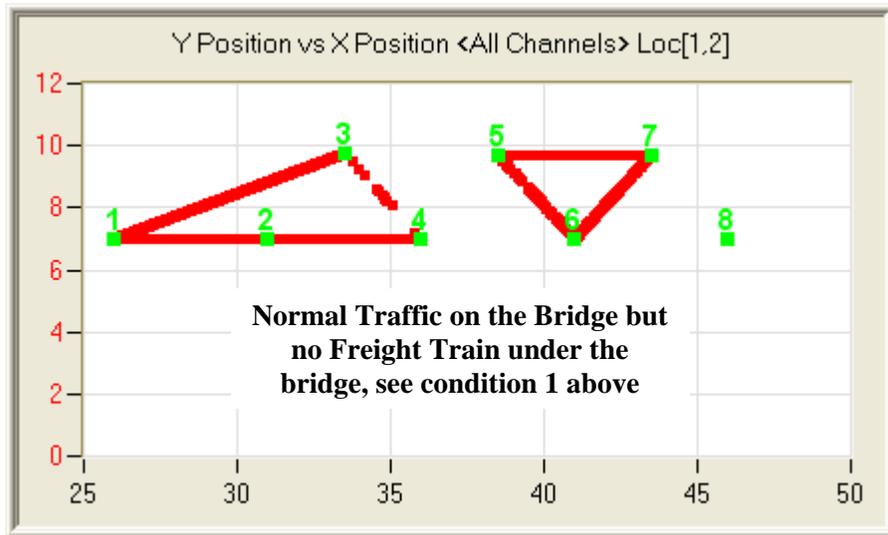
seen on Figure 13. Whereas, no AE activity was recorded between sensors 4 and 5, 4 and 6; and 7 and 8, there was AE activity between sensors 3 and 4. Further, strong AE activity was recorded between sensors 1 – 3, 5, 6 and 7. These observations clearly show AE activity originating from vertical locations. Further, the amount of AE activity shown in between sensors 3 and 4; and between sensors 5 and 6 is lower in comparison to that between 5 and 7. This demonstrates that the AE activity is not uniform in the entire wall but there are strong AE activity areas along the wall closer to the foot of the wall.

Figure 13. AE responses from AE sensors 1 – 8 recorded on February 02, 2011 for the sensor locations in Table 3 for a regular traffic on the bridge but no freight train movement under the bridge.

- *Measurement and mapping of the cracks (both active and existing) in all the (4) back walls of this bridge should be undertaken. AE is relatively better suited technique for the purpose.*
- *Evaluation of the entire height of the wall, especially the areas falling under the central girders and the anchorage regions of the girders with the walls should be conducted.*
- *VDOT should consider using AE periodically to evaluate the health of this structure and determine which regions are exhibiting the greatest AE activity. Regions with elevated AE activity should take precedence over non-active regions during inspection.*
- *More number of bridges that cross R/R should be evaluated using AE in conjunction with other inspection techniques if necessary. VCTIR and HU/ESITAC should provide guidance for this recommendation on request from VDOT.*

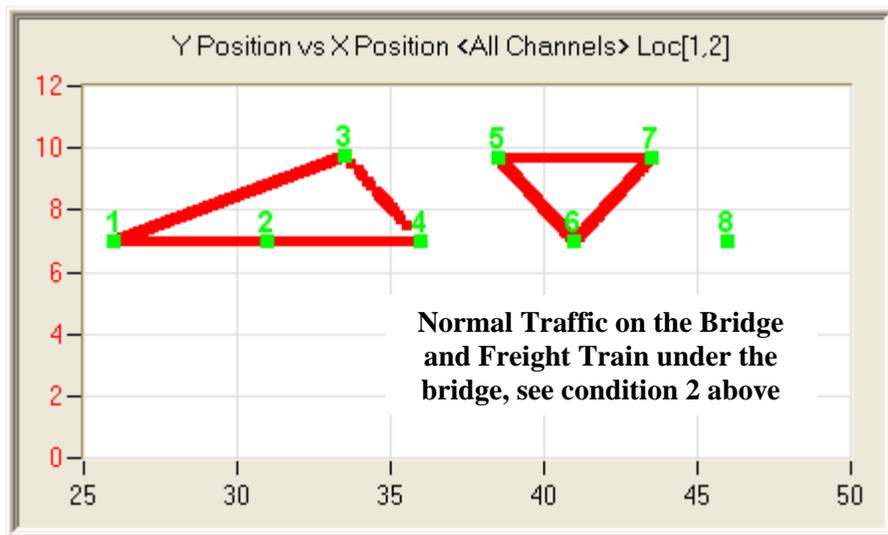
Figure 14 shows spur in AE activity due to arrival of freight train under the bridge in comparison to that in Figure 13 when the freight traffic is absent.

Figure 14. AE responses from AE sensors 1 – 8 recorded on February 07, 2011 for the sensor locations in Table 3 for a regular traffic on the bridge and also freight train movement under the bridge.

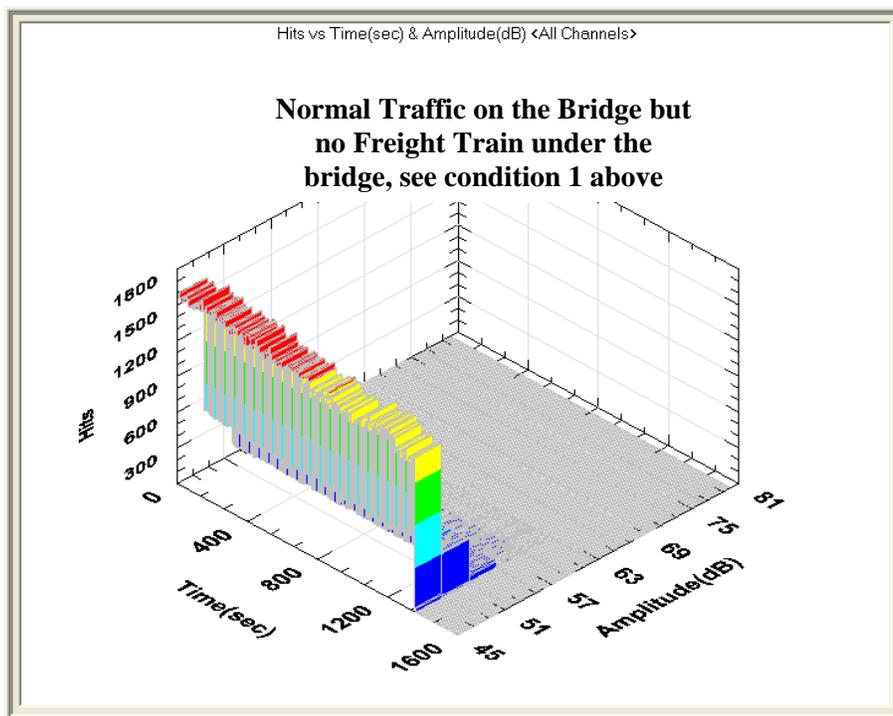
Figure 15. 3D representation of responses from AE sensors 1 – 8 recorded on February 02, 2011 for the sensor locations in Table 3 for a regular traffic on the bridge and no freight train movement under the bridge.

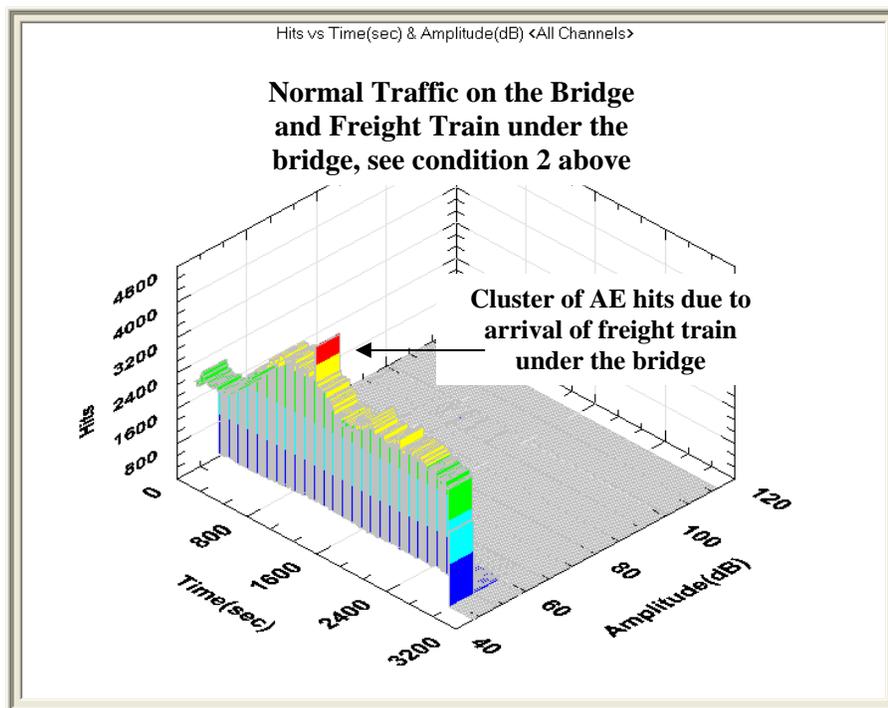
Figure 16. AE responses from AE sensors 1 – 8 recorded on February 07, 2011 for the sensor locations in Table 3 for a regular traffic on the bridge and also freight train movement under the bridge.
