Evaluation of Effects of Super-Heavy Loading on the US 41 Bridge Over the White River

EVALUATION OF EFFECTS OF SUPER-HEAVY LOADING ON THE US-41 BRIDGE OVER THE WHITE RIVER

Report Number: FHWA/IN/JTRP-2011/15

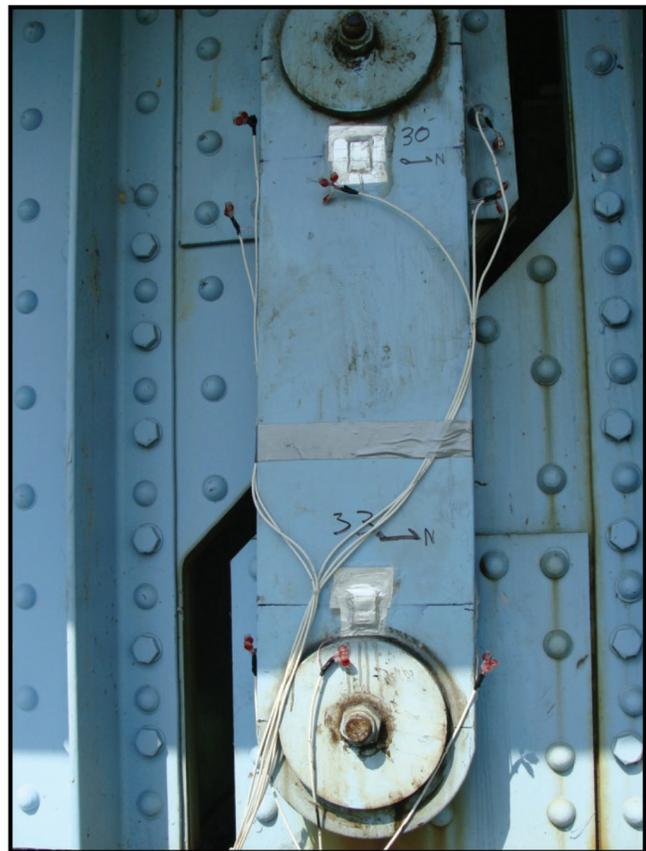
Figure 2.11: East pin and hanger on G2

The pin and hanger assemblies were of great interest during this study. Historically, problems have occurred in other bridges when the pin and hanger elements seize up as a result of corrosion. The fixity that results from the corrosion can introduce bi-axial bending that was

not accounted for during the original design. In some cases, this bi-axial bending has led to the development of fatigue cracks. Thus, sixteen (16) strain gages were installed on four hangers to determine if bi-axial bending is present in the pin and hanger assemblies. One of the four hangers (east hanger Girder G2) was heavily instrumented with eight strain gages. This hanger had gages installed on the sides of the hanger (top, middle and bottom) and on the face of the hanger (centerline). The location of these gages can be seen in Figure 2.11. *(Note: some of the strain gages in the photograph were moved due to a preliminary data review during the installation. Please consult the as-built instrumentation plans attached in the appendices for final strain gage locations.)* The remaining four hangers had either two or four strain gages each. Table 2.4 is a

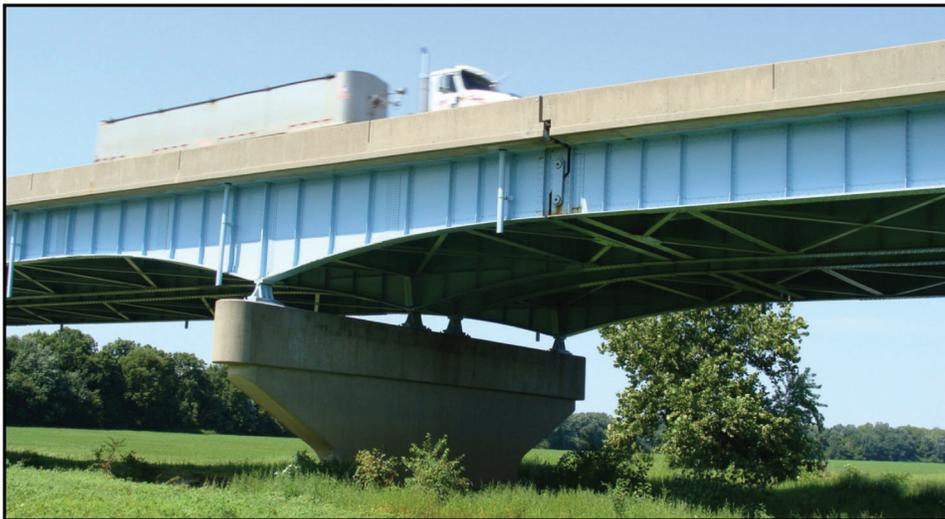
Figure 4.31: Photograph of pin and hanger

Some minor compression was also measured at CH_33. The compressive response occurred when the test trucks were in the adjacent spans to the pin and hanger. This sort of response is extremely common in continuous structures. Typically, as a load moves

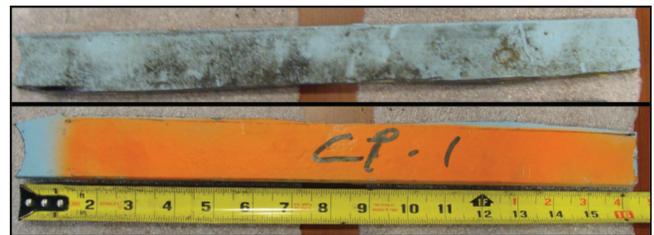
Figure 6.1: Example material sample

INDOT extracted the samples from the bridge under the direction of the Purdue Research Team. The specimens were taken from areas of low stress (e.g., at the end of a member) with the consideration of the difficulty of removal. To remove each sample, a hole was first drilled at the corner of the specimen. This was done to create a smooth transition to the removed section for improved fatigue resistance. Likewise, after each sample was removed the cut surface was ground smooth to improve the fatigue resistance. Finally, all bare surfaces were painted to reduce the effects of corrosion. Figure 6.2 is an example location where a material specimen was removed from the US-41 White River Bridge. The area in the photo is at a cover plate termination.

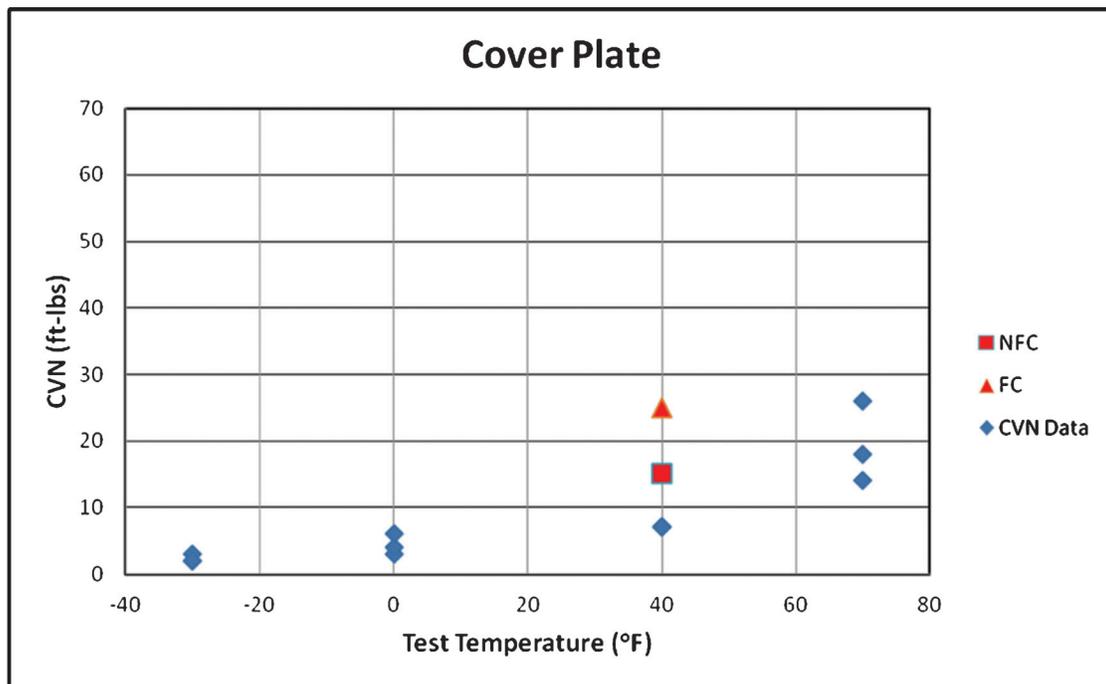
Figure 6.3: Cover plate angle plot of CVN data

To determine if brittle fracture was a concern for a 3/8 inch flaw due to the low CVN values, the stress intensity factor was calculated. A standard K_I solution for a plate with a hole having a crack at the edge (Figure 6.7) was used for the stress intensity factor

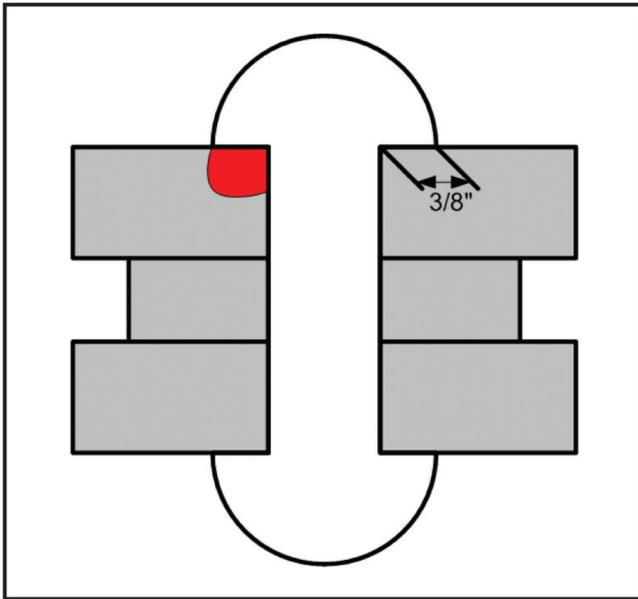
Figure 6.6: Critical crack length versus rivet head

To determine the critical flaw size a quick evaluation was first performed to determine the smallest flaw detectable during a routine bridge inspection. It was determined that a 3/8 inch long crack emanating from the edge of a rivet hole would remain hidden under the head of the rivet and therefore would not be detectable during a routine visual inspection. An illustration of this concept is presented in Figure 6.6. Thus, it was first evaluated if a 3/8" flaw had the potential for fracture. (It is noted that cracks extending past the head of the rivet (i.e., larger cracks) could also be missed; however, if a 3/8 inch defect is large enough to lead to fracture a larger
