State Study 173--Evaluation Of Preventive Maintenance Treatments

Randall L. Battey, P.E.
Assistant Chief Engineer—Operations
Mississippi Department of Transportation
September 2009 (Updated April 2012)

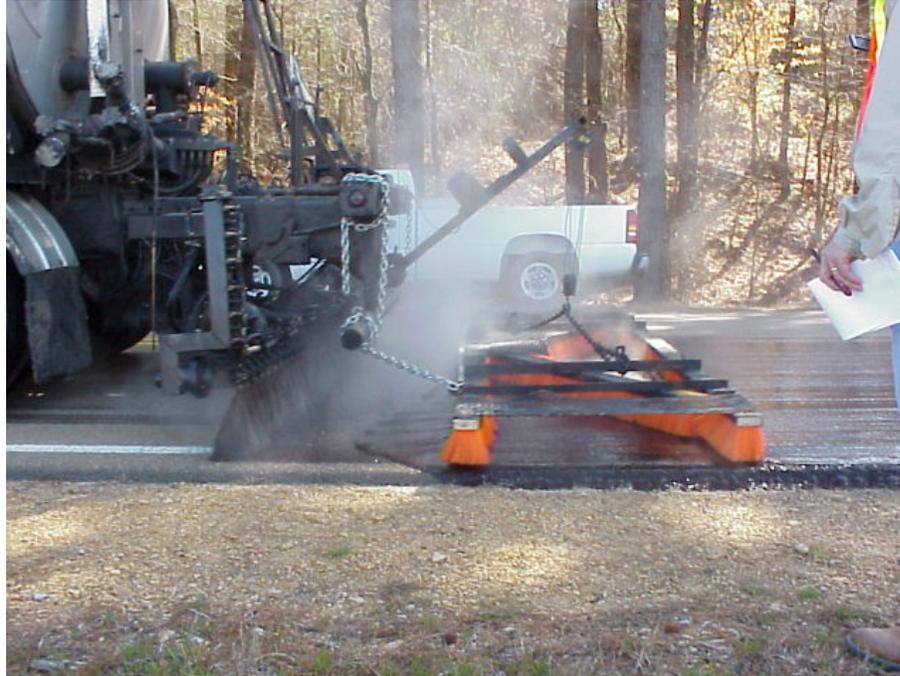
The following pictures were taken on Highway 35 in Charleston, Mississippi, on March 25, 2005. The initial emulsion application rate was .30 gal/yd², and the aggregate was applied at 16 lbs/yd² while not using the broom apparatus behind the emulsion application vehicle. When the broom was later added the initial emulsion application rate remained the same, but the aggregate application rate was reduced to 14 lbs/yd². During the first emulsion pass, the cracks were not wide enough to allow the full amount of emulsion (.30 gal/yd²) to absorb into the pavement fast enough at brooming, resulting in the broom pushing half the emulsion off the road. To combat this two passes of 0.15 gal/yd² were made, which solved the problem. In the picture below the asphalt emulsion was sprayed and then scrubbed with the broom apparatus:

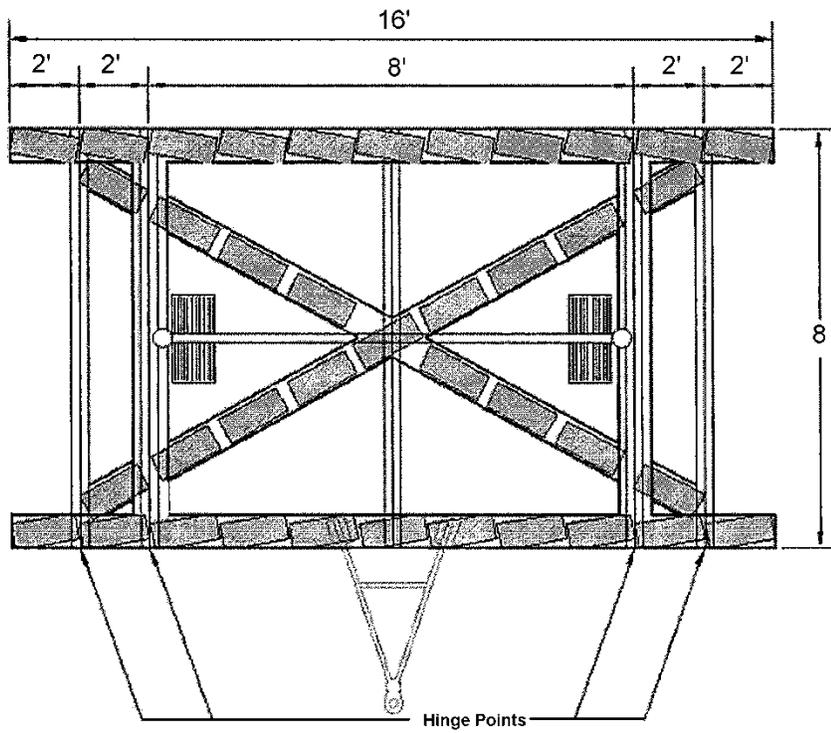
Street Broom w/ Nylon Bristles

Lift For Wheels (Typical)

Note: Wheels are up and the broom is in the scrub position.

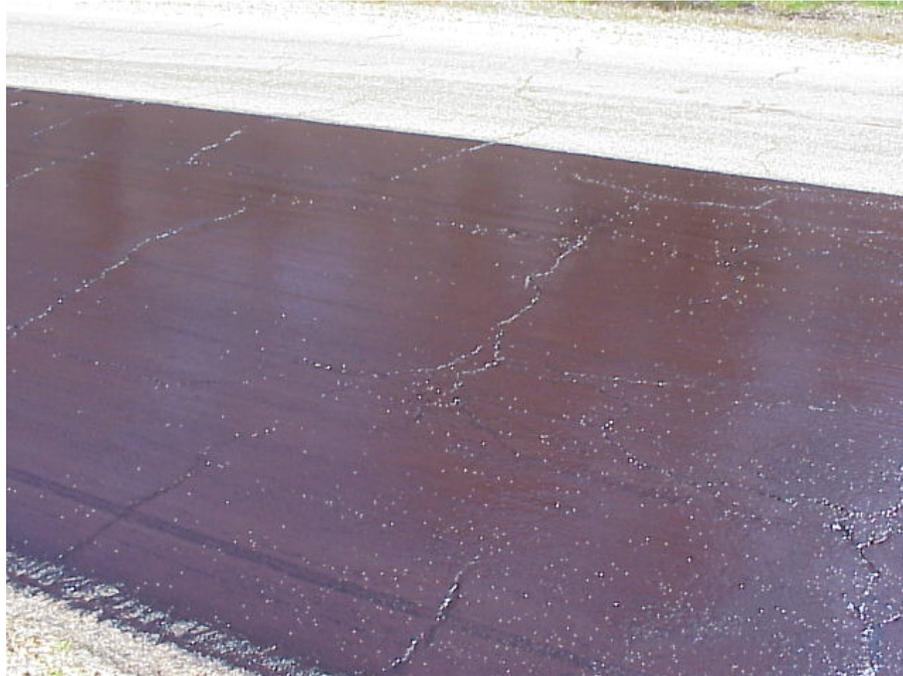
The photograph below shows the emulsion filling the cracks in the asphalt.

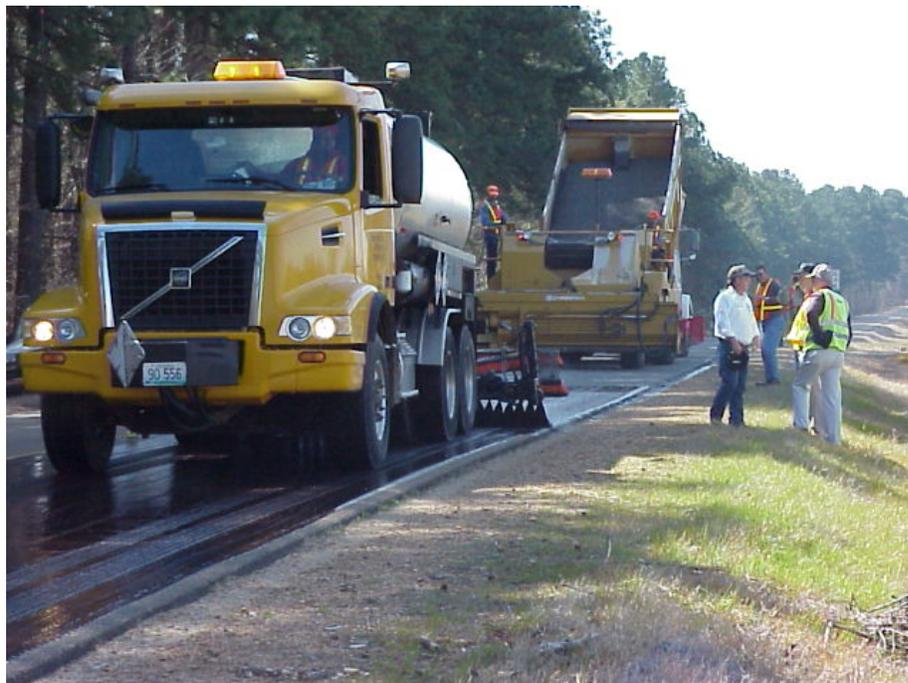
Two passes were made to prevent asphalt emulsion runoff:

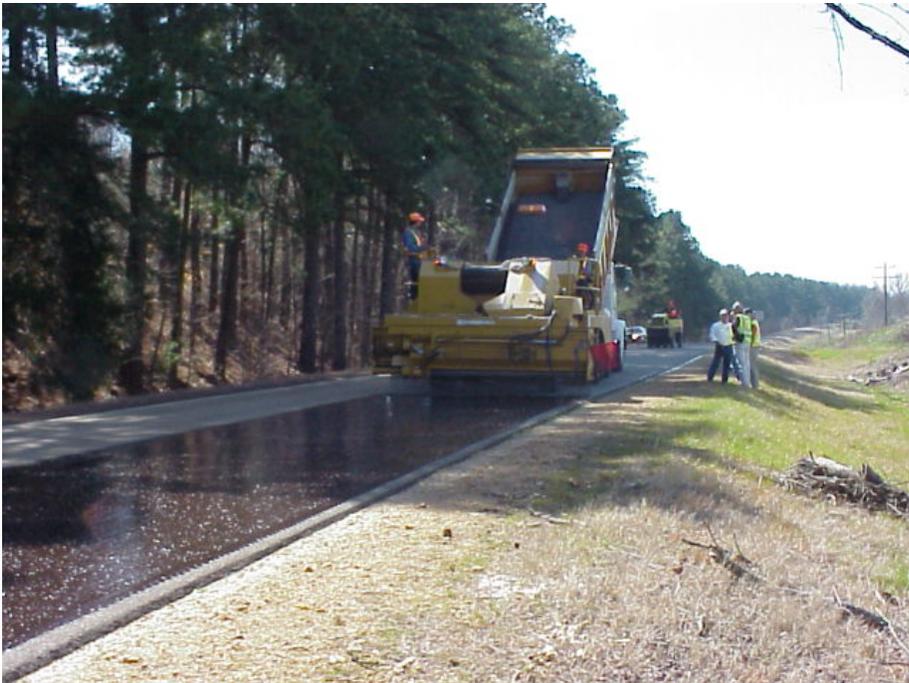
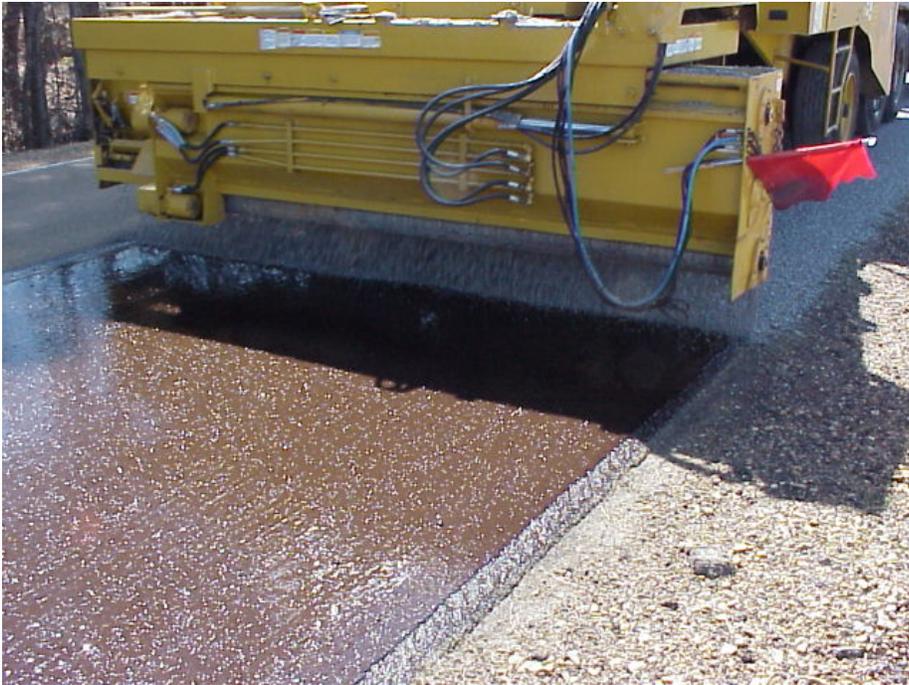
In the photos below the aggregate is being applied to emulsion after the second pass.

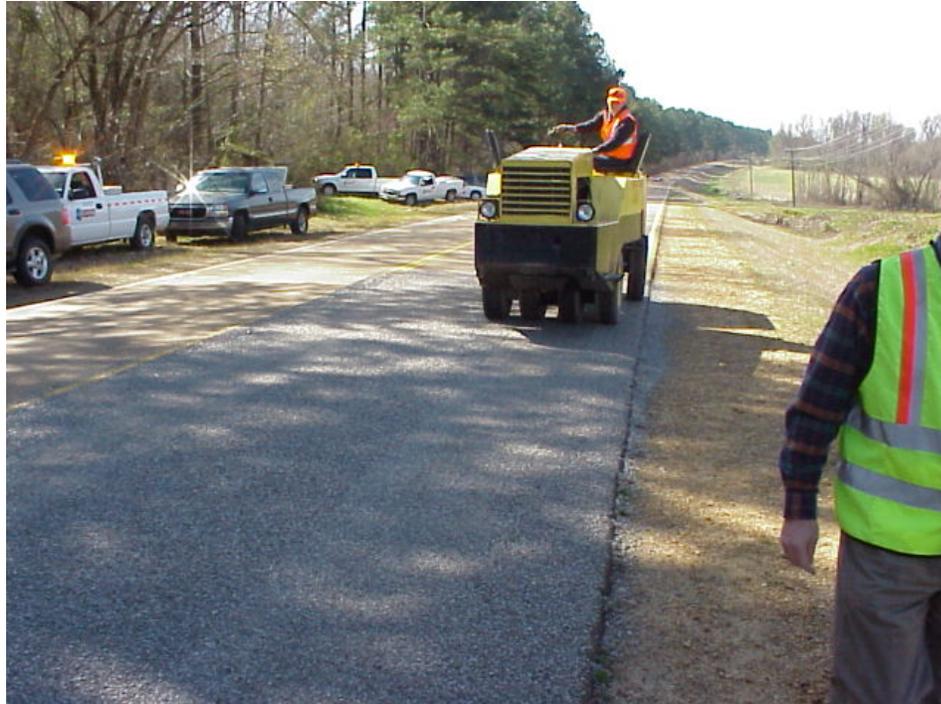
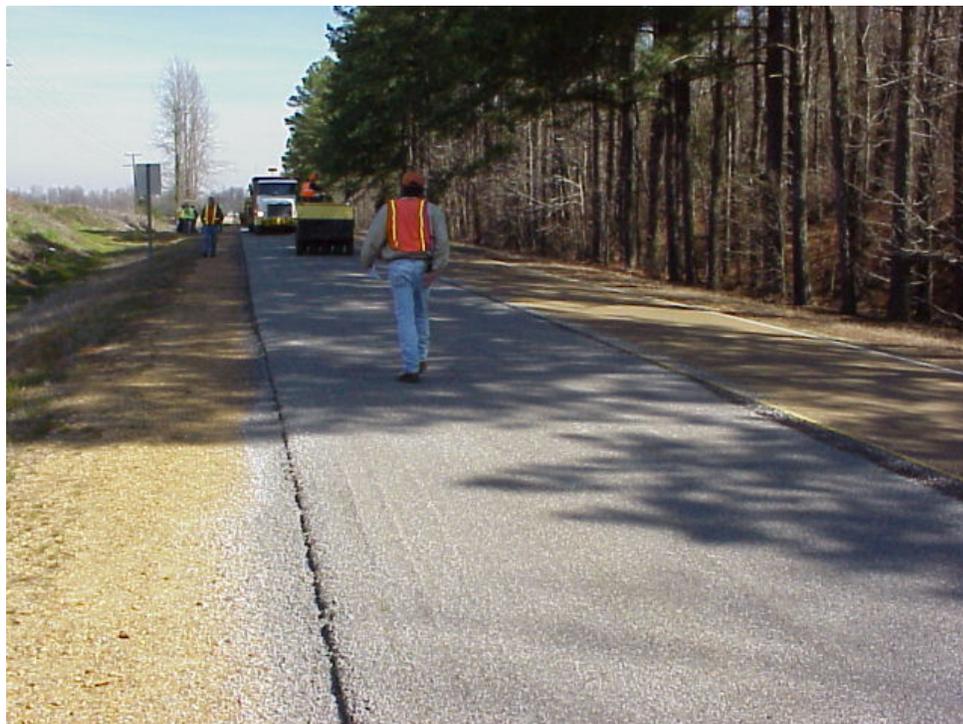
The pneumatic tire roller is shown compacting the lane once the aggregate was applied in the two photos below:

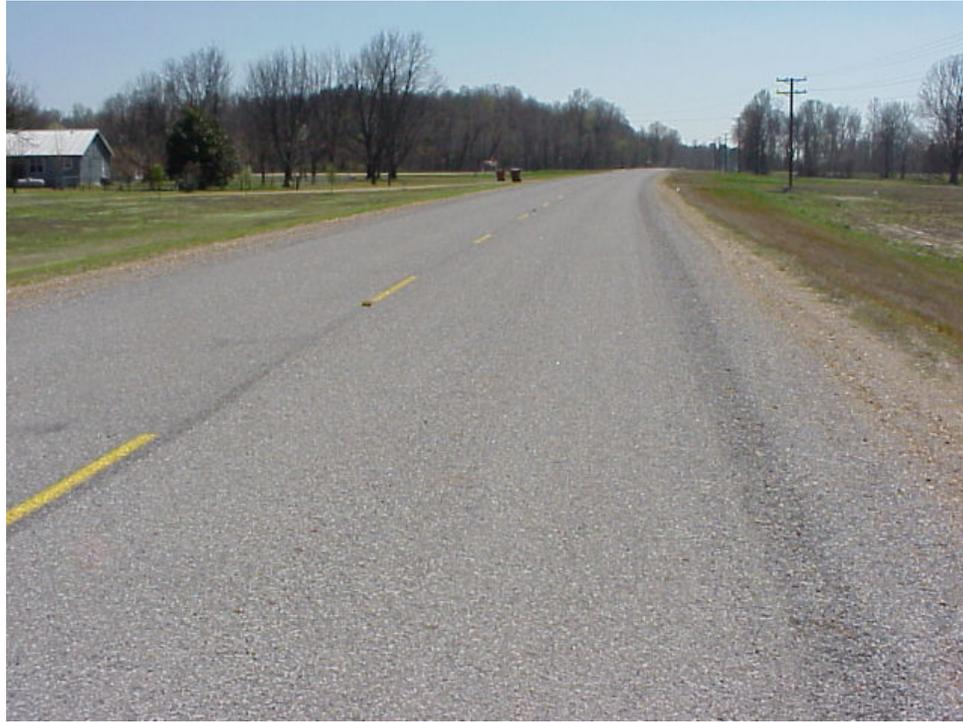
This is the seal 4 days after the application:

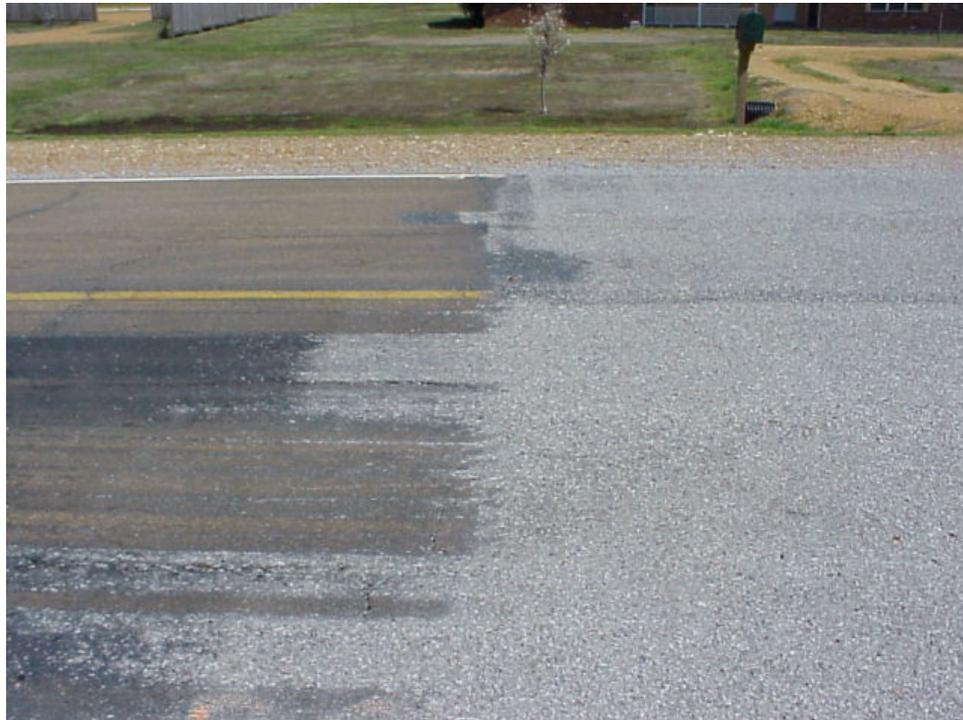
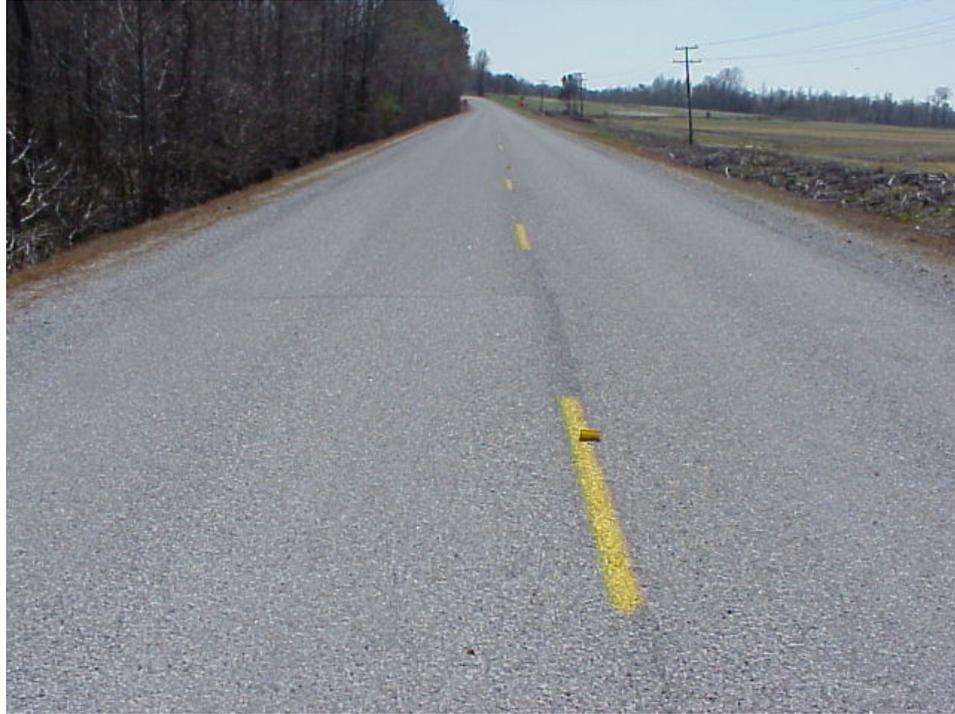
The following photos illustrate the transition from the scrub seal section to the pavement.

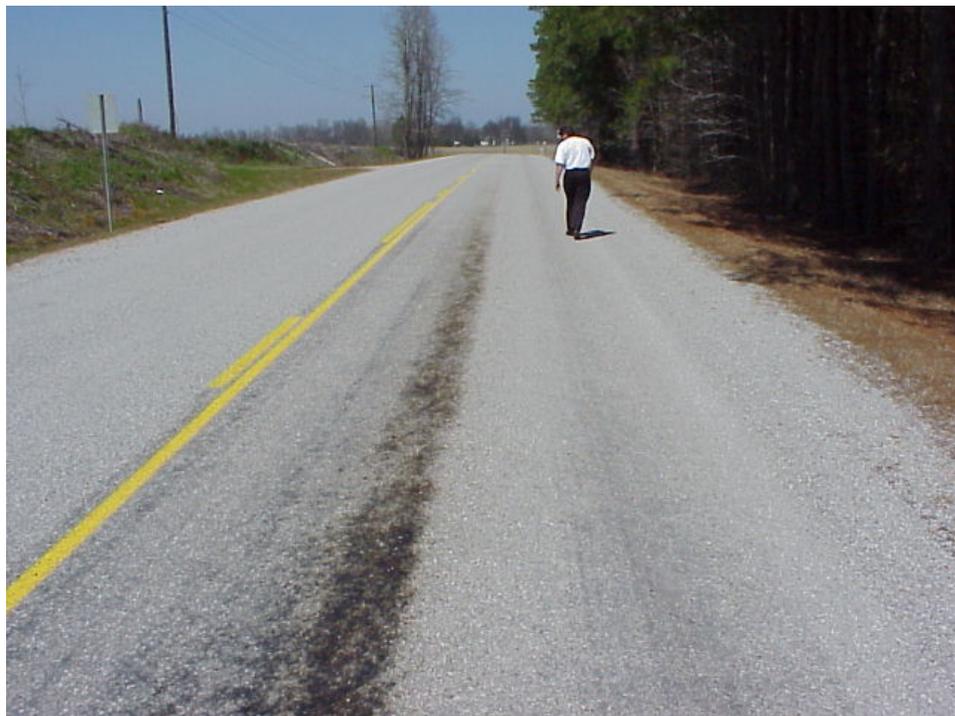
The photo below shows the aggregate coming up in the wheel path. This issue occurred during the 1-mile demo but was rectified before the 2007 District-wide project.

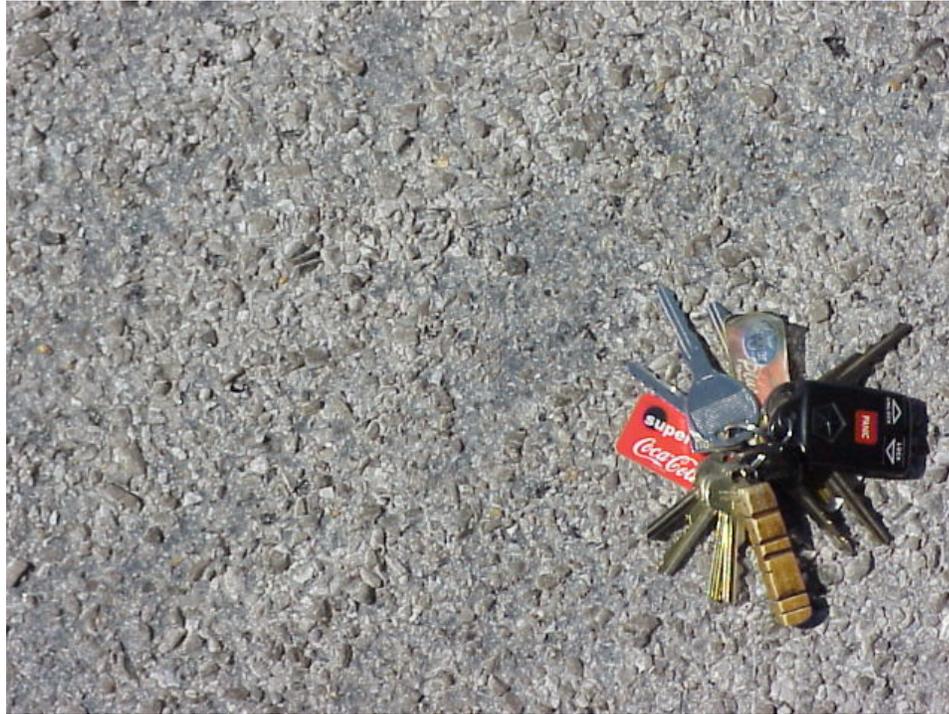
A picture of the aggregate and the emulsion after rolling:

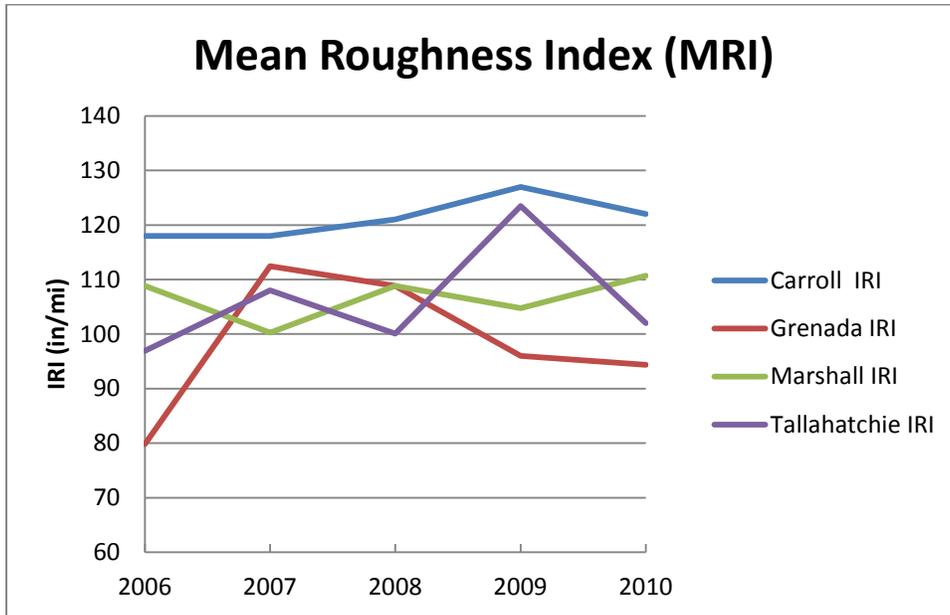
operating costs, overall ride quality, dynamic wheel loads (that is, damage to the road from heavy trucks and braking and cornering safety limits available to passenger cars), and overall surface condition (*The Little Book of Profiling*, September 1998). A new smooth pavement might have an MRI of 50-60 inches/mile. The roughness is more on these routes are they are low-volume, older and had cracking.

The graph below shows the MRI values for the test sections over a five-year period.

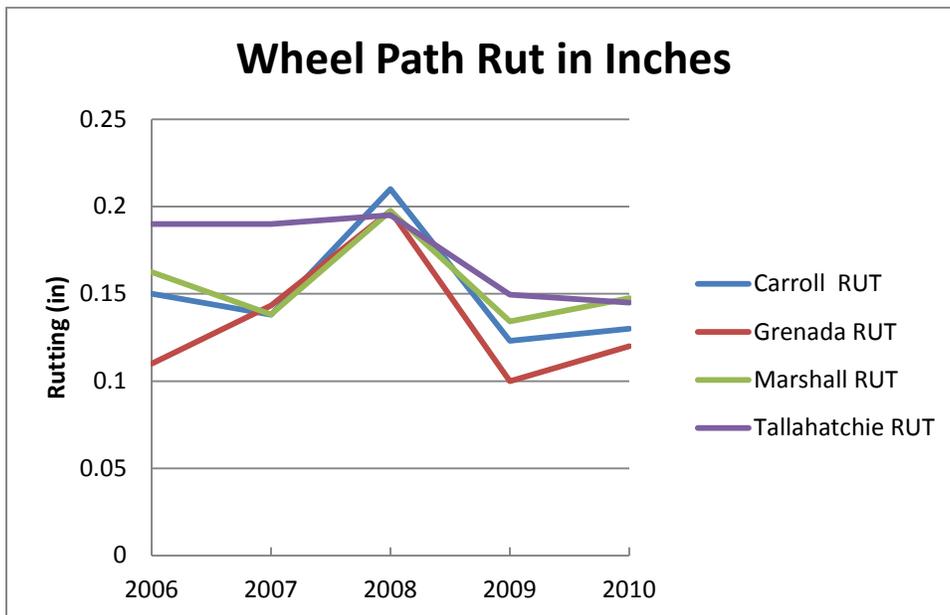
The graph below shows the depth of ruts in the wheel path.

The rutting values were all in a good-to-fair range (from 1/10" to slightly more than 2/10" in Carroll County. Rut data collection changed drastically in 2008, when our condition survey data collection contractor began collecting rutting data with scanning lasers, which are much more sensitive than the conventional 3-point laser, which was used in 2009 when the data was collected in-house. Beginning in 2010 the condition survey was collected on 100% of the roadway as opposed to the previous 20% sampling due to imaging technology improvements and affordability. The use of different vehicles and data collection methods makes trends hard to see; however, the pavements in these projects stayed within acceptable rutting ranges.

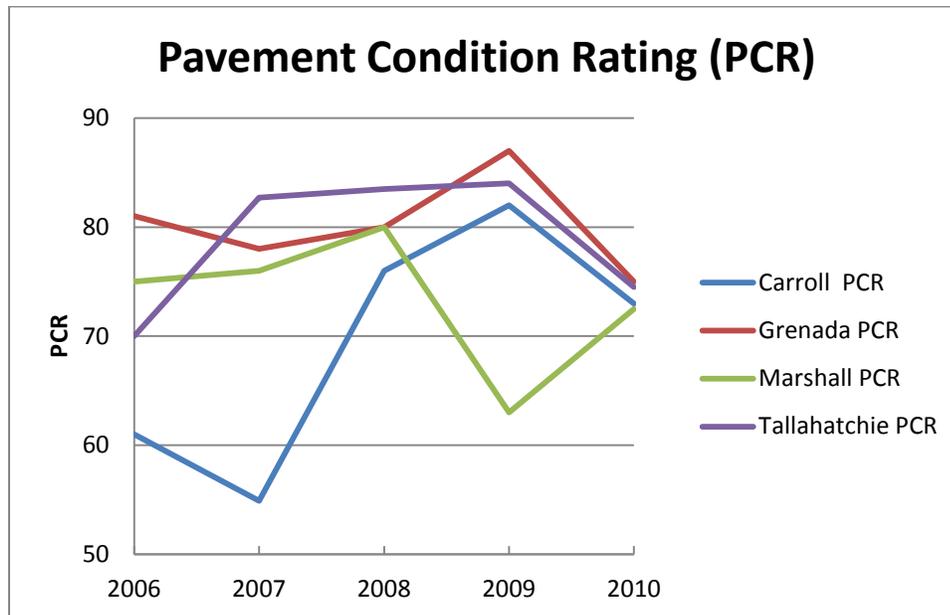
PCR is an important pavement management index calculated using the distress evaluation (cracking, rutting, and roughness are combined into a composite value using an algorithm developed by MDOT and the University of Mississippi). PCR is on a 0-100 scale with 100 being perfect. Below are the PCRs for the four test sections over a five-year period. PCR values were also affected by the newer rutting and 100% automated data collection methods, so trends are difficult to see with PCR, as with rutting and roughness. However, it can be seen from the graph below that the pavements in the projects increased to or stayed within the fair-to-good range.
