1. Report No. FHWA/TX-12/0-6080-1		2. Government Accession No.		3. Recipient's Catalog No.	
4. Title and Subtitle PERFORMANCE MONITORING PAVEMENTS WITH THERMAL SEGREGATION IN TEXAS				5. Report Date January 2012 Published: April 2012

# **PERFORMANCE MONITORING PAVEMENTS WITH THERMAL SEGREGATION IN TEXAS**

Report 0-6080-1

Project Title: Performance Histories of Thermally Segregated HMA

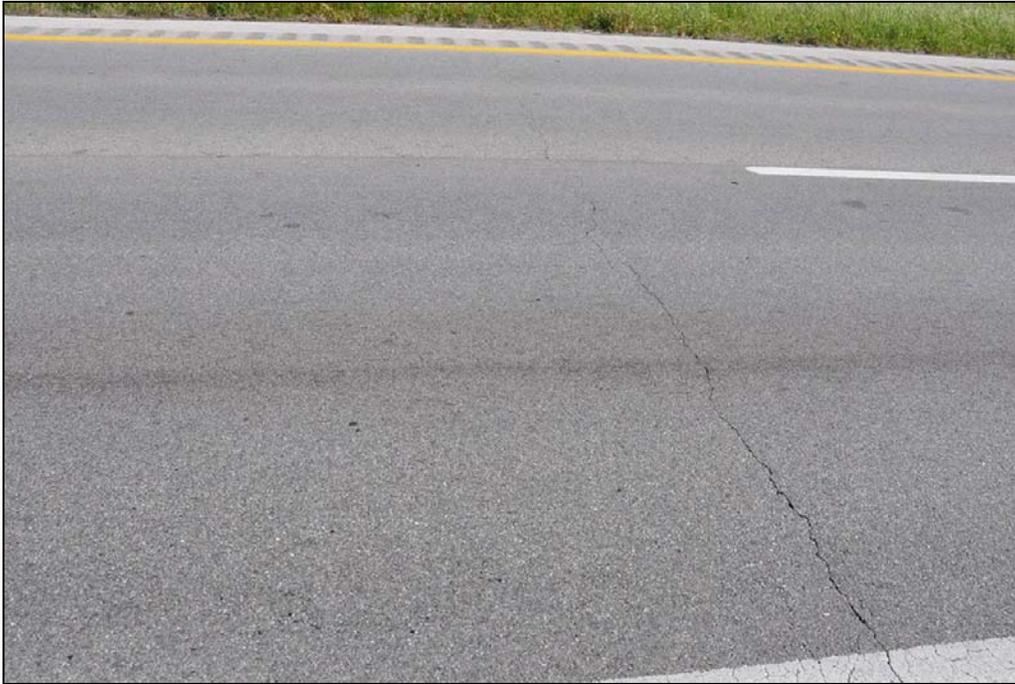
In July 2011, TTI conducted a visual and GPR survey of this project. The only distresses noted were occasional transverse cracks, as Figure 8 illustrates, and occasional longitudinal cracking on the shoulder. The longitudinal cracking was likely due to the subgrade and dry weather pattern that existed at the time of the survey. The GPR survey did not reveal any items of concern, with clean, uniform traces and uniform surface dielectric values. Figure 9 presents an example excerpt from the GPR data collected over the westbound inside lane.

**Figure 8. Example Transverse Cracking on IH 10 after Four Years of Service.**

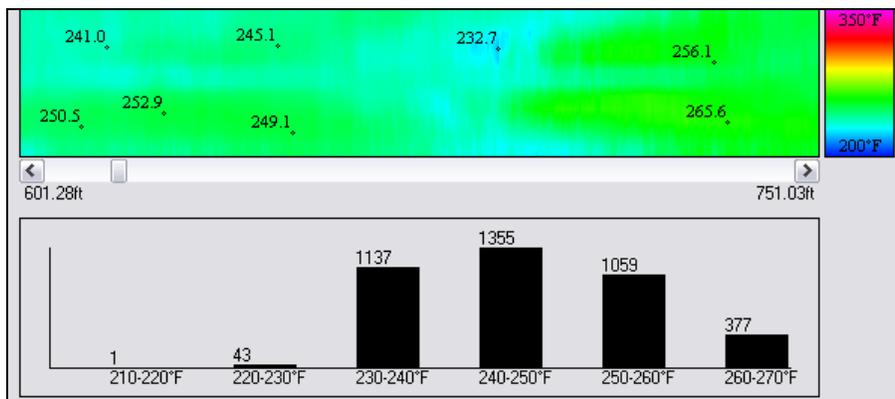
Figure 34 presents the most severe location of thermal differentials observed on the US 81 project. This location has a temperature differential of 36°F; only two other profiles were observed with temperature differentials exceeding 30°F.

**Figure 34. Location of Most Severe Temperature Segregation on US 81.**

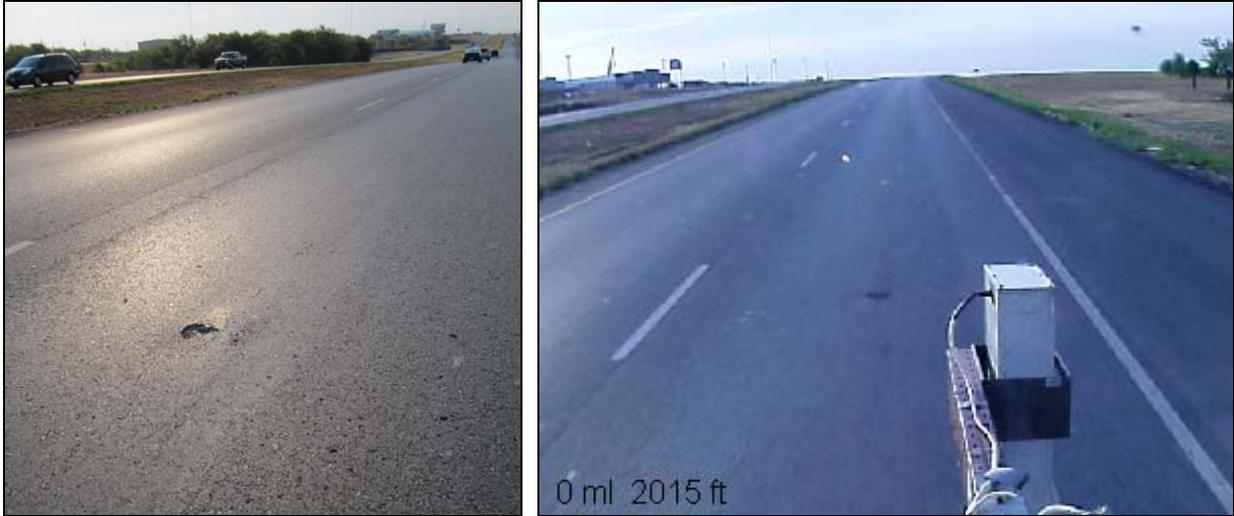
TTI performed a visual and GPR survey on the US 81 section in August 2011. The section exhibited some roughness, which was probably due to the subgrade, and had five locations of low-severity potholes, as Figure 35 shows.

**Figure 35. Localized Distress on US 81.**

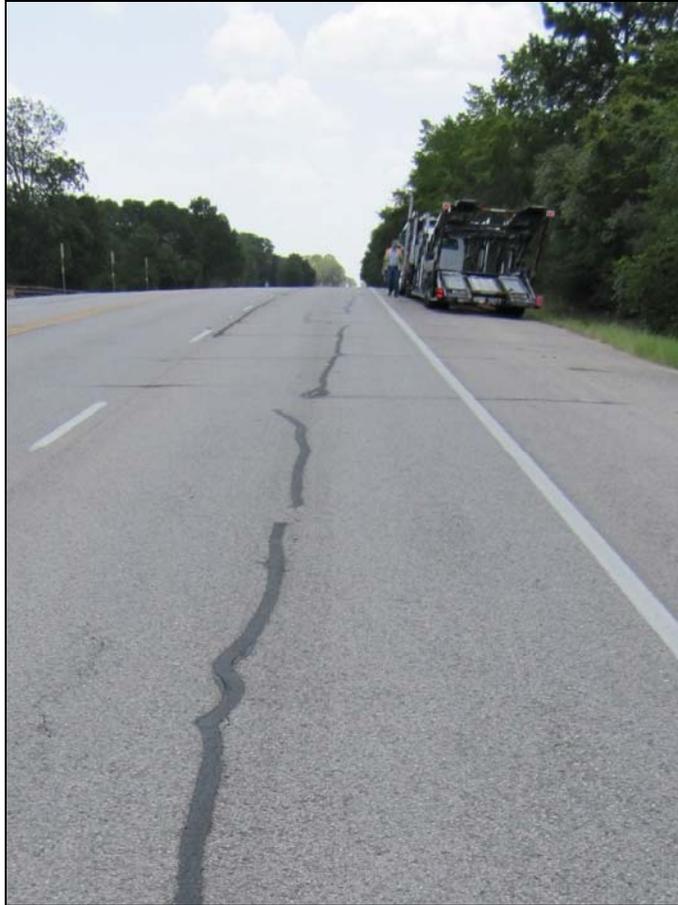
TTI performed a follow-up visual and GPR survey on the section in July 2011. The section exhibited transverse and reflection cracking and some longitudinal cracking, as Figure 43 illustrates.

**Figure 43. Transverse and Longitudinal Cracking on BU 290.**

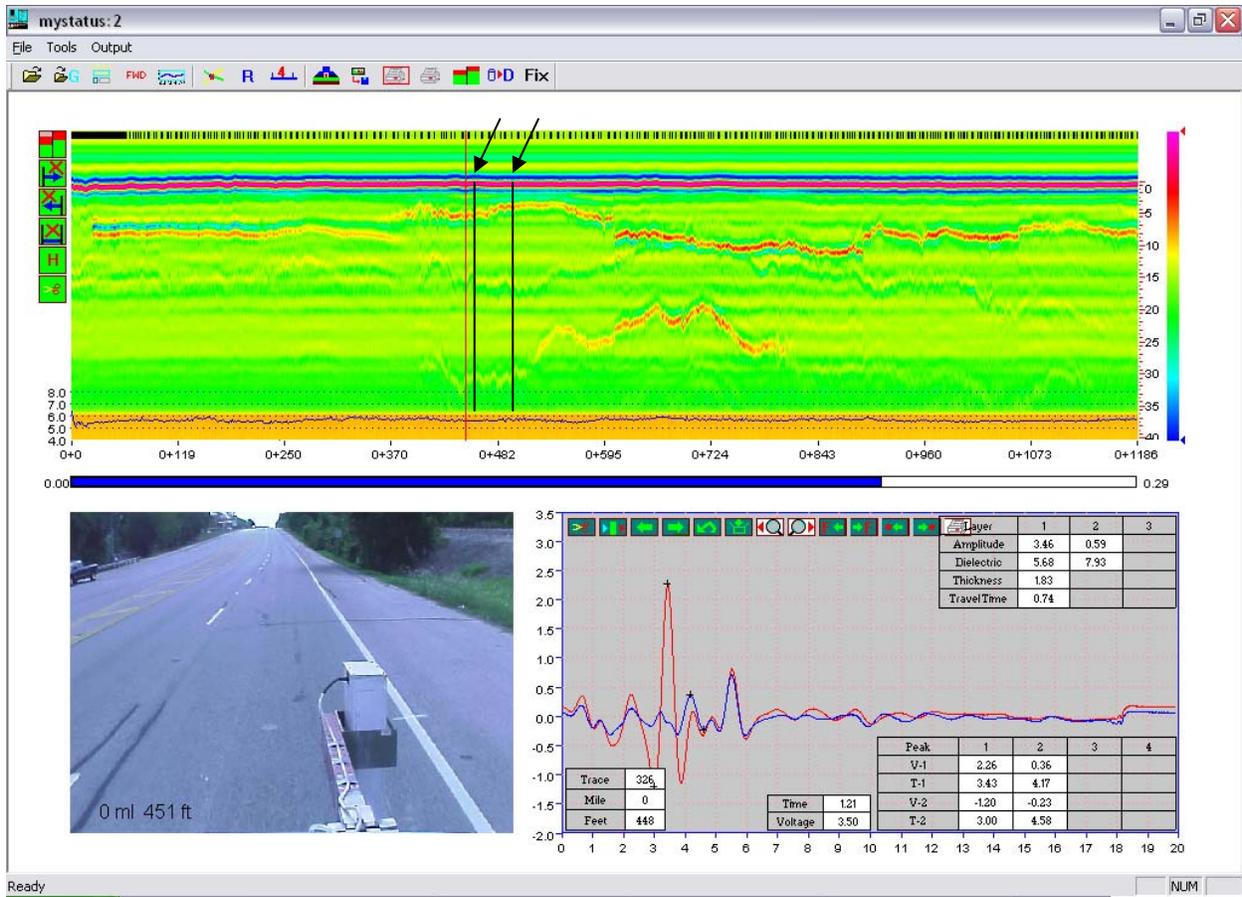
Figure 44 illustrates the GPR data collected on the section. The GPR data do not show any unusual traces at the segregated locations identified during construction. Additionally, Figure 45 shows photos as of July 2011 at the locations that exhibited greater than 10 percent air voids at the time of construction. Based upon the radar and condition data, at this time no distress in the field appears due to these segregated locations.

**Figure 44. GPR Data on BU 290 after Seven Years of Service.**  
*Note: segregated areas identified during construction annotated with arrows.*

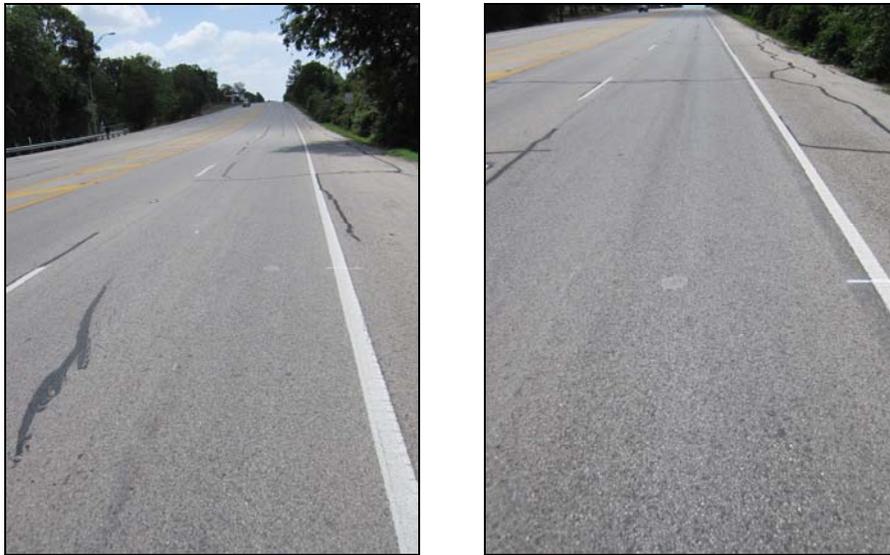
**Figure 45. Thermally Segregated Locations on BU 290 after Seven Years of Service.**

Although a few segregated locations of over 10 percent air voids were observed at the time of construction, after seven years of service no unusual distress was identified at those locations. Current cores from the segregated zones identified during construction were between 7 and 8 percent air voids, so densification under traffic occurred. Comparing performance test results (overlay and Hamburg test) from these current pavement cores to current cores from the non-segregated zones revealed no notable difference. It appears that during trafficking, on this project the segregated zones densified into what would be considered a “normal” air void content range and exhibited performance properties comparable to the mix identified as non-segregated at the time of construction. In both cases, the Hamburg results were acceptable and the overlay test results were poor, with specimens from both segregated and non-segregated zones failing in three cycles.

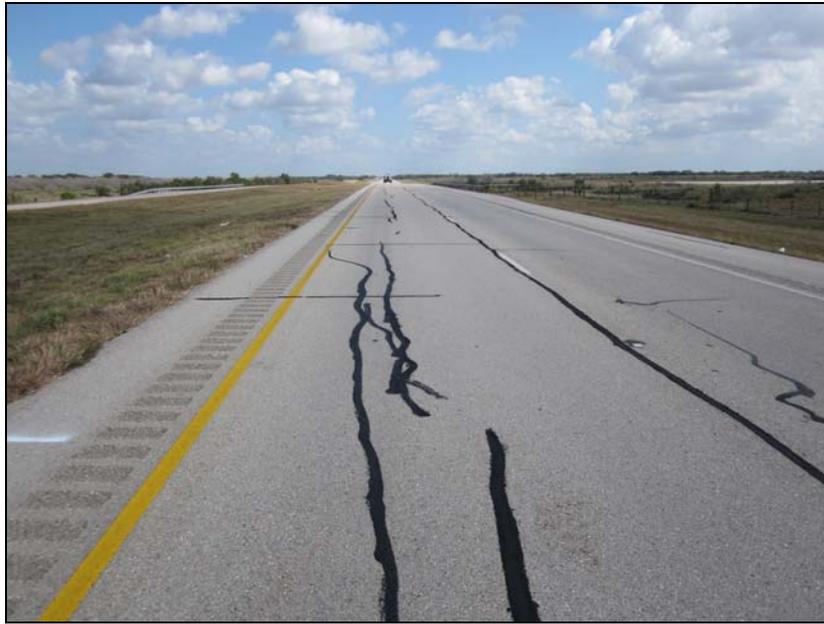
TTI conducted a visual and GPR survey on this section of US 77 in July 2011, approximately five years after construction. The pavement exhibited some longitudinal and transverse cracking, as Figure 51 illustrates. Additionally, the visual and GPR survey shows clear signs of truck-end segregation. Figure 52 presents the GPR data, which show cyclical dips in the surface dielectric value. Many of these cyclical dips correspond to locations of high air voids shown in Figure 49 identified at the time of construction.

**Figure 51. US 77 Section after Five Years of Service.**

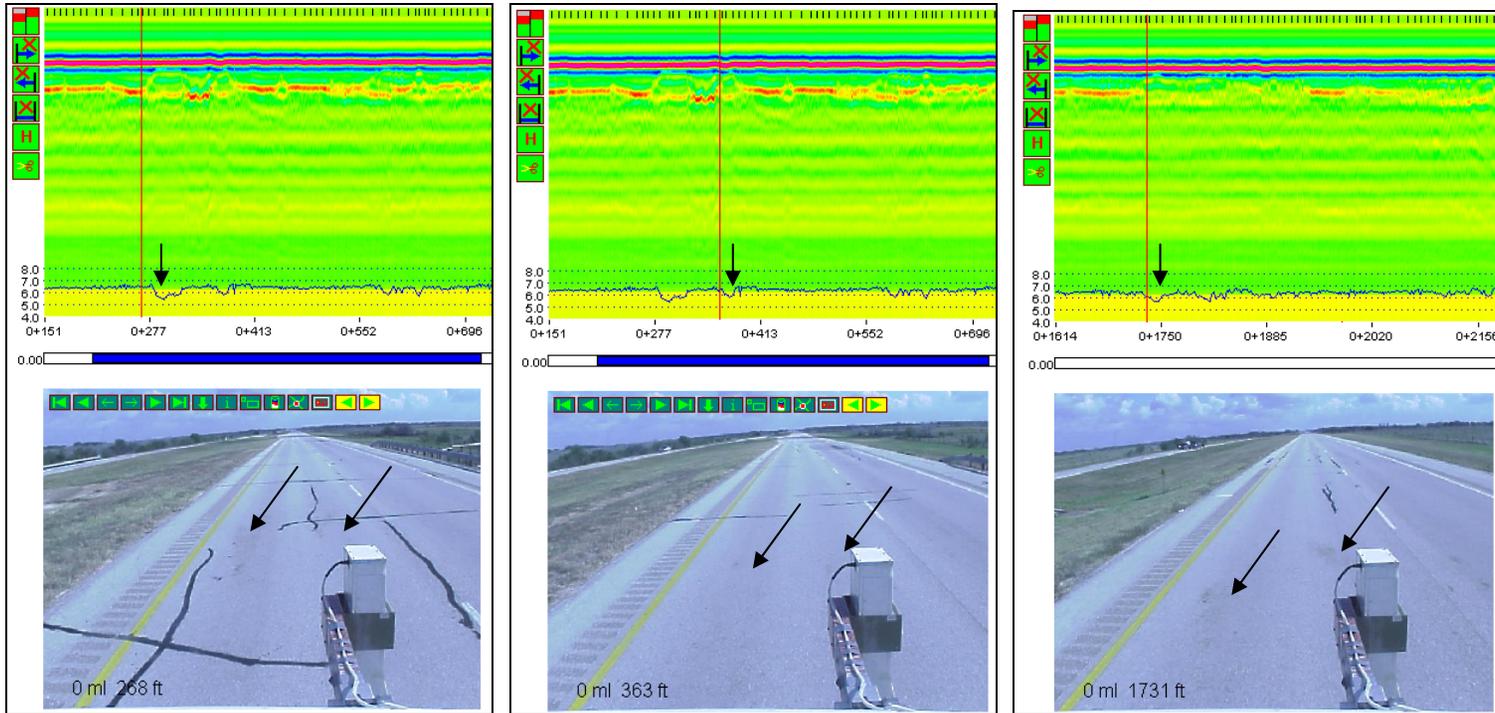
Figure 53 illustrates the current condition of some of these segregated locations. Although difficult to distinguish in Figure 53, all locations show signs of a coarser texture. At one location, a crack originates over the segregated location in the inside wheel path. However, since longitudinal cracking exists project-wide, this occurrence may not necessarily be due to the segregation.

**Figure 53. Cyclically Segregated Locations on US 77 after Five Years of Service.**

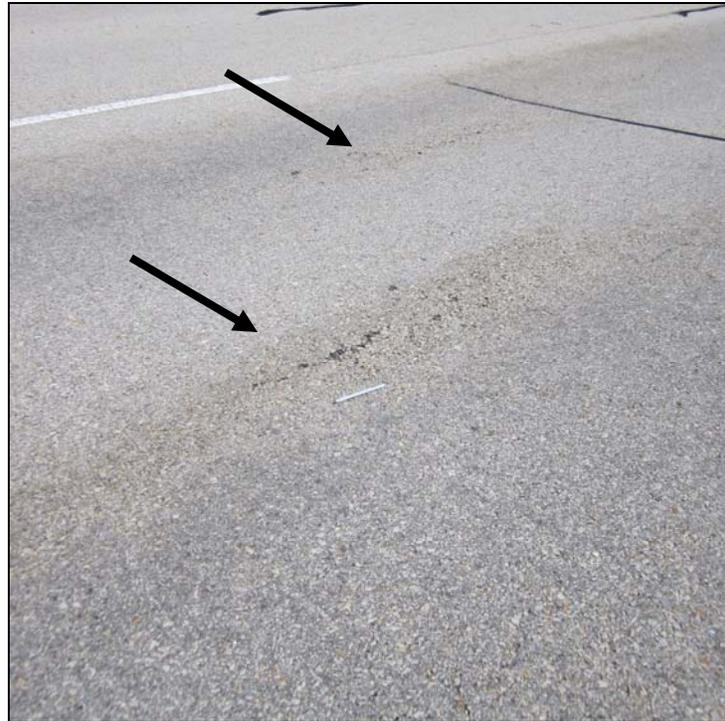
Elsewhere on the US 77 project, other locations of segregation were observed, as Figure 54 illustrates. Although these locations were not surveyed at the time of construction, Figure 54 illustrates classic cases of cyclical segregation, exhibiting a coarser surface texture, raveling, and cracking. Additionally, some locations of patching exist on the project, and at one location, these patches were centered about 150 ft apart, typically the distance between truckloads. Figure 55 shows this location.

**Figure 54. Segregated Location on US 77.**

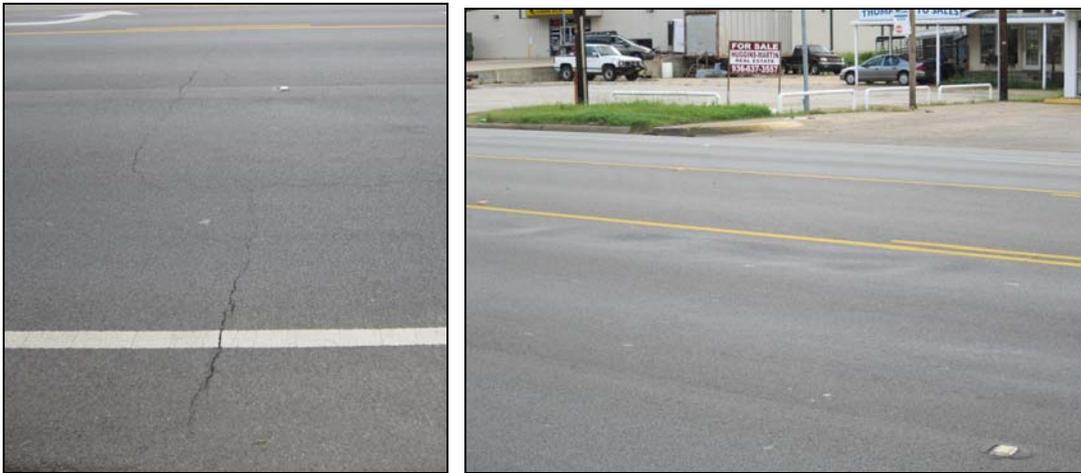
In July 2011, TTI conducted a follow-up visual and GPR survey on the section. The only distresses observed were reflection cracking and some locations of corrugations. Figure 67 provides visual examples of these distresses.

**Figure 67. Distresses Observed on BU 59 after Five Years of Service.**

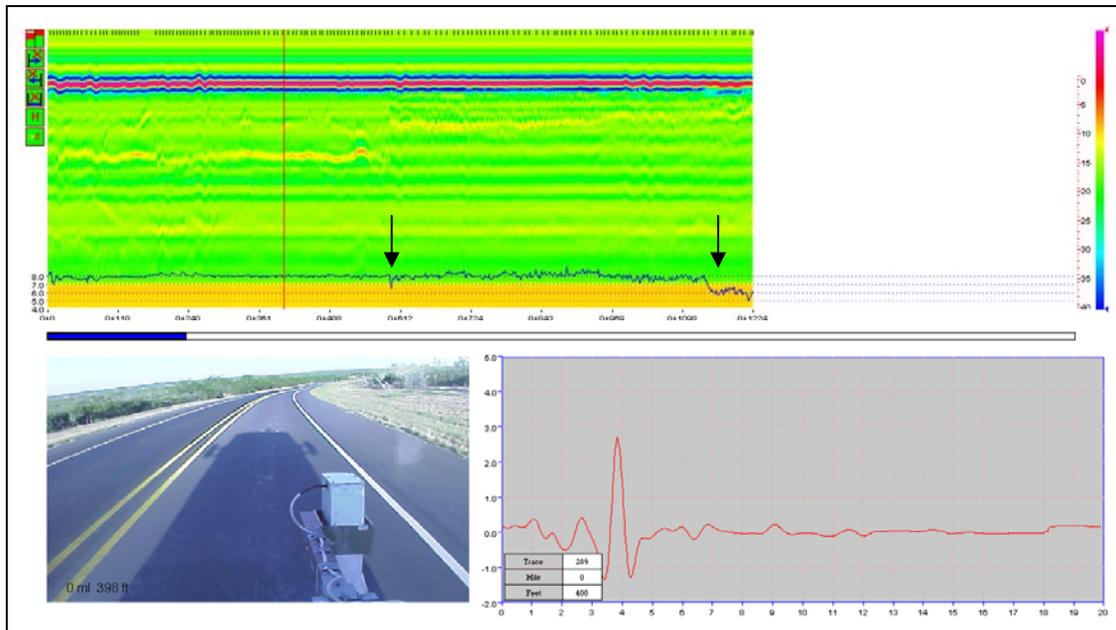
In July 2011, TTI conducted a follow-up visual and GPR survey. Figure 73 shows the GPR data, which show a significant drop in the dielectric in the middle and at the end of the evaluated section. Visually, some locations of coarser surface texture, and some corrugations, were observed. Figures 74 and 75 show the thermally segregated locations selected for coring.

**Figure 73. US 90 CAM after Three Years of Service.**

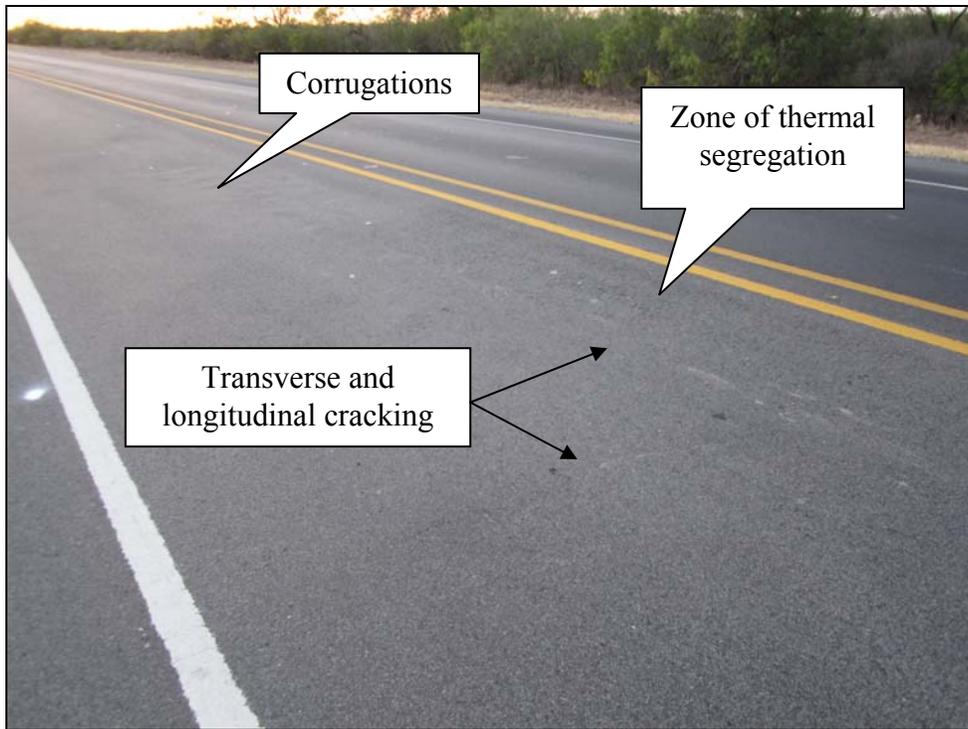
**Figure 75. Corrugations, Cracking, and Thermal Segregation on US 90 CAM after Three Years of Service.**  
*Note: follow-up coring performed at location of arrow, which corresponds with 525 ft in Figure 71.*

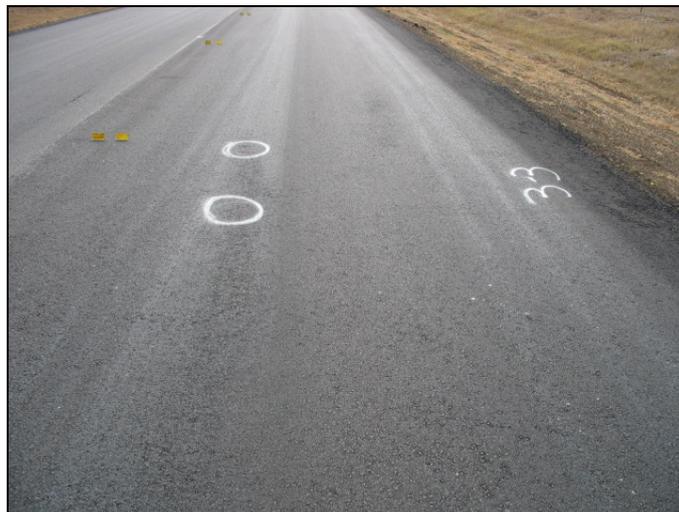
**Figure 80. Visually Observed Segregation on FM 2440 after Construction.**

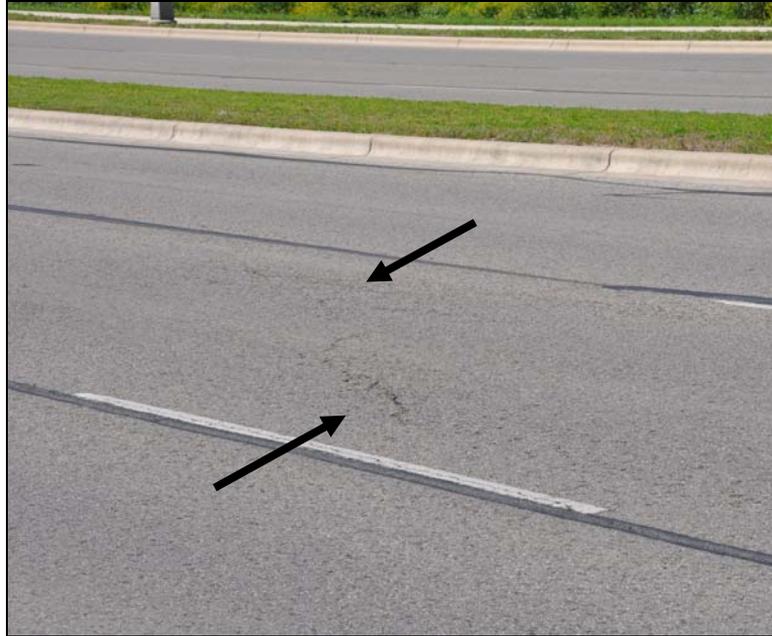
**Figure 105. Example Cyclical Cracking on A.W. Grimes.**

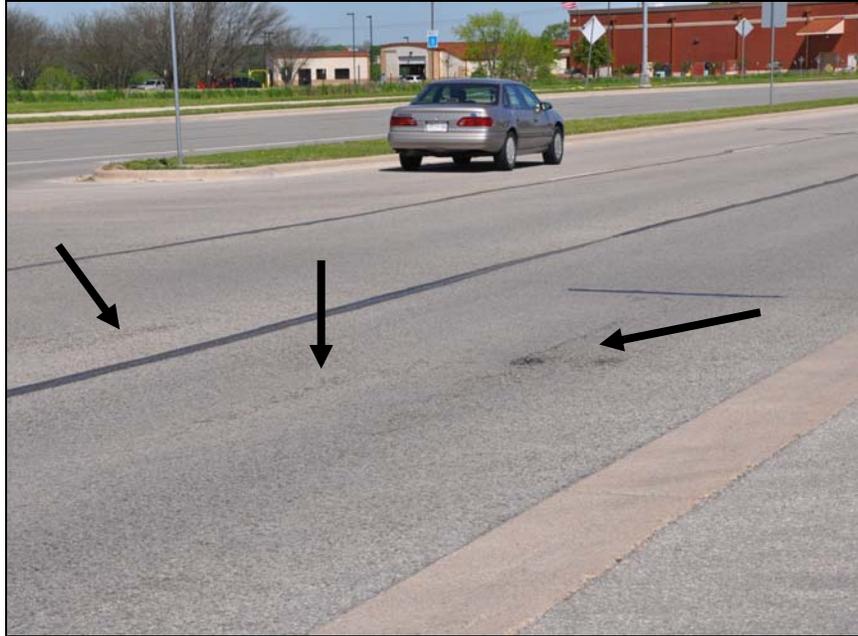
**Figure 106. Example Cyclical Distress with Raveling and Cracking on A.W. Grimes.**

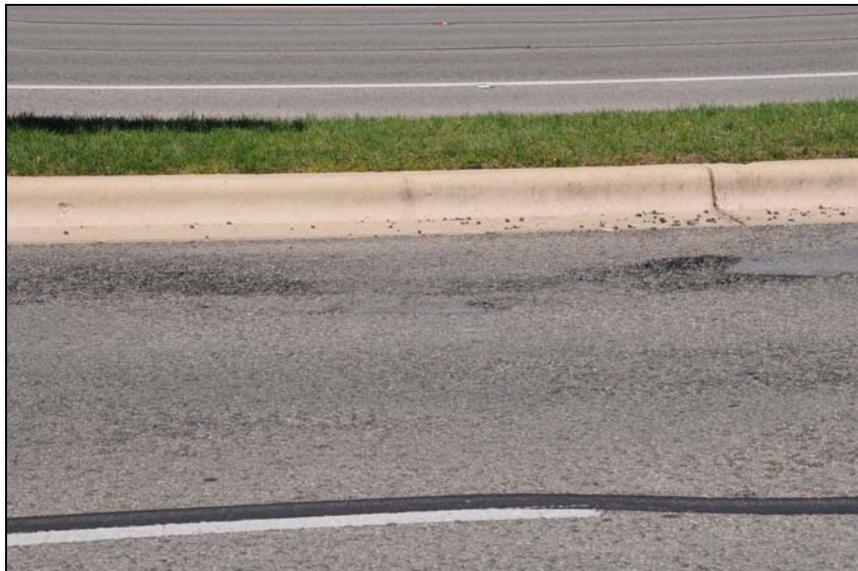
**Figure 107. Severe Raveling on A.W. Grimes.**

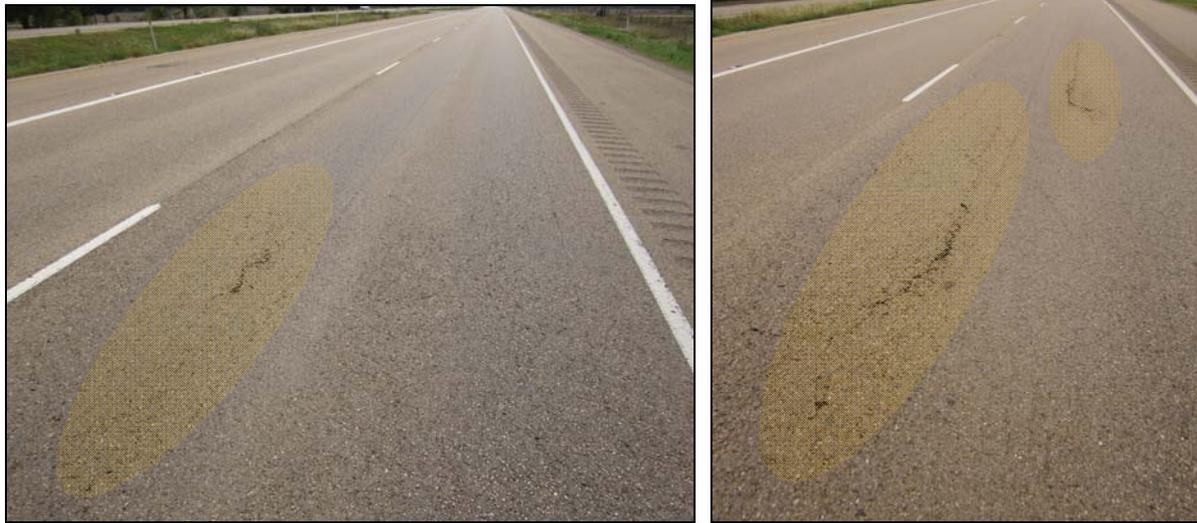
**Figure 108. Examples of Cyclical Distress on SH 21.**

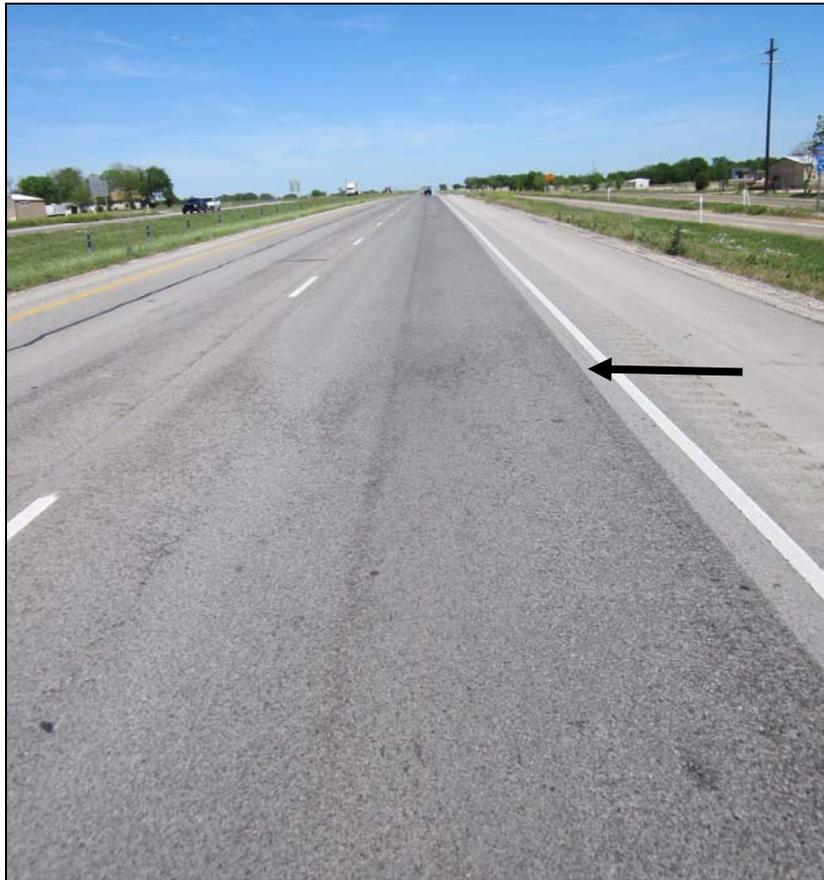
**Figure 110. Zone of Cyclic Segregation on IH 35W.**

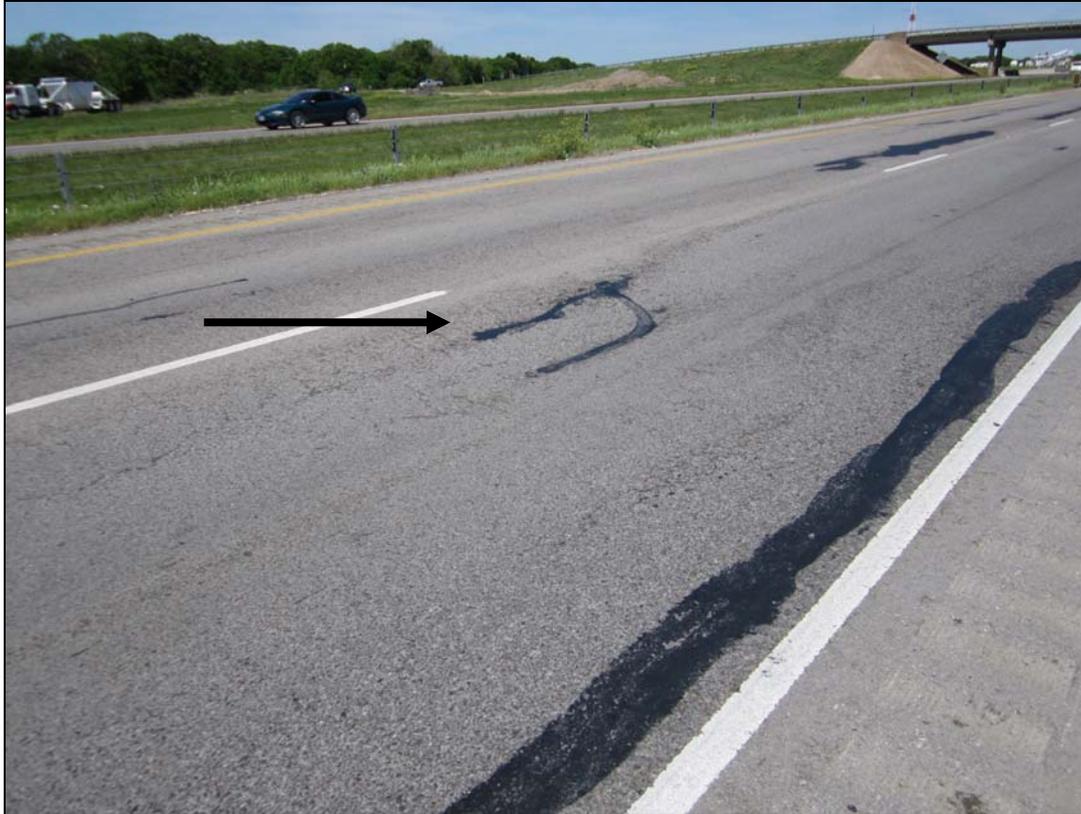
**Figure 111. Raveling and Cracking Failures in Segregated Zones on IH 35W.**

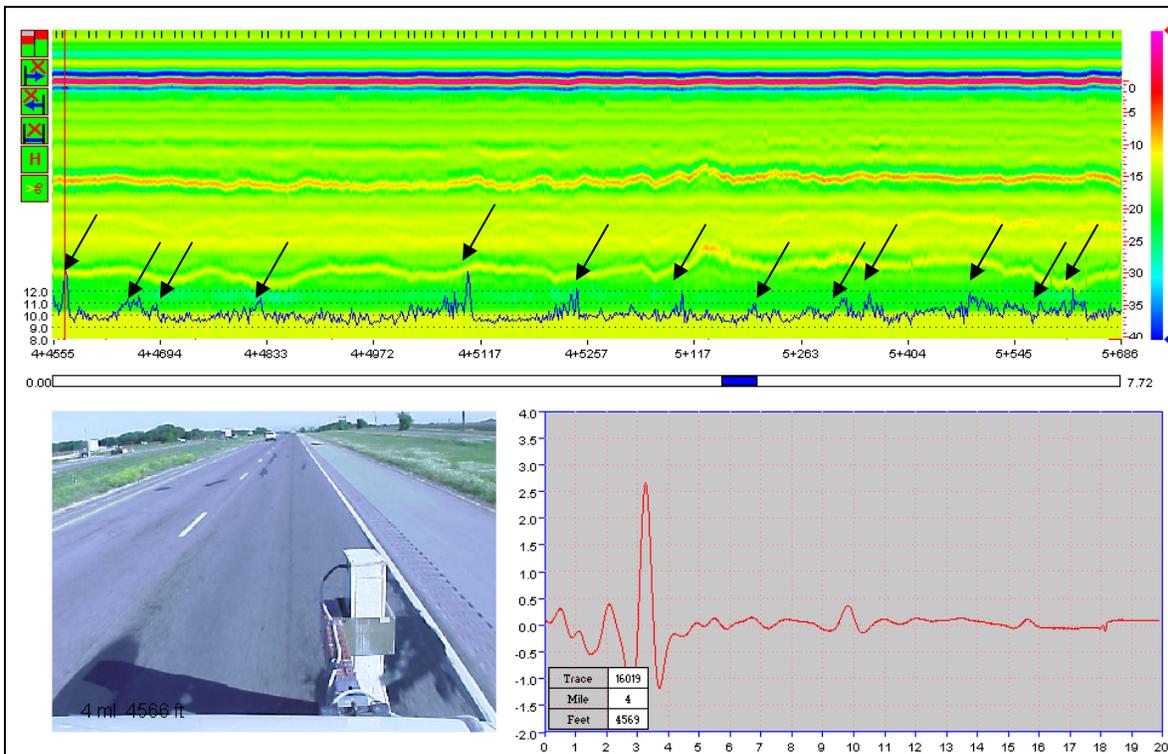
**Figure 112. Cyclic Failures with Raveling and Cracking on IH 35W in GPR.**

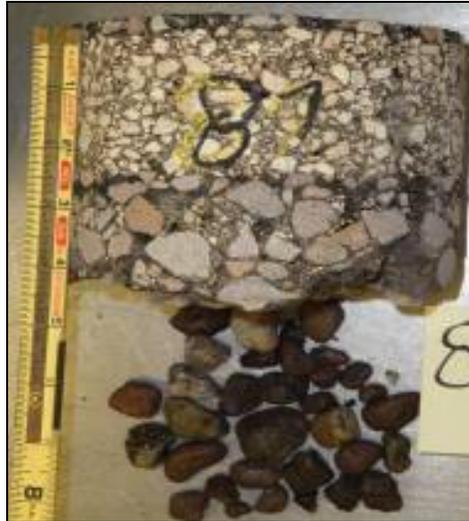
**Figure 115. Core Taken from TRM 87 on IH 20.**

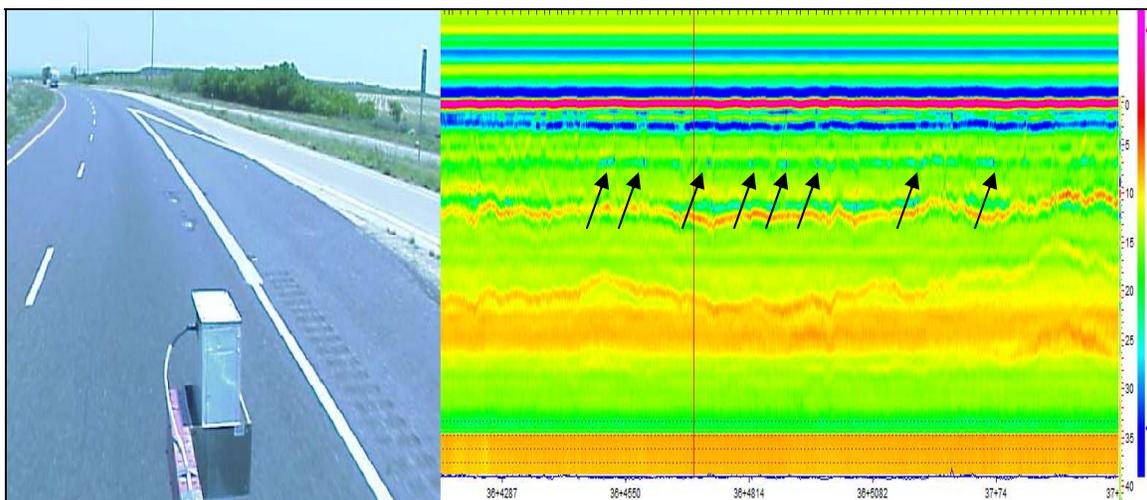
**Figure 116. IH 20 near TRM 157 Eastbound.**
