JOINT TRANSPORTATION RESEARCH PROGRAM

SPR-3474

Evaluation of Effects of Fire on the I-465 Mainline Bridges—Volume I

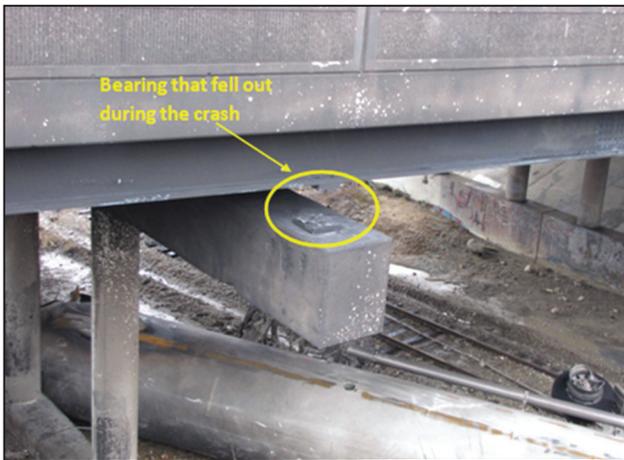
Bearing that fell out during the crash (Beam #12; Bent #3) – Eastbound Bridge.

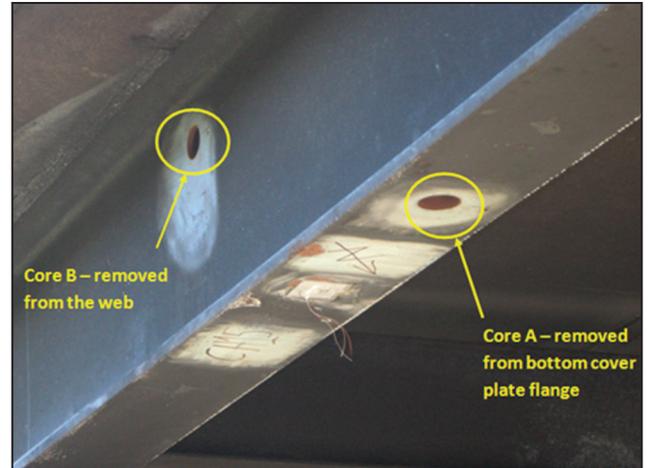
Cores removed from the web and bottom cover plate (Beam #11) – Westbound Bridge.
