# LTPP Pavement Maintenance Materials: PCC Partial-Depth Spall Repair Experiment, Final Report

PUBLICATION NO. FHWA-RD-99-153

OCTOBER 1999

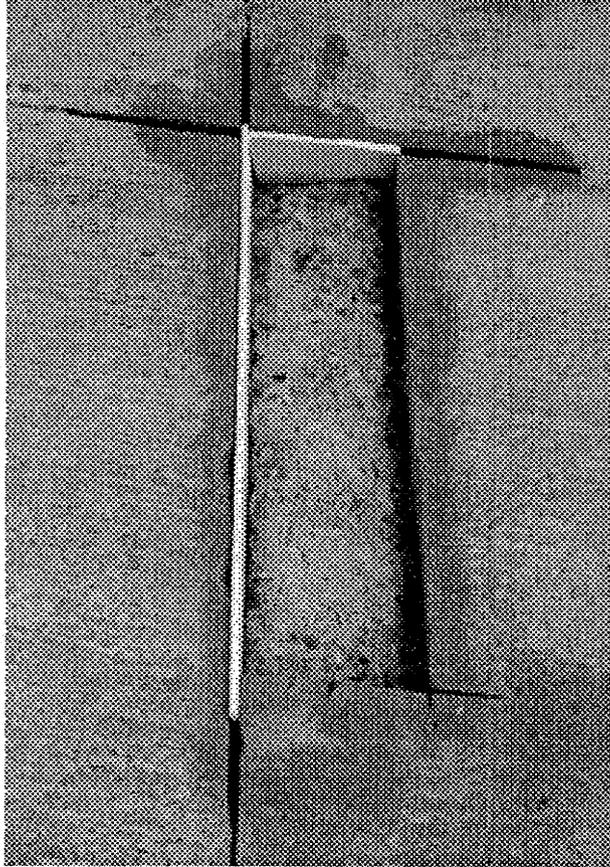
Figure 10. Joint bond-breaker installed at patch edges.

Following the cleaning operation, a joint bond-breaker was placed full-depth in the joints adjacent to repair areas that were to be patched with nonflexible repair materials (i.e., Type III PCC, Duracal, Set-45, Five Star HP, MC-64, SikaPronto 11, and Pyrament 505), as shown in figure 10. The joint bond-breaker consisted of a 102-mm-high, 13-mm-wide, closed-cell polystyrene foam board that was slightly wider than the saw cut. In back-to-back repair areas at a joint, difficulty was encountered in maintaining a true, straight joint line. In locations deeper than 102 mm, it was also difficult to stack the joint bond-breaker to the desired height. Latex caulking was used occasionally to seal any irregularities or gaps between the joint bond-breaker and joint opening in order to prevent repair material from flowing into the joint or crack opening below the bottom of the patch. A joint bond-breaker was not installed in repair areas that would be patched with Percol FL, Penatron R/M-3003, UPM High Performance Cold Mix, AMZ, or Rosco.

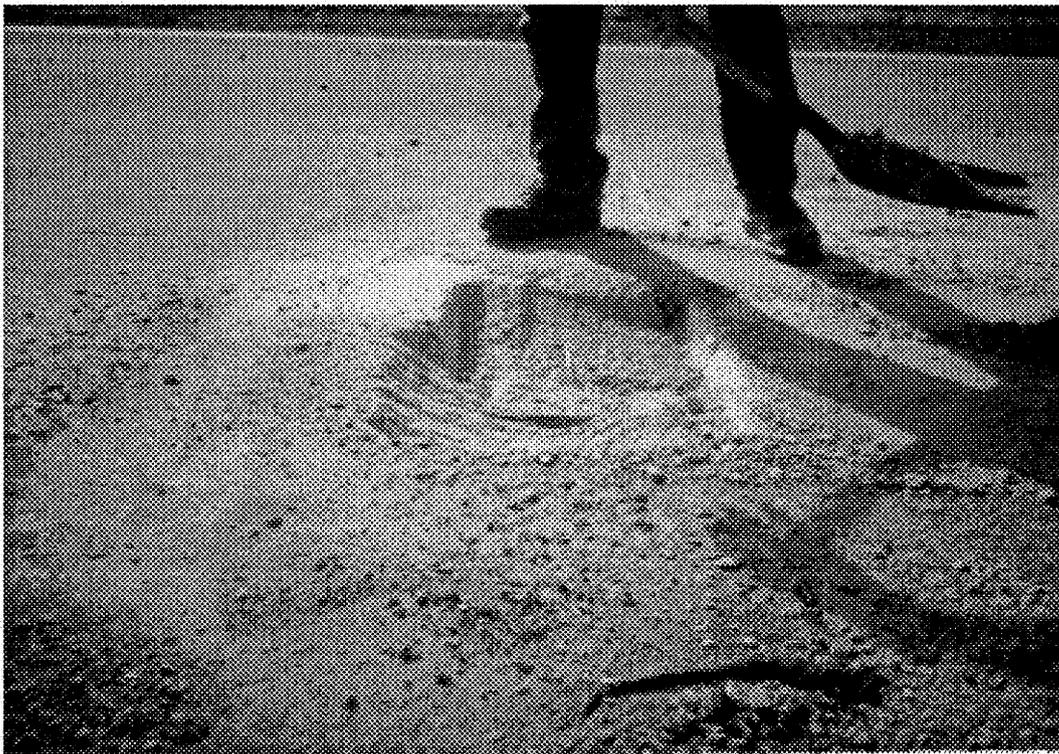
Figure 17. Patch area for milling operation.

The milling machine is very efficient in removing large areas of spalled concrete. With a milling head of 0.3 m, the smallest currently available for this use, the repair area will be a minimum of 0.09 m<sup>2</sup>. Therefore, if the area to be repaired is small, the patch may be larger than necessary. The exposed bottom surface of the concrete created by milling is very rough and very level, as shown in figure 17. The hole created by the operation will tend to be concave, rather than vertical, at the boundaries that are perpendicular to the direction of the milling. The milling operation also caused spalling on the edges of the adjacent pavement. The removed concrete becomes a fine slurry that is easy to wash away. The size of the machine and the location of the milling head in relation to the rest of the equipment affects the efficiency of the removal operation.

The orientation of the concave edges was parallel to the direction of traffic where possible. However, because of traffic constraints, the equipment was not always able to maneuver into such an orientation. It may be desirable in such cases to chisel the edges to form a vertical face. This was done on all but one test section in Arizona. Cementitious materials, in particular, may not perform well when feather-edged.
