Technical Memo

Project 0-6132: Task 6 – Test Sections in the Districts

Subject: Field Performance Monitoring Report# 01 for the TTI Sections on US 83, Loop 20, US 59, & Spur 400 (Webb County, Laredo District)

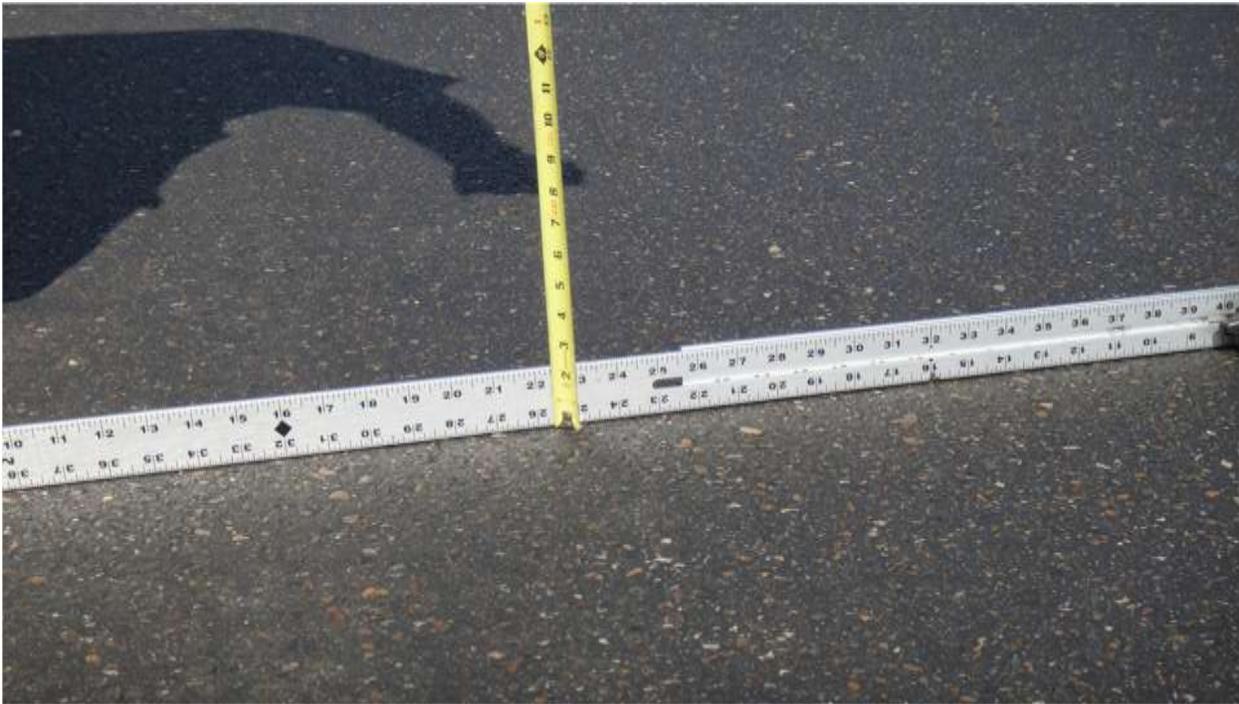
Field Performance: So far, all the Hwy Test Sections are performing very well with *no* cracking or rutting problems; the average rut depth measured was only 0.08 inches (i.e., about 1.95 mm). Details of the performance evaluation are included in the subsequent appendices. The next performance evaluation is scheduled after this summer 2011.

Figure II-1. Surface Rut Measurements with a Straightedge on US 59.

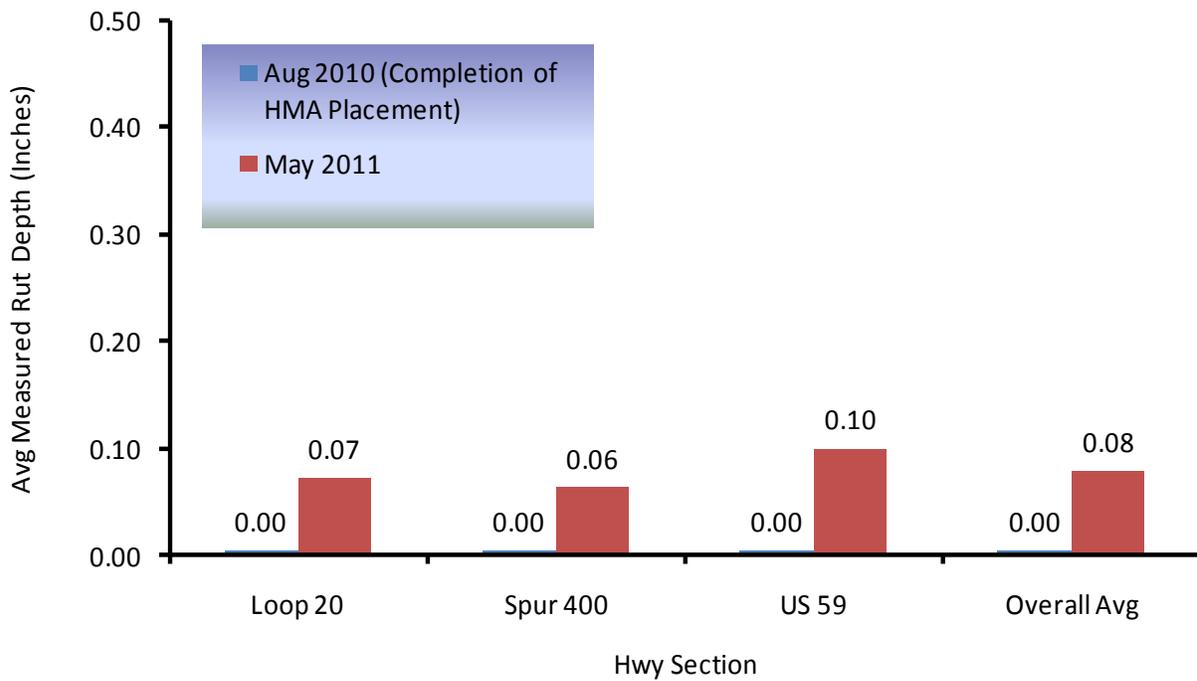
Figure II-2. Comparison of Surface Rut Measurements.

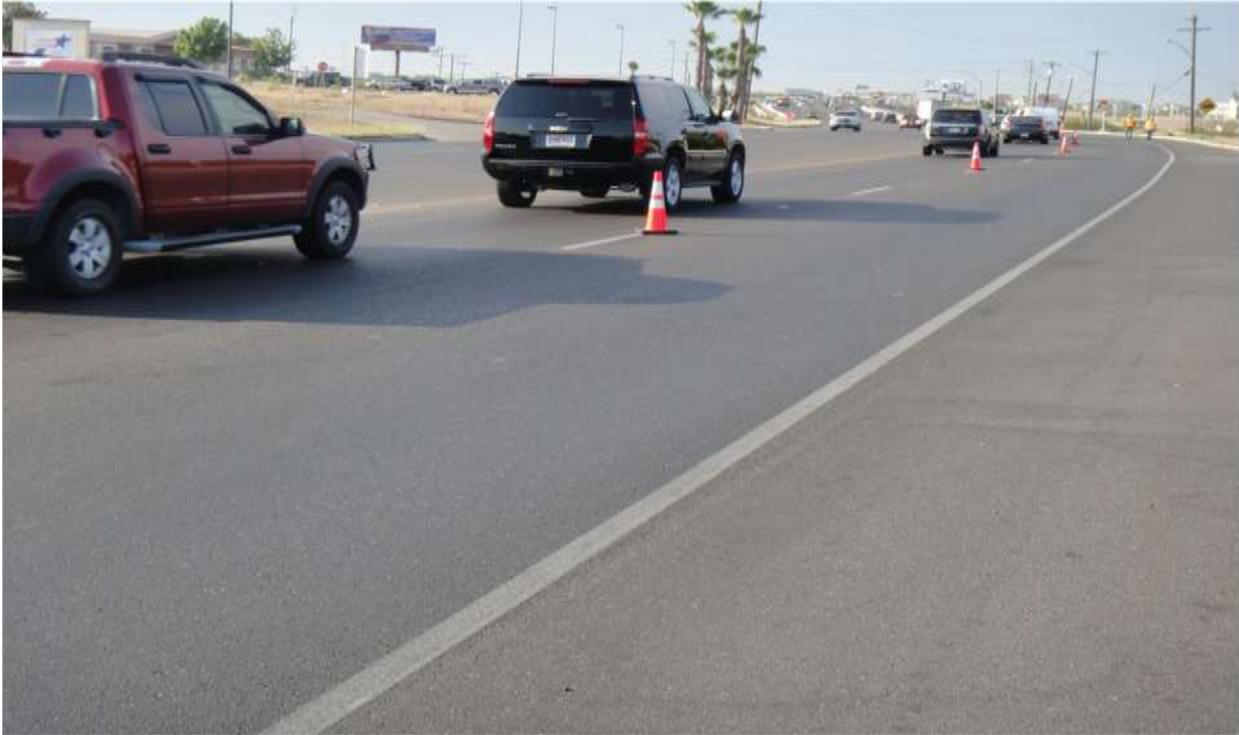
Figure III-1. Loop 20 SB Direction – No Cracking or Rutting Observed.

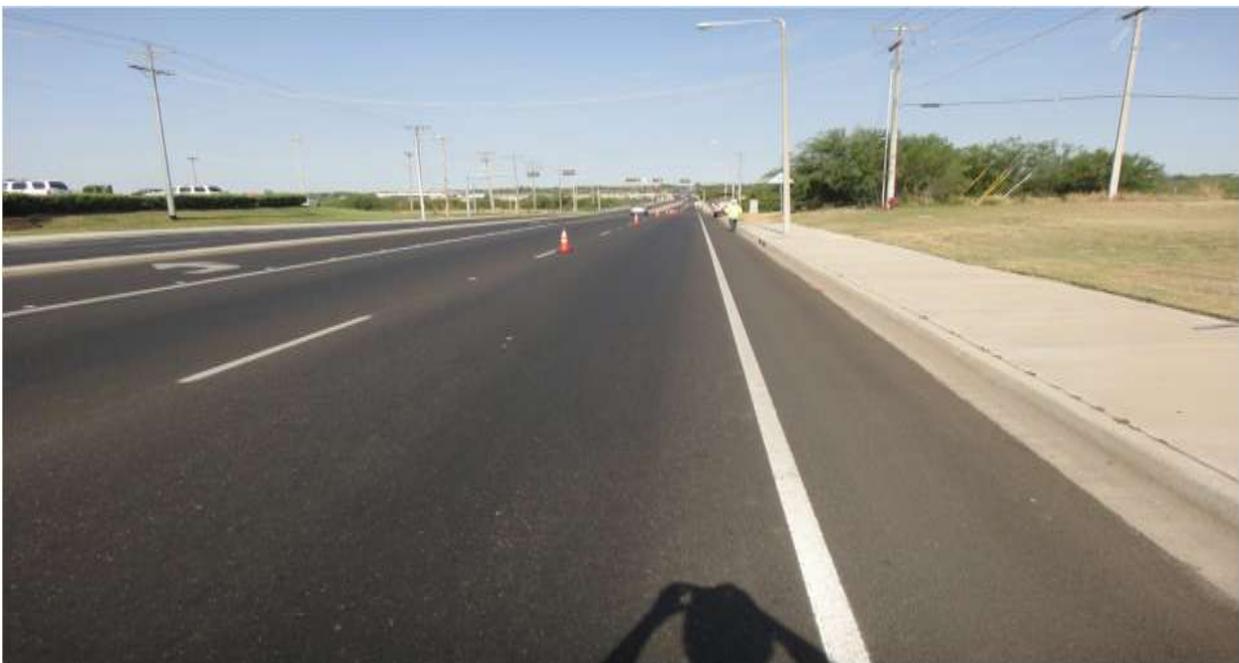
Figure III-2. Spur 400 WB Direction – No Cracking or Rutting Observed.

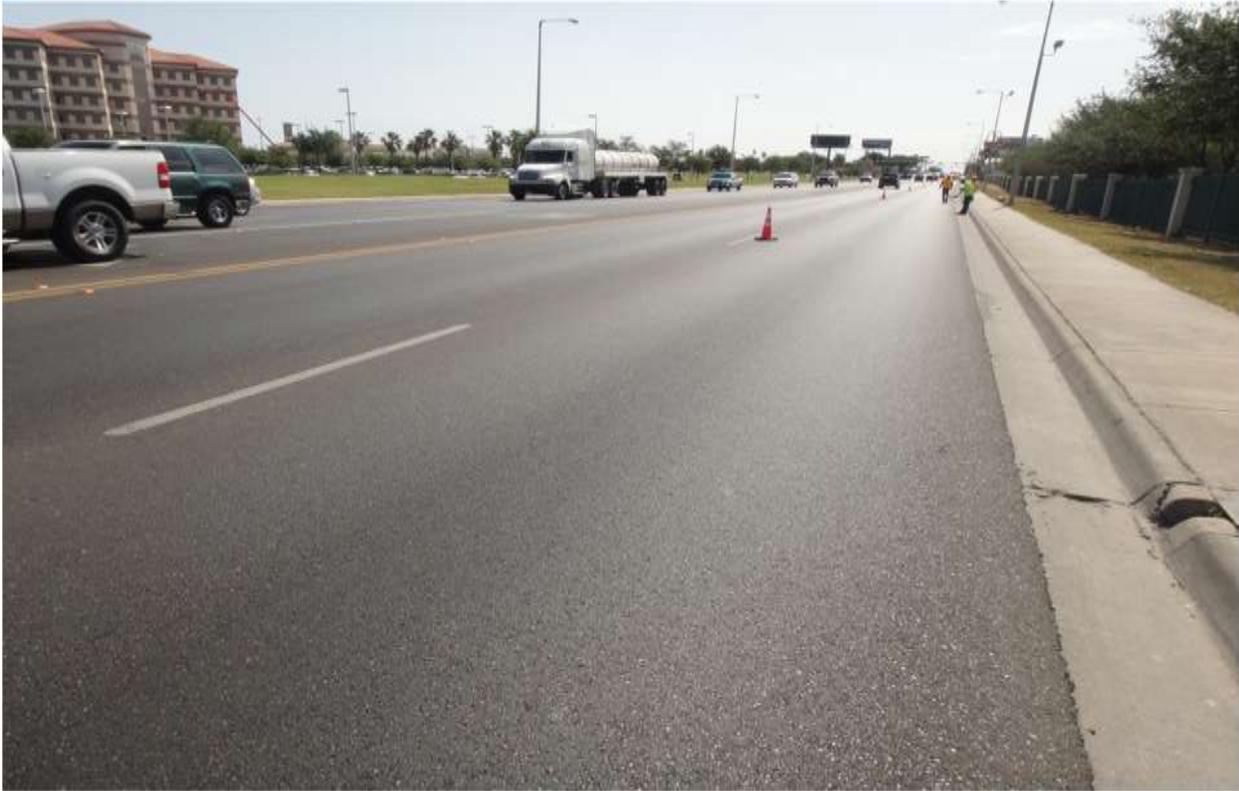
Figure III-3. US 59 EB Direction – No Cracking or Rutting Observed.

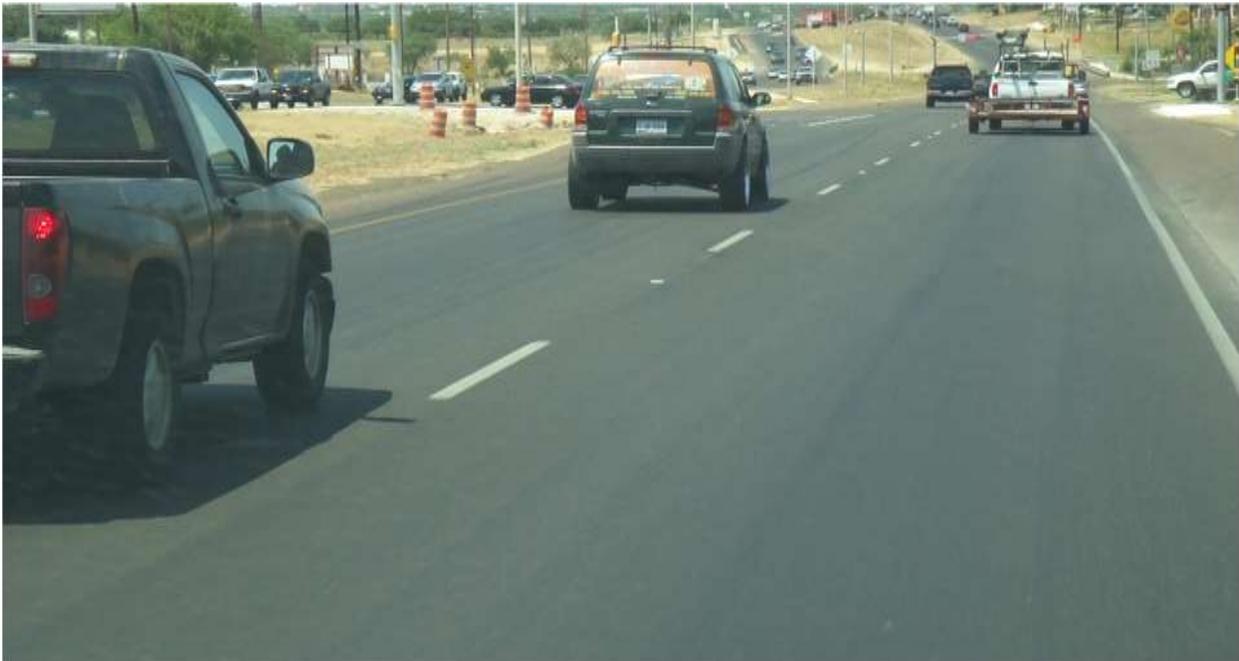
Figure III-4. US 83 SB Direction (Control) – No Cracking or Rutting Observed.

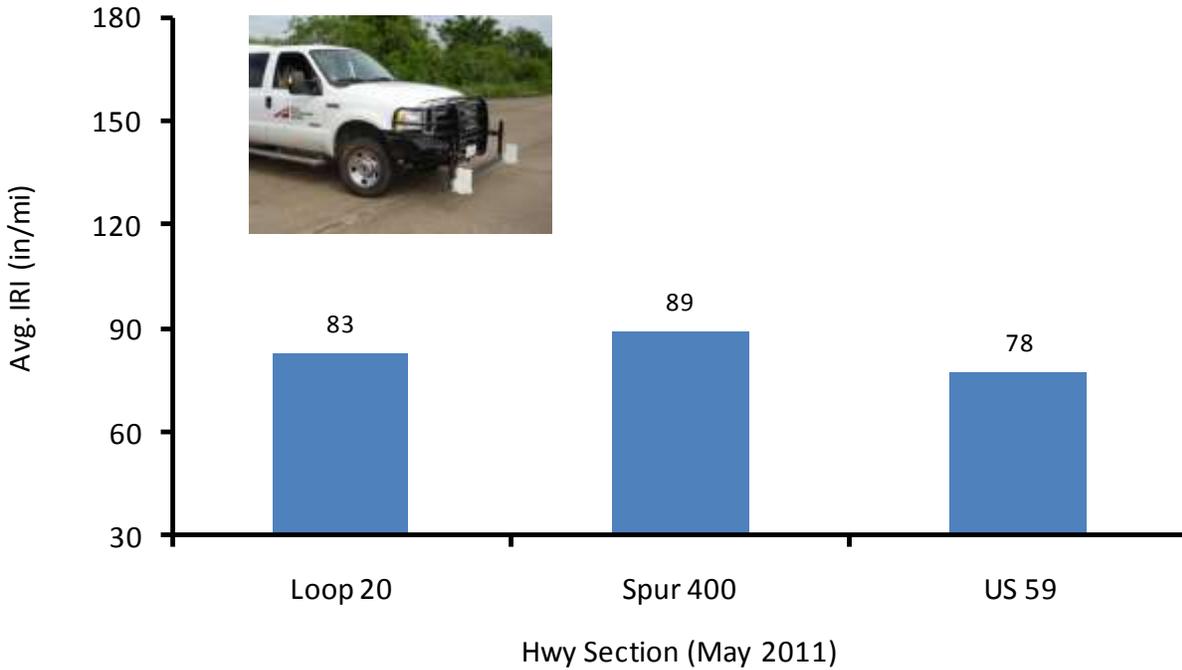
Figure IV-1. Surface Profiles (Outside Lane) – Avg IRI (RWP+LWP) as of May 2011.

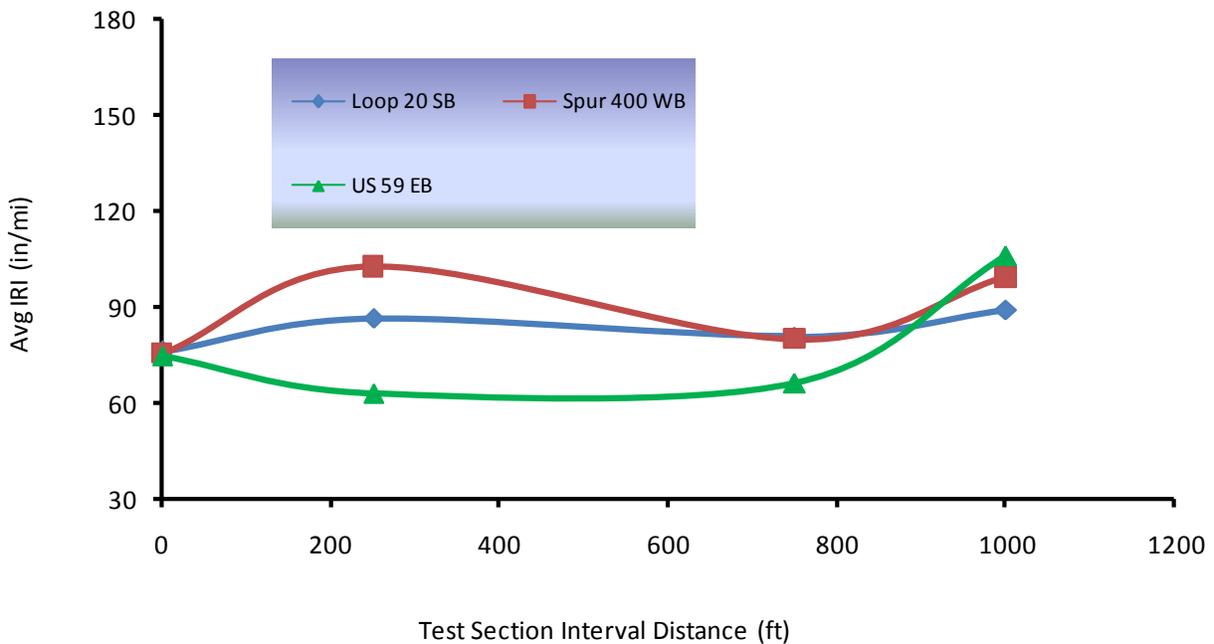
Figure IV-2. Surface Profiles (Outside Lane) – Avg IRI (RWP+LWP) Plot as a Function of Test Section Length (May 2011).

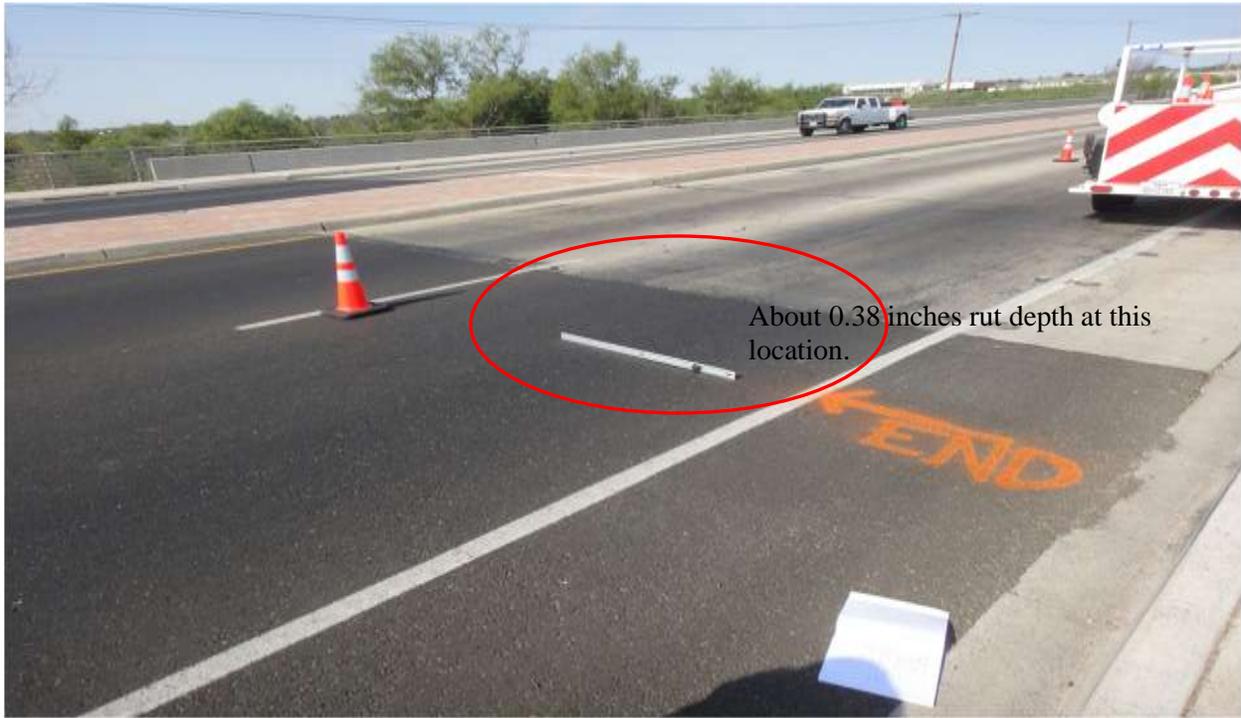
Item	Loop 20	Spur 400	US 59	US 83
HMA overlay thickness	2 inch	2 inch	2 inch	2 inch
Date of HMA placement	August, 2010	August, 2010	August, 2010	Sumer 2010
Date of 1 st field performance evaluation	May 3 rd , 2011	May 3 rd , 2011	May 3 rd , 2011	May 3 rd 2011
Cracking (05/11)	None	None	None	None
Avg. surface rutting in wheel path (inches) (05/11)	0.07	0.06	0.10	≅ 0.10
Avg. IRI (in/mi) (05/11)	83	89	78	-
Avg. PVMNT surface temp	68 °F	81 °F	95 °F	96 °F
Other distresses (05/11)	-	≅ 0.38 inch rut depth @ HMA-bridge transition point on WB outside lane	-	-

Figure V-1. HMA to Bridge Concrete Deck Transition \cong 0.38 Inches Rut Depth (Spur 400).

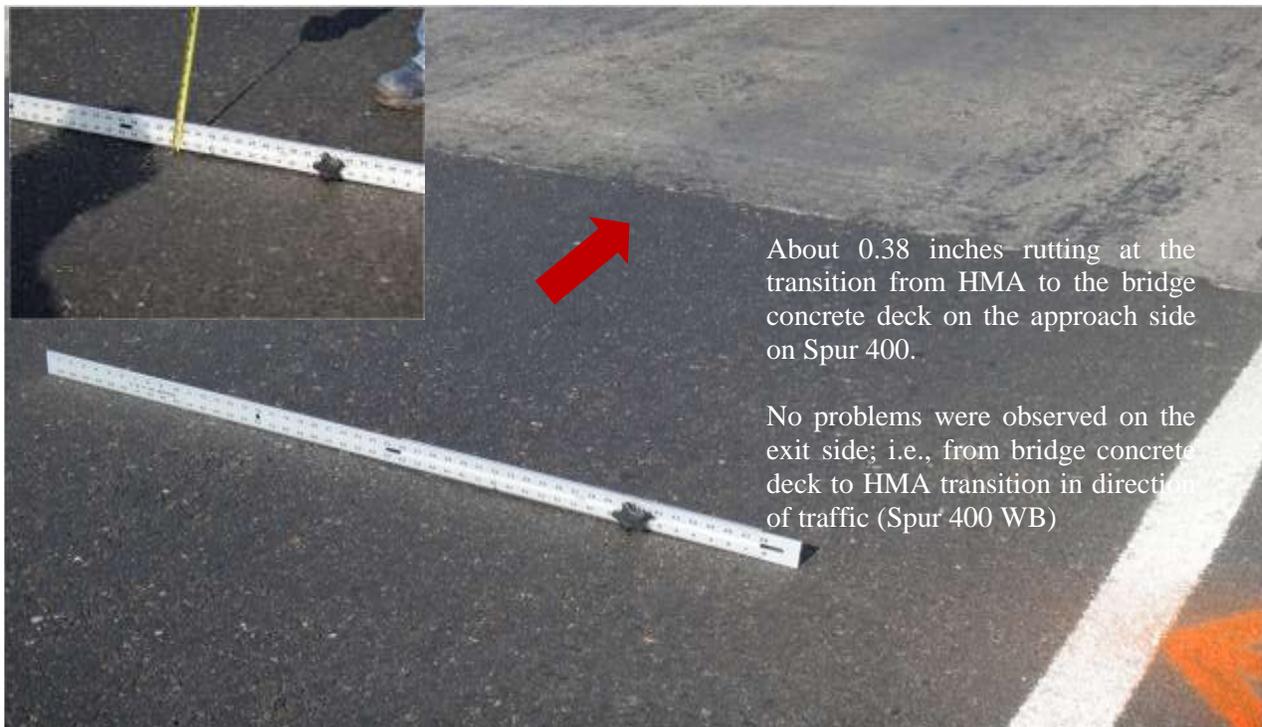
Figure V-2: Rut Measurements at the HMA-Bridge Transition on Spur 400 on the Traffic Approach Side; No Problems were Observed on the Traffic Exit Side.
