PERFORMANCE EVALUATION OF IOWA BRIDGE DECKS CONSTRUCTED WITH EPOXY-COATED REINFORCING BARS

Final Report
August 19, 2011
WJE No. 2010.0868

Prepared for:
Iowa Department of Transportation
Office of Bridges and Structures
800 Lincoln Way
Ames, Iowa 50010

Prepared by:
Wiss, Janney, Elstner Associates, Inc.
330 Pfingsten Road
Northbrook, Illinois 60062
847.272.7400 tel | 847.291.4813 fax

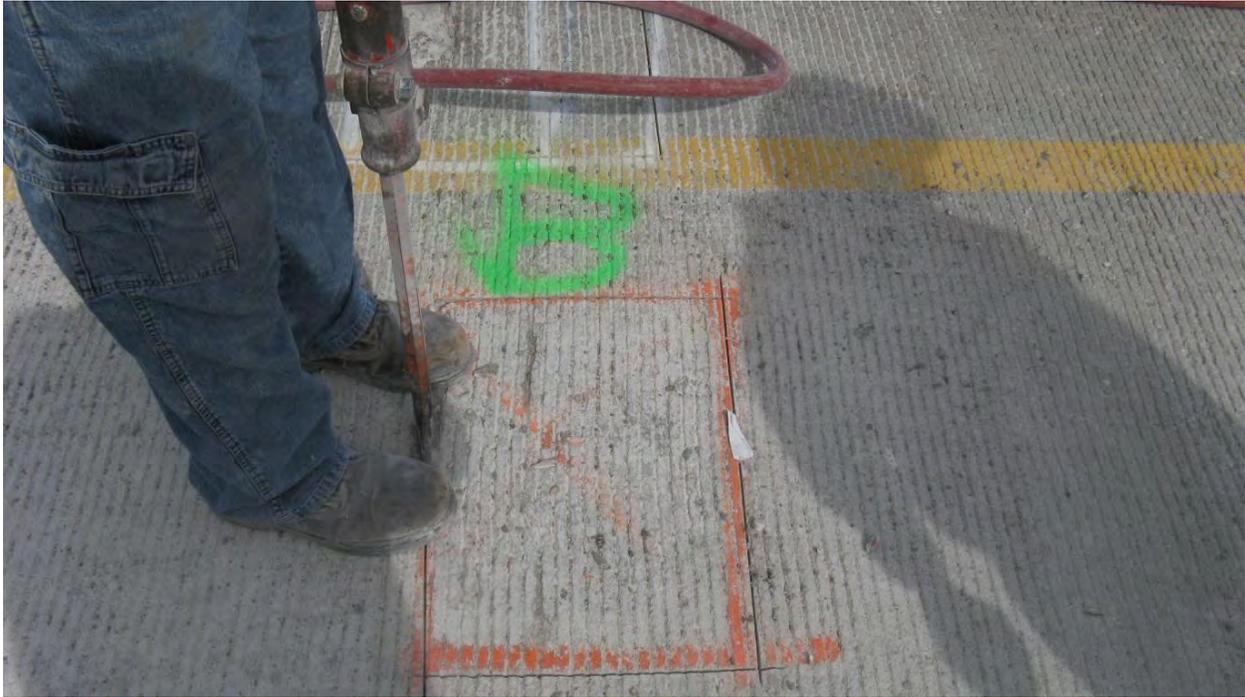
Figure 1. Concrete removal process at deck patching performed by Iowa DOT maintenance personnel at Southbound US 65 Bridge over the Union Pacific Railroad in Bondurant, Iowa (photography courtesy of Iowa DOT).

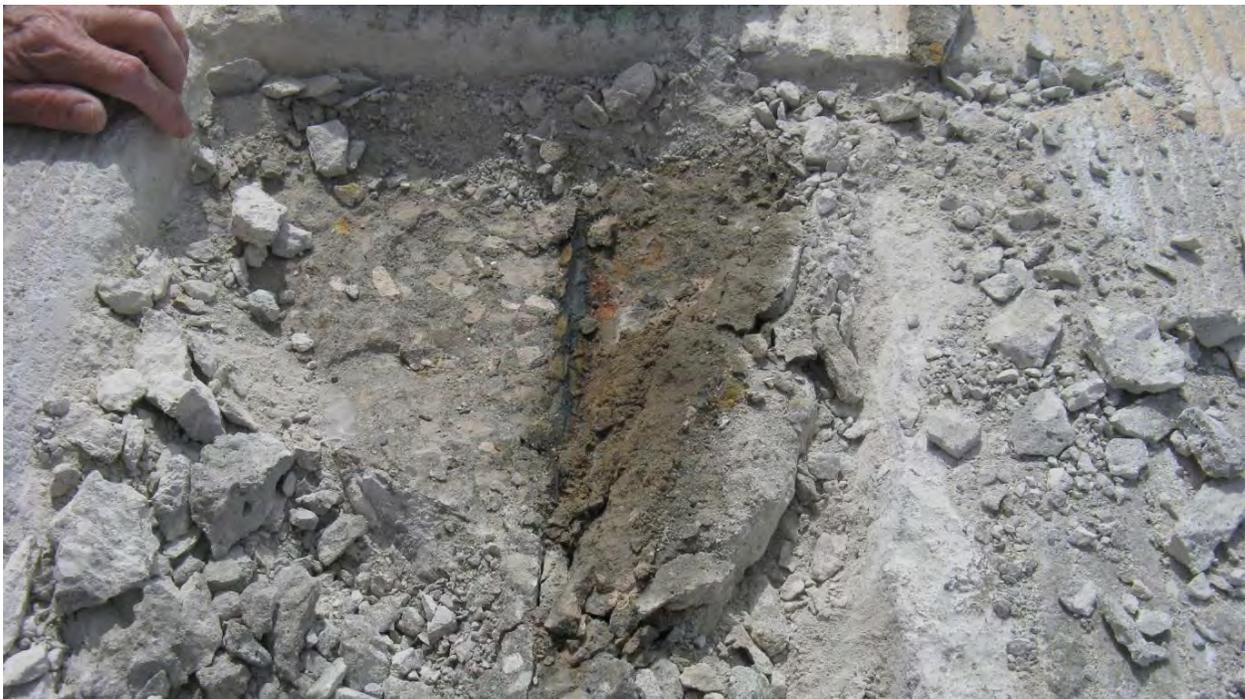
Figure 2. Corroded reinforcing bar exposed during the deck patching performed by Iowa DOT maintenance personnel at Southbound US 65 bridge over the Union Pacific Railroad in Bondurant, Iowa (photograph courtesy of Iowa DOT).

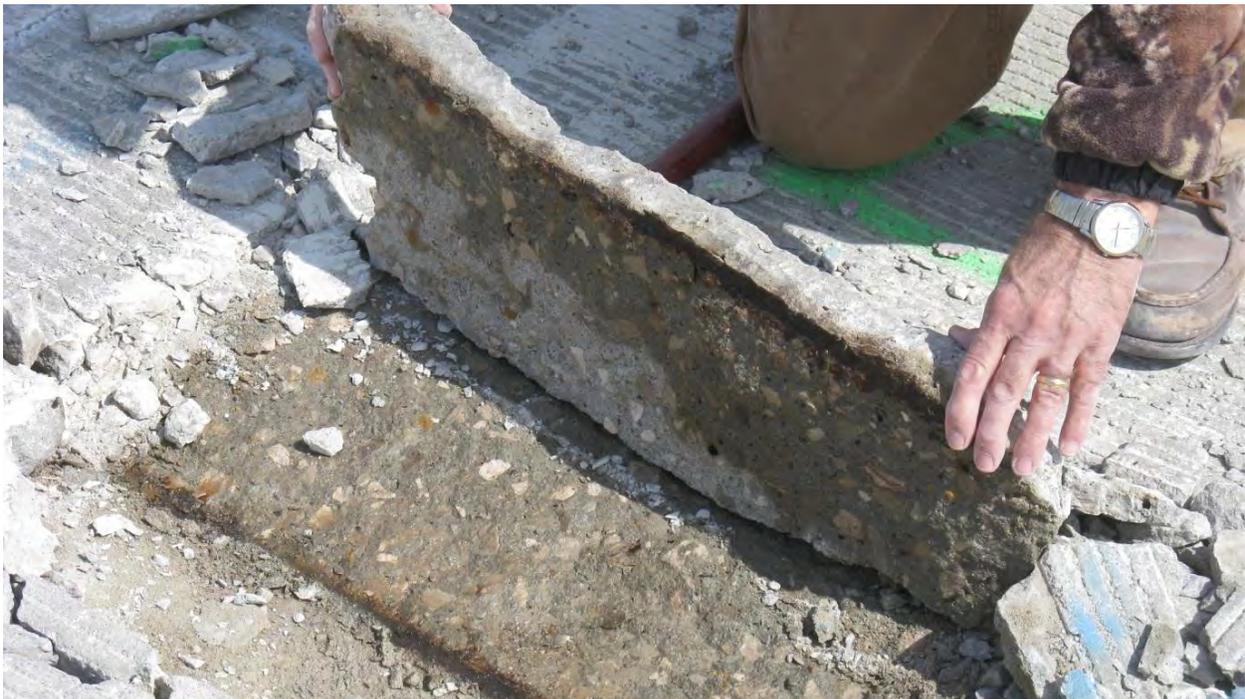
Figure 3. Delaminated section of concrete at a corroded reinforcing bar exposed during the deck patching performed by Iowa DOT maintenance personnel at Southbound US 65 Bridge over the Union Pacific Railroad in Bondurant, Iowa (photograph courtesy of Iowa DOT).

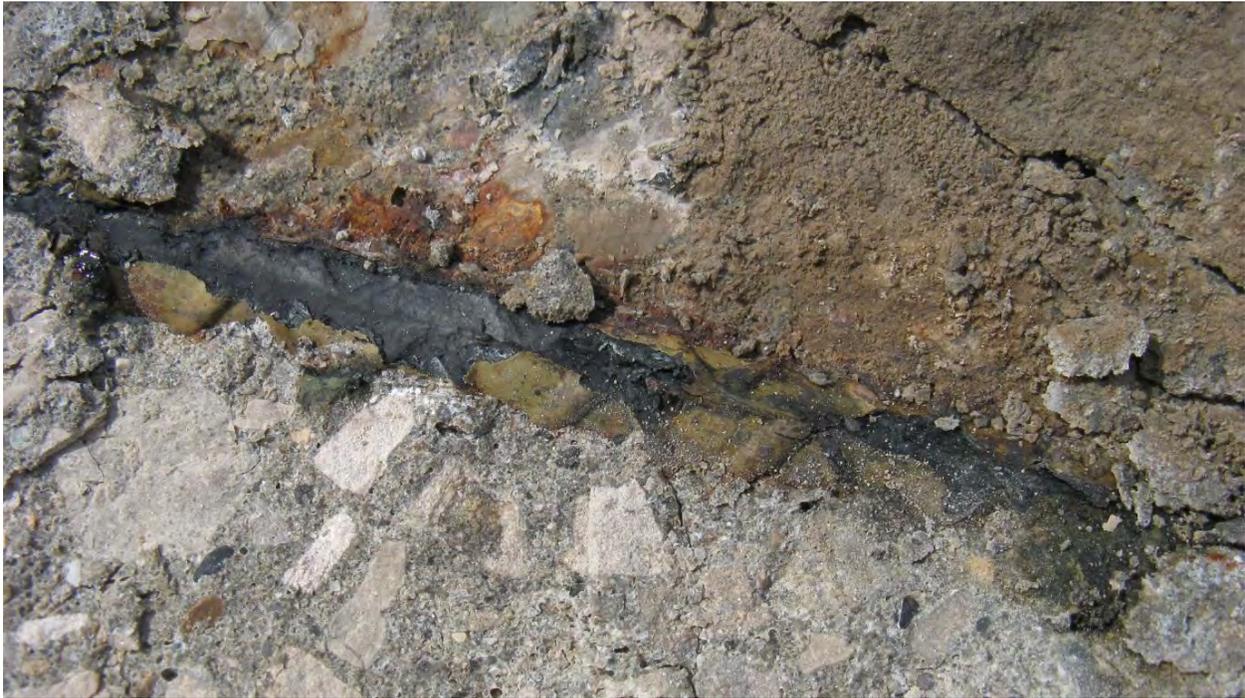
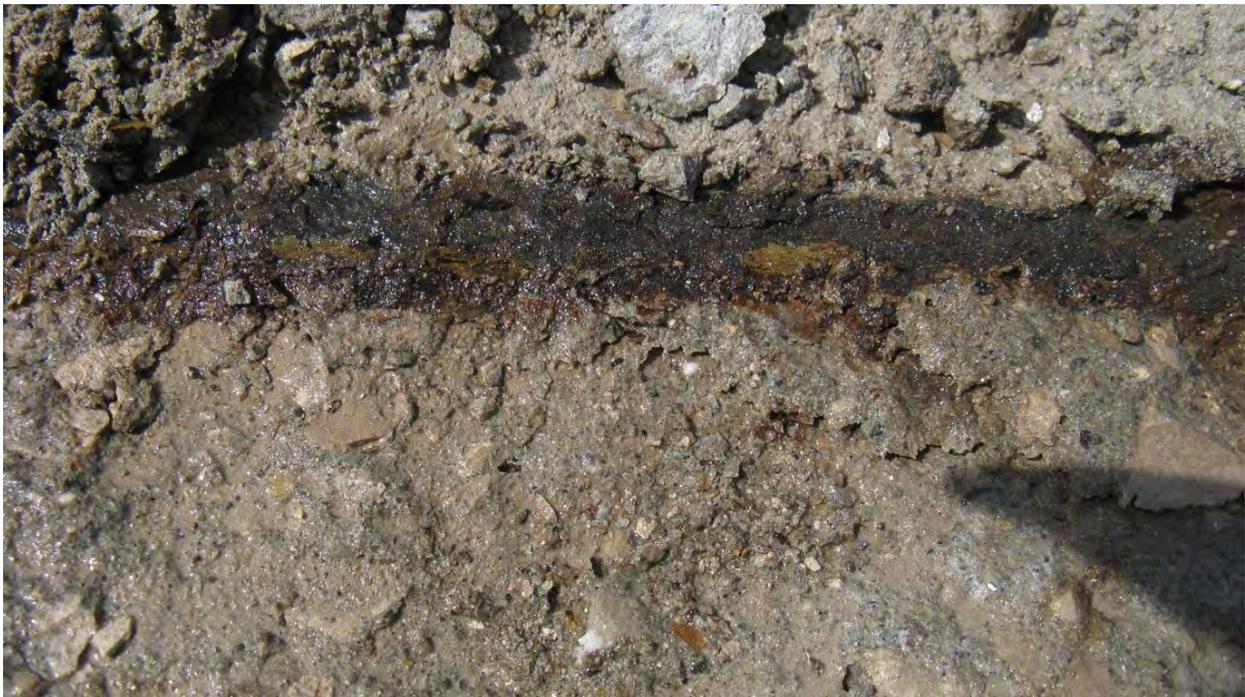
Figure 4. Close-up views of corroded epoxy-coated reinforcing bars uncovered during deck patching performed by Iowa DOT maintenance personnel at Southbound US 65 Bridge over the Union Pacific Railroad in Bondurant, Iowa (photograph courtesy of Iowa DOT).

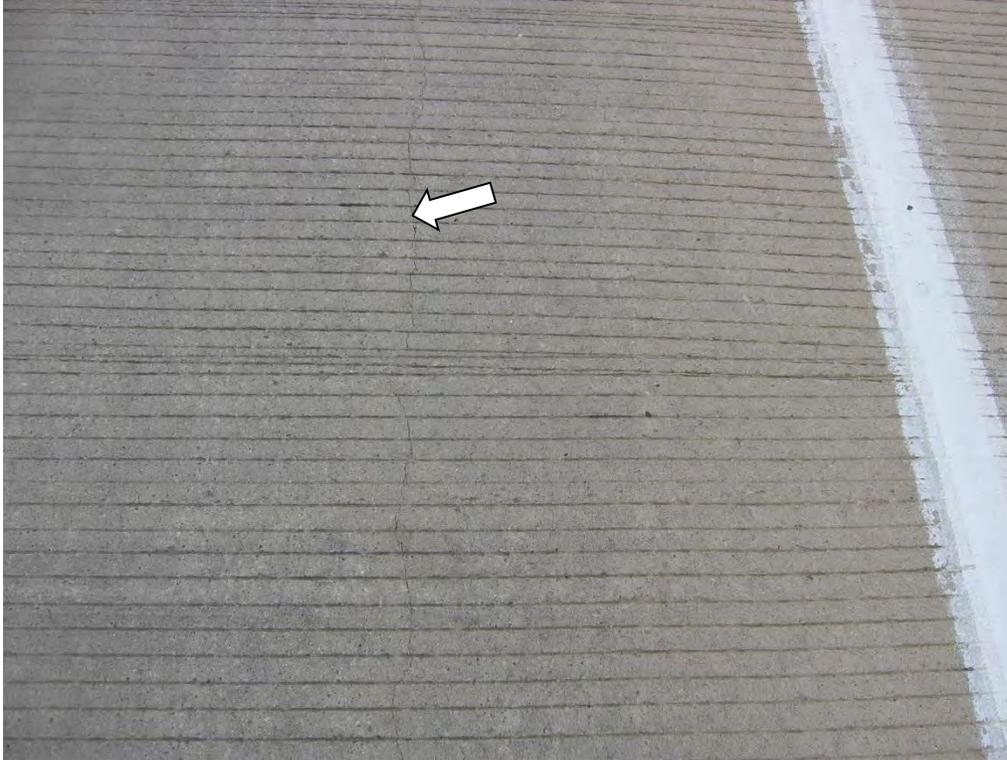
Figure 31. Typical longitudinal crack in wheel path of approach spans at Southbound US 218 bridge.

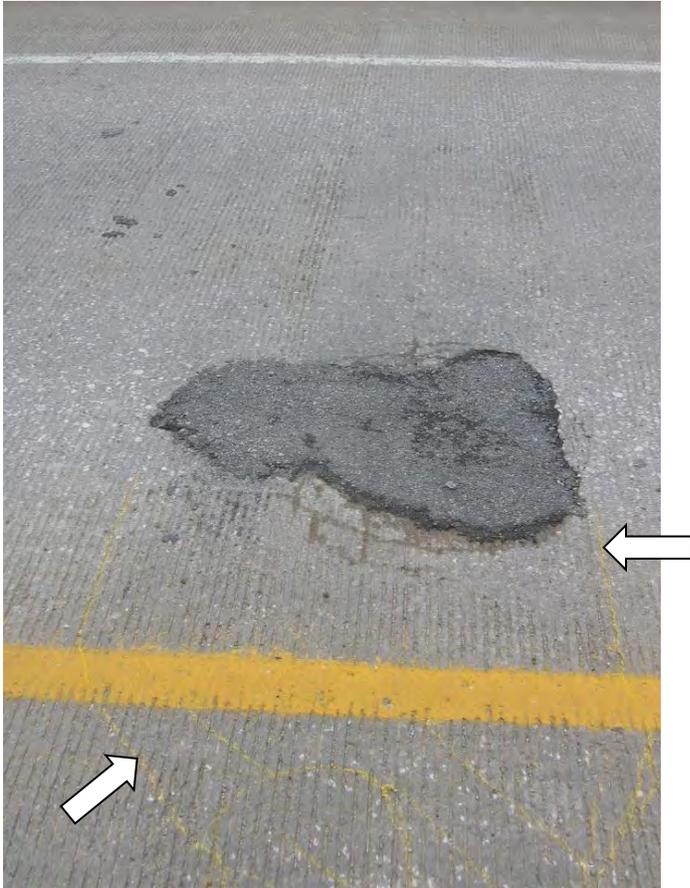
Figure 33. Asphalt patch on IA 150 bridge deck, with areas of continued delamination marked in yellow.

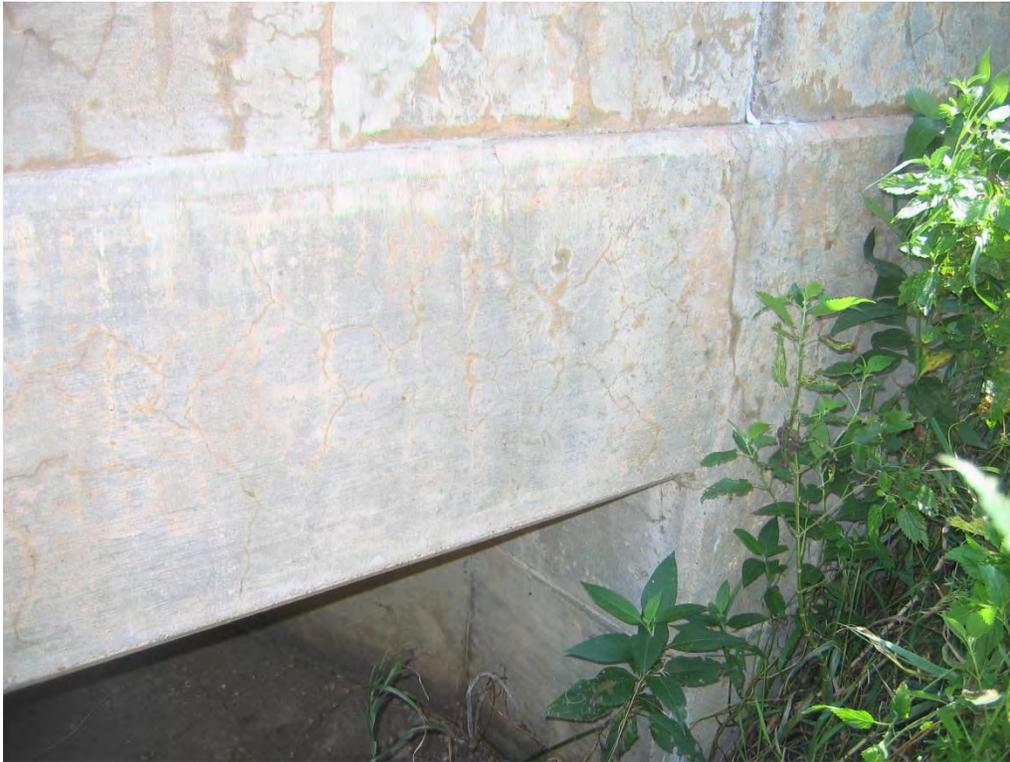
Figure 37. Hairline cracking in edge of deck slab and barrier rail at southwest corner of the Southbound Iowa 13 bridge deck.

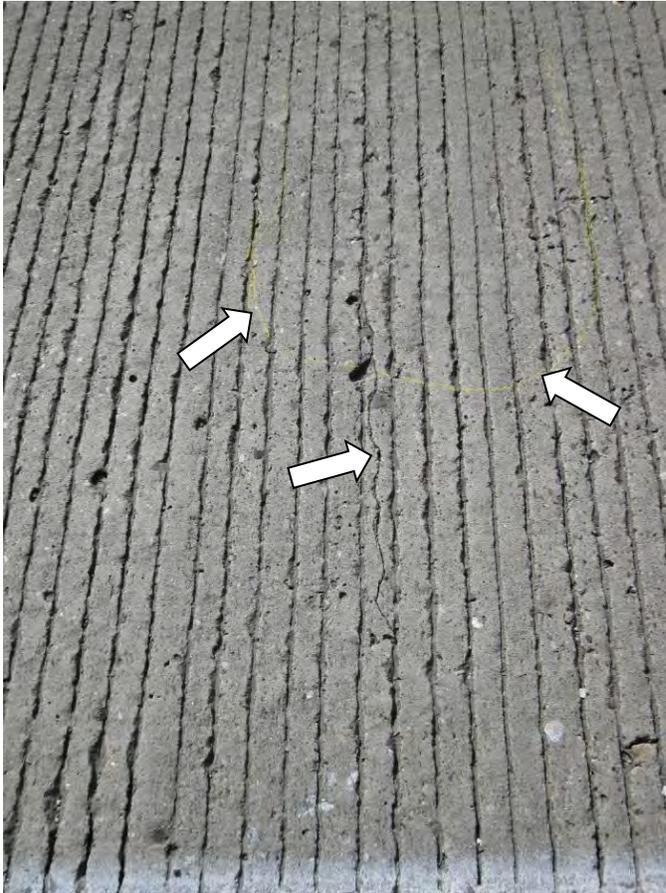
Figure 39. Typical transverse crack in east approach spans of US 30 bridge deck. Note delamination outlined in yellow (see arrows)

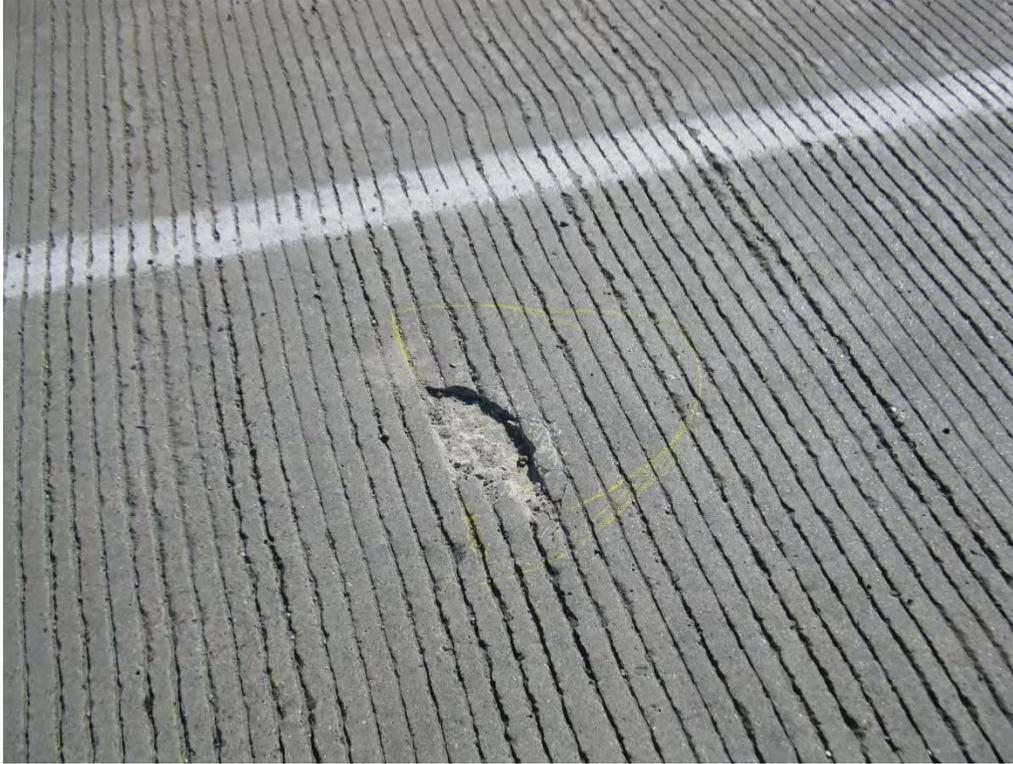
Figure 41. Incipient spalling at an area of delaminated concrete on the US 30 bridge deck.

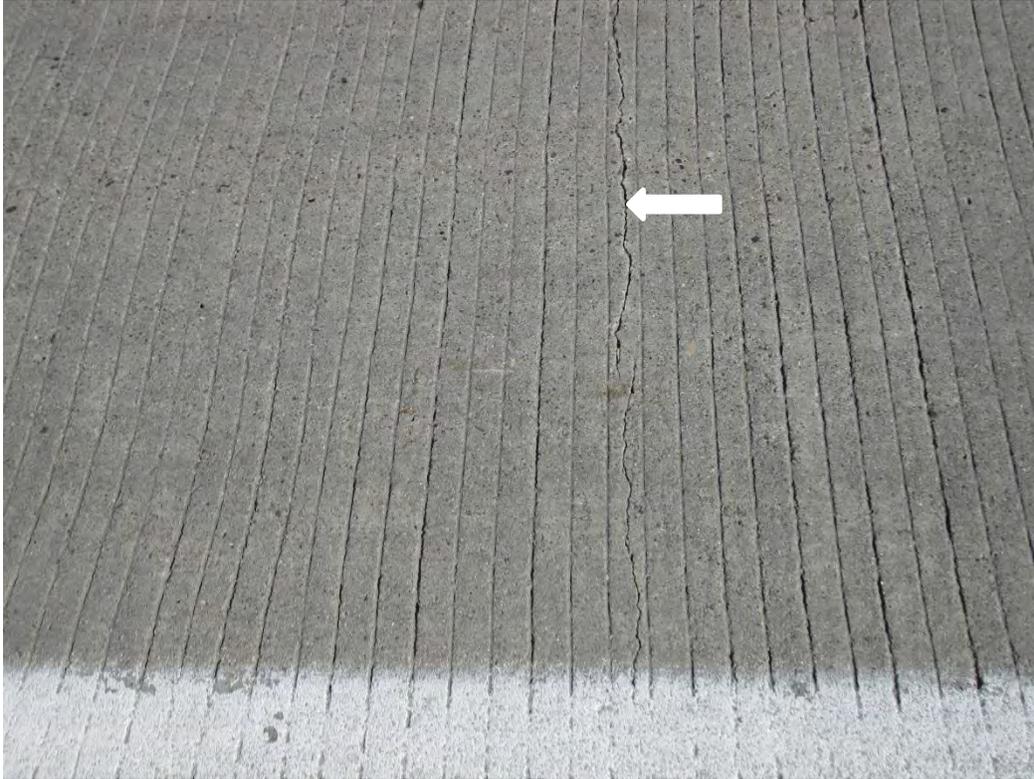
Figure 43. Typical transverse crack in US 30 bridge deck.

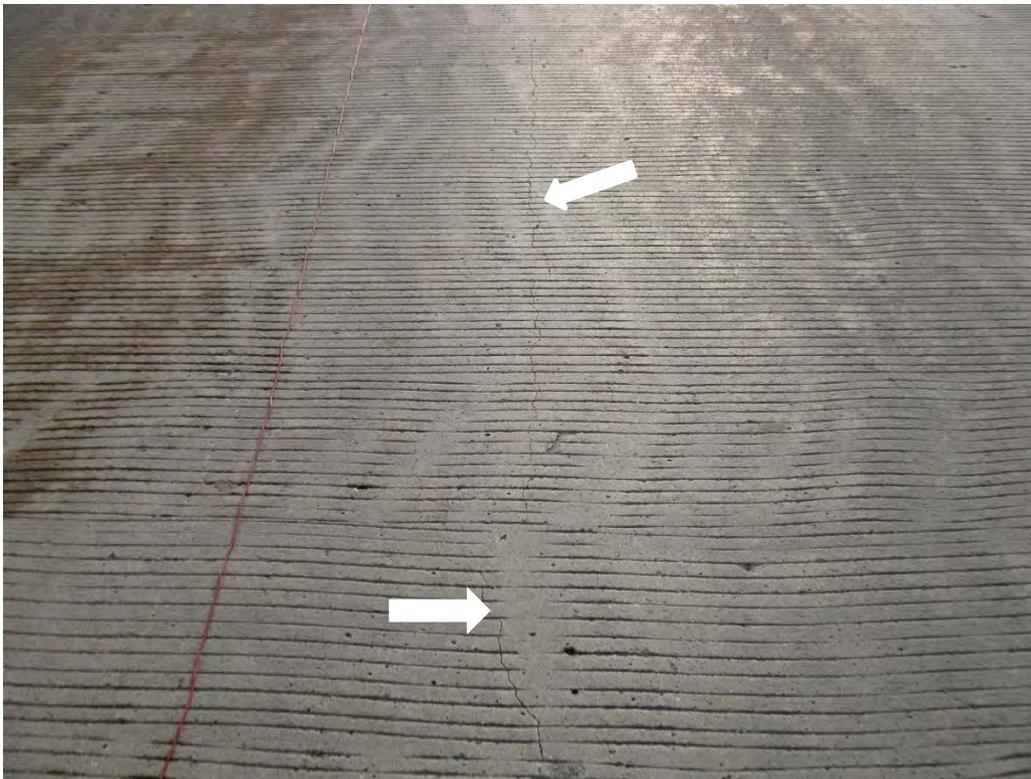
Figure 46. Typical view of longitudinal crack in US 18 bridge deck.

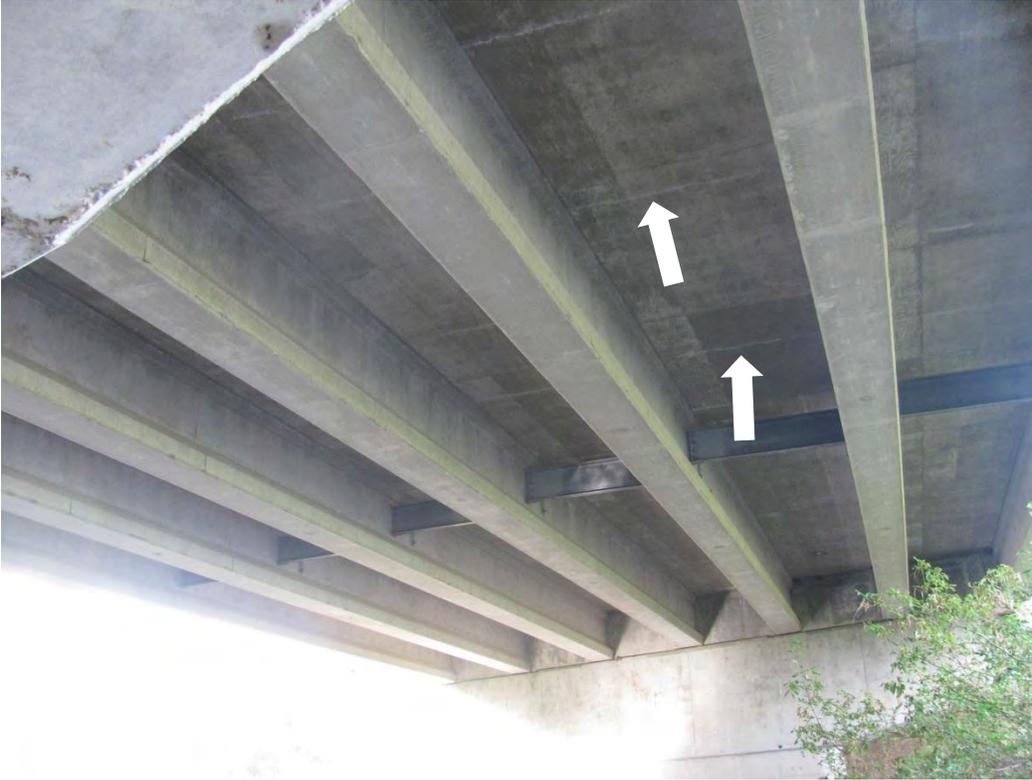
Figure 47. Typical view of underside of center span of US 18 bridge deck, with cracking indicated by arrows.

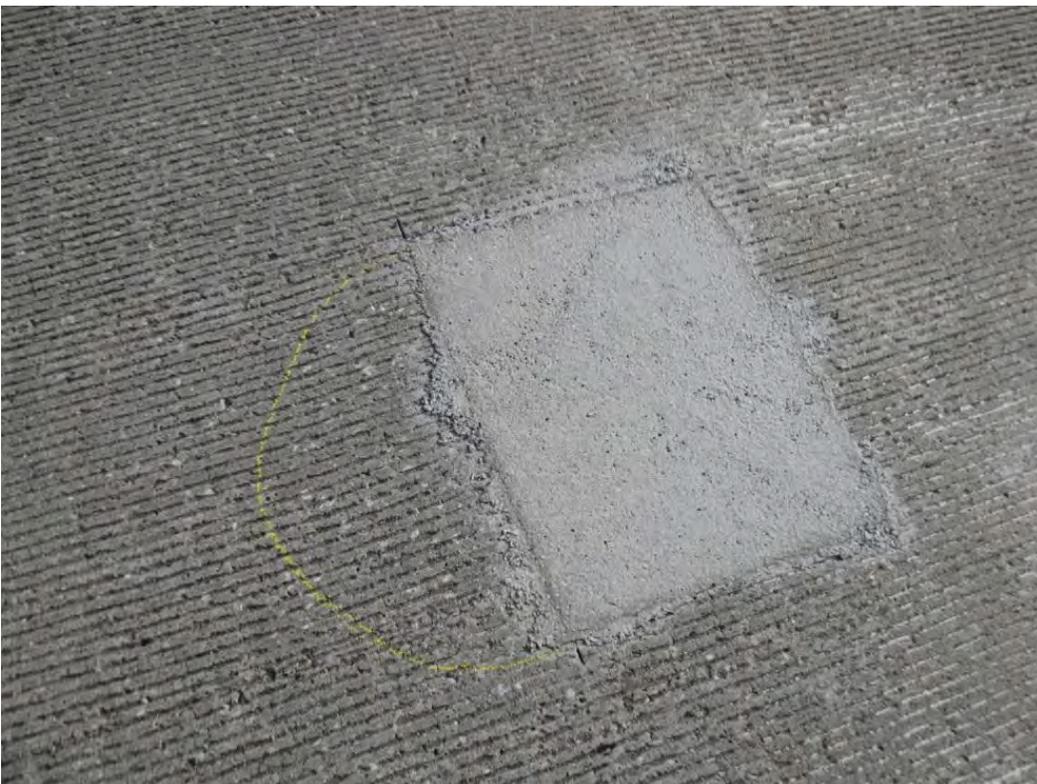
Figure 48. Area of patching on top surface of Southbound US 65 bridge deck, with adjacent area of delaminated concrete outlined in yellow.

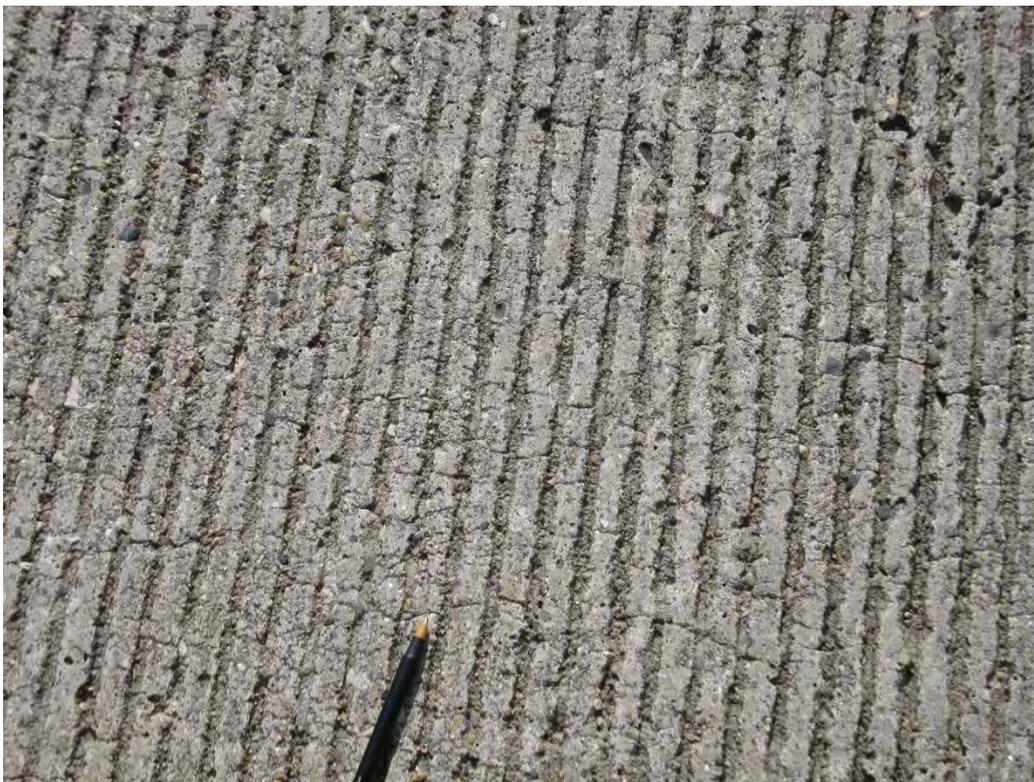
Figure 50. Fine hairline cracking in deck top surface with the appearance of plastic shrinkage cracking.

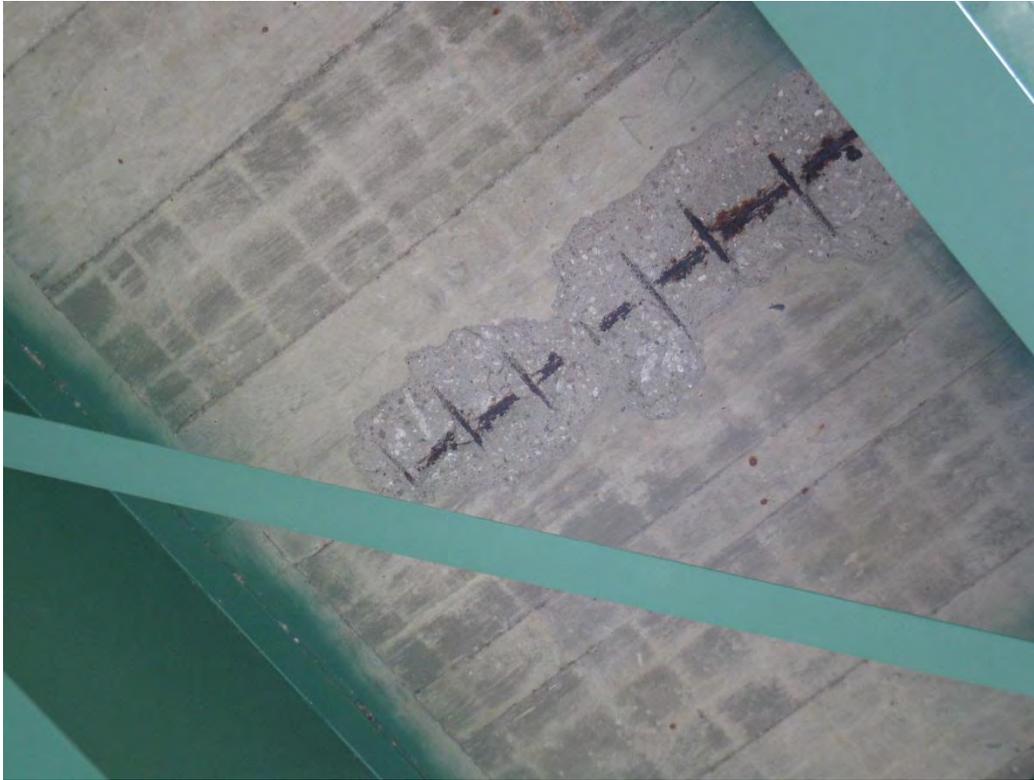
Figure 51. Area of spalled concrete on underside of Southbound US 65 bridge deck

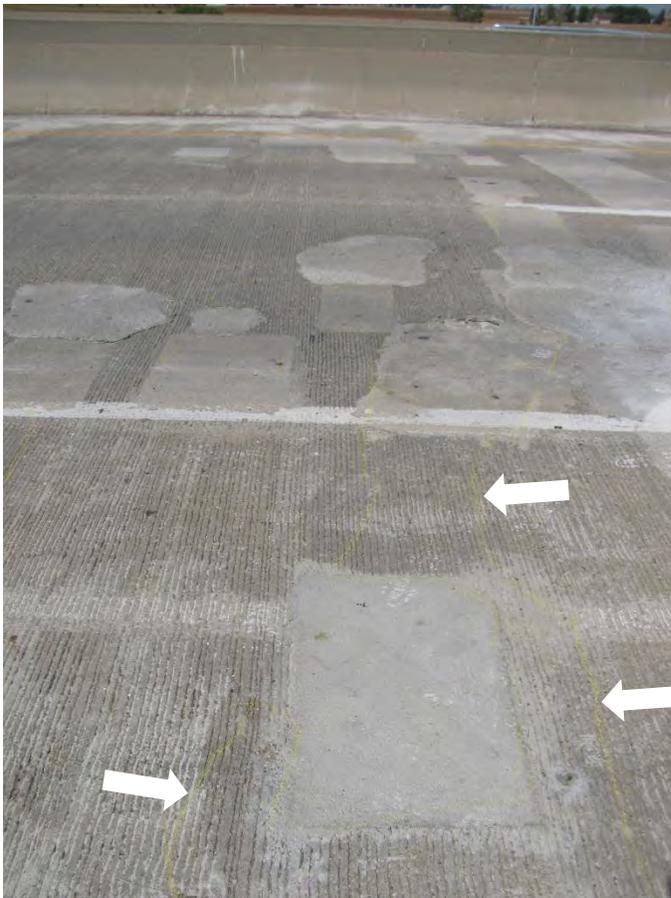
Figure 52. Area of extensive patching on the surface of Northbound US 65 bridge deck, with adjacent delaminations outlined in yellow.

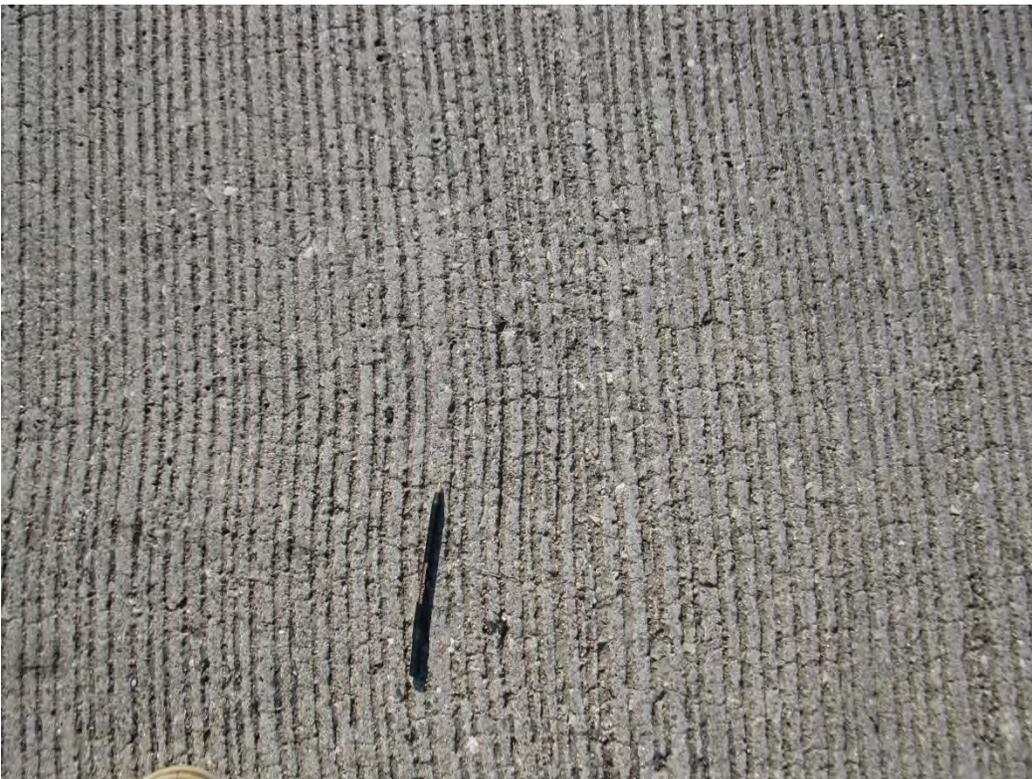
Figure 54. Multiple short hairline cracks on deck top surface (Northbound US 65) similar to plastic shrinkage cracking.

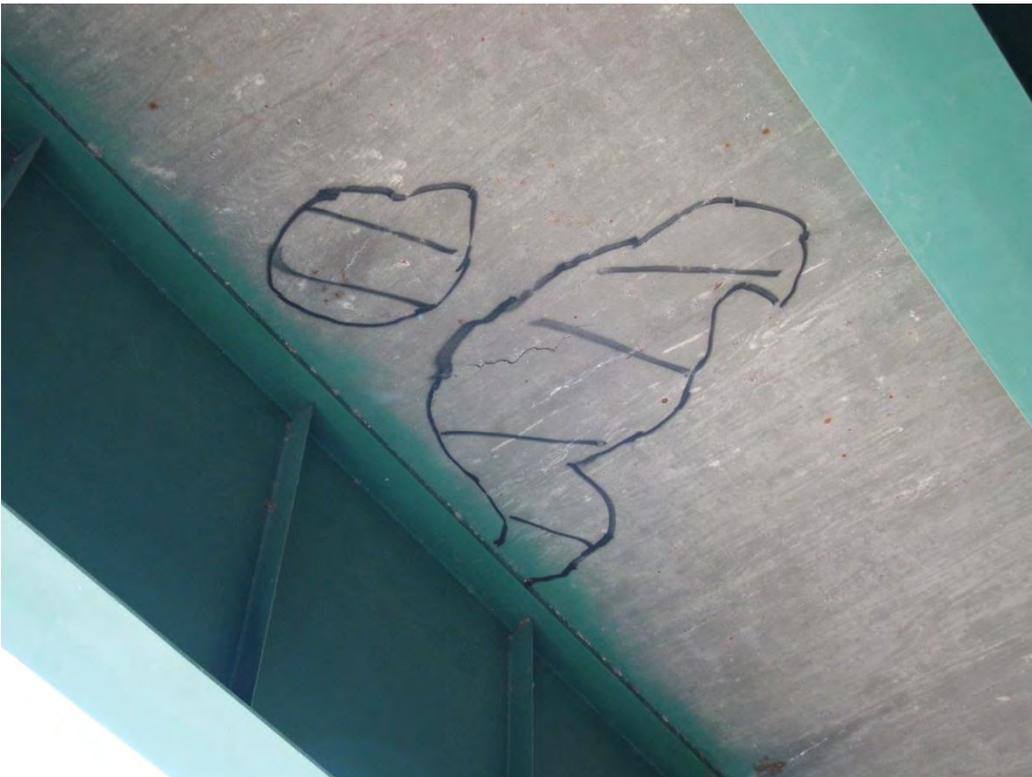
Figure 56. Marked areas of delamination on underside of Northbound US 65 bridge deck (marked by others).

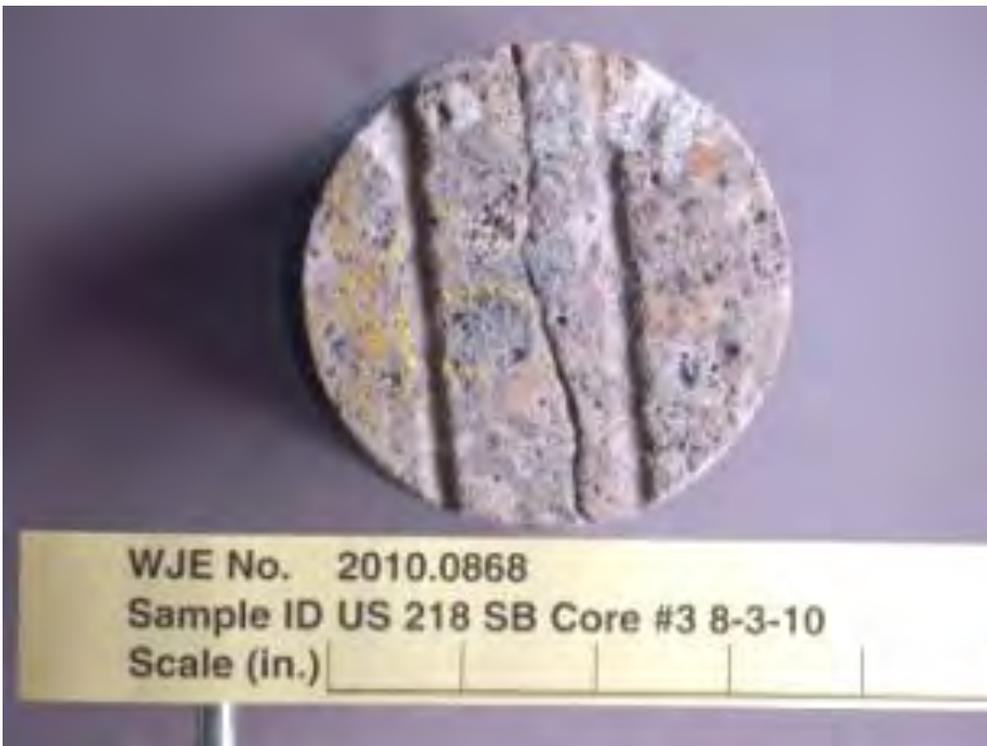
Figure 12. The as-received appearance of the top of Core US 218 SB #3 using low angle lighting to emphasize crack and tinting on top surface.

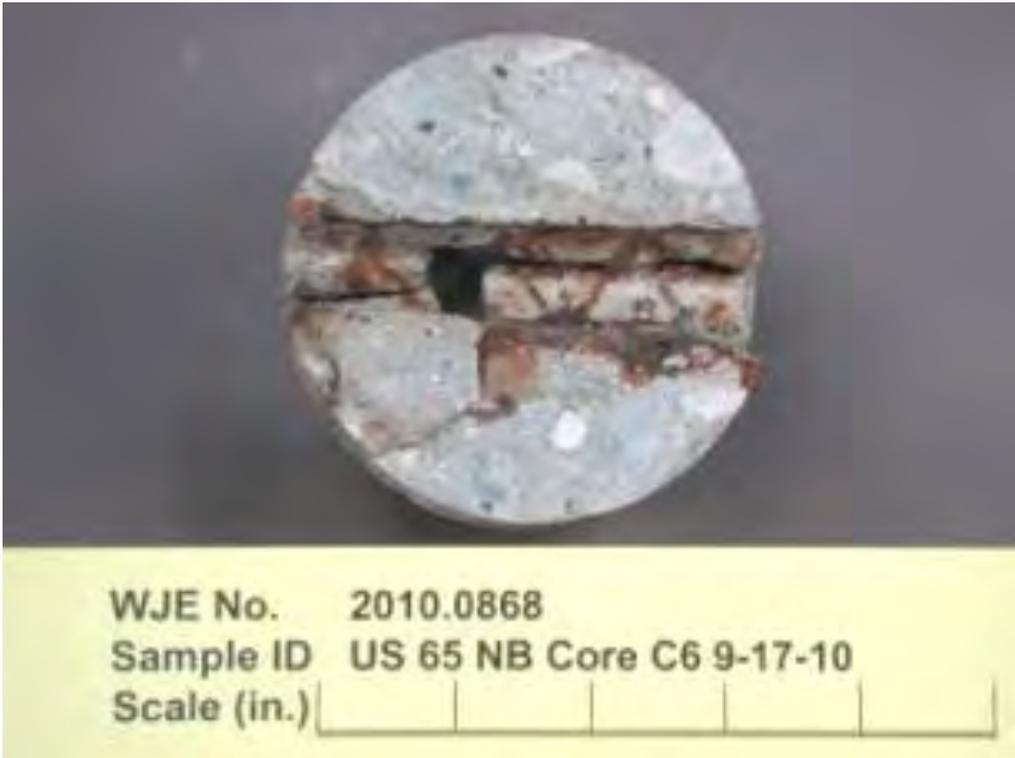
Figure 27. The as-received appearance of the bottom of the top section of Core US 65 NB #6 showing multiple cracks at the location of the removed reinforcing.

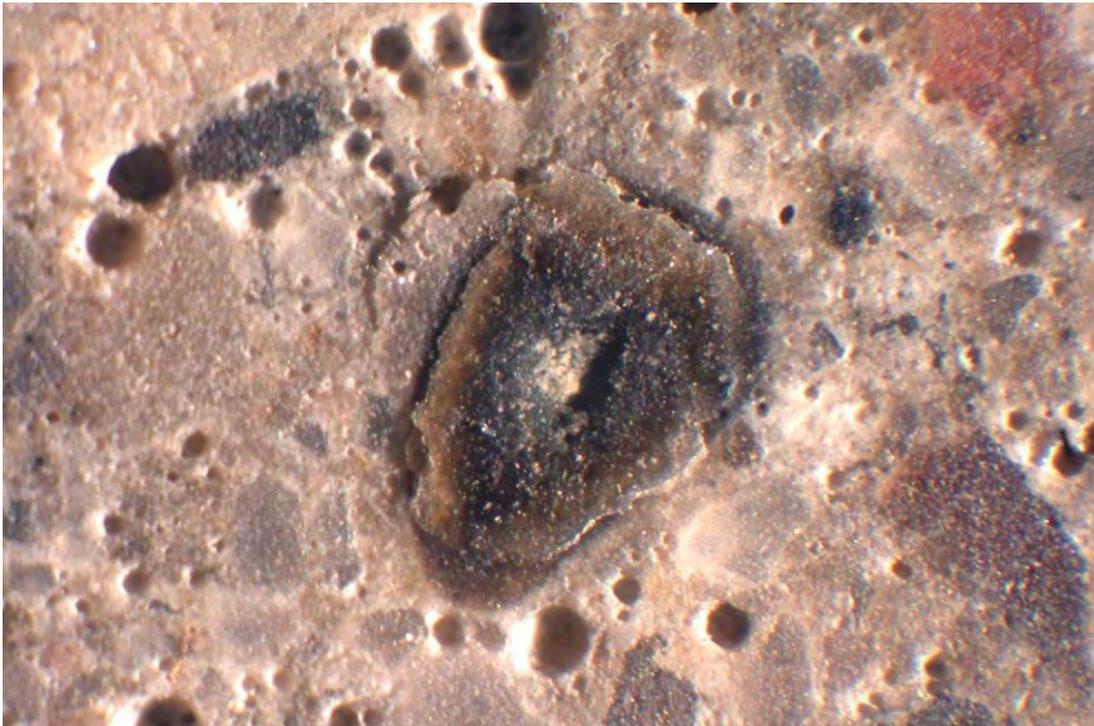
Figure 42. A sand particle that expanded after it was exposed on a lapped surface of Core IA 17 #1. The height of the field of view is 0.18 inch.

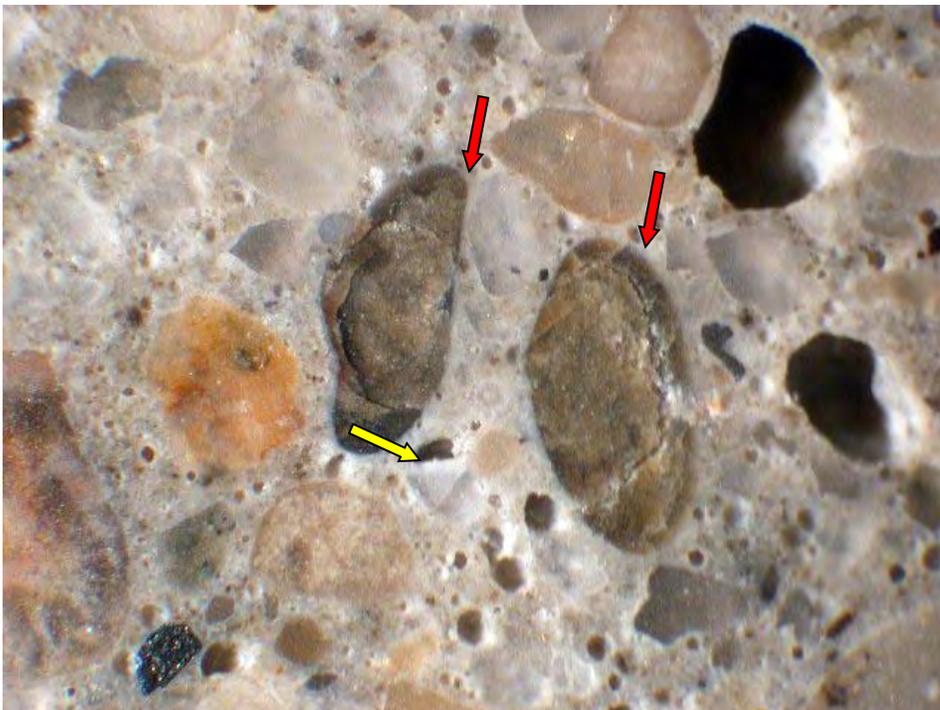
Figure 43. Two internally fractured sand particles contained in Core IA 17 #1 are marked with red arrows. The yellow arrow marks a void that is partially filled with silica gel, which is indicative of ASR. The width of the field of view is 0.15 inch.

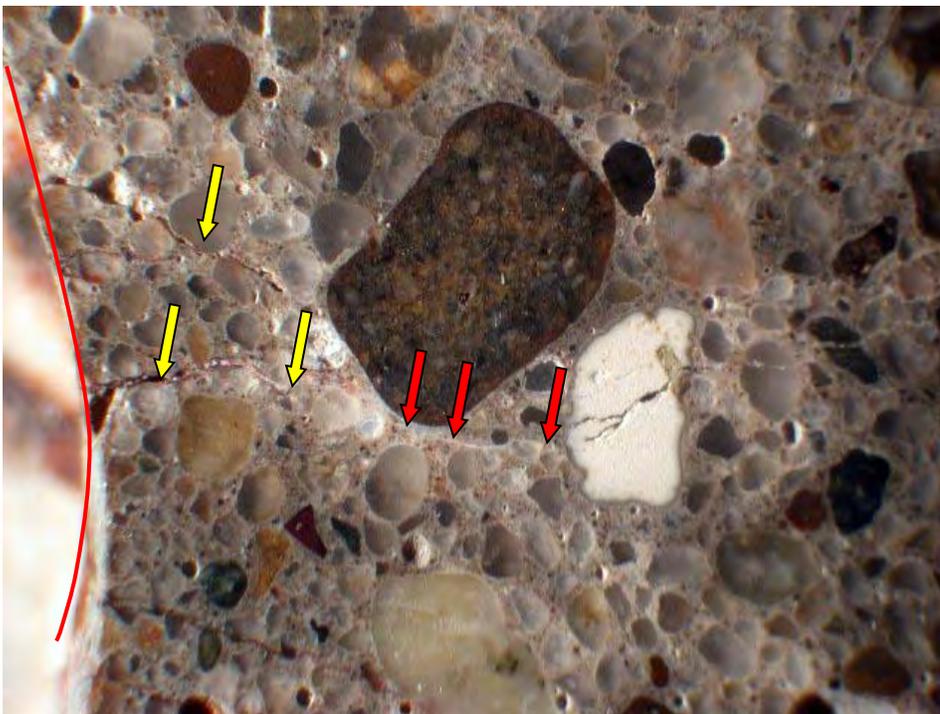
Figure 44. A cross-sectional view oriented perpendicular to the axis of an impression of an embedded steel reinforcing bar contained in Core IA 150 #5. The red curve marks the intersected surface of the steel reinforcing bar impression. Several cracks that were judged to have initially been induced by deposition of corrosion by-products from the embedded steel reinforcement are marked with yellow arrows. Iron oxide deposits are visible along these cracks. The red arrows mark the extension of the one of the corrosion-induced cracks. Silica gel has been deposited along the portion of the same crack in the region marked with red arrows. The width of the field of view is 0.5 inch.
