Use of H2Ri Wicking Fabric to Prevent Frost Boils in the Dalton Highway Beaver Slide Area, Alaska Final Report

December 2012

INE/AUTC 12.23

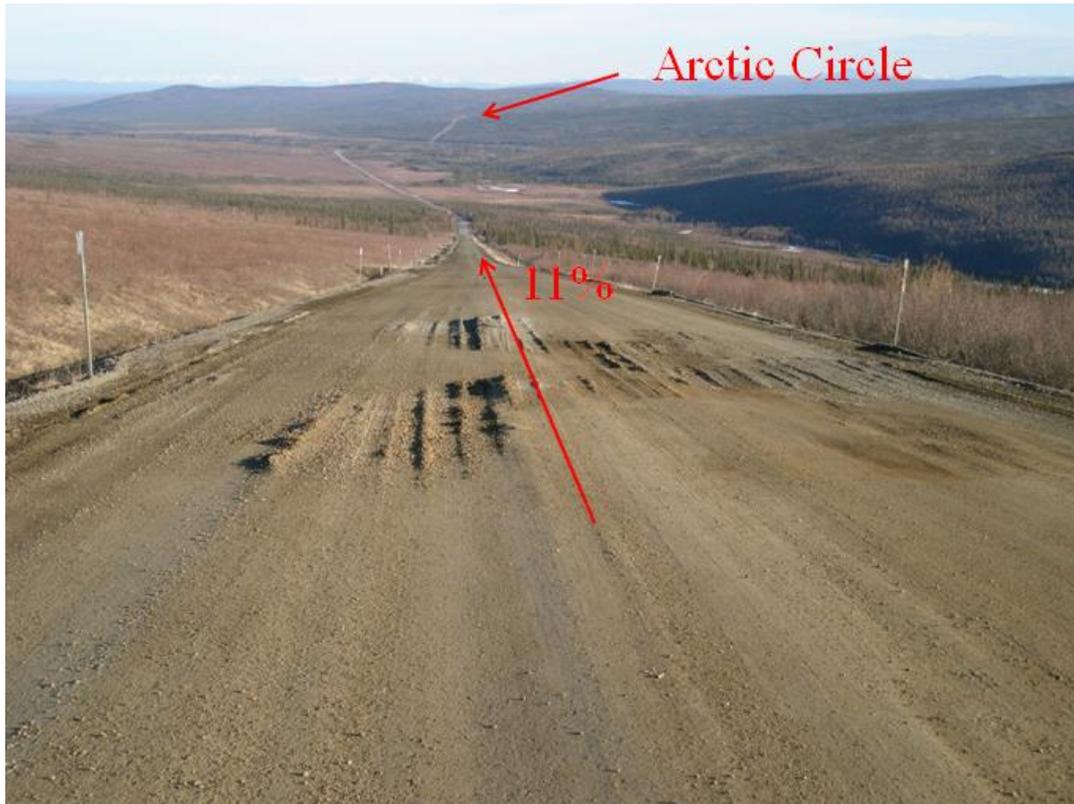
Figure 2. Frost boils at Beaver Slide on May 12, 2012 (looking north)

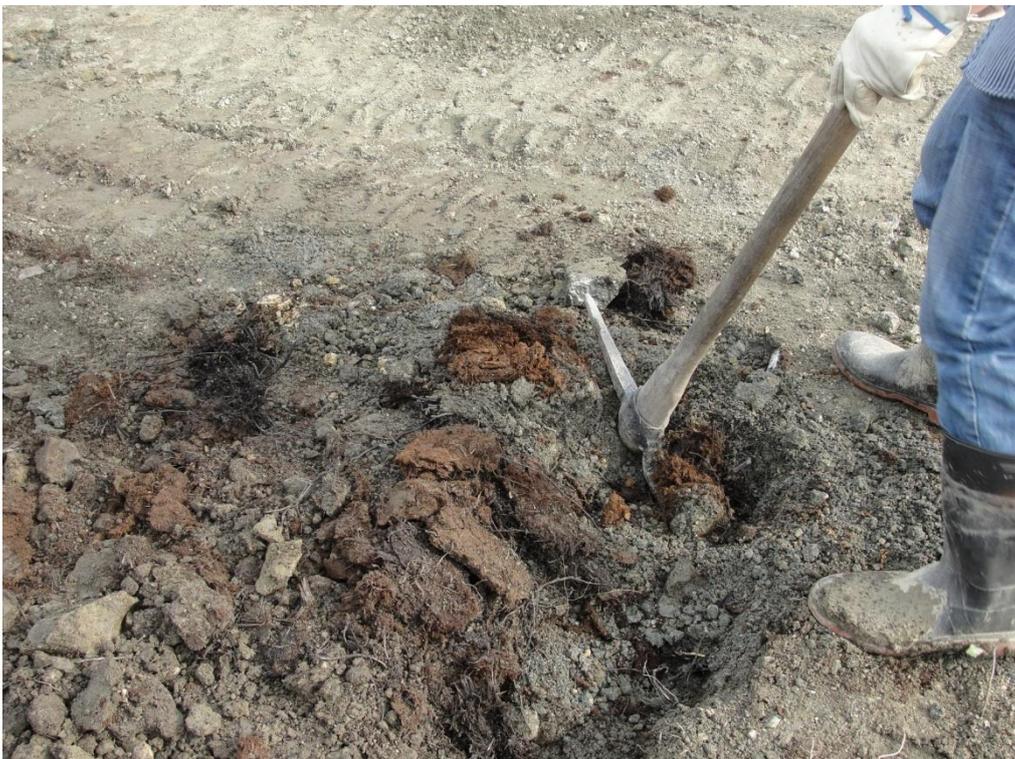
vegetation layer was encountered 4 feet below the original road surface (0.5–1.0 feet below the excavation bottom). Sand with gravel was on top of the degraded vegetation layer. Under the degraded vegetation layer were crushed rocks with sand. The soils excavated from pits at sensor locations 2 and 6 were generally sand with gravel, the same as soils excavated from the first 3.5 feet of soils. No degraded vegetation layer was found in these two excavation pits.

Figure 33. Degraded vegetation layer found on the bottom of the excavation

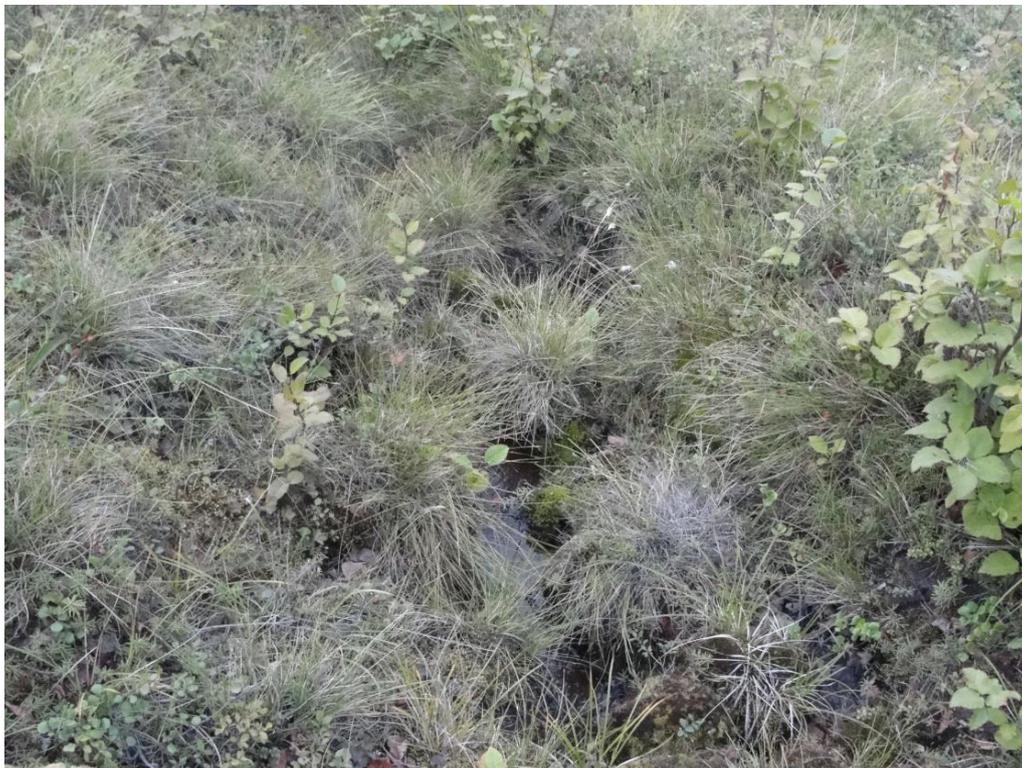
Figure 51. Water found in the tundra on the slope near the data collection box

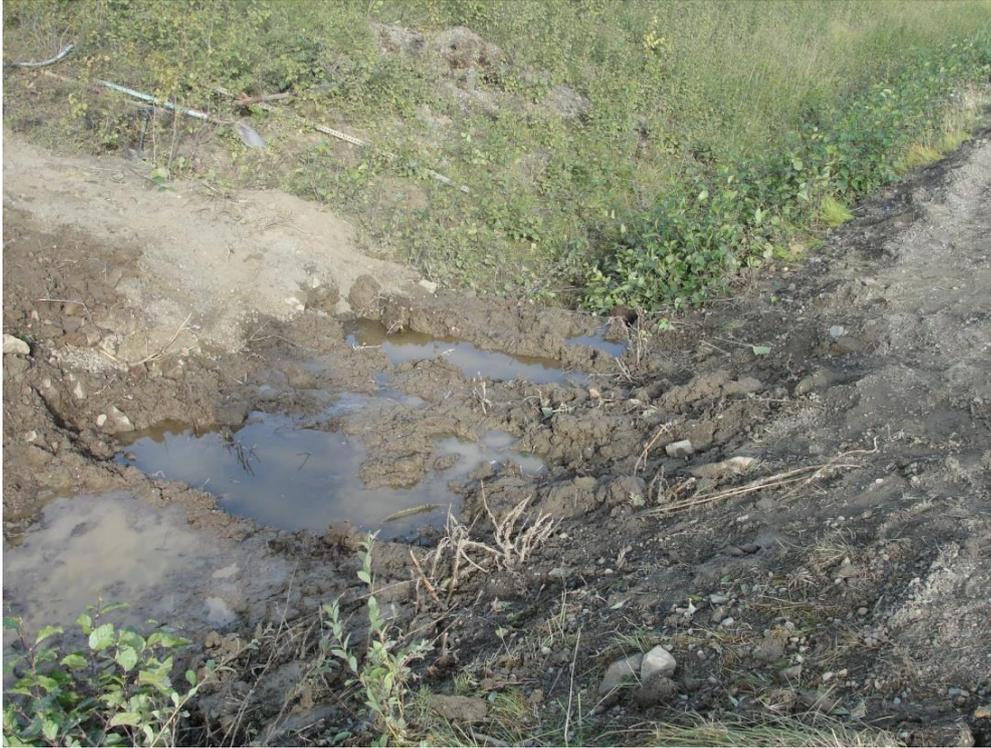
Figure 52. Water found in the existing ditch along east side of the road on August 5, 2010

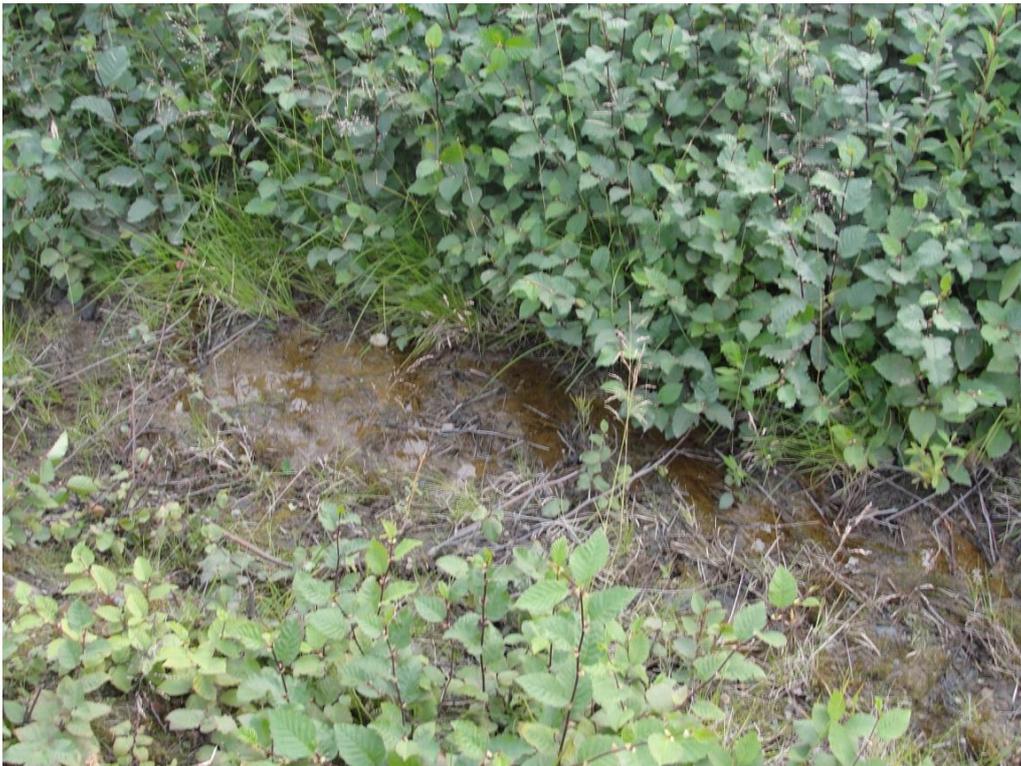
Figure 53. Water found along the tree line sporadically, on the west side of the road

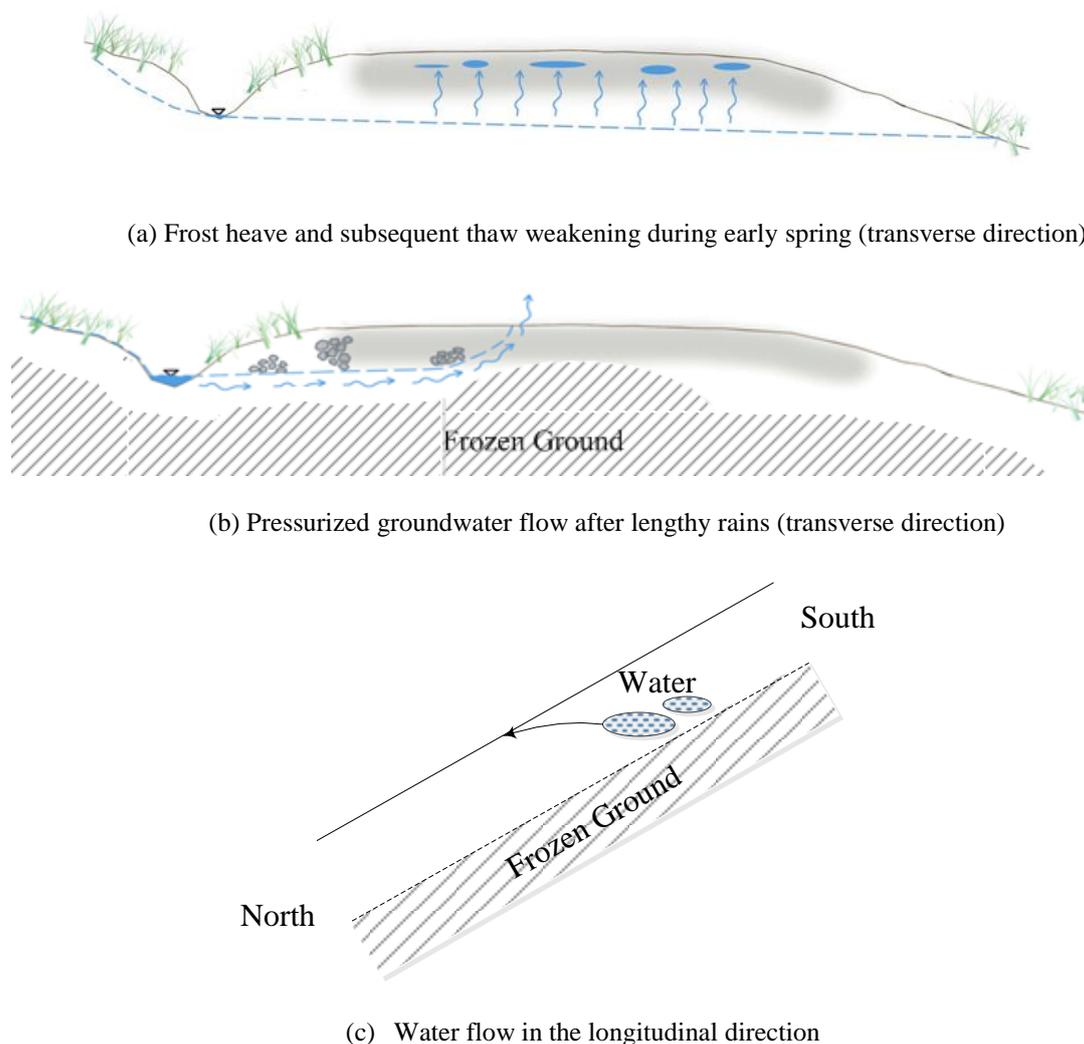
The obtained data indicate that there are two mechanisms for the formation of frost boils (also referred to as "soft spots") at Beaver Slide: (a) frost heave and subsequent thaw weakening, which occur in early spring, and (b) upward pressurized water flow to the road surface during lengthy rainy periods, similar to Artesian water, from mid-summer to fall. The test section was built at a site where soft spots had occurred most frequently in previous years. Surface observations made by the Alaska Department of Transportation and Public Facilities Maintenance and Operations (M&O) road crew for the Dalton Highway indicate that use of H2Ri eliminated the damage caused by both formation mechanisms. The test section performed well over the two-year study. During this time, no soft spots or frost boils occurred in the test section treated with H2Ri, though they were observed past both the upper and lower ends of the test section during early spring or a particularly rainy period. The M&O road crew reports that it is clear where the road was treated with H2Ri based on the road surface performance.

Figure 123. Mechanism of frost boils/soft spots
