Testing and Recommended Practices to Improve Nurse Tank Safety, Phase I

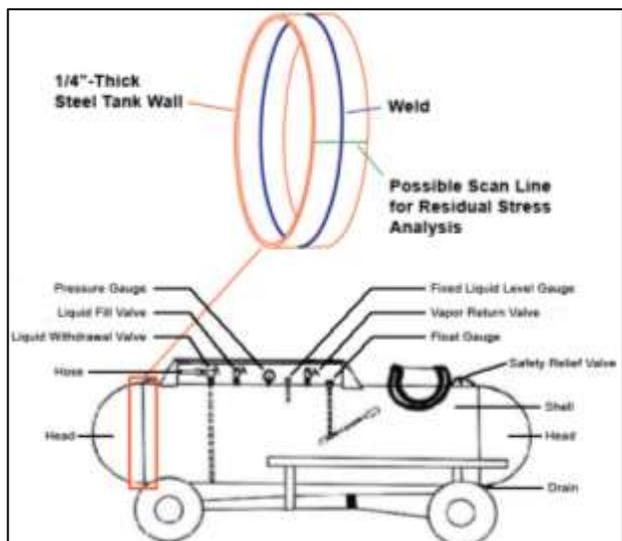
- Neutron diffraction analysis performed on hoop sections from two nurse tanks (see Figure 2) showed that the unannealed weld seams contained extremely high residual tensile stresses (i.e., the maximum stress a material can withstand while being stretched before failing). These were in the heat-affected zone of the steel immediately adjacent to the unannealed welds. The welds are used to assemble the heads to the shell while manufacturing the tanks. Tensile stress is a necessary factor in SCC, both in crack initiation and growth.

Figure 2. Location of hoop weld sections cut from tanks.
