DEVELOPING COUNTY BRIDGE REPAIR AND RETROFIT TECHNIQUES

OTCREOS11.1-24-F

| 4. TITLE AND SUBTITLE Developing County Bridge Repair and Retrofit Techniques | | 5. REPORT DATE August 2013 | |

OTCREOS11.1-24 Developing County Bridge Repair and Retrofit Techniques

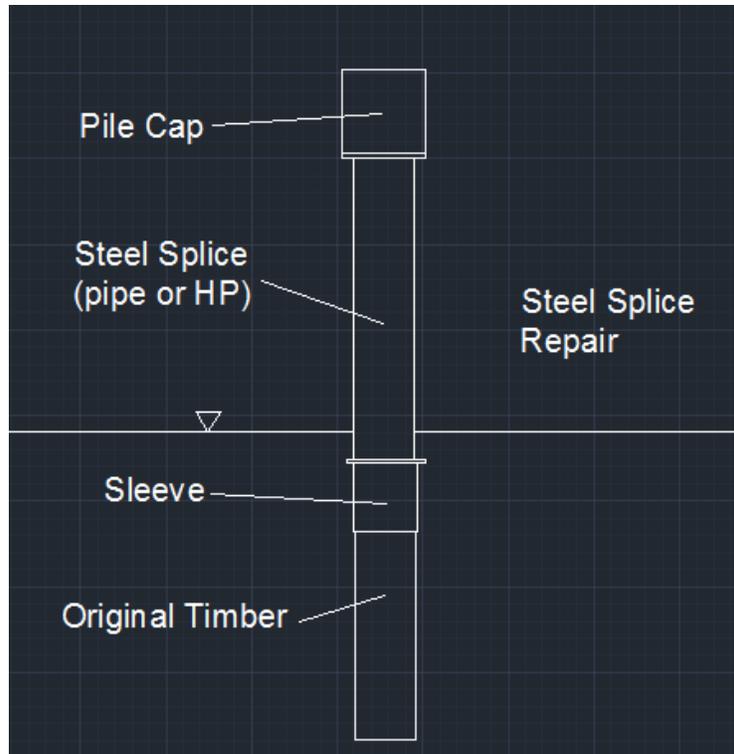
Figure 1. Steel Splice Repair

One specific repair was mentioned in the meeting that had been used around the state previously. This repair involved removing decayed timber piles from under the bridge and splicing metal shapes, either pipe or H-Pile, under the bridge to replace the timber. In the field, this repair has been considered when 50% section loss of a pile has been estimated. It has been observed by ACCOK that the timber piles do not decay or rot below grade. Because of this, the steel member can be connected to the existing timber pile that extends into the ground, thus resulting in a pile repair that does not require driving a new pile into the soil. Avoiding pile driving in the repair provides numerous benefits. The connection of the steel member to the existing pile below ground consisted of a "sleeve" of metal pipe that capped off the top of the timber pile. This cap is welded onto the new steel pile, which extends all the way to the pile cap. The repair is displayed below.

This repair method provided the perfect opportunity for the project. It was an idea that ACCOK came up with that is inexpensive and easy to install. However, ACCOK has not tested the repair's effectiveness of transferring load from the bridge deck to the soil. There is also no design standard for the repair.

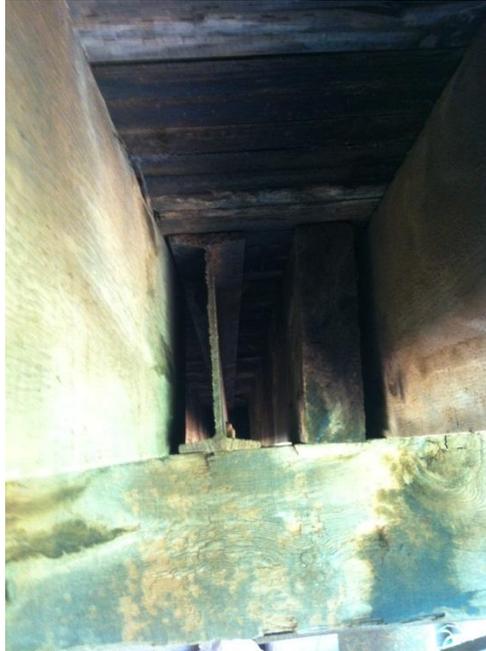
Figure 20. W-Shape Acting as a Replacement Timber Beam

The timber beams are 15 inches by 4 inches and are spaced at 18 inches, center to center. Some are showing signs of damage such as cracking or decay. One of these beams has been replaced with a steel W-Shape, as shown in figure 20.

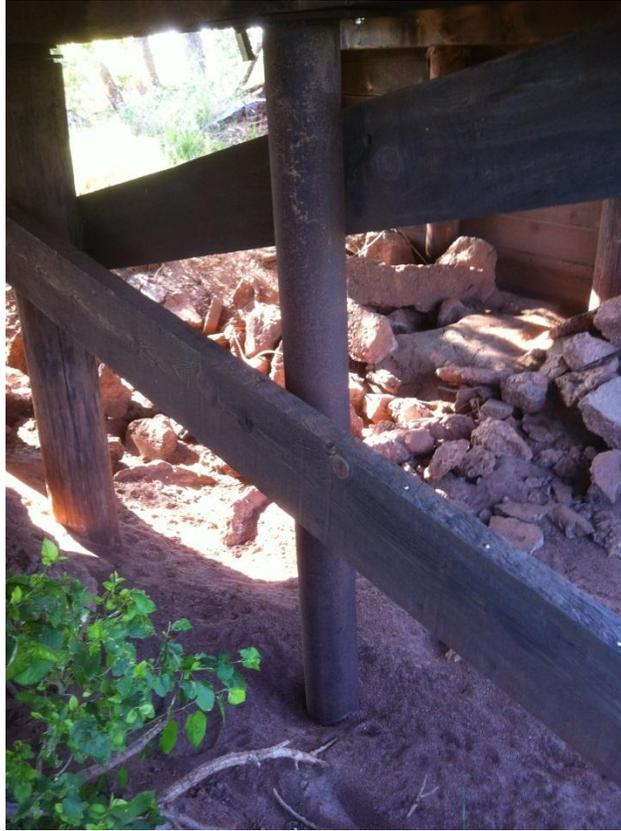
Figure 21. Installed Steel Splice

The splice repair was installed on the south bent cap, designated as S2 (shown in figures 18 and 19). According to past inspections the replaced timber pile had undergone more than 50% section loss and severe splitting. The replacement pipe is illustrated in figure 21.

The pipe which replaced the timber pile was 7 5/8 inches in outside diameter and had a wall thickness of 0.450 inches. The grade of the steel is unknown, but was assumed to be grade 50. The pipes connection to the bent cap is shown in figure 22.

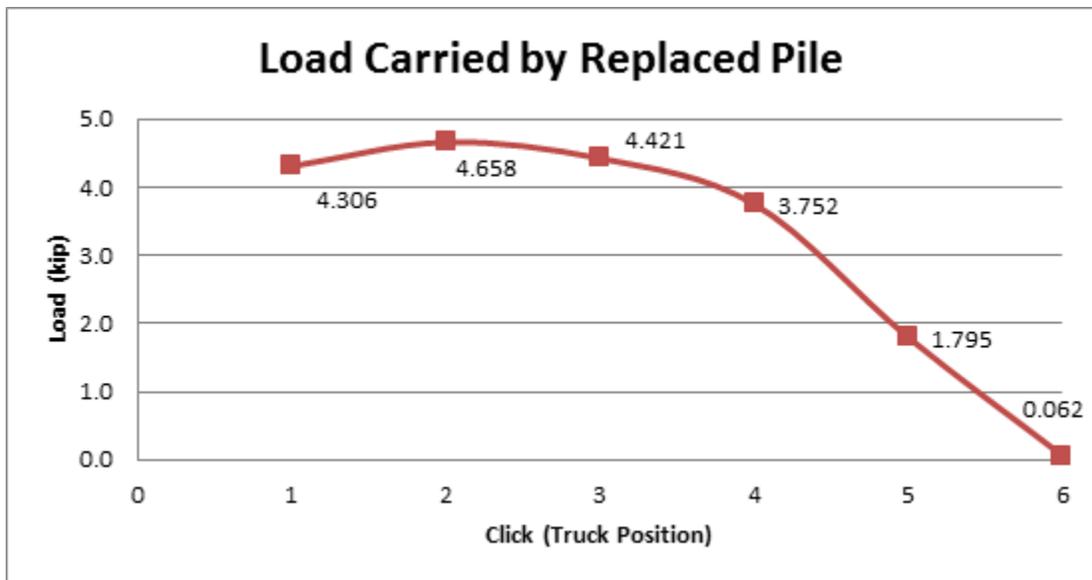
Figure 38. Load Carried by Replaced Pile

The findings from the field testing performed in Grant Country suggest the successful flow of load from the pile cap of the bridge, through the spliced repair, to the existing timber pile in the foundation. The following figure illustrates that as the truck drives across the bridge, the replaced pile takes up to 4.658 Kip (all values are averaged from three data sets).

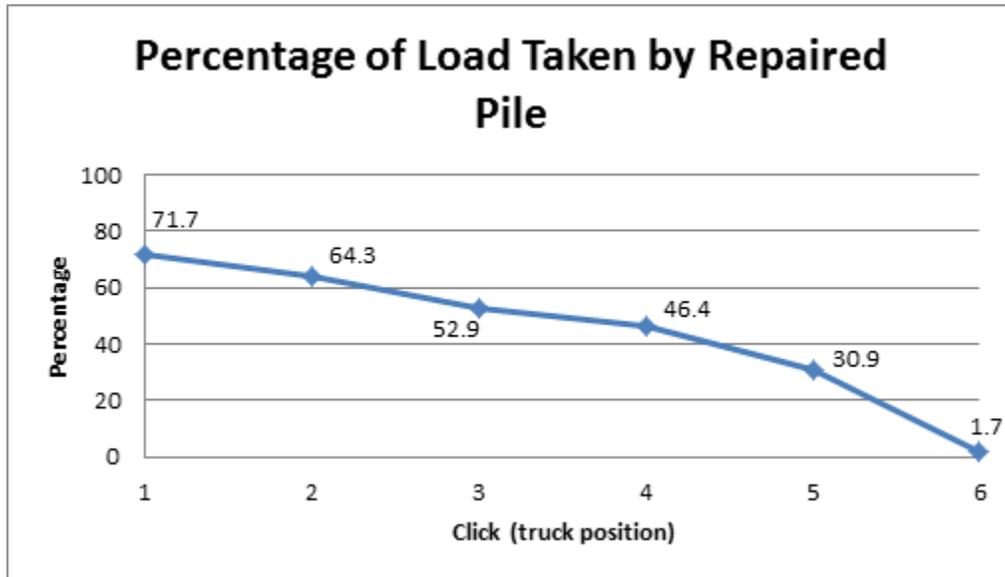
Figure 39. Percentage of Load Taken by Repaired Pile

In addition, the repaired pile took a large percentage of the total load of the truck, as shown in the following figure:

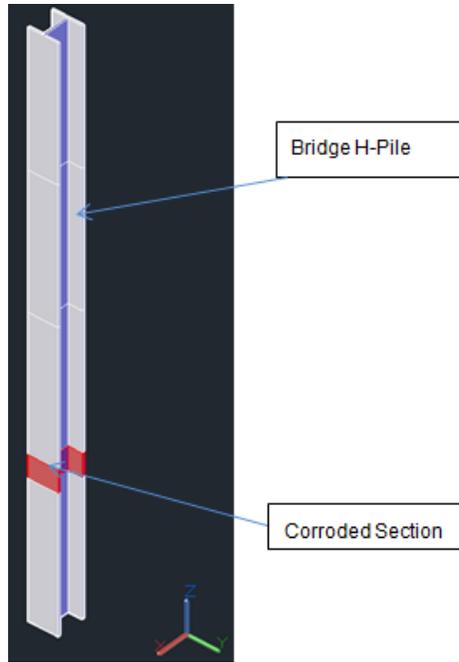
Figure 50. Corroded bridge H-pile with repair plate

A meeting with Randy Robinson, P.E., Donny Head, and Jimmy Watson was conducted and a few common county bridge repairs were discussed. Mr. Robinson stated that the cause for most of the structurally deficient bridges is due to the timber and steel piling deterioration, whereas the bridge beams themselves are normally in fine condition. One specific repair identified was a steel reinforcement plate welded on to corroded steel piles for many county bridges. This technique involves welding supplemental steel plates onto steel H-piles which have significant section loss to increase the cross section of the pile. However, this repair had not been analyzed in an engineering perspective to determine the actual effectiveness of the repair. It was simply done with the best judgment and available materials of the specific counties. Figure 50 and Figure 51 show sample drawings of the corroded bridge piles both before and after the supplemental repair plates have been added. Donny Head provided information on two bridges which had steel corrosion of their H-piles. One bridge had not yet been repaired, while the other was already repaired with the supplemental plate welds. It was stressed by Randy Robinson that this repair technique was not to prevent the bridge from needing to be replaced but to prolong the life of the bridge until replacement funding becomes available.
