Technical Report 10-03

Culvert Rehabilitation & Invert Lining using Fiber Reinforced Polymer (FRP) Composites

June, 2010

Culvert Invert Lining with Fiber Reinforced Polymer (FRP) Composites, Route 9, West Branch Half Mile Pond Brook, Amherst, Maine

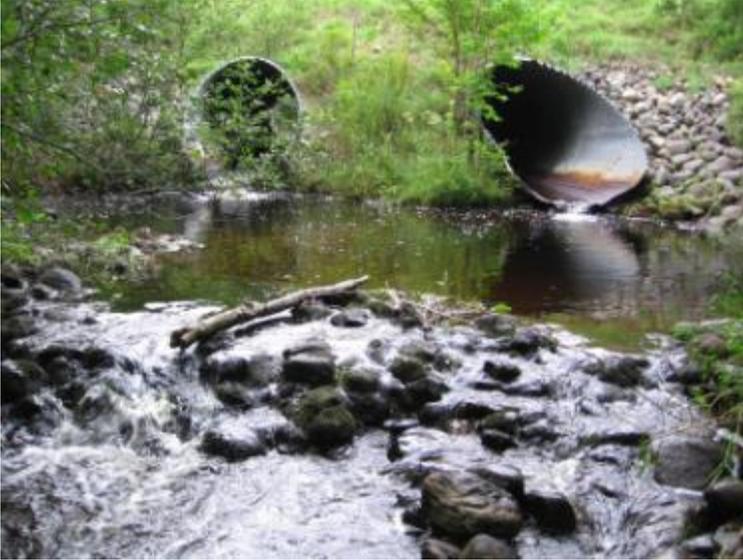
Figure 6- Existing Outlet before Project

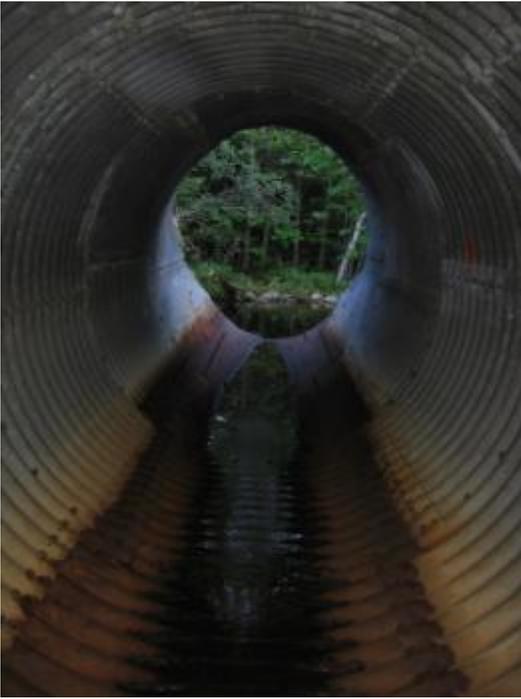
Figure 9- Corrosion of Corrugated Culvert

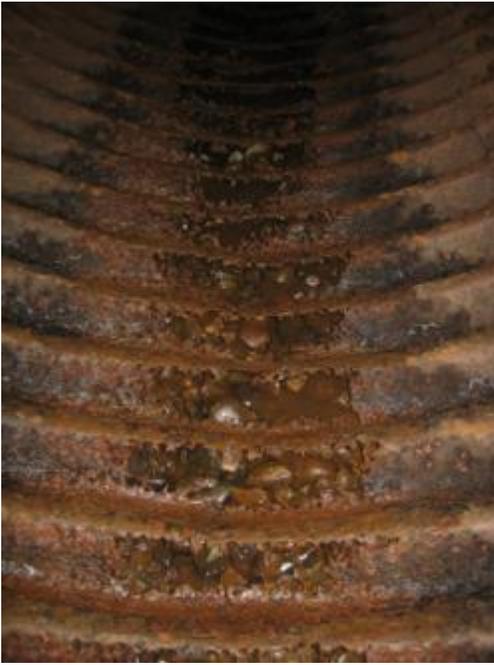
Figure 12- Holes in Bottom of Culvert; Stones and Sub Soil Visible

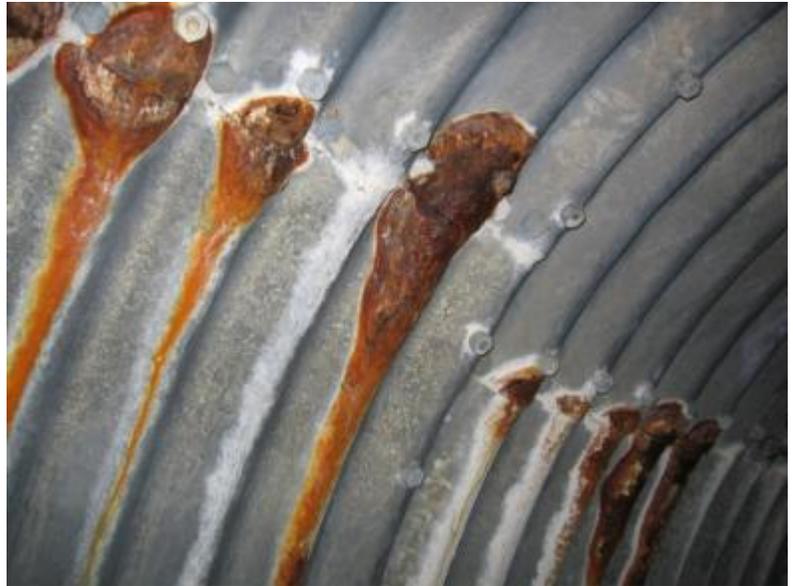
Figure 13- Corrosion on Culvert Walls & Top
