**ENGINEERING STUDIES ON JOINT BAR INTEGRITY, PART I: FIELD SURVEYS  
AND OBSERVED FAILURE MODES**

This paper is the first of a two-part series describing a research project, sponsored by the Federal Railroad Administration (FRA), to study the structural integrity of joint bars. In Part I of this series, observations from field surveys conducted on revenue service track are presented. Automated and visual inspections of rail joints were conducted to identify defective joint bars. Detailed information and measurements were collected at various joint locations.

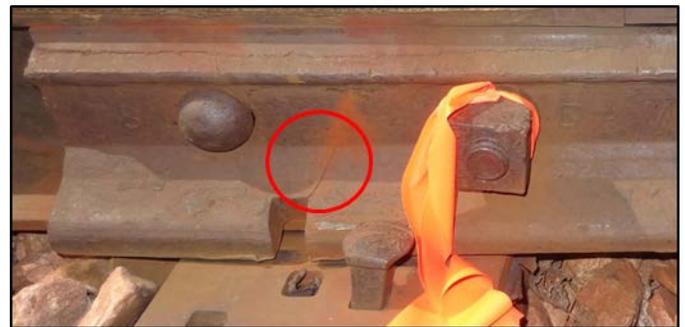
**Figure 4: Quarter Crack**

assemblies were not found in FRA Track Class 3 and above. Head-free bars were the most common design found during the surveys. When they are installed, head-free joint bars contact the rail at a single point in the head-web fillet region and the rail base. Head-contact joint bars are in full contact at the bottom of the rail head. Anecdotally head-contact joint bars are assumed to promote rail failures by head-web separation, but are also claimed to provide additional stiffening for better ride quality. The most common defect found in long-toe angle bars is referred to as a quarter crack, which originates at the corner of the spike hole in the bar (see Figure 4). Figure 5 is a photograph of a quarter crack that has grown through the entire cross section of the bar.

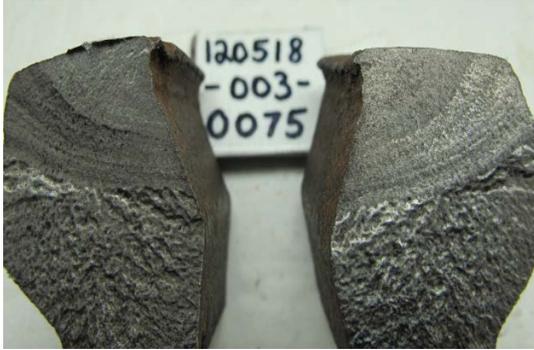
**Figure 6: Top Center Crack**

The most common defect found in standard (head-contact and head-free) joint bars is a crack that originates from the top center of the bar. Figure 6 shows a photograph of the mating fracture surfaces of a top center crack in a standard joint bar. The macroscopically visible ridges, which may be referred to as clamshell or beach marks, are characteristic of metal fatigue. Evidence of plastic flow at the top of the bar can also be seen in the photograph. In some cases, fatigue cracks were seen to originate from the bottom center of a standard joint bar. For example, Figure 7 shows the fracture surface of an edge crack, which appears to emanate from the toe of the bar.

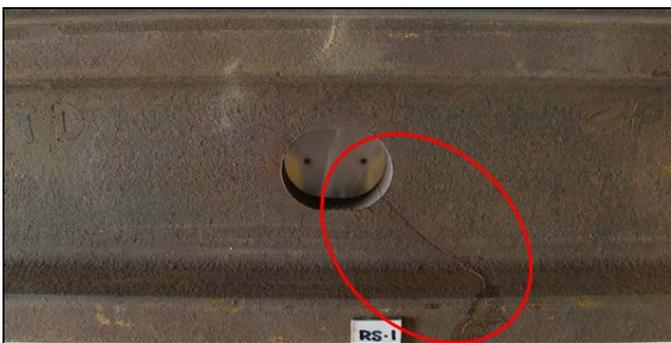
**Figure 8: Bolt Hole Crack**

Figure 8 is a photograph of a crack emanating from a bolt hole. Bolt-hole cracks represented a small percentage (about 7%) of the observed defects in the survey sample population. Upon further inspection of these types of defects, the origin of the cracking was observed to be a manufacturing anomaly, presumed to be nick from punching the hole in the bar.
