JRC2014-3786

CONVENTIONAL FUEL TANK BLUNT IMPACT TESTS: TEST AND ANALYSIS RESULTS

Volpe National Transportation Systems Center
United States Department of Transportation
Cambridge, Massachusetts, USA

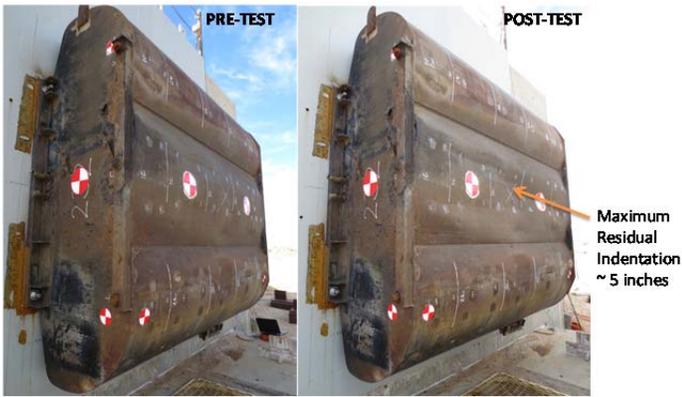
Figure 8 shows photographs of the tank before and after the blunt impact. The residual indentation is most pronounced at the point of impact from the indenter. The maximum depth is 5 inches.

Figure 8. Tank 232 Pre-test (right) and Post-test (left)

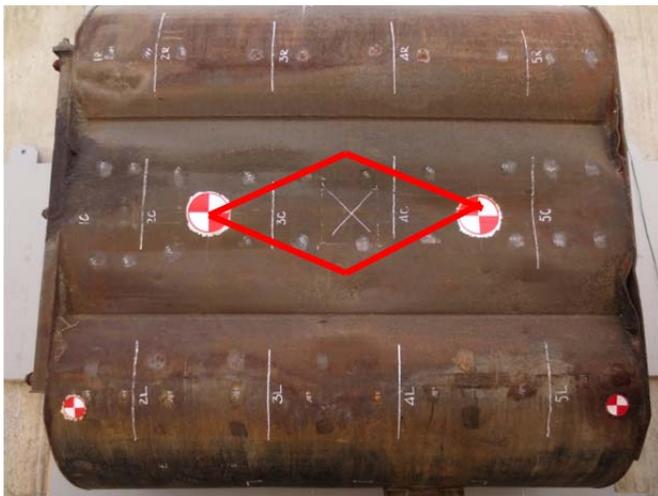
Tank 232 experienced a diamond-shaped dent across its center section due to the center impact from a 12” by 12” square-shaped indenter head. Figure 9 shows a view of the tank post-test with the dent shape highlighted. The deepest residual dent is at the center, at the location of indenter, measuring approximately 5 inches. The deformation was confined to the center billow. The two adjacent billows of the tank, above and below, showed no deformation from the blunt impact at the center of the tank.

Figure 9. Post-test Dent Shape, Tank 232

Post-test tank autopsies were conducted to document the deformation behavior of the interior structure. The indenter impacted the center of the fuel tank, which for Tank 232, is about halfway between two horizontal baffles. This is a 5-inch gap between the bottom surface of the tank and the baffles. Upon inspection, the two horizontal baffles adjacent to the impact had markings about 5-7 inches long indicating that the bottom sheet deflected enough to just make contact with the ledge of the two baffles.

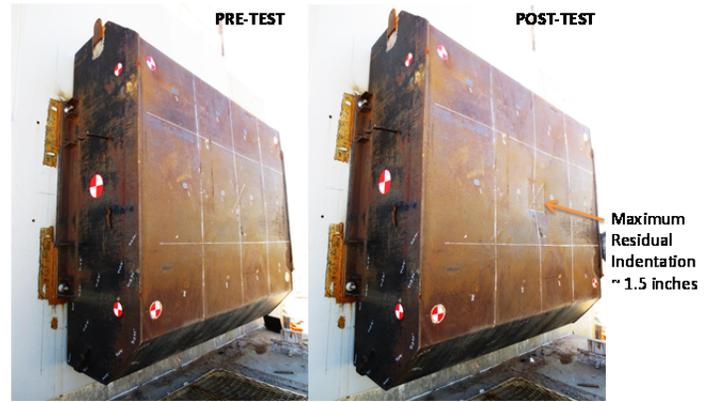
Figure 10 shows photographs of the tank before and after the blunt impact. The residual indentation is most pronounced at the point of impact from the indenter. The maximum depth is 1.5 inches at the point of impact.

Figure 10. Tank 202 Pre-test (right) and Post-test (left)

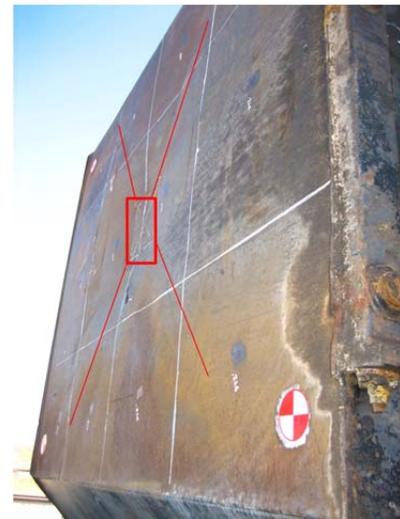
Tank 202 experienced a shallow X-shaped deformation radiating out from the pronounced square dent at the impact zone. The “X” shape spans across the continuous single sheet that makes up the bottom of Tank 202. Figure 11 shows a photograph with the deflection pattern highlighted.

Figure 11. Post-test Dent Shape, Tank 202

A post-test autopsy of Tank 202 showed the behavior of the interior structure to the blunt impact. Tank 202 was constructed with the baffles attached to the inner surface of the bottom sheet with a series of tack welds. Due to the layout of the baffles, a center impact of Tank 202 impacts directly on a baffle. During the test, the baffle directly beneath the impactor showed localized buckling within a few inches of the bottom sheet.

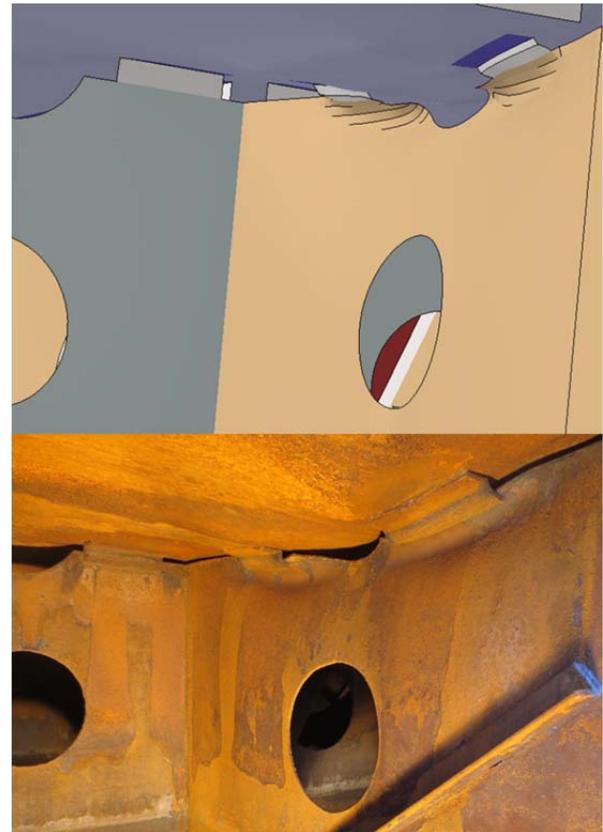
Following the impact test, Tank 202 was cut open to permit examination of the internal deformations. The impactor struck this tank at the center of a baffle. The initial drop in load observed in both the test and FE accelerations prior to 0.01 seconds, shown in Figure 20, is associated with this baffle and its attachment brackets immediately folding up. Because the baffle remains in contact with the underside of the bottom sheet, the acceleration climbs as the tank offers increasing resistance to further indentation. This behavior was captured by the post-test FE model. The deformed shape of the baffle is shown for both the model and the actual tank in Figure 22.

Figure 22. Post-test Baffle Deformation of Tank 202. Interior Views of Baffle and Bottom Fuel Tank Connections at Point-of-Impact; Image of FEA (Top) and Test Specimen (Bottom)
