EVALUATION OF 588 WEATHERING STEEL GUARDRAIL LAP SPLICES  
PROBLEM SOLVING 91-30

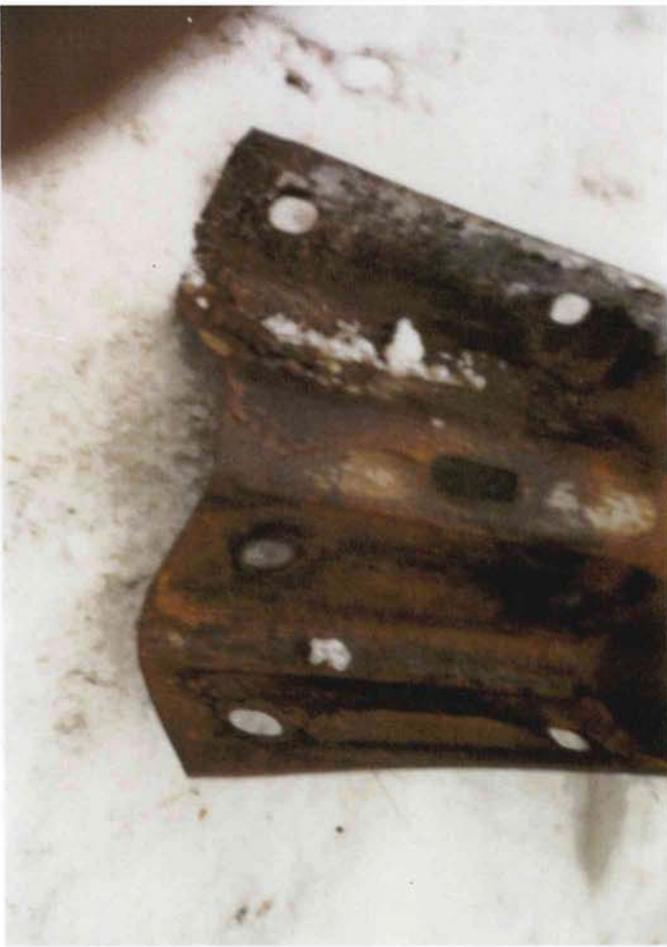
Photo No. 1 West Paris

This bridge project in interior Maine was constructed twelve years ago and has an extensive amount of A588 guardrail. The inspection revealed that minor corrosion was present when the surface was scraped with a wire brush. There was also evidence that the oxide coating had not formed in valleys and crest of the lap splice. A typical lap splice is shown in photos No 1 and 2. Note the tight oxide coating on the exposed portion of the beam as compared to the irregular surface on the lap splice.

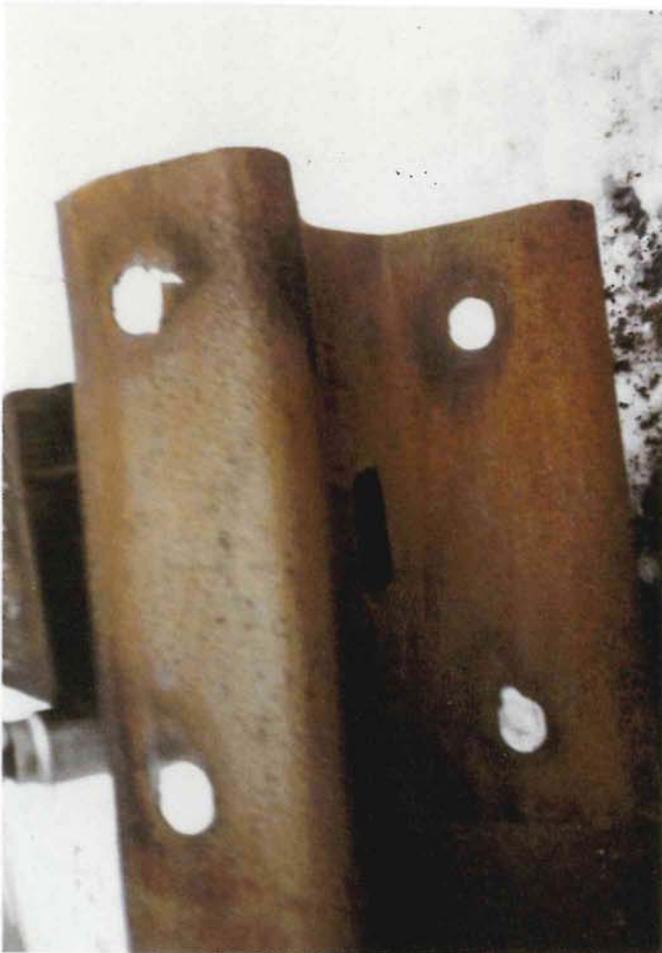
Photo No. 3 Minot

This projects constructed in 1979, has an extensive amount of A588 weathering steel guardrail on the bridge approaches. There were signs of deterioration on the overlapped joints. Photos No 3 and 4 show that minor pitting and flaking have occurred, especially at the top and bottom portion of the joint.

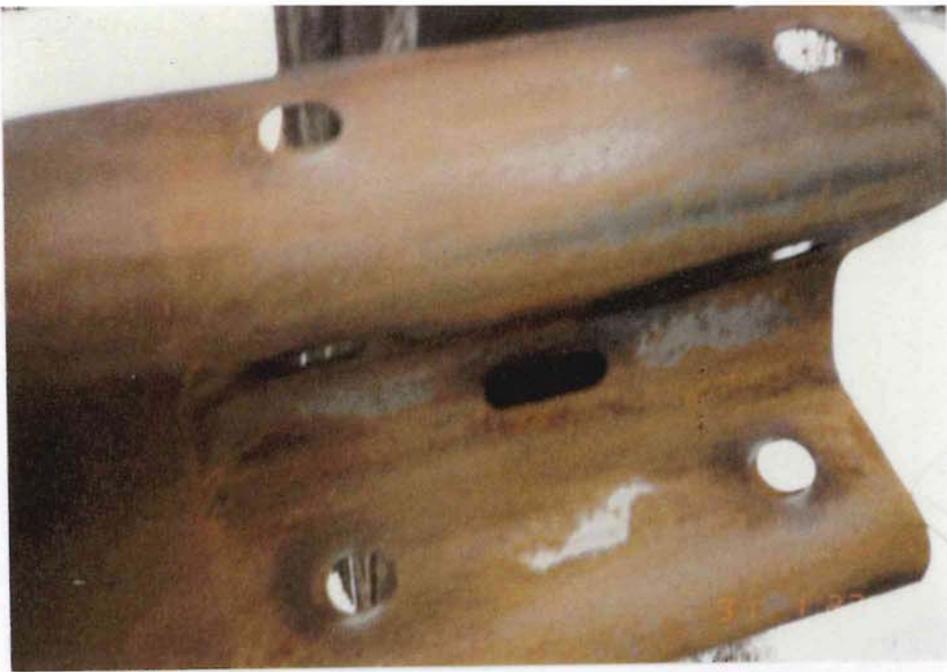
hoto No. 5  
Greene

This bridge was constructed in 1977 and the A588 steel guardrail is performing well. There was no evidence of corrosion or black spots present on the guardrail beam or lap splices. This project is in an open area where the sunlight can keep the guardrail dry which improves the performance of the A588 steel. However, photo No 5 indicates that the oxide coating is not providing uniform protection at the lap splice.

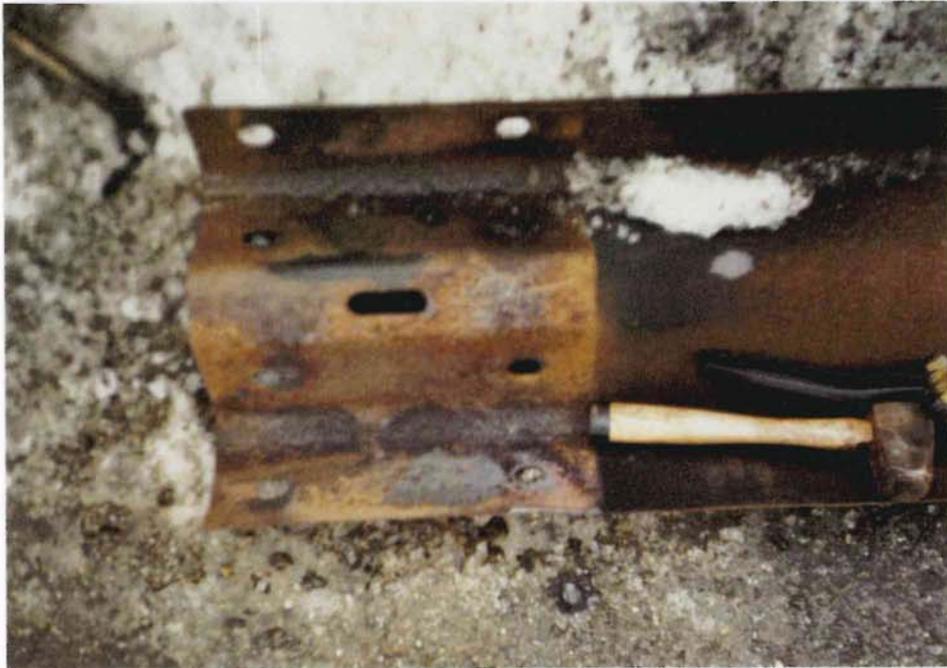
hoto No. 6  
Eagle Lake

This bridge was constructed in 1975 and has one of the oldest A588 steel guardrail installations. This project is located in a coastal environment and contains a large amount of A588 guardrail. Extensive deterioration was observed and when the flakes were removed, a black color confirmed the lack of protective oxide film. Although corrosion is a concern, the rail does not appear to be in any danger of failure. Photos No 6 and 7 show the corrosion. Note the extreme difference between the exposed and concealed portion of the beam.

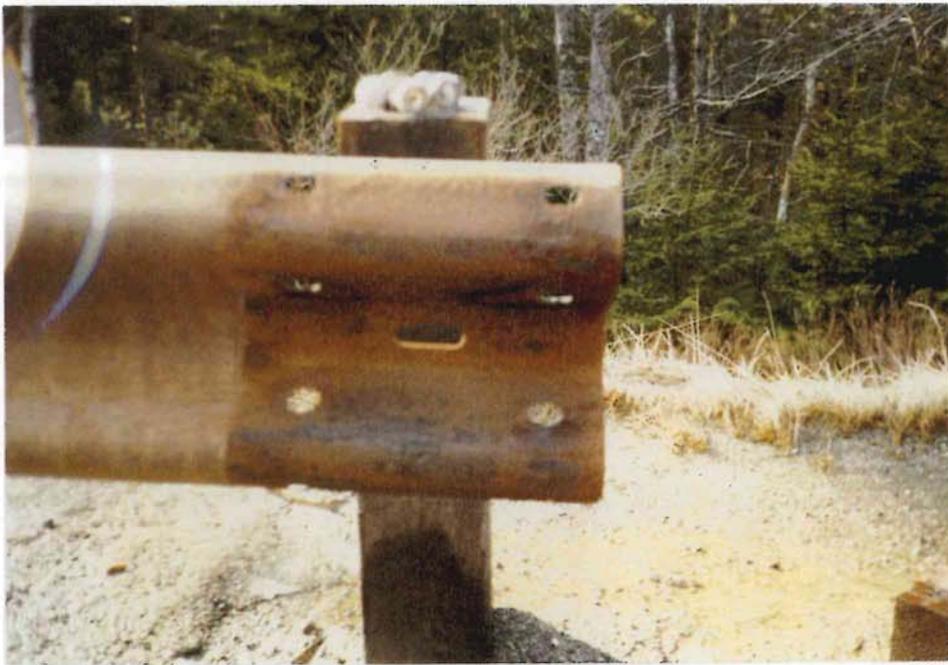
Photo No. 8  
Mt. Desert

This project was constructed ten years ago along Echo Lake. This guardrail was not as old as the Eagle Lake guardrail and the deterioration was not as extensive as that described at the Eagle Lake Bridge. However, the A588 guardrail is located in a tree shaded area and exhibits discoloration, pitting, and flaking. There were also black spots after wire brushing the rail overlap areas which indicate poor coating performance. Photo No 8 shows the serious deterioration that has occurred in the coastal environment.

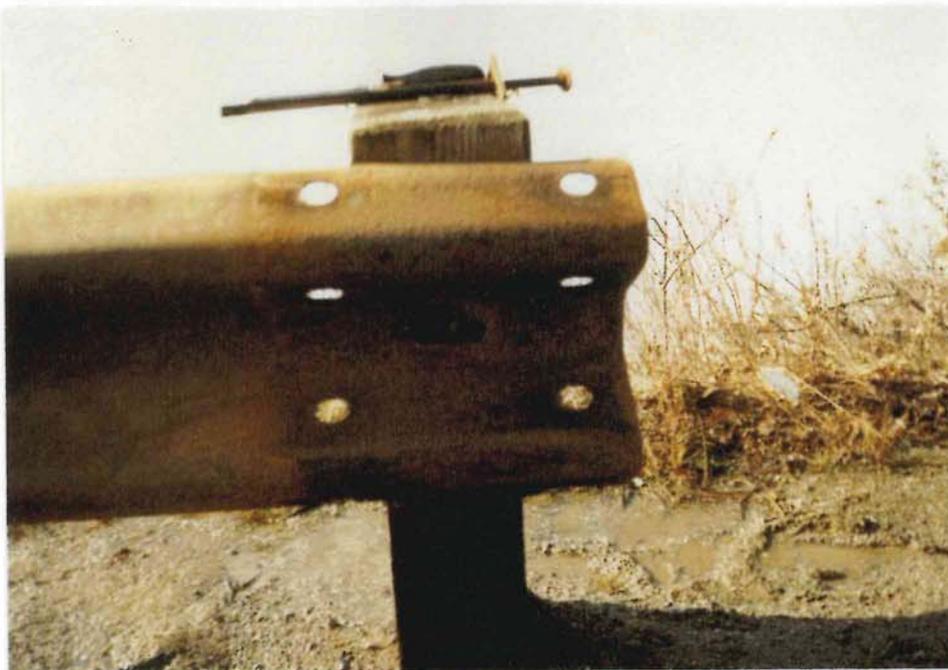
Photo No. 9  
Mt. Desert

This project was constructed in 1982 and is also located on Echo Lake. It is 1 1/2 miles from the above Mt. Desert project. This location has an extensive amount of A588 steel guardrail, but it is in better condition than the guardrail on the Mt. Desert project. Some flake spots and corrosion have started to appear in the overlap areas but wire brushing did not expose any black color. Photos No 9 and 10 clearly show the advanced deterioration that has occurred after only 8 years.
