Maine Department of  
Transportation  
**Transportation Research  
Division**

**Technical Report 99-11**  
*Innovative Solutions to Buried Portland  
Cement Concrete Roadways*  
*Final Report, March 2005*

## *Innovative Solutions to Buried Portland Cement Concrete Roadways*

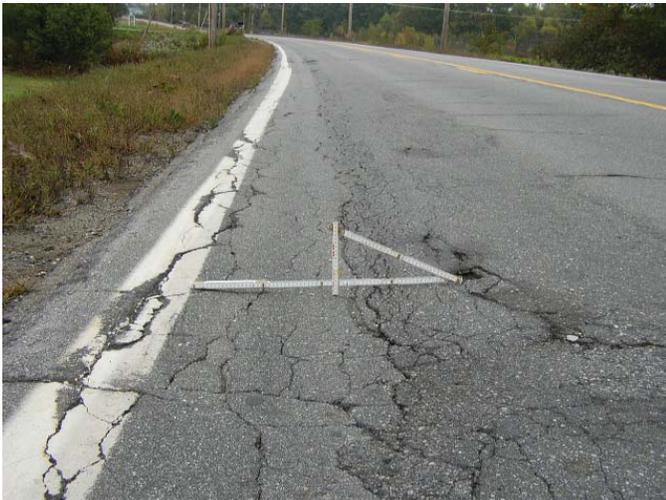
Photo 2. Control Section Cracking

PCC related cracking is evident throughout the entire section. Shoulder elevation has dropped 4 to 12 mm (0.2 to 0.5 in) below roadway elevation and greater than 13 mm (0.5 in) in a 50 meter (164 foot) section. Photo 2 illustrates load associated alligator cracking and rutting with missing HMA. Maintenance has patched a number of small areas of the shoulder to improve hazardous driving conditions.

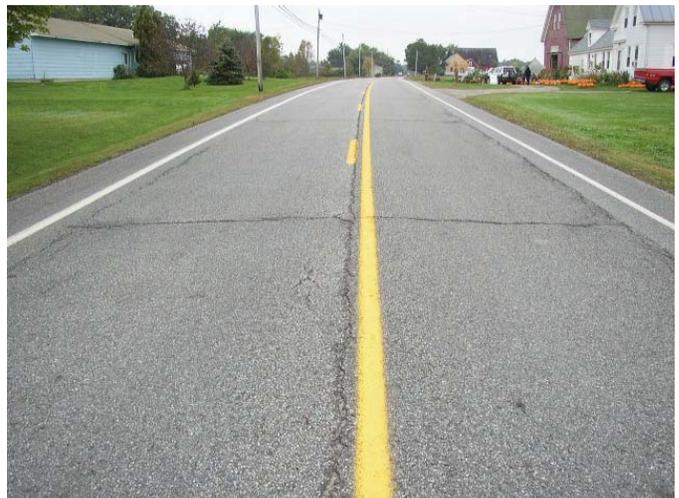
Photo 3. Section 1 Transverse Crack

majority of the cracks are PCC joints reflecting through the pavement. The shoulder treatment is preventing the cracks from migrating beyond the PCC edge as depicted in Photo 3. The number of transverse cracks between the wheel path has decreased from 13 to 8. A number of these cracks have extended across the roadway and are now full width transverse cracks.

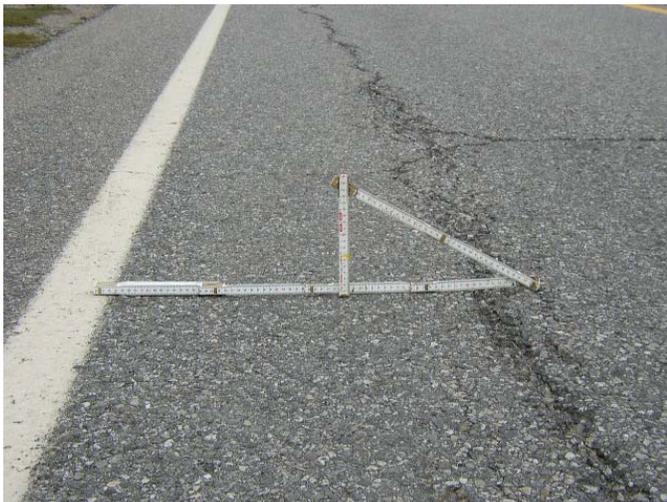
Photo 4. Section 1 Shoulder Settlement

PCC edge related longitudinal cracking has increased slightly from 71.2 to 79.9 percent. Initial load cracking was observed in a number of areas at the PCC edge. There is little elevation change between the roadway and shoulder in the north bound lane. The south bound shoulder has dropped between 6 and 13 mm (0.25 and 0.5 in) in a few small areas. Photo 4 displays the shoulder settlement. Section 1 has the second lowest amount of shoulder settlement of the experimental sections.

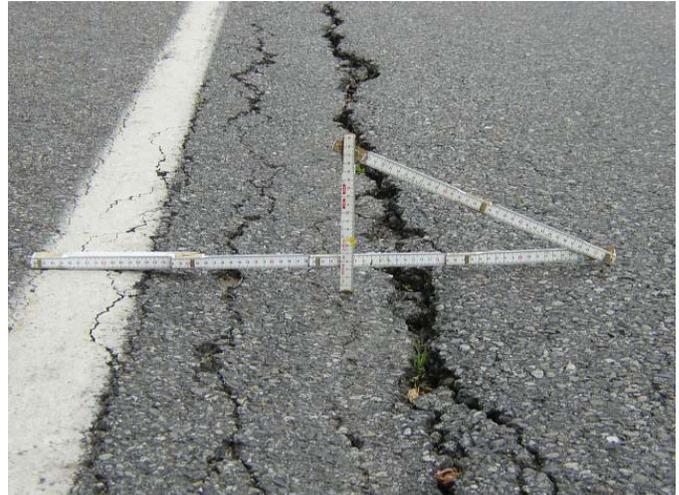
Photo 5. Section 2A PCC Edge Cracking

PCC edge cracking increased from 71.1 to 83 percent. The majority of which is in the south bound lane near the north end of the project.

Shoulder elevation change has dramatically increased in a 40 meter (131 foot) portion of the south bound lane at the north end of the section. The shoulder has dropped more than 24 mm (1 inch) with initial load cracking and missing HMA. Photo 5 reveals the extent of PCC edge cracking.

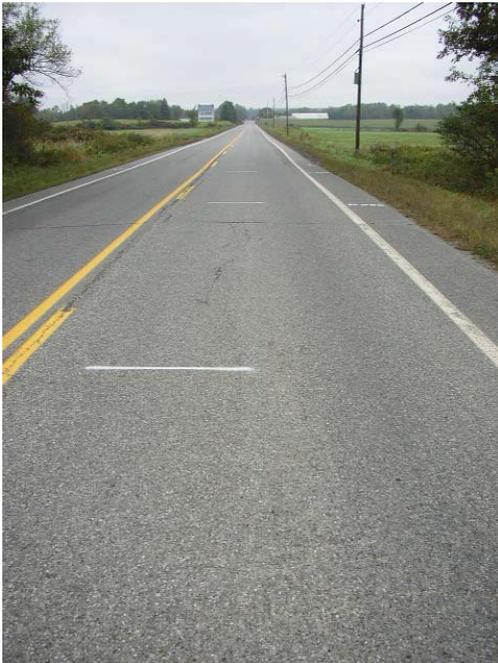
Photo 6. Section 2B

This section continues to outperform the remaining experimental sections.

Twenty percent of the PCC edge has reflected through the HMA with an elevation change of less than 6 mm (0.25 in). This is the lowest amount of PCC edge cracking of all sections. A view of the section is illustrated in Photo 6.

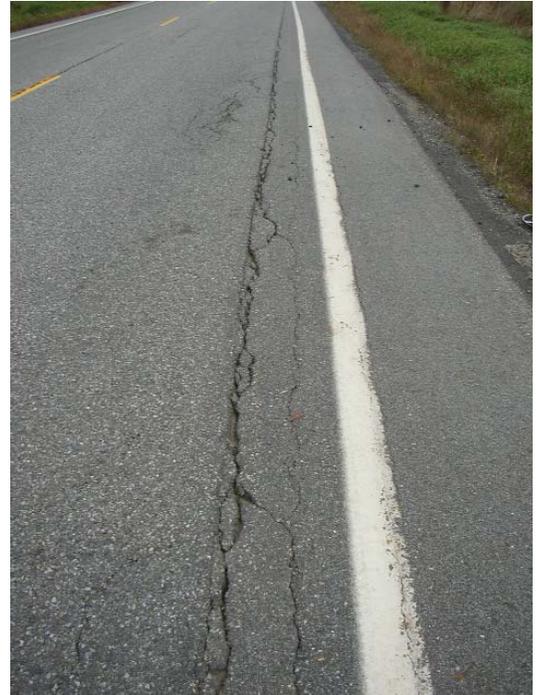
Photo 7. Section 3 HMA Construction Joint

The experimental shoulder on this section was surfaced differently than the other sections. Each lane of Section 1, 2A, 2B, and 4 from centerline to the shoulder edge, a width of 4.3 m (14 ft), was surfaced in one pass. Due to seasonal restrictions, each lane of Section 3 was surfaced to within  $\pm 150$  mm ( $\pm 6$  in) of the PCC edge prior to shoulder treatment. The shoulder was then constructed and surfaced leaving a longitudinal joint 2.9 m (9.5 ft) left and right of centerline. Photo 7 displays a typical construction joint.

Section 3 utilizing 230 mm (9 in) of Superpave is also reducing the amount of PCC edge cracking. This section has a longitudinal construction joint that parallels the PCC roadway edge making it difficult to evaluate. The construction joint was constructed poorly allowing the joint to ravel and crack. The outside edge of the PCC roadway is at an offset of 150 mm (6 in) from the construction joint. Longitudinal cracking observed outside the construction joint were considered PCC edge cracks as illustrated in Photo

7. Only 38.6 percent of PCC edge cracking was observed. This equates to 18.6 percent more than Section 2B and 41.3 percent less than Section 1, the next best treatment. Shoulder elevation changes are more prevalent especially the first 250 meters (820 feet) of the north lane beginning at the end of Section 2B. Shoulder construction began at this point and it appears the contractor made construction adjustments for the first 250 meters (820 feet) resulting in shoulder elevation differences.

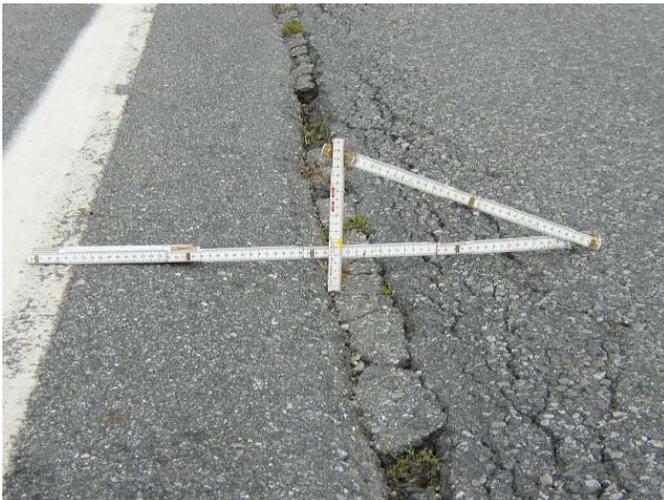
Photo 8. Section 3 Construction Joint

One hundred percent of the shoulder construction joint has separated with HMA missing in portions of the joint as illustrated in Photo 8.

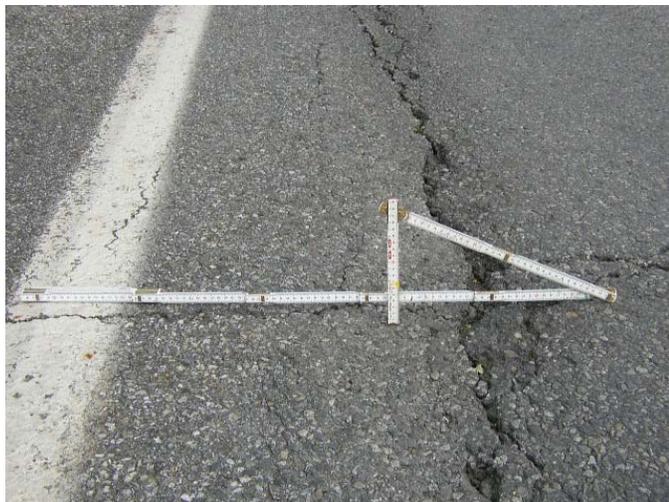
Photo 9. Section 4 PCC Reflected Edge Crack

PCC related edge cracking has increased from 68.6 to 86.6 percent. This is slightly less than the Control Section and slightly more than the experimental Sections 1 and 2A. Experimental Sections 2B and 3 continue to have significantly less PCC edge cracking.

Shoulder elevation remains even with the roadway in both lanes but HMA at the reflected PCC edge crack has settled resulting in increased rutting as can be observed in Photo 9.

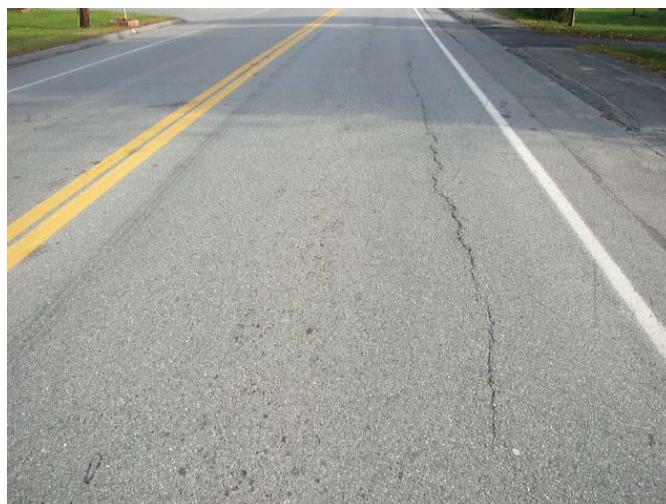
Photo 10. Self Adhesive Mesh PCC Edge Cracking

Cracking has increased from 16.8 to 29.6 percent which is 12.5 percent less than the Control section. A majority of the edge cracking is in the north bound lane. Photo 10 illustrates cracking in the north lane. Shoulder elevation has not changed and is still even with the roadway.

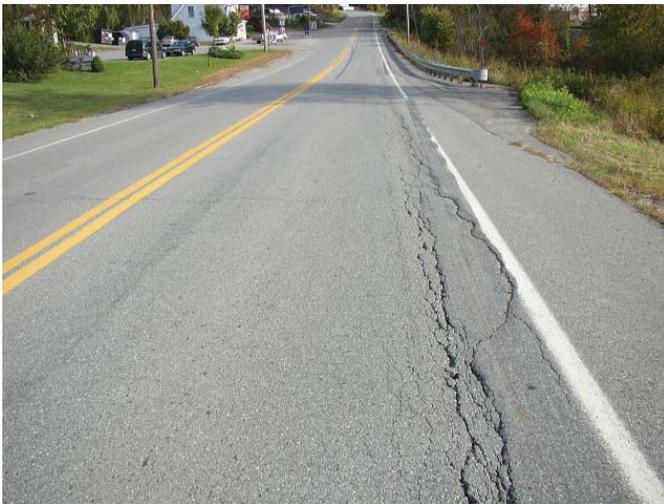
Photo 11. Control Section PCC Edge Cracking

PCC edge related cracking has increased from 36.8 to 42.1 percent. Shoulder elevations are 6 mm (0.25 in) below the roadway in this area with a small portion that is greater than 25 mm (1.0 in) below the roadway. The majority of cracking is in the north bound lane. Photo 11 and 12 illustrates PCC reflected cracking and elevation change.
