## **Repair of Earthquake-Damaged Bridge Columns with Interlocking Spirals and Fractured Bars**

**NUTC  
R298**

1. Report No. NUTC R298	2. Government Accession No.	3. Recipient's Catalog No.	
4. Title and Subtitle Repair of Earthquake-Damaged Bridge Columns with Interlocking Spirals and Fractured Bars		5. Report Date July 2014

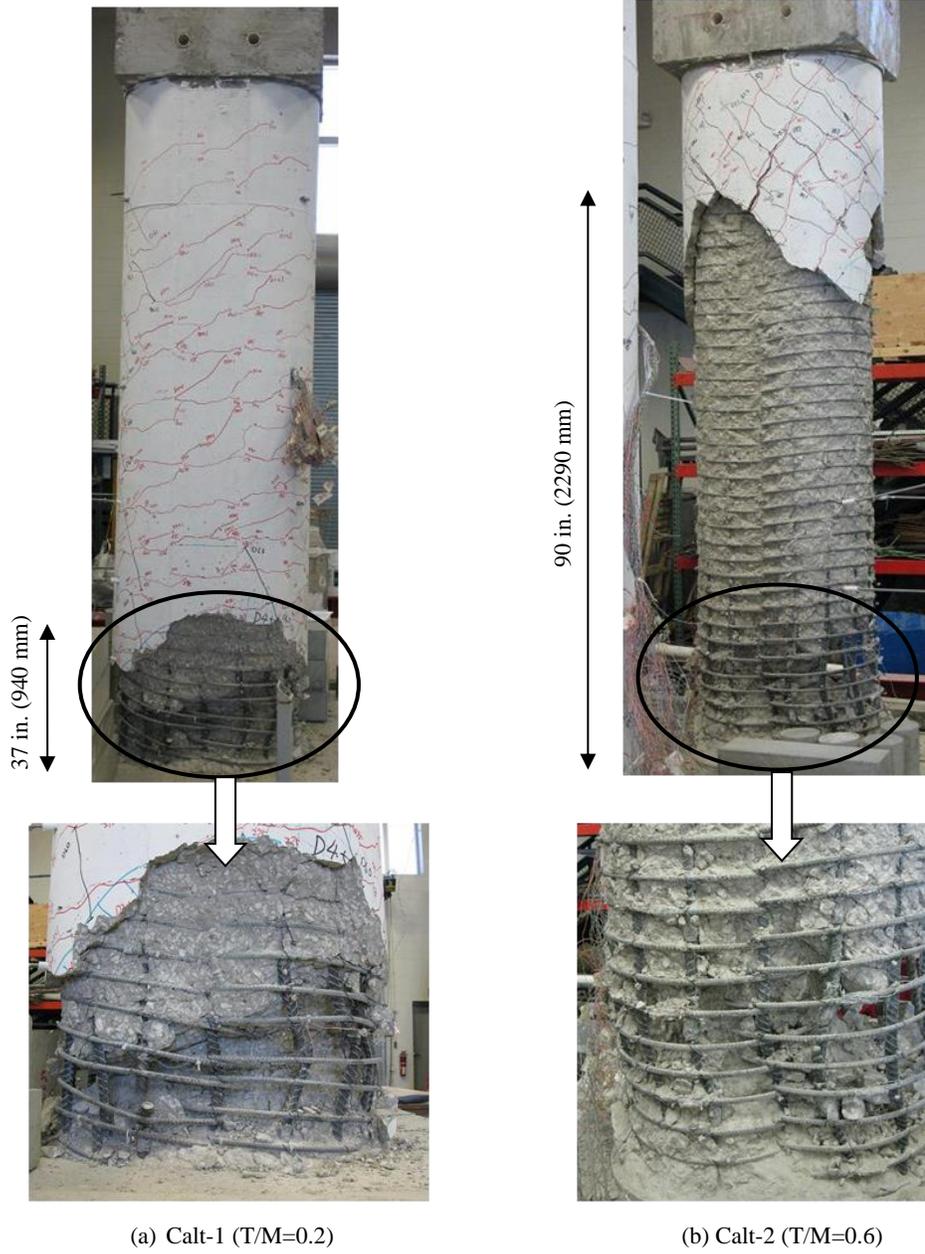
Figure 3-4 Visible Damage After Original Test to (a) Calt-1 and (b) Calt-2

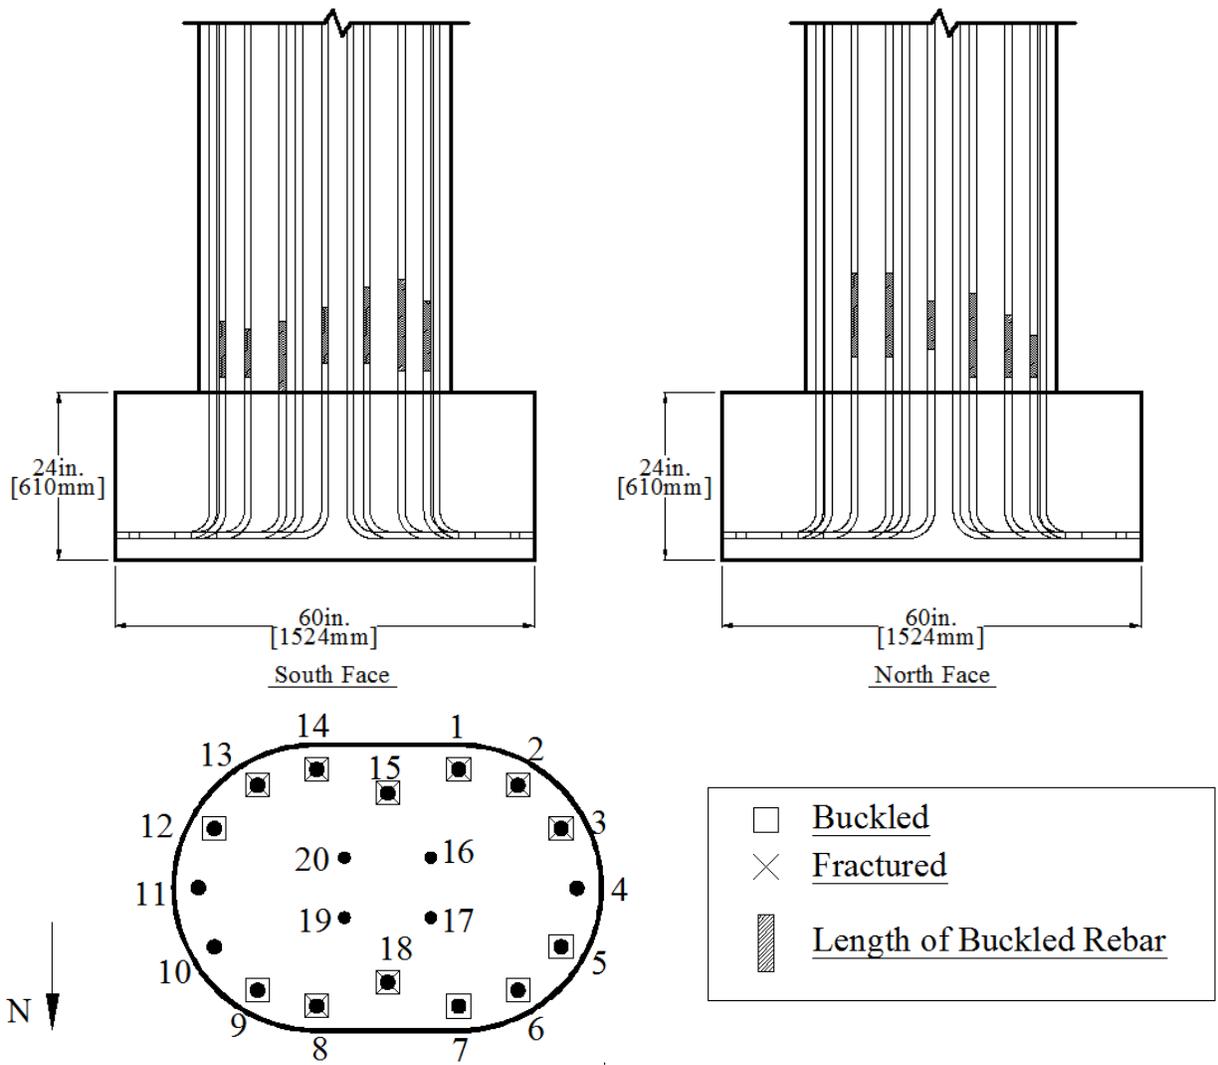
Bar Number	1	2	3	5	6	7	8	9	12	13	14	15	18
Fracture Location (in.)	5	2.5	4	-	-	-	11	-	-	10.5	9	6	7
Buckled Region (in.)	11~21	12~20	14~20	13~26	2~25	7~26	6~28	4~27	6~26	6~26	4~25	11~24	13~26

Figure 3-6 Visible Damage to Longitudinal Reinforcement of Calt-1 After Original Test

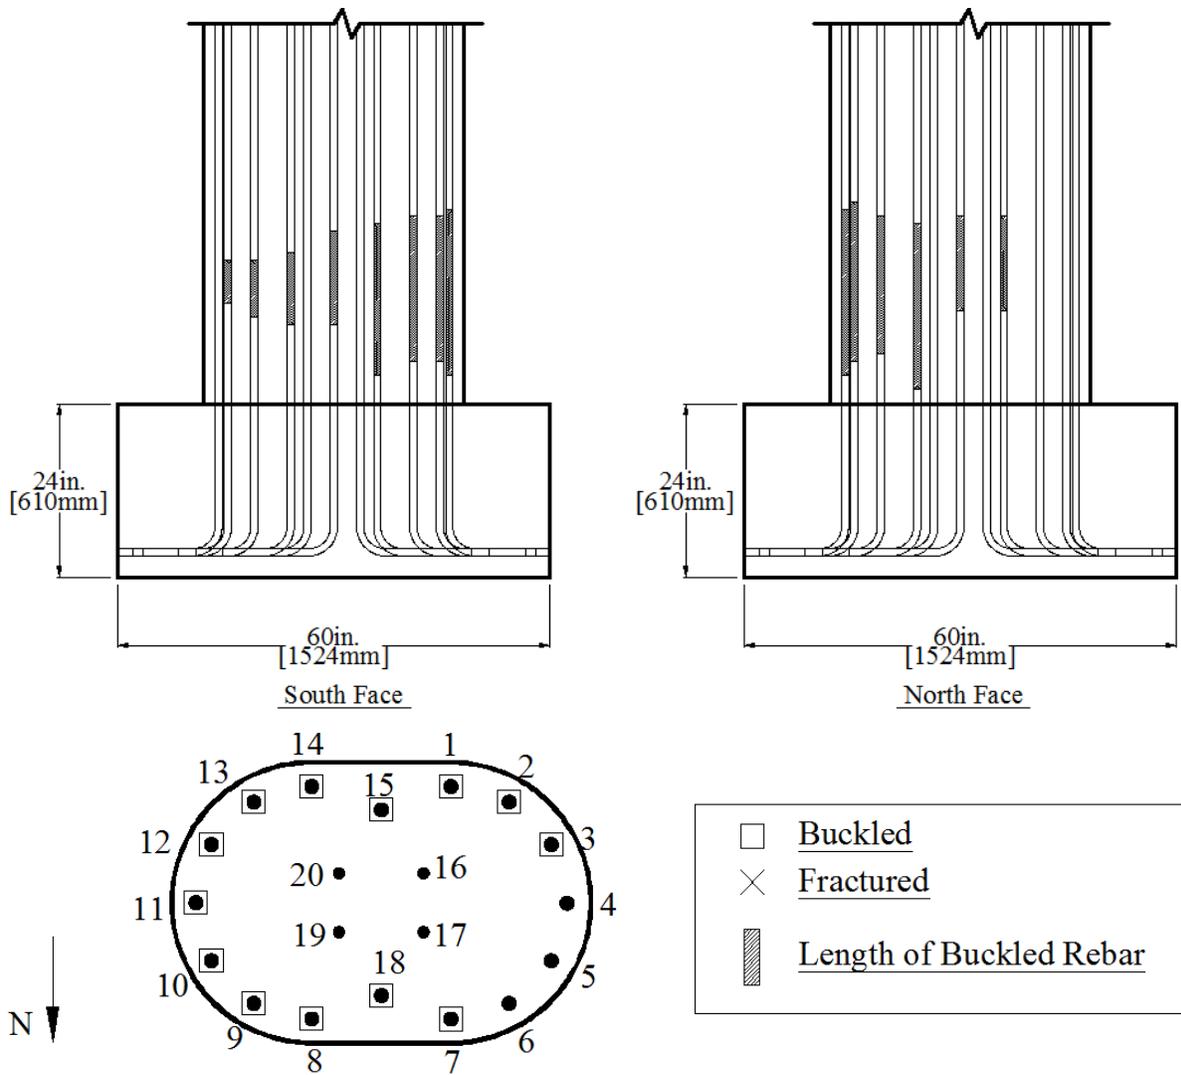
Bar Number	1	2	3	7	8	9	10	11	12	13	14	15	18
Fracture Location (in.)	-	-	-	-	-	-	-	-	-	-	-	-	-
Buckled Region (in.)	11~21	12~20	14~20	13~26	2~25	7~26	6~28	4~27	6~26	6~26	4~25	11~24	13~26

Figure 3-7 Visible Damage to Longitudinal Reinforcement of Calt-2 After Original Test

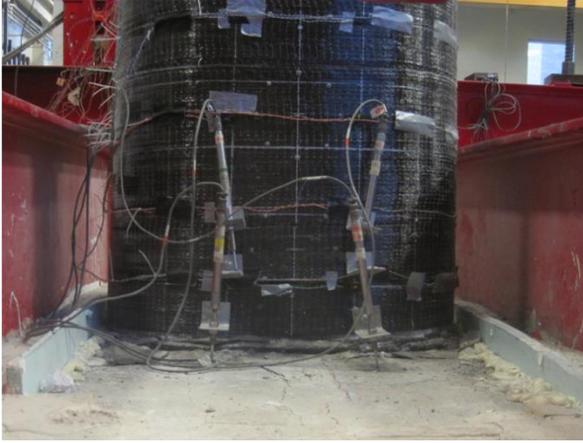
(a) Cracking of Footing on North Side at DC-6 (+)

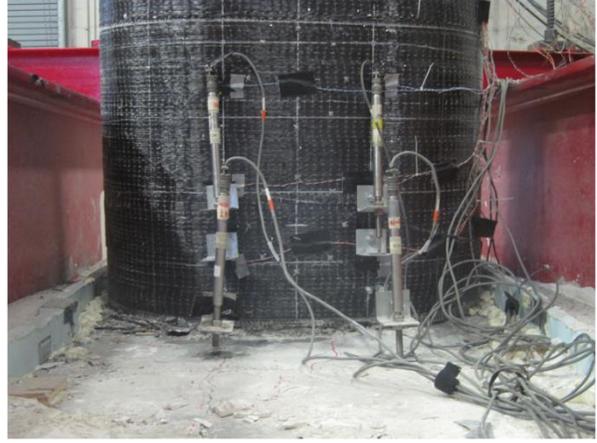
(b) Cracking of Base on North Side at DC-6 (-)

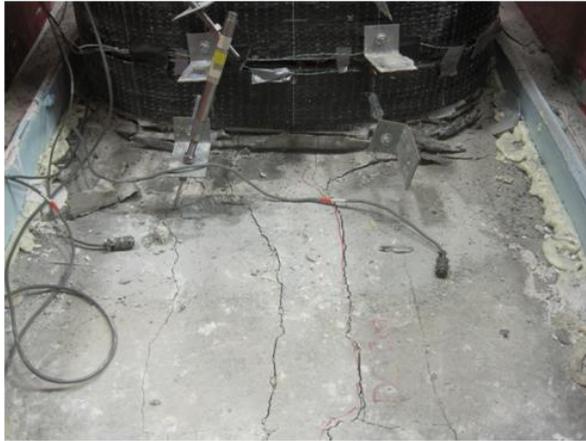
(c) Cracking of Footing on North Side at DC-7 (+)

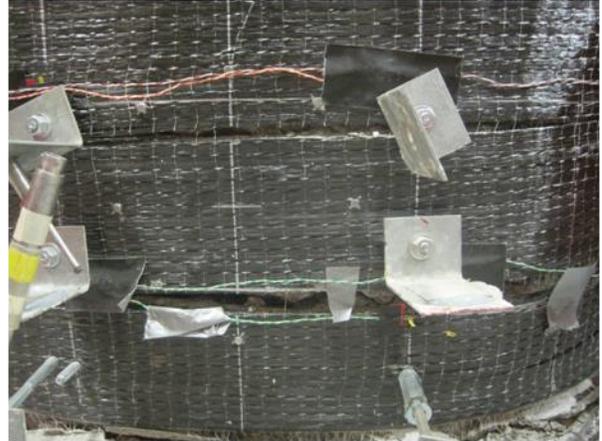
(d) Splitting of CFRP on North Side at DC-7 (+)

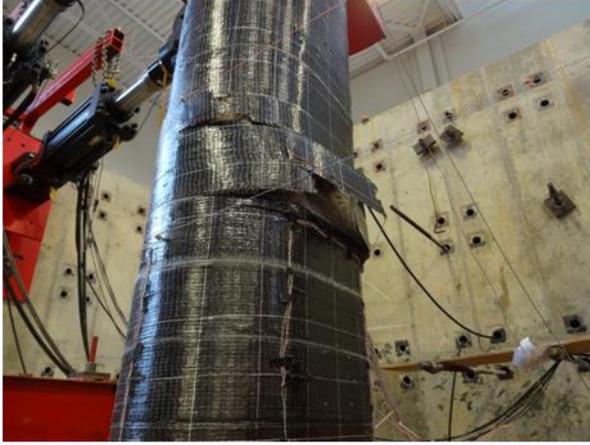
(a) Fracture of CFRP South Side at DC-3 (+)

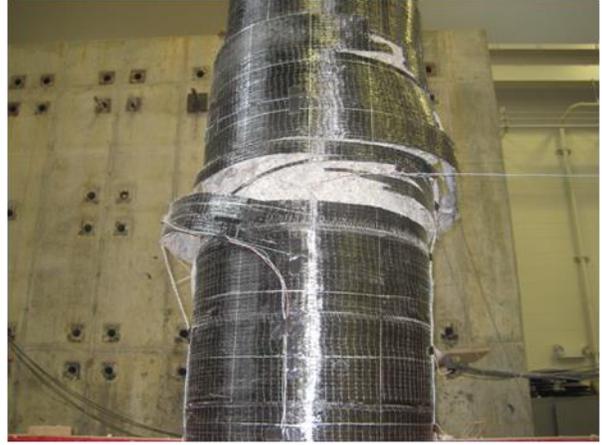
(b) Fracture of CFRP on West Side at DC-3 (-)

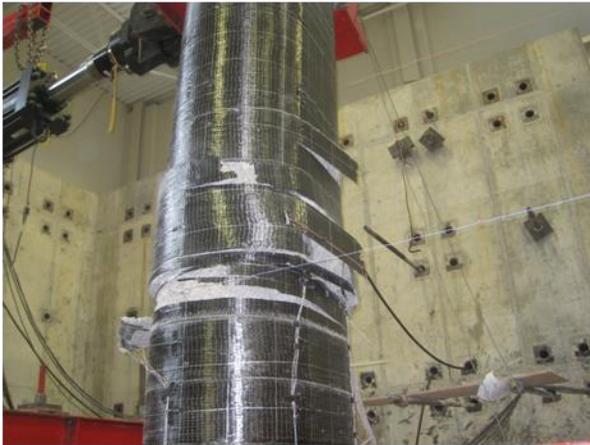
(c) Fracture of CFRP on South Side at DC-3.5 (+)

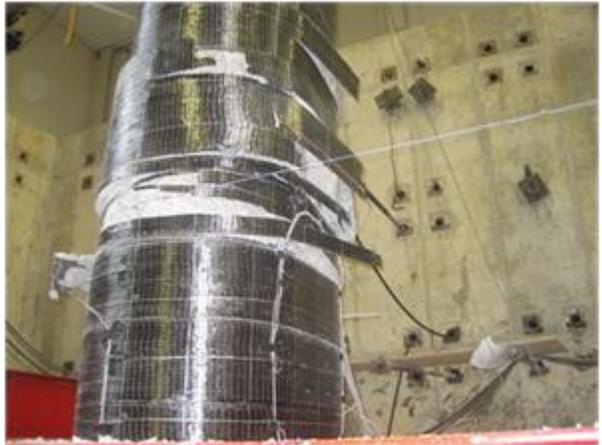
(d) Fracture of CFRP on South Side at DC-4 (+)

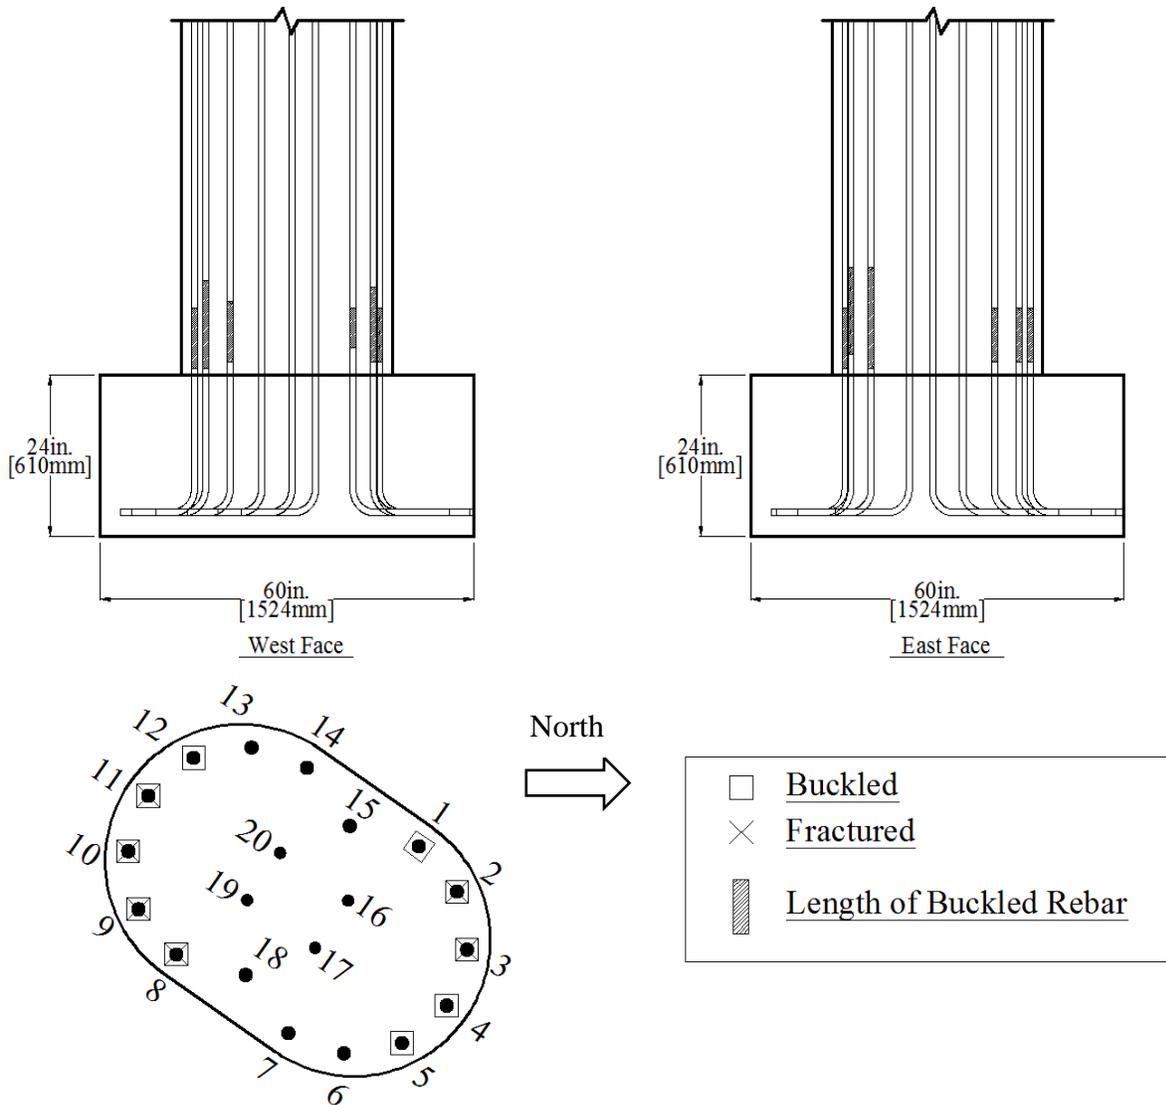
Bar Number	1	2	3	4	5	8	9	10	11	12
Fracture Location (in.)	-	4	3	-	-	3	2	5	2	-
Buckled Region (in.)	4~10	2~13	2~10	2~10	2~10	1~16	3~16	1~10	1~14	2~11

Figure 5-4 Visible Damage to Longitudinal Reinforcement of Calt-3 after Original Test

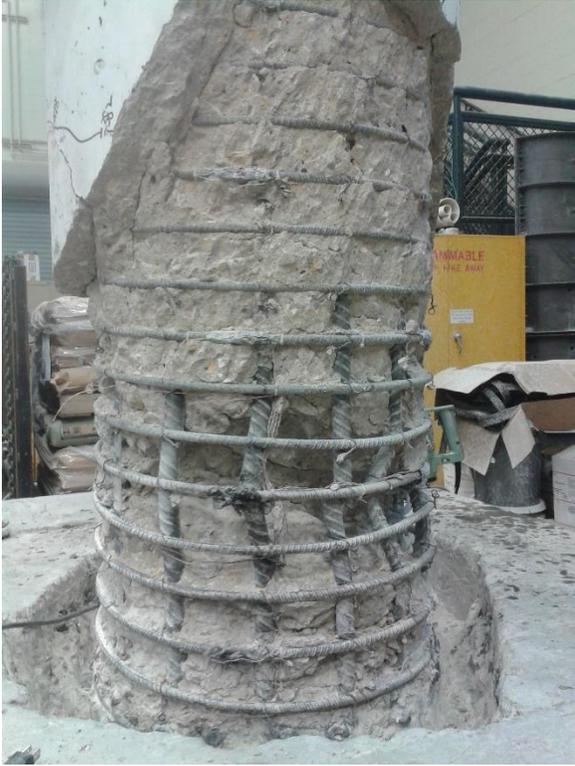
(a) Concrete damage after trenching

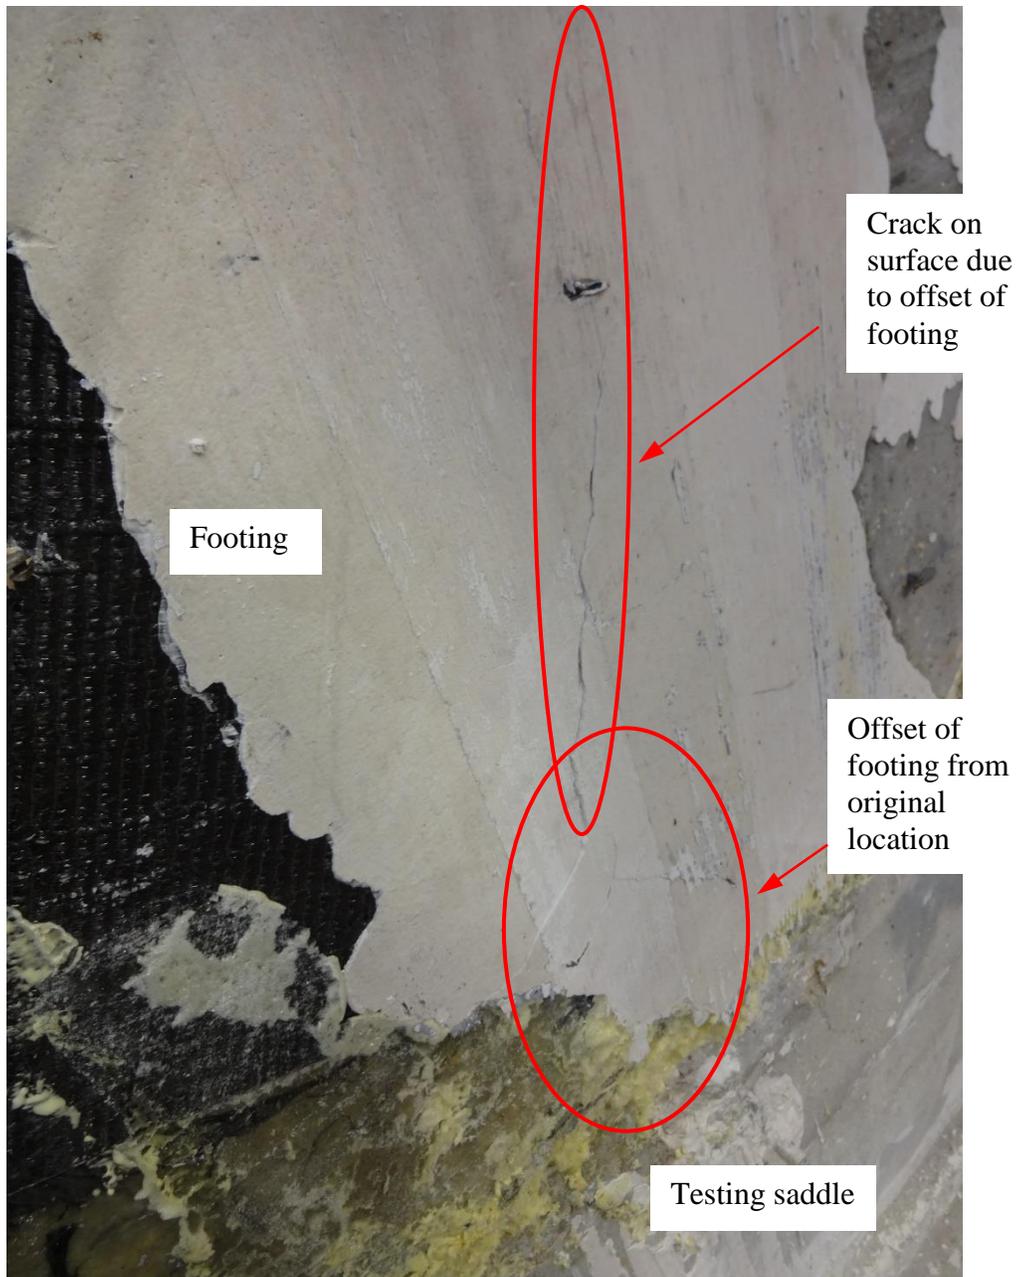
Figure 6-2 Offset of R-Calt-3 Footing Observed at Drift Ratio of 1%

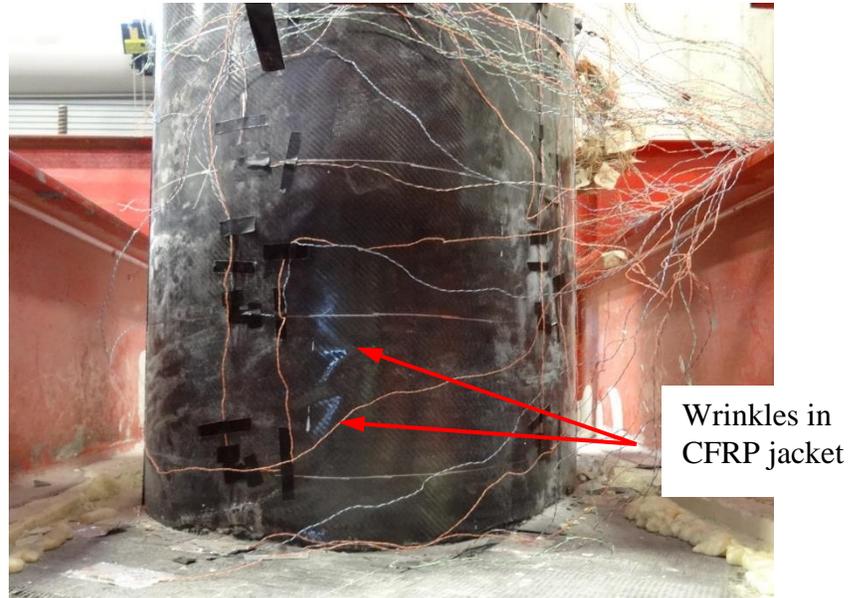
(a) Wrinkles in CFRP jacket on column compression side

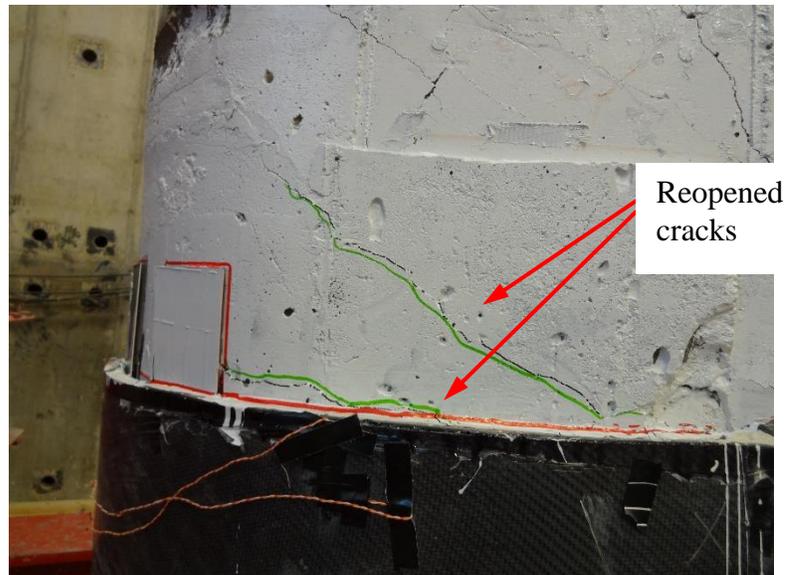
(b) Reopening of cracks on west side

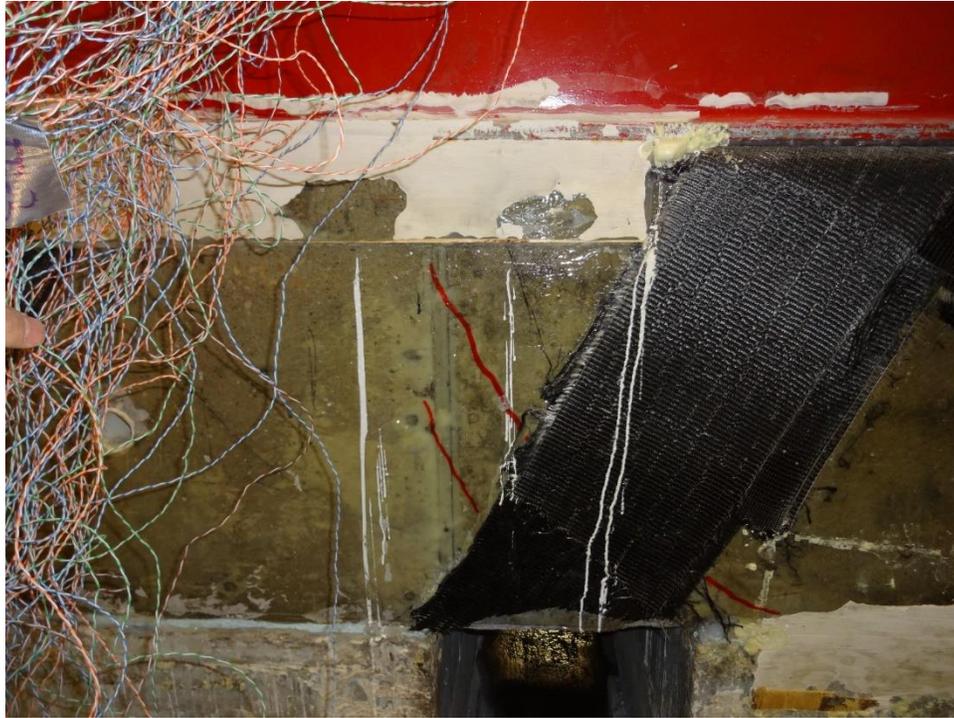
(a) East side

Figure 6-4 Cracking in R-Calt-3 Footing at Drift Ratio of 3%

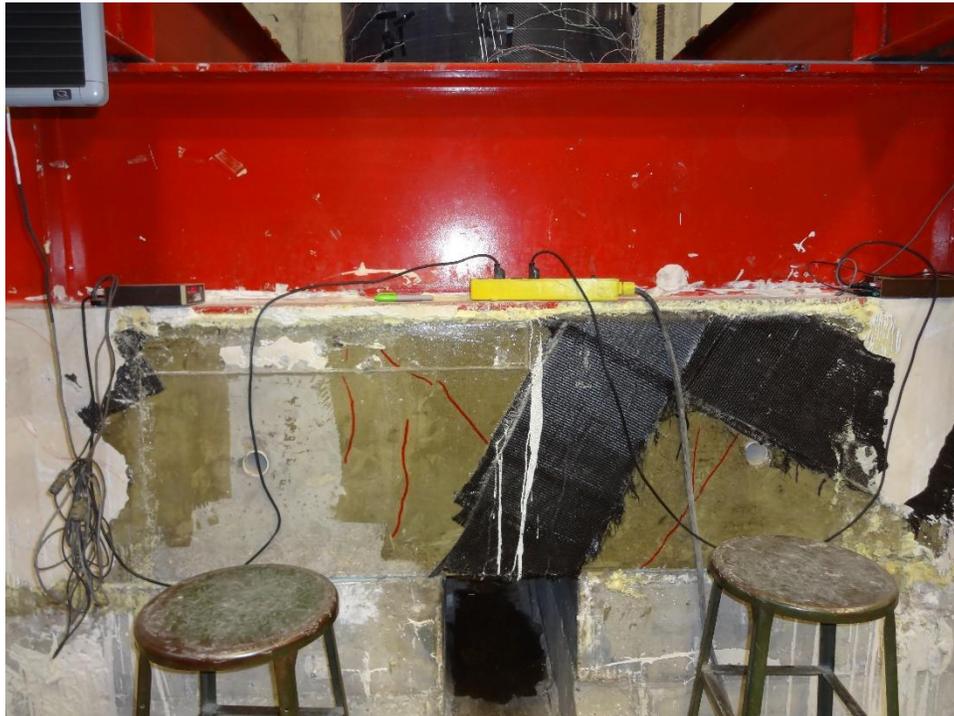
(b) West side

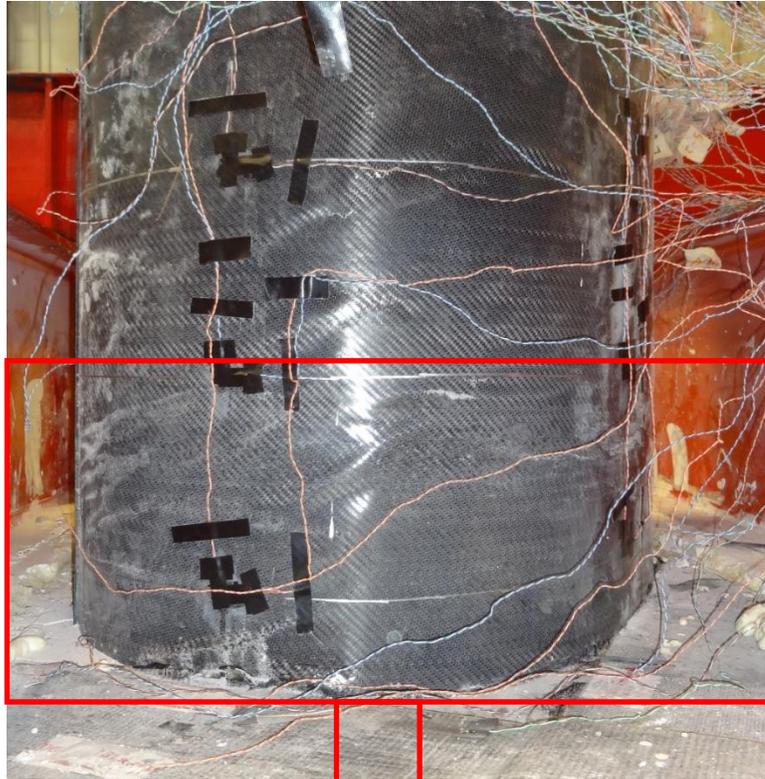
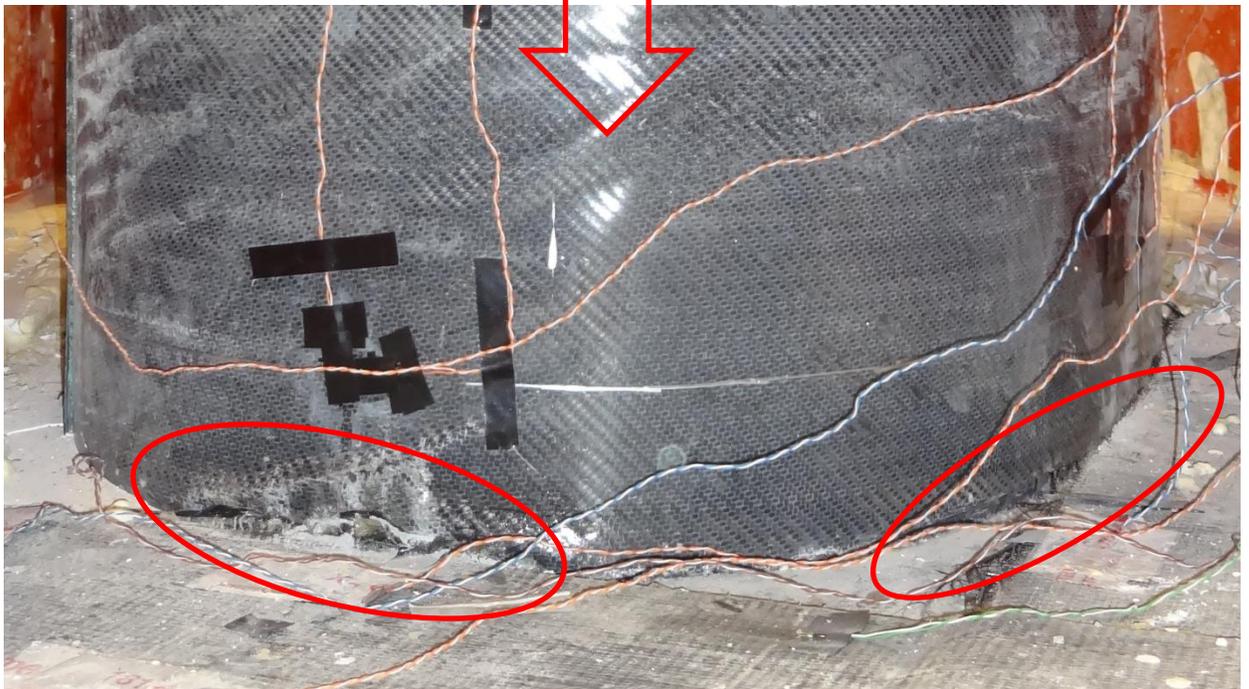
Figure 6-5 CFRP Rupture on Column Compression Side at Drift Ratio of 3% (R-Calt-3)

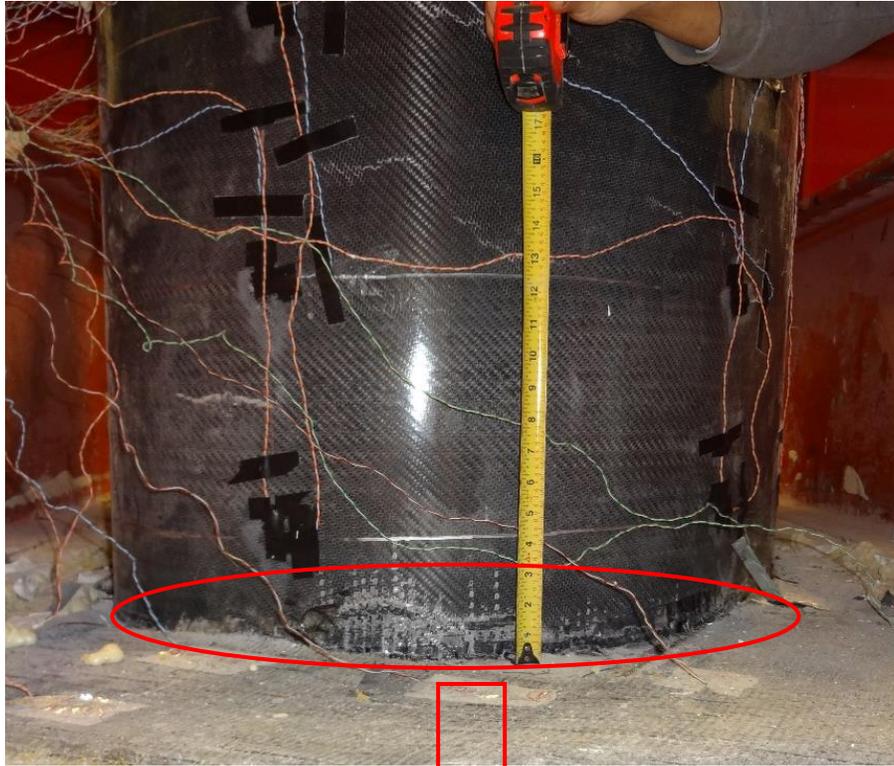
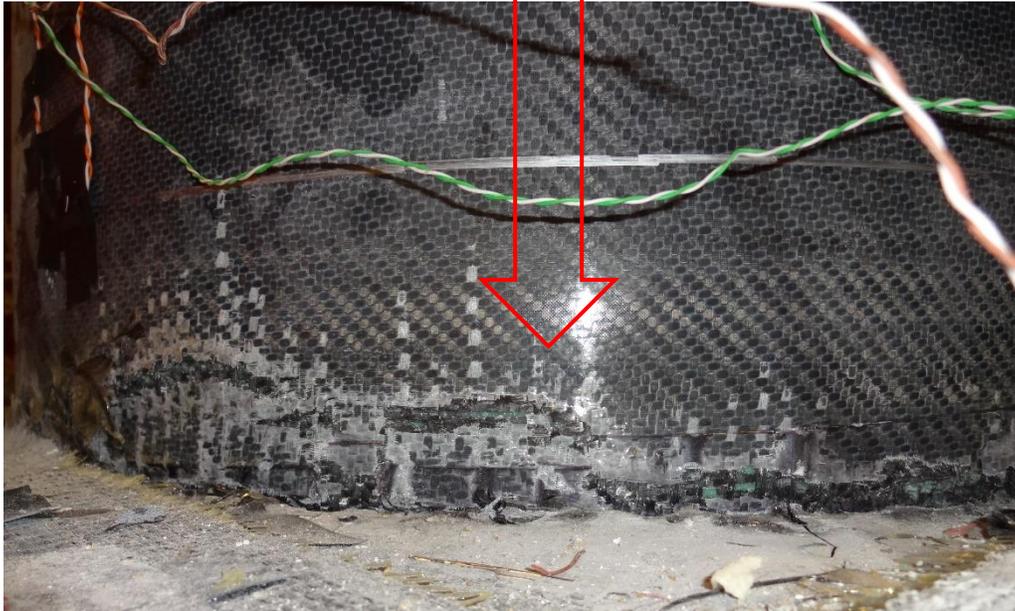
Figure 6-6 CFRP Rupture on Column Tension Side at Drift Ratio of 3% (R-Calt-3)

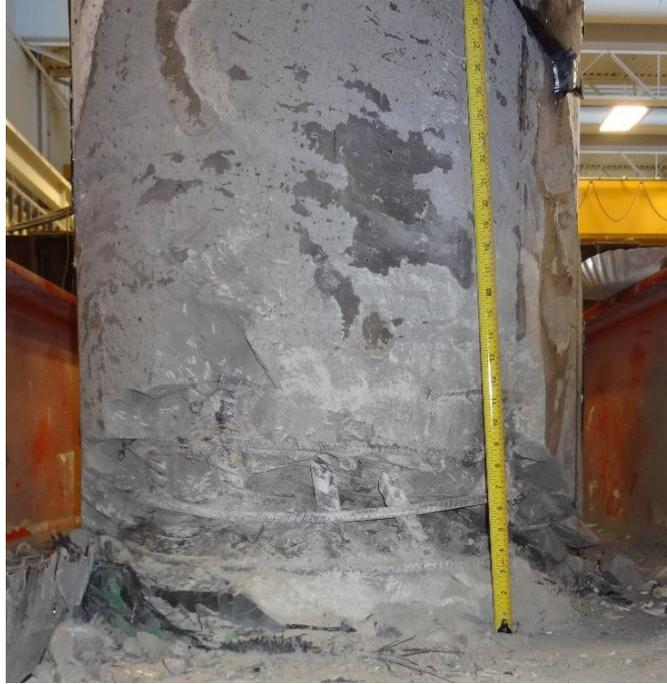
(a) North side

Figure 6-7 Damage to Concrete of R-Calt-3

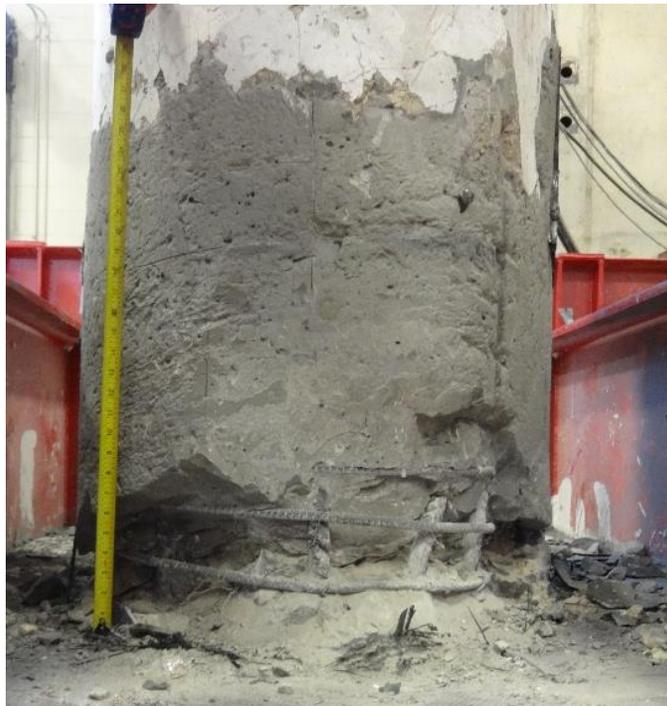
(b) South side

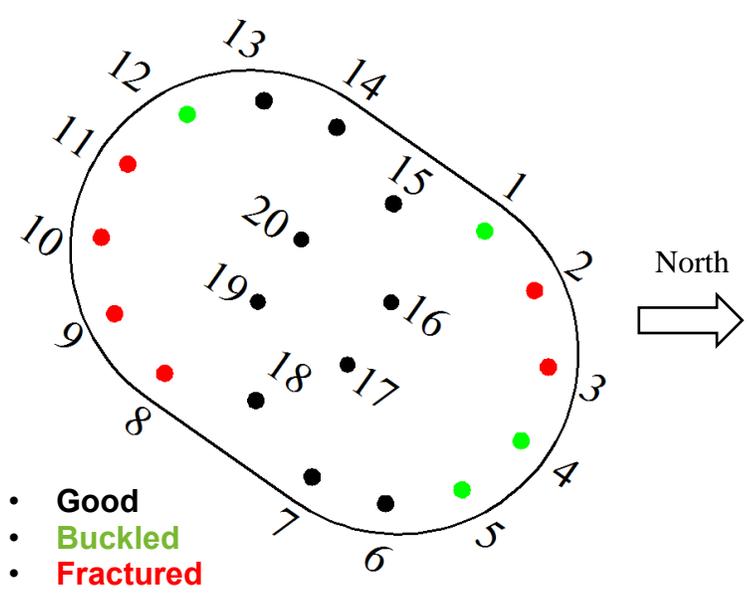
(a) Rebar damage to Calt-3

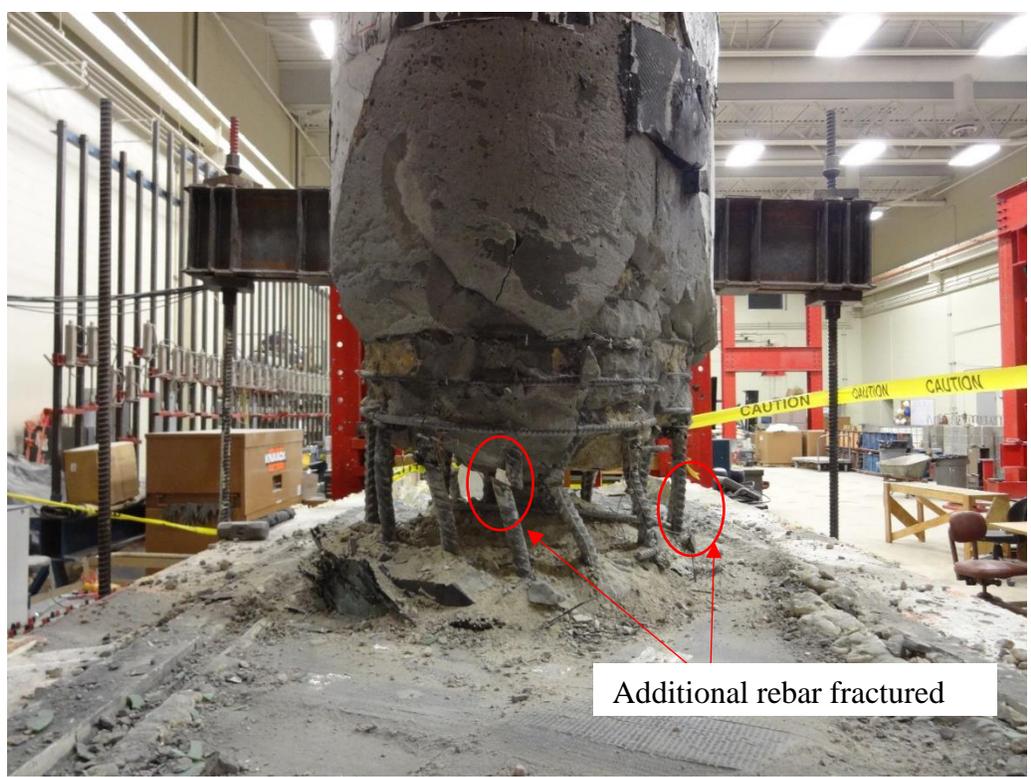
(b) Rebar damage to R-Calt-3 (North Side)

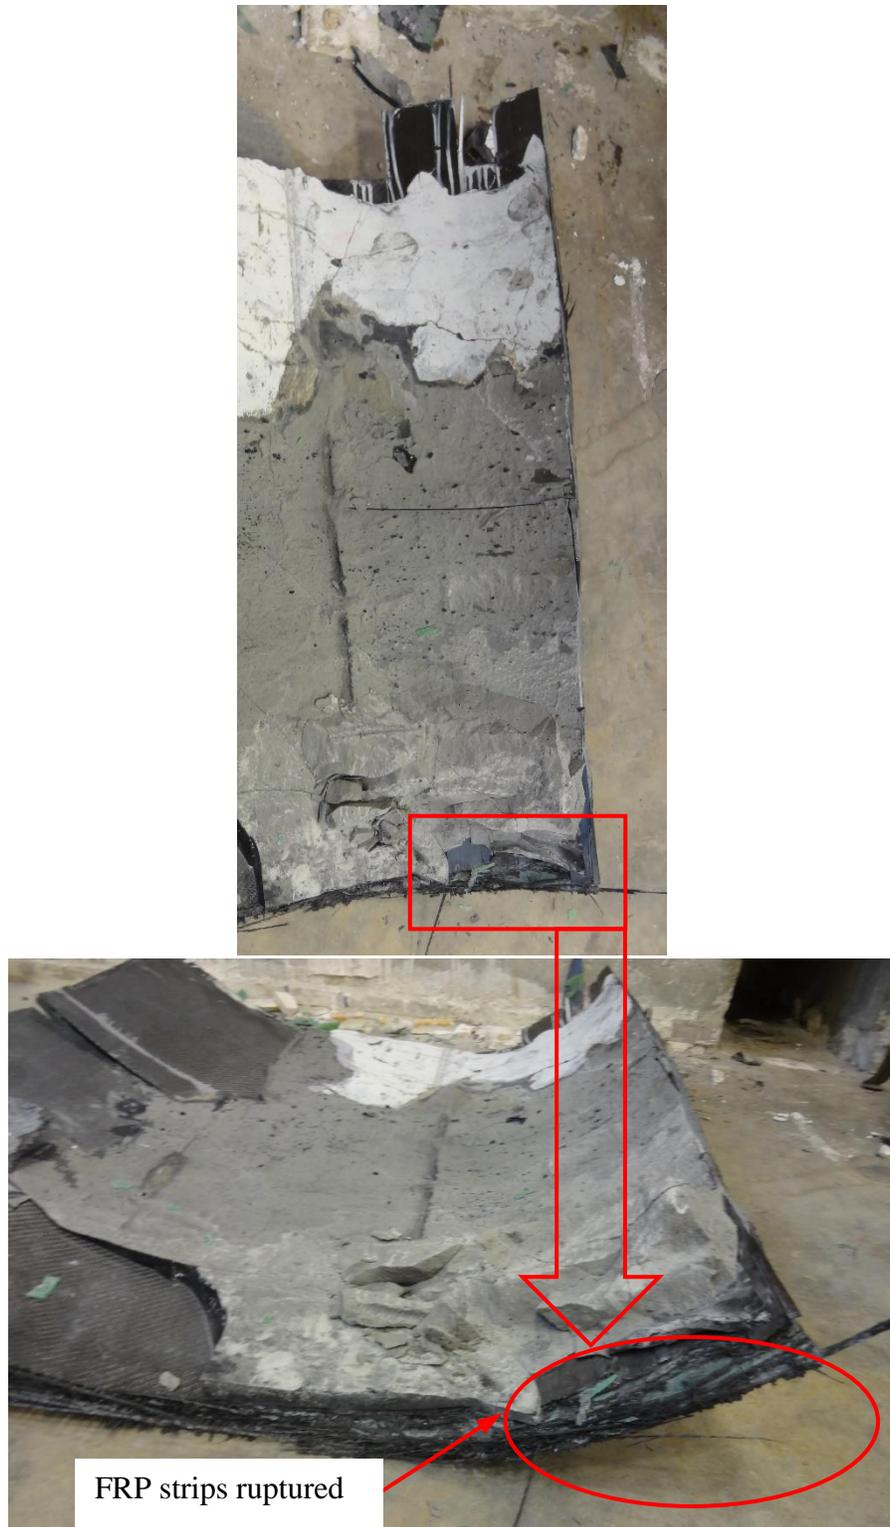
Figure 6-9 Rupture of CFRP Strips of R-Calt-3
