STRUCTURAL PERFORMANCE OF ULTRA-THIN WHITETOPPING ON ILLINOIS ROADWAYS AND PARKING LOTS

Research Report No. FHWA-ICT-14-018

A report of the findings of
ICT-R27-61
**Mechanistic-Empirical Design Implementation and Monitoring for Rigid
Pavements**

August 2014

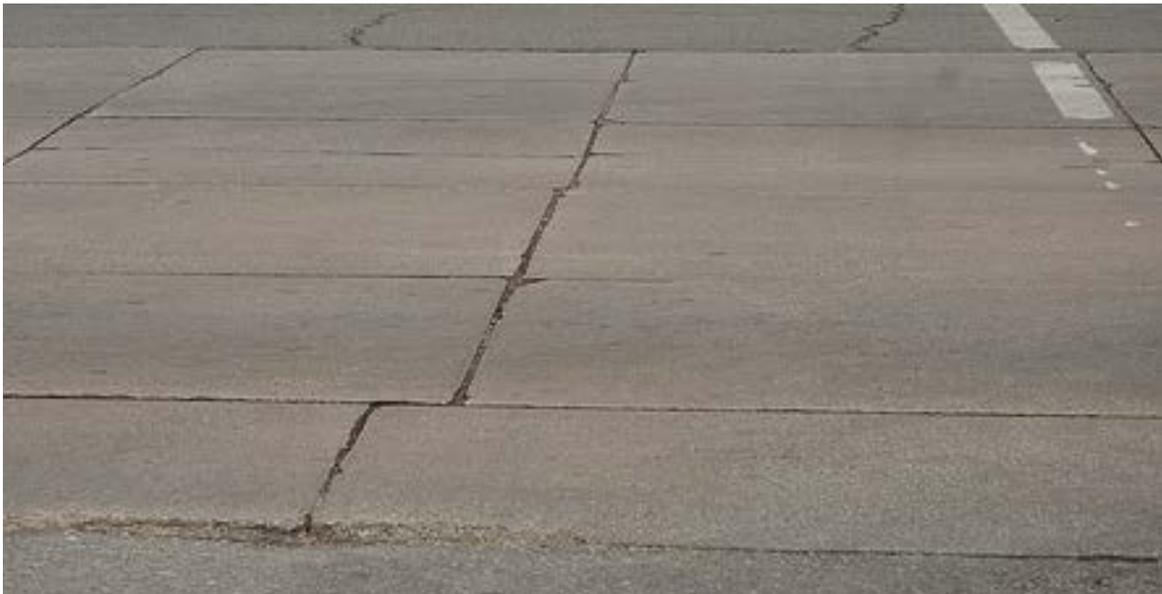
Figure 2.4. Slab migration (June 2012).

There were also three to five instances of partial slab blow-ups in panels caused by slab migration toward the intersection going eastbound. The inside five rows of slabs had migrated into the intersection from 1 inch to as much as 6 inches at the end of that section, where it transitions to asphalt, as seen in Figure 2.4. As hypothesized by Winkelman (2005), the slab migration is likely caused by vehicles stopping or slowing as they approach the intersection, thus “shoving” the UTW surface eastward. Faulting was observed in the transverse and longitudinal joints for a significant number of slabs, visible in Figure 2.5.

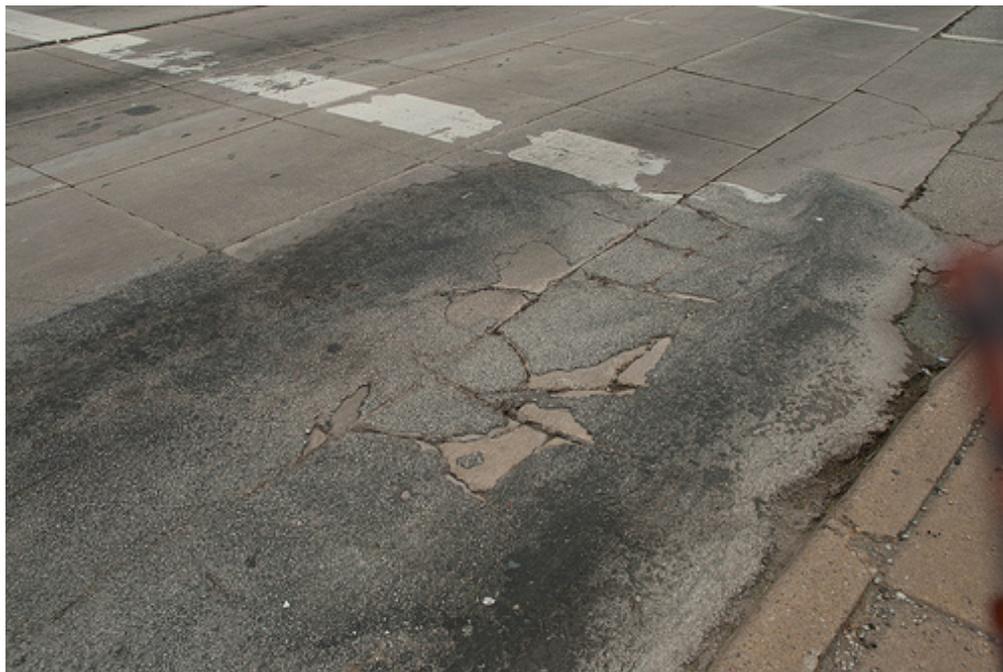
Figure 2.6. Asphalt patching (June 2012).

Five slabs had been patched with asphalt, as seen in Figure 2.6. Also, the outermost panels in a small section in the intersection were missing. It was not clear from the original construction notes whether the project was built this way or whether the panels had been removed or patched at some point.

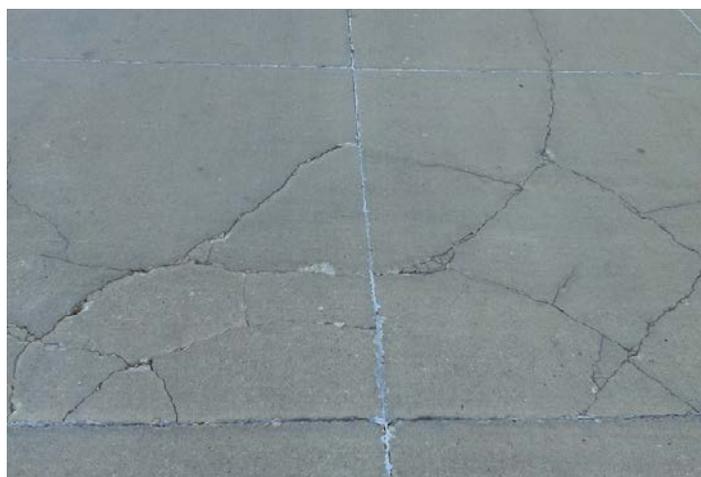
Figure 2.9. Distresses near the entrance to the Talbot lot (August 2013).

The lot was in good condition overall in 2012, especially considering its age. Although 22% of panels were cracked, as noted in Table 2.6, the majority of the distresses appeared to be the result of use of the lot as a staging area for heavy vehicles and equipment during renovation projects on Talbot Lab rather than repeated loading from parking lot traffic. Cracks were most prevalent near the entrance to the lot, as seen in Figure 2.9, but none exceeded medium severity. Spalling of cracks and joints was minimal, and there was no faulting. The pavement was still in good serviceable condition.

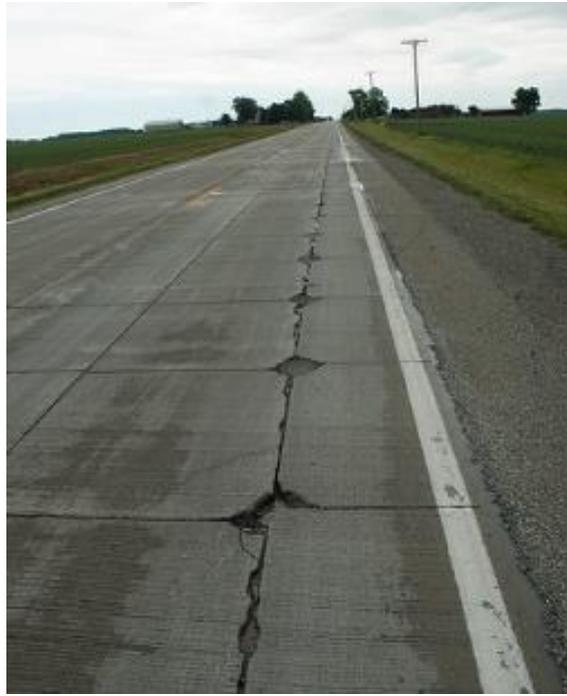
Figure 2.14. Corner cracking along a longitudinal joint (June 2012).

Although corner cracking was the most prevalent distress, other types of cracking and shattered slabs were frequent as well, especially at the ends of the project. Faulting was a major issue throughout the entire section, contributing to a very rough ride. Additionally, panels in the eastbound and westbound lanes were migrating in opposite directions, as seen in Figure 2.15. In this case, the migration may have been due to thermal movements. As with the Decatur project, application of macro-fibers would likely have helped slow the faulting and slab migration.

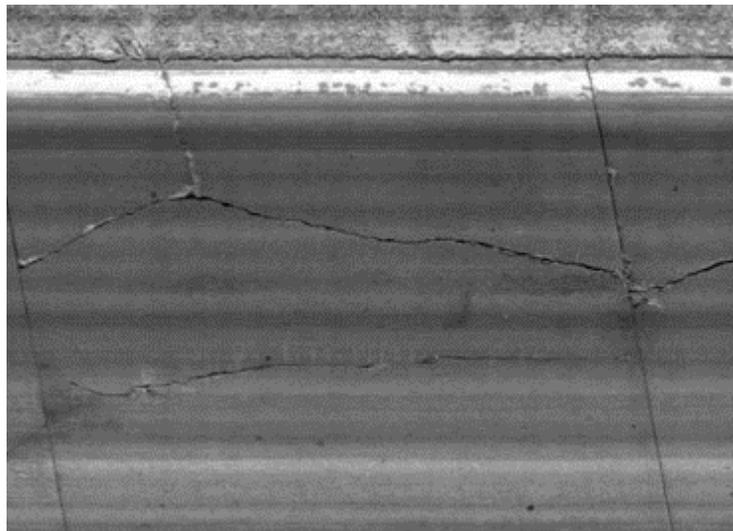
Figure 2.18. Longitudinal cracking in the middle of the 11 foot panels (ERI 2012).

An informal survey was performed in June 2012 because of adverse traffic and weather conditions. From this survey, it was obvious that there was severe faulting and a high number of cracked panels, especially in the 11 foot section. Longitudinal cracking down the middle of the 11 foot slabs and at the edges of the pavement was particularly noticeable, which can be seen in Figure 2.18.

A complete report on the pavement condition of County Highway 4 was completed by ERI Inc. in September 2012. The report indicated that longitudinal cracking, corner breaks, cracking near the edge of the pavement, and shattered slabs were the primary distresses found in the project. Only 1.36% of all panels in the 5.5 foot section were cracked, compared with 17.8% of the 11 foot panels, with as many as 58% of the panels cracked in portions of the 11 foot section (ERI 2012). This part of County Highway 4 is being prepared for rehabilitation in the next few years.

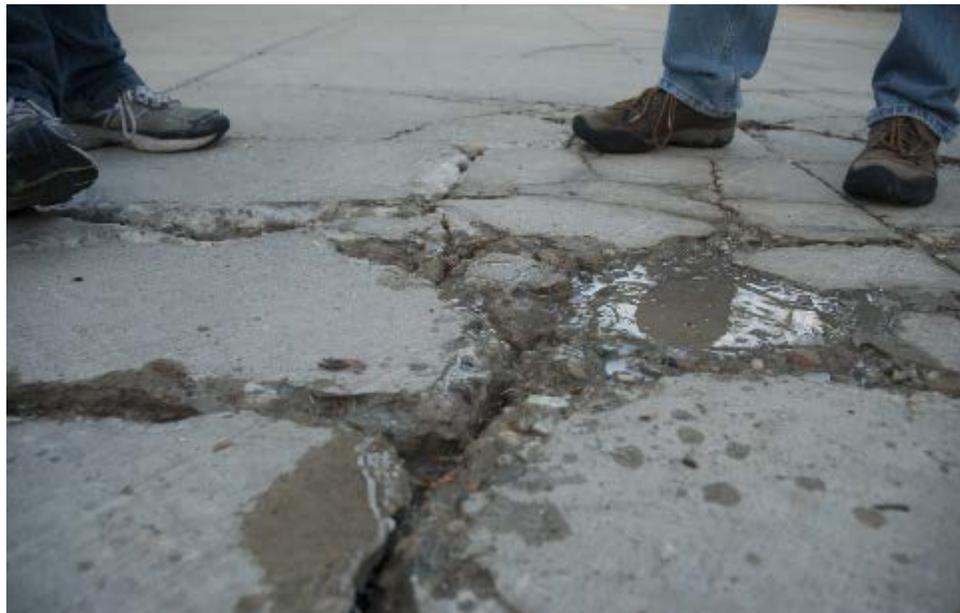
Figure 2.30. Shattered slab near the front entrance (August 2012).

Project performance varied greatly across the lot. Most of the lot featured concrete between 4 and 6 inches thick over either stone or a 6 inch asphalt layer and was in good serviceable condition. However, some areas of the lot performed very poorly. There were severe cracks of all types and shattered slabs at the front entrance to the lot, which were likely due to the inadequate slab thickness (2 to 3 inches). There was also a cold milling mistake in this section where the HMA layer had been milled down to about 2.5 inches (it was intended to be 6 inches). These concrete distresses were accompanied by faulting, spalled cracks, and debonding. A shattered slab from this area of the lot is pictured in Figure 2.30.

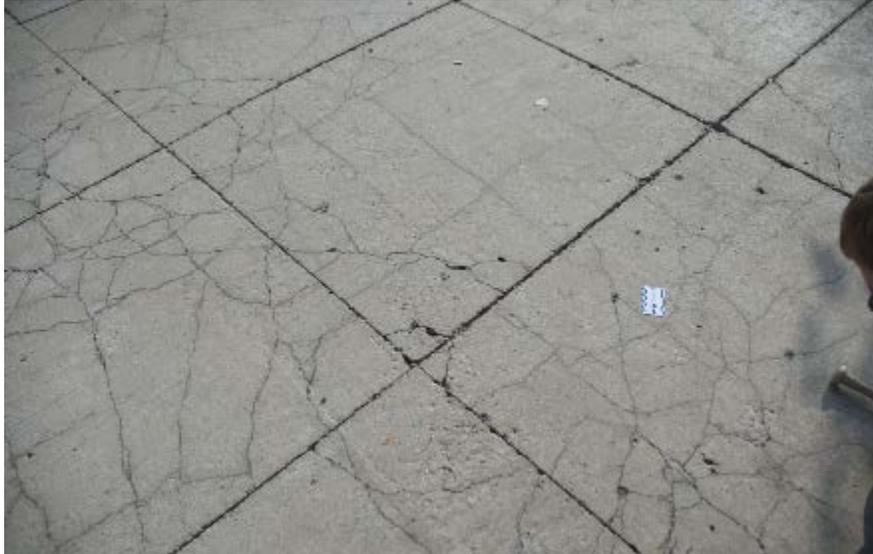
Figure 2.31. Less severe cracking near a different lot entrance (August 2012).

There were also distresses at the other entrances to the lot, as shown in Figure 2.31, but the cracks and joints held together much better than in the thinner-pavement area, and there were fewer instances of debonding. This improved performance may indicate that a higher-than-normal macro-fiber dosage was used in these areas or could be attributed to a sufficiently thick overlay and a good base. The area featured in Figure 2.31, with low-severity distresses, did not appear to contain macro-fibers.

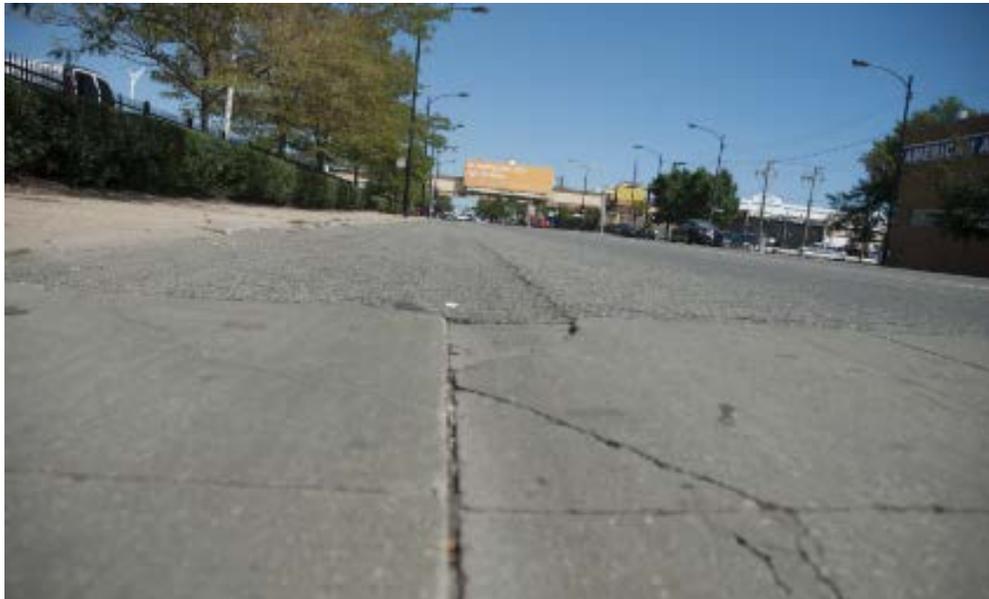
Figure 2.34. Joint opening and faulting at Western and Washington (August 2012).

Certain observations unique to particular stops included faulting in a longitudinal joint at the beginning of the Washington stop that may have resulted from a distress in the adjacent asphalt, pictured in Figure 2.34; joint opening and faulting near a patch at a manhole at the Hubbard stop, pictured in Figure 2.35; and some minor slab migration on the approach panels of the Warren stop. The pad with the highest percentage of cracked panels, at Washington, was noted to have had the toughest construction conditions. Also at this bus stop, a geotextile had been placed between the concrete and base layers toward the beginning of the pad but had not led to any observable distresses.

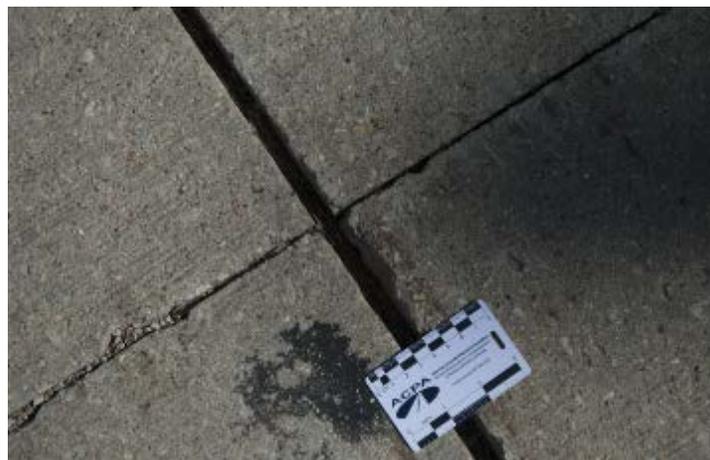
Figure 2.41. Longitudinal joint opening and spalling (August 2012).

The joint opening and rotation could be due to several factors. One possibility was loss of shoulder or edge support. Another possible cause was truck traffic—this joint was in the “loaded” lane, traveled by the trucks after leaving the quarry with a full load. Over the remainder of the project, the ride was very smooth.

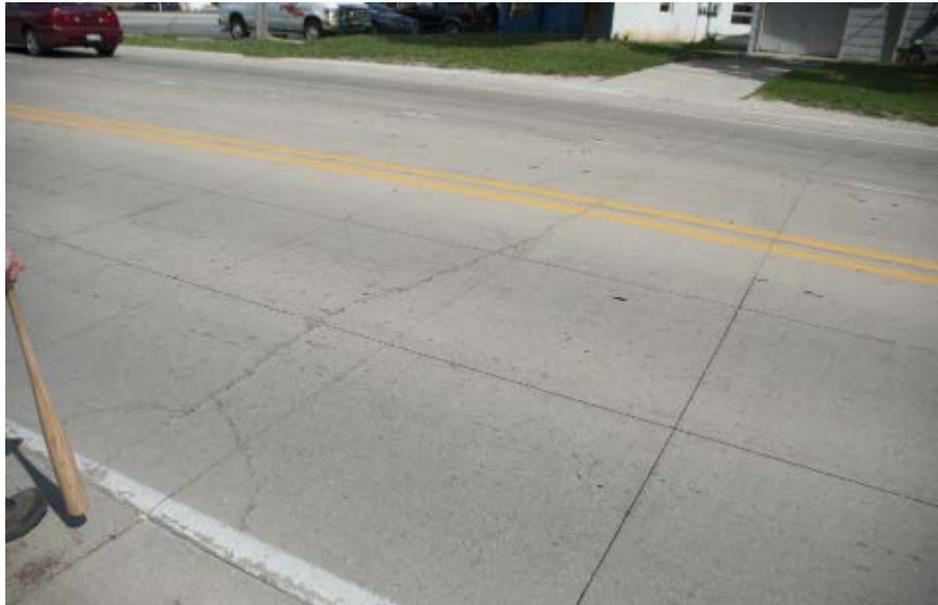
Figure 2.48. Transverse and corner cracking at widened pavement section (August 2012).

Schank Avenue was more stable toward the centerline of the pavement but was still prone to some of the same issues. The longitudinal joint in the centerline in the section on the embankment also opened up, resulting in spalling, debonding, slab migration, and some faulting as well. Corner and transverse cracking were located primarily in the wide areas of the pavement near the intersections, as shown in Figure 2.48. Debonding was also detected in the widened sections.

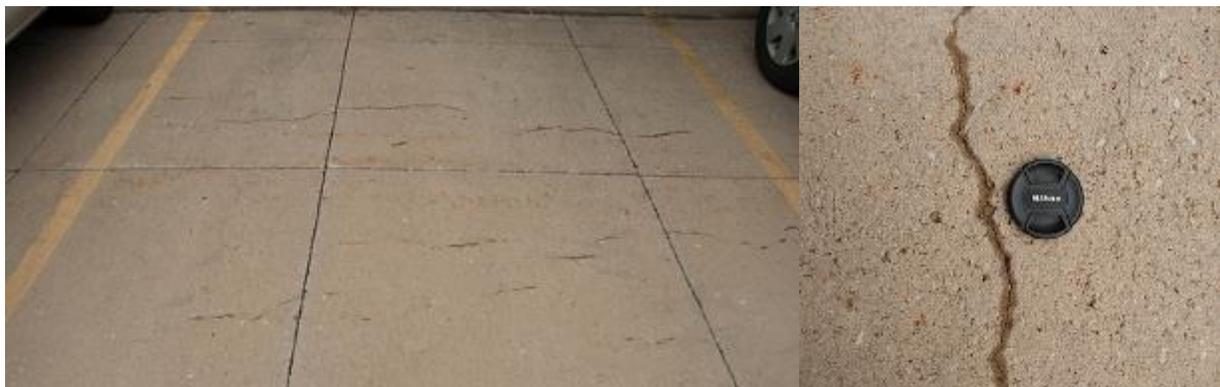
Figure 2.51. Plastic shrinkage cracking (June 2012).

Several distresses were found in the northwest section of the lot including scaling, joint spalling, and plastic shrinkage cracking, which can be seen in Figure 2.51. In total, 35 panels showed shrinkage cracks, which were easier to identify than normal because it rained the morning of the survey. These distresses were likely the result of a combination of hot and windy conditions on the day of the pour. These distributed shrinkage cracks were not counted in Table 2.29.

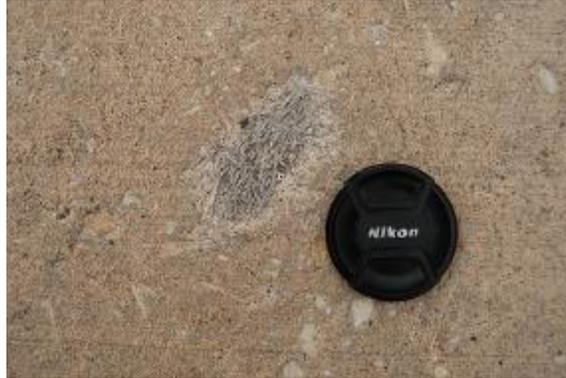
Figure 2.52. Fiber ball pop-out (June 2012).

Areas of debonding were found mainly near the construction joints and in low spots where water is directed to the drainage inlets. Fiber balls near the surface were seen in all sections of the parking lot and measured about 1 to 2 inches in diameter. An example of a fiber ball pop-out is pictured in Figure 2.52. There did not appear to be any other distresses associated with this pop-out.

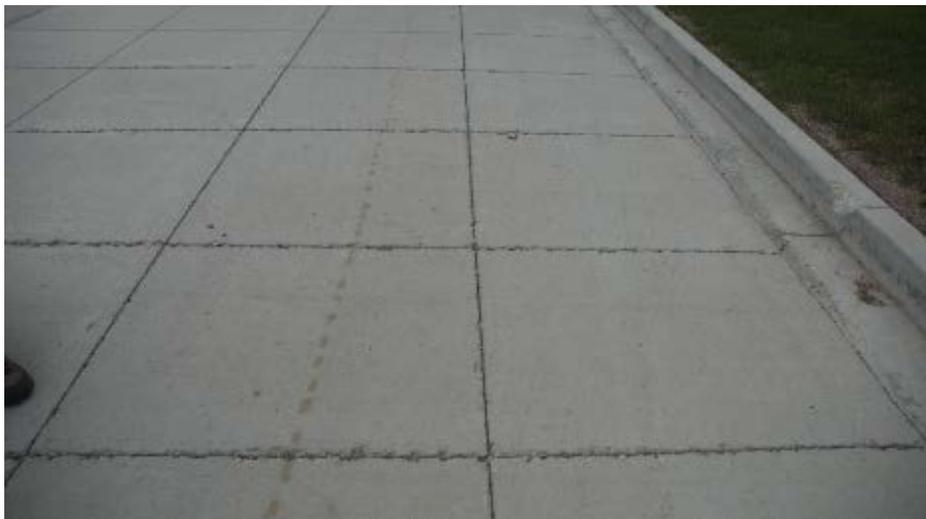
Figure 2.63. Joint spalling on DuPage Avenue (August 2012).

The most common distress was joint spalling resulting from too-early saw-cutting, as demonstrated in Figure 2.63. There were also instances of hairline corner cracking on slabs at the edge of the pavement where transverse joints were not finished all the way to the curb. Out of the four streets in the project, DuPage Avenue appeared to have the fewest surface distresses, while Lombard Avenue had the most. All of these distresses were construction issues that were not related to traffic. The macro-fibers appeared to be keeping the joints tight, there was no faulting, and the ride was very smooth. The macro-fibers were clearly visible on the surface of the pavement, and there were some instances of fiber balling.
