Maine Department of
Transportation
**Transportation Research
Division**

Technical Report 02-3
*The Use of Micro-Surfacing for Pavement
Preservation*

Final Report - April, 2009

The Use of Micro-Surfacing for Pavement Preservation

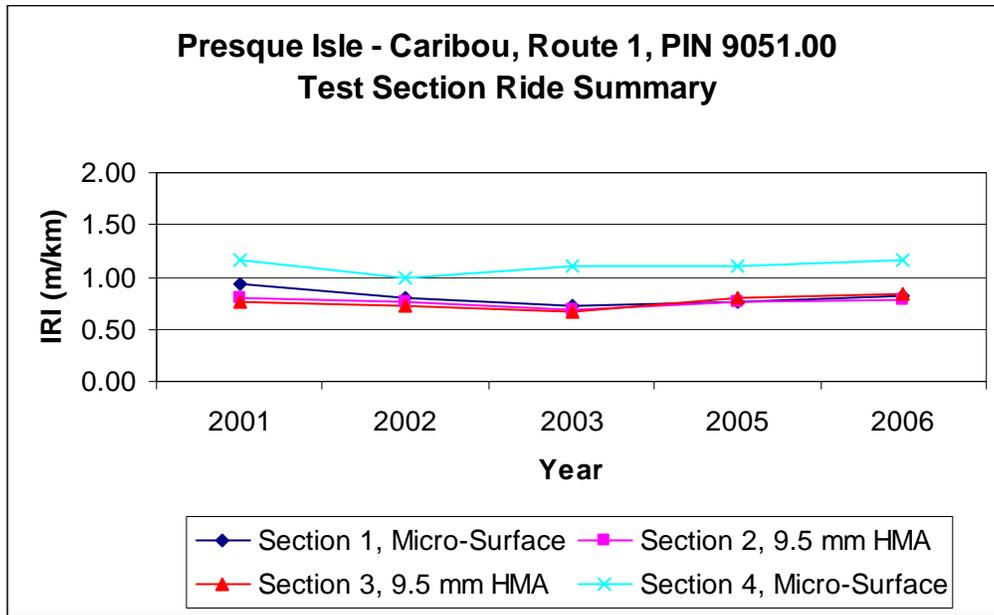
Figure 2: Presque Isle Test Section Level IRI Summary

IRI values over the five year period have changed very little as display in Figure 2.

Roughness in Micro-Surface Section 1 and Section 4 increased 6 percent from last year to a value of 0.81 and 1.17 m/km (51.3 and 74.1 in/mi) respectively. Both values continue to be in the high quality pavement range.

IRI values in HMA Section 2 and Section 3 increased 3 and 4 percent respectively to a value of 0.77 and 0.73 m/km (48.8 and 46.3 in/mi). Both sections have had consistently smooth IRI readings and remain in the high quality pavement range.

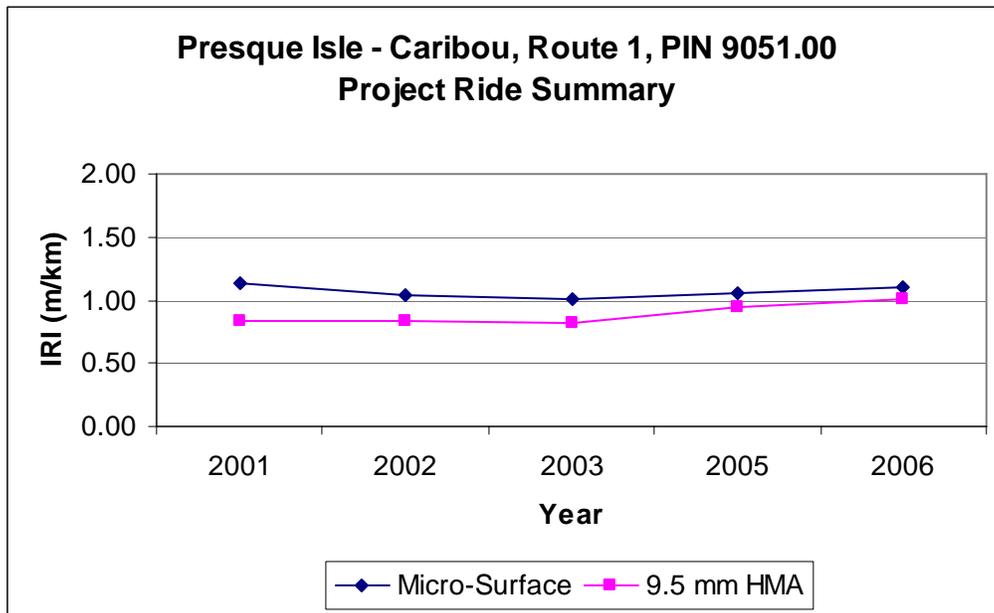
Figure 3: Presque Isle Project Level IRI Summary

For comparison the ARAN collected data on the entire length of the project. Figure 3 contains a summary of the test results.

Both treatments are in the high quality pavement range but Micro-Surface treatments continue to have higher IRI values than HMA treatments.

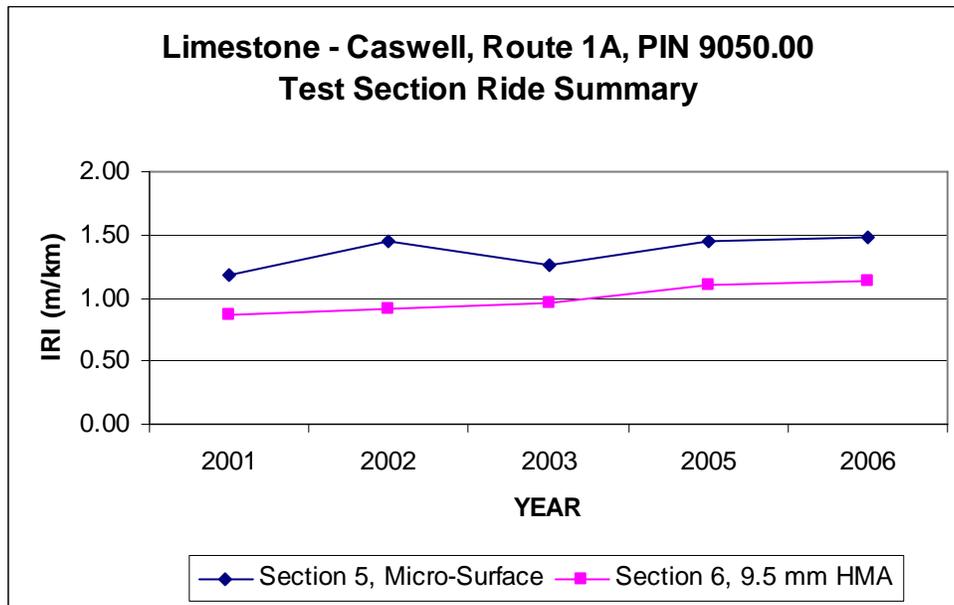
Figure 4: Limestone Test Section Level IRI Summary

Figure 4 contains smoothness test results for Section 5 and 6. Micro-Surfacing continues to have higher IRI values than the HMA section. Test results remain in the high quality pavement range.

IRI values for Micro-Surface Section 5 increased from 1.45 m/km (91.9 in/mi) to 1.48 m/km (93.8 in/mi).

Section 6 with HMA has increased from a reading of 1.10 m/km (69.7 in/mi) to 1.13 m/km (71.6 in/mi).

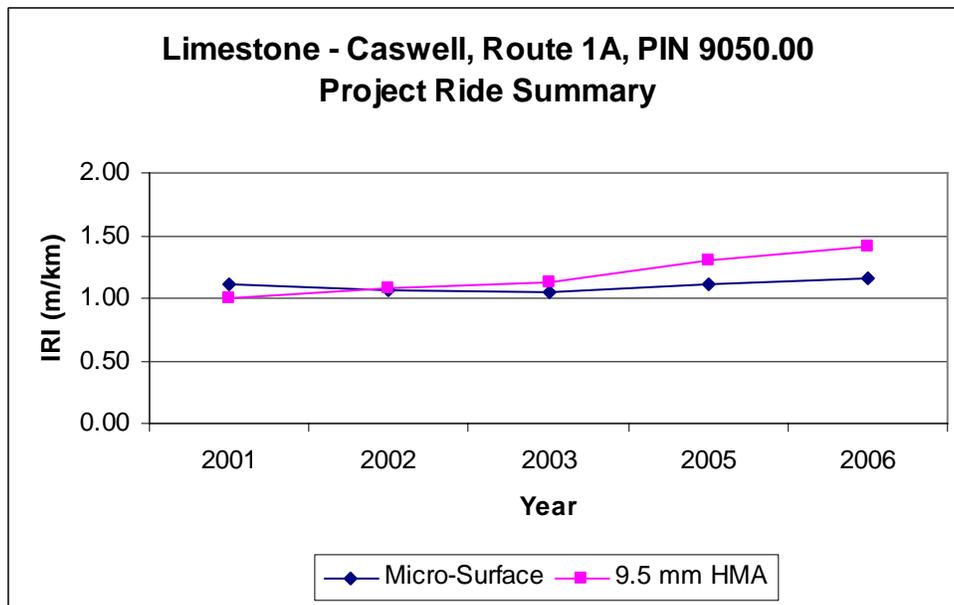
Figure 5: Limestone Project Level IRI Summary

The ARAN also collected data on the entire length of this project. Results are displayed in Figure 5. All IRI values remain in the smooth range of 1.02 – 1.57 m/km (65-99 in/mi).

IRI values have increased each year on the HMA portion of the project to a level that is rougher than the Micro-Surfaced portion. The ride increased from 1.30 m/km (82.4 in/mi) in 2005 to 1.41 m/km (89.3 in/mi) in 2006.

Micro-Surfaced areas have a smoother ride. Values increased from 1.12 m/km (71.0 in/mi) to 1.16 m/km (73.5 in/mi).

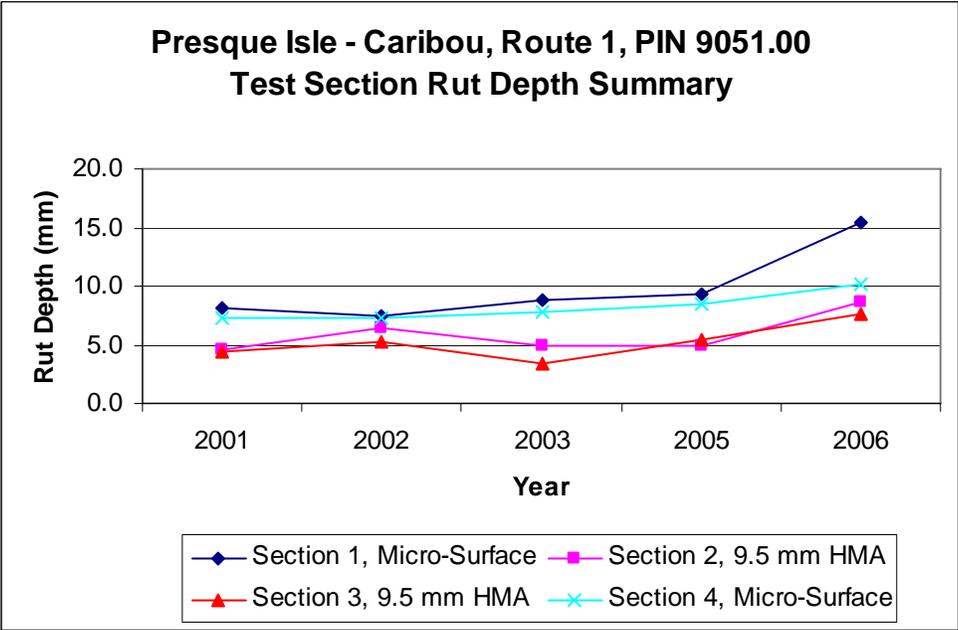
Figure 6: Presque Isle Test Section Level Rut Depth Summary

HMA rutting continues to be less severe than Micro-Surfaced areas. Figure 6 contains a summary of rut depth measurements for each test section.

Rutting in Micro-Surface Section 1 has increased 65.6 percent from a reading of 9.3 mm (0.37 in) in 2005 to 15.4 mm (0.61 in) in 2006. Micro-Surface in both wheel paths of the south lane has worn down to the original HMA. Resultant rut depths are deeper than pre-construction rut depths by 2.4 mm (0.09 in) as display in Appendix A, Photo 5.

Rutting in Micro-Surface Section 4 has not increased as much as Section 1. Depths increased from an average of 7.8 mm (0.31 in) in 2005 to 8.4 mm (0.33 in) in 2006 an increase of 7.7 percent.

Rutting in HMA Section 2 and 3 continue to be less severe than the Micro-Surface Sections. Rut depths have increased from a reading of 5.0 mm (0.20 in) in 2005 to 8.6 mm (0.34 in) in 2006 in Section 2 and 5.5 mm (0.22 in) in 2005 to 7.6 mm (0.30 in) in 2006 in Section 3.

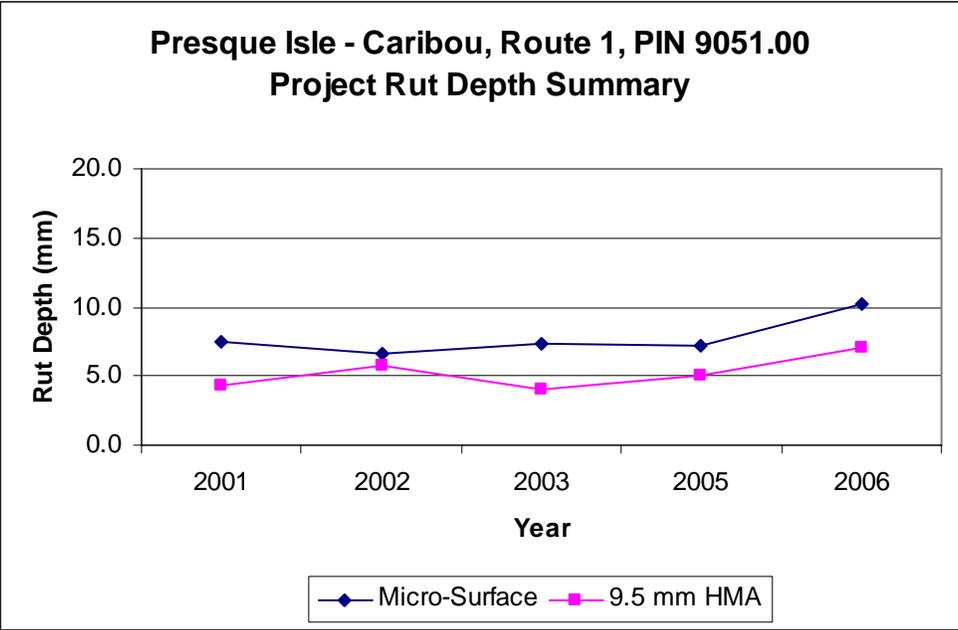
Figure 7: Presque Isle Project Level Rut Depth Summary

Figure 7 contains a summary of rut depth measurements collected on the length of the project. The HMA treatment continues to have less rutting than the Micro-Surface treatment.

Micro-Surface portions increased from a reading of 7.1 mm (0.28 in) in 2005 to 10.2 mm (0.40 in) in 2006 an increase of 44 percent.

HMA portions increased from an average of 5.0 mm (0.20 in) in 2005 to 7.1 mm (0.28 in) in 2006, an increase of 42 percent.

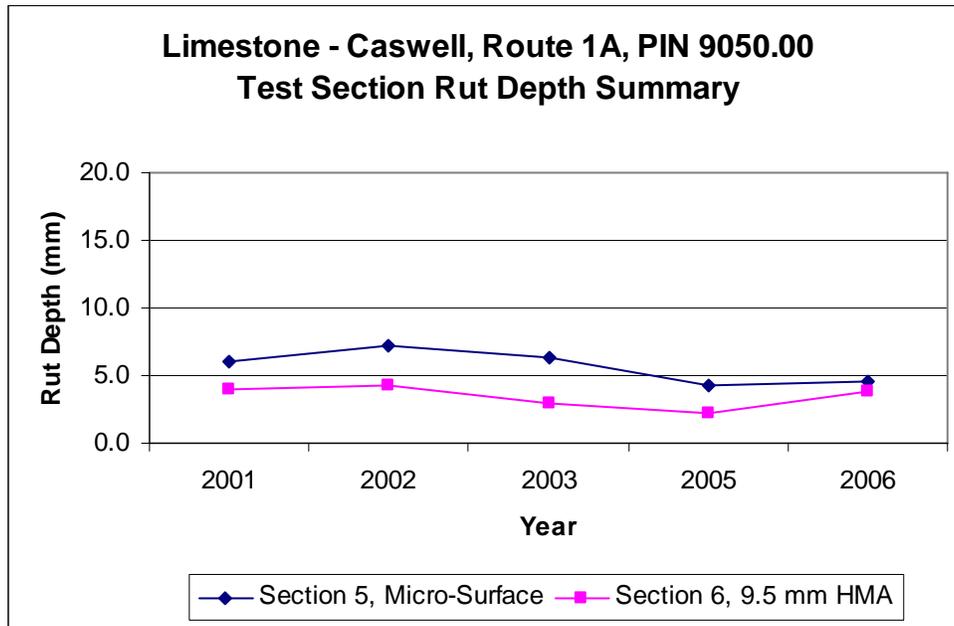
Figure 8: Limestone Test Section Level Rut Depth Summary

Rutting increased on both sections in 2006. Figure 8 contains a Rut Depth Summary of each test section.

Micro-Surface Section 5 increased from an average of 4.25 mm (0.17 in) in 2005 to 4.53 mm (0.18 in) in 2006, an increase of 7 percent.

HMA Section 6 increased from an average of 2.25 mm in 2005 to 3.78 mm in 2006, an increase of 68 percent.

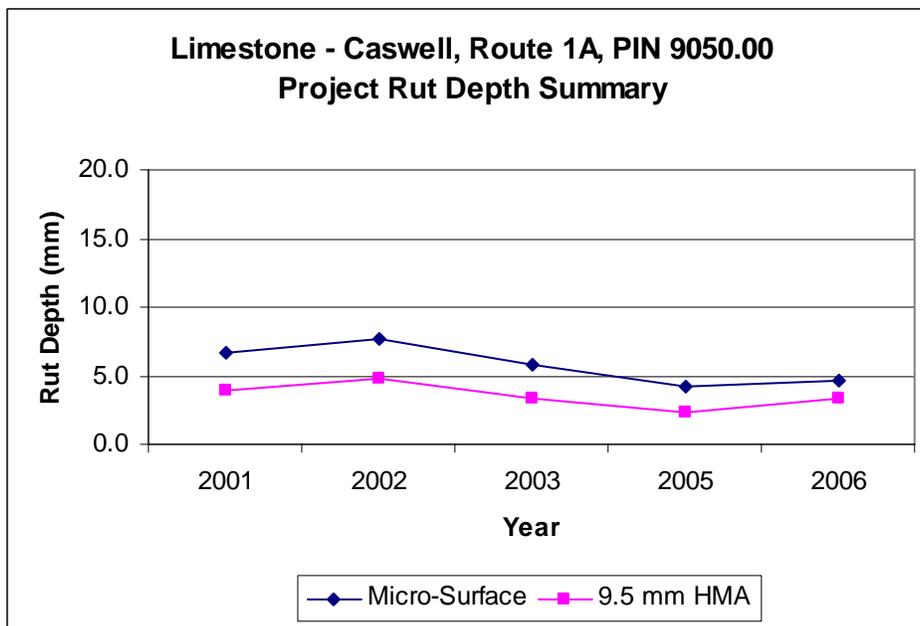
Figure 9: Limestone Project Level Rut Depth Summary

Average rut depths for the project also increased in 2006. Figure 9 displays a summary of the results. Micro-Surface treated portions of the project increased from an average of 4.24 mm (0.17 in) in 2005 to 4.65 mm (0.18 in) in 2006, an increase of 10 percent.

HMA portions of the project increased 44 percent from an average of 2.28 mm (0.09 in) in 2005 to 3.28 mm (0.13 in) in 2006.

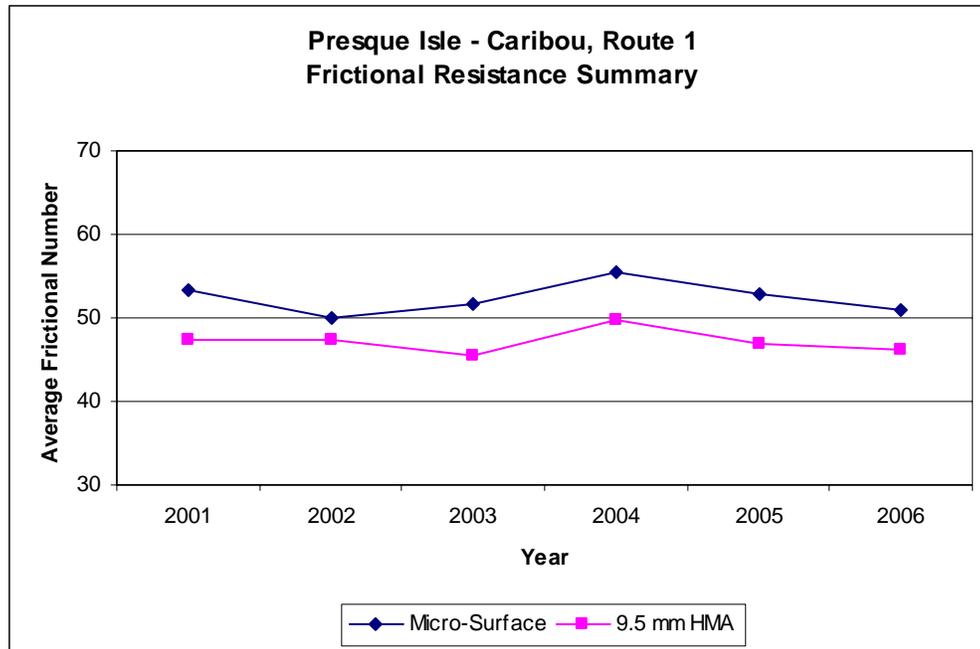
Figure 10: Presque Isle Frictional Resistance Summary

Figure 10 contains a summary of Frictional Numbers (FN) for the Presque Isle project. Micro-Surface frictional resistance decreased from an average of 52.8 in 2005 to 51.0 in 2006, a 3.4 percent decrease.

Frictional resistance on 9.5 mm HMA decreased 1.5 percent from a reading of 47.0 in 2005 to a reading of 46.3 in 2006.

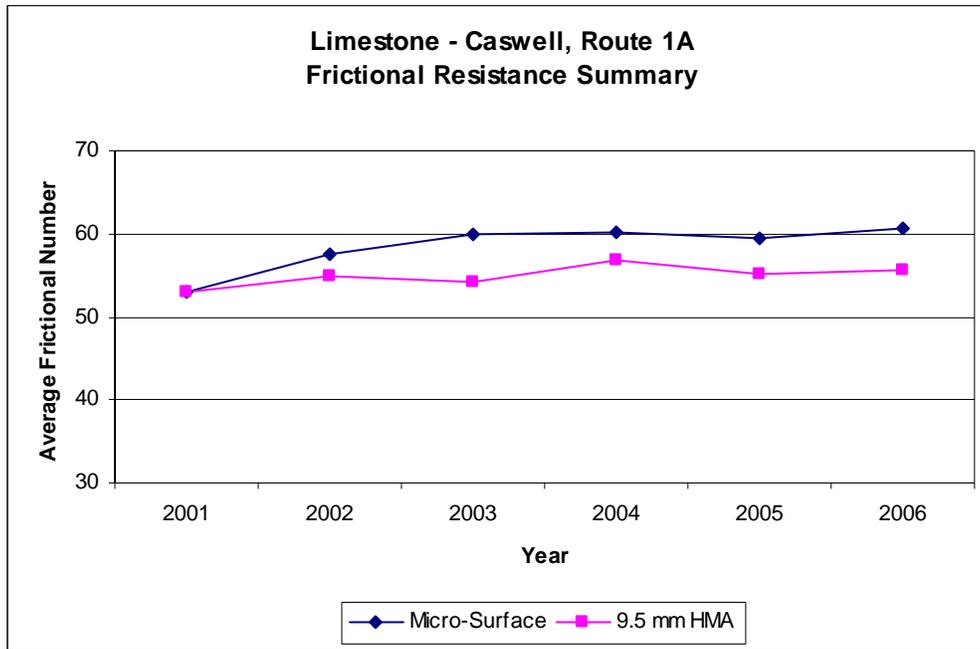
Figure 11: Limestone Frictional Resistance Summary

Figure 11 displays a summary of Frictional Numbers for the Limestone project. Micro-Surface results increased 2.2 percent from an average of 59.4 in 2005 to 60.7 in 2006.

Frictional Numbers increased from an average of 55.1 in 2005 to 55.7 in 2006, an increase of 1.1 percent.

Frictional results have been fairly uniform on the Limestone project with little change after two years exposure to traffic.

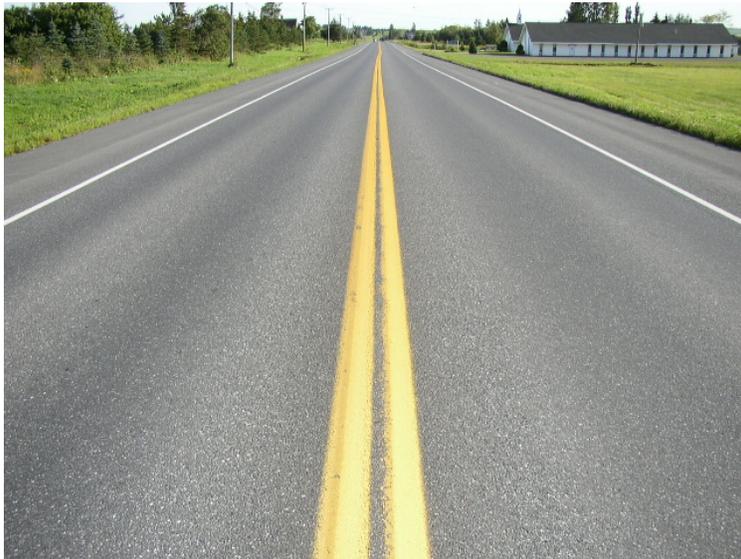
HMA surfaced portions are performing as expected. Reflected cracking is delayed one or two years as compared to Micro-Surfaced portions and rutting is less severe. Section 2 and 3 are represented in Photos 1 and 2.

Photo 1: HMA Section 2; August, 2006.

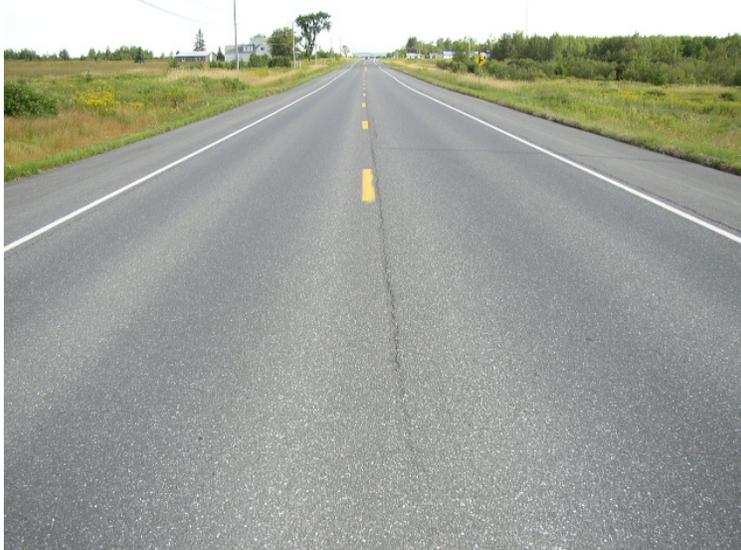
Photo 2: HMA Section 3; August, 2006.

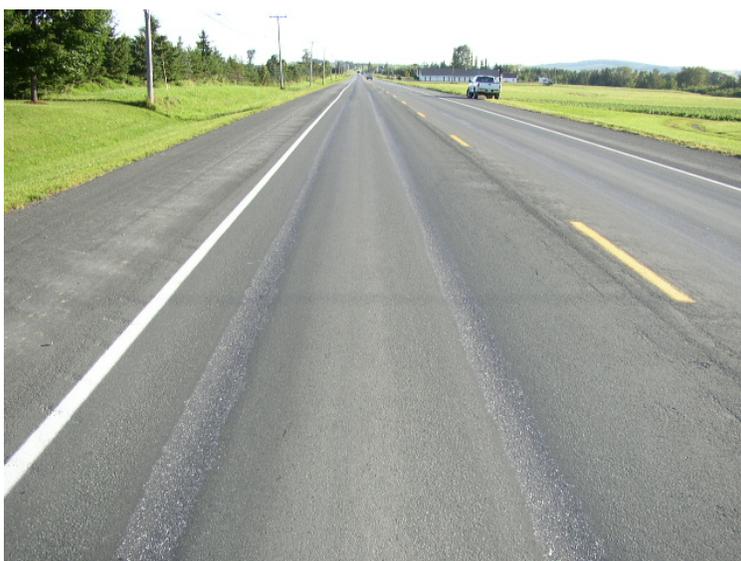
After five years of traffic with a Factored AADT of 8600 much of the Micro-Surface in Section 1 has worn down to the original HMA in each wheel path. Both wheel paths are worn in the south lane as displayed in Photo 3. The north lane has less wear on the outer wheel path as seen in Photo 4. Snow plows continue to abrade the centerline and shoulders throughout this Section. As mentioned earlier, rut depths are greater than pre-construction depths and appear to be deep enough to trap water which has the potential to cause vehicles to hydroplane, see Photo 5.

Photo 3: Section 1 Micro-Surface South Lane Wheel Path Abrasion; August, 2006.

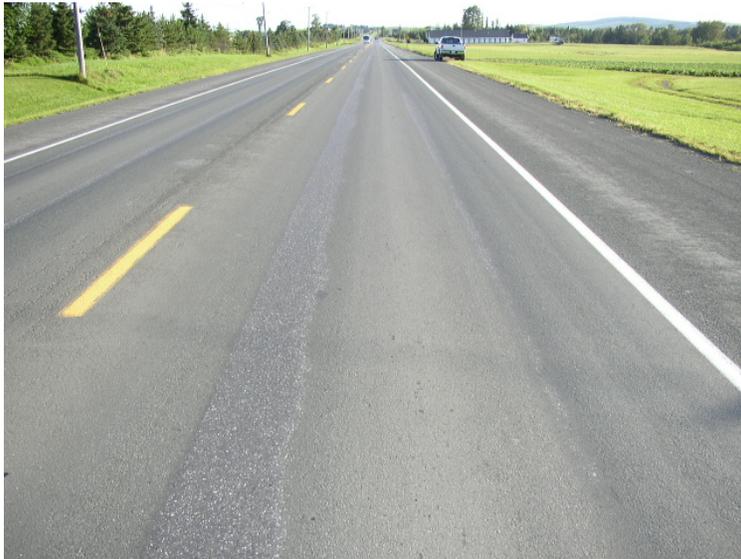
Photo 4: Section 1 Micro-Surface North Lane Wheel Path Abrasion; August, 2006.

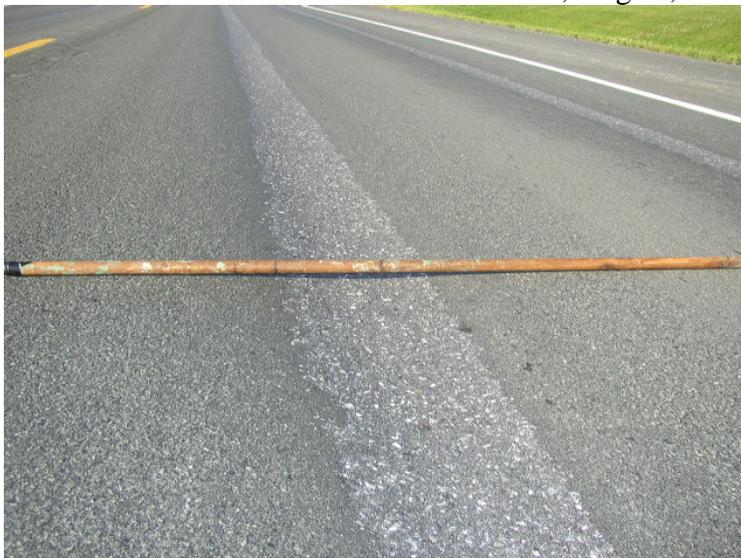
Wheel rutting on the Presque Isle project is worn down to the original HMA. This condition has actually increased depth of rutting to levels greater than pre-construction levels. Traffic worn wheel path areas are deep enough to trap water which could cause a vehicle to hydroplane. It appears that high AADT counts attributed to excessive wheel rutting.

Photo 5: Section 1 South Lane Wheel Rut; August, 2006.

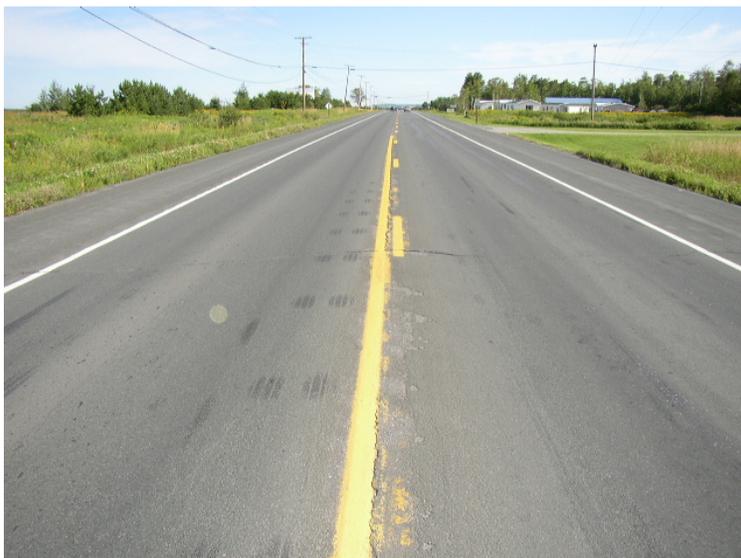
Micro-Surface Section 4 has less wheel path wear with the same amount of snow plow wear as seen in Photo 6. Average rutting is less severe in this section but there are isolated spots with deep ruts as shown in Photo 7. This section had less severe pre-construction wheel ruts which could account for the reduced wheel path wear.

Photo 6: Section 4 Micro-Surface Centerline and Quarter Point Plow Abrasion; August, 2006.

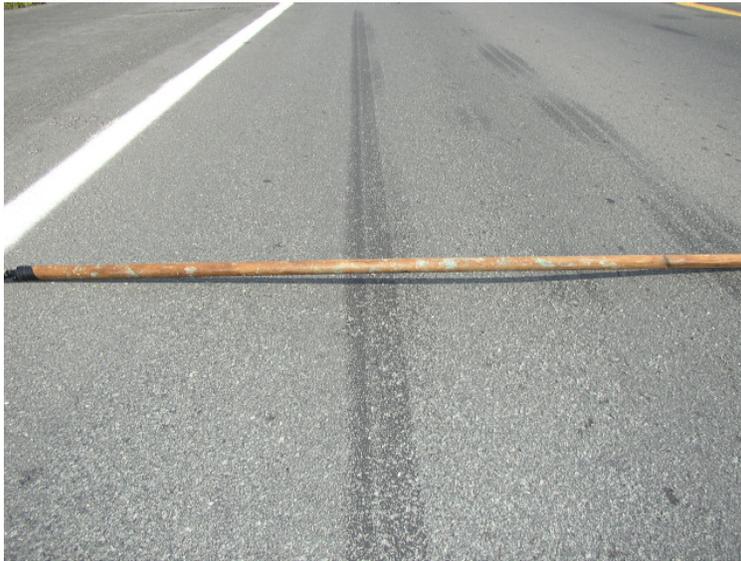
Photo 7: Section 4 Outer Wheel Path of South Lane; August, 2006.

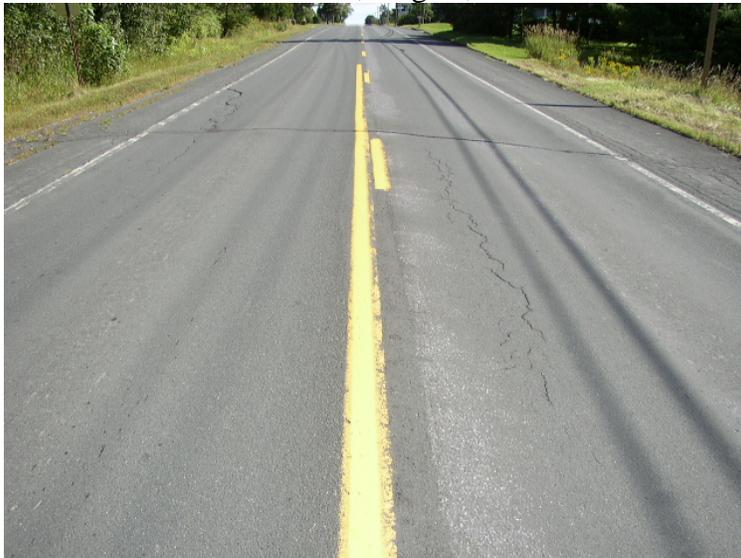
Plow abrasion at centerline on Section 5 is displayed in Photo 8. Snow plowing has abraded the centerline down to the original HMA throughout the entire section. Wheel path abrasion is less severe than the Presque Isle project, most likely due to the amount of traffic. This project has a Factored AADT of 1100.

Photo 8: Section 5 Centerline Plow Wear; August, 2006.

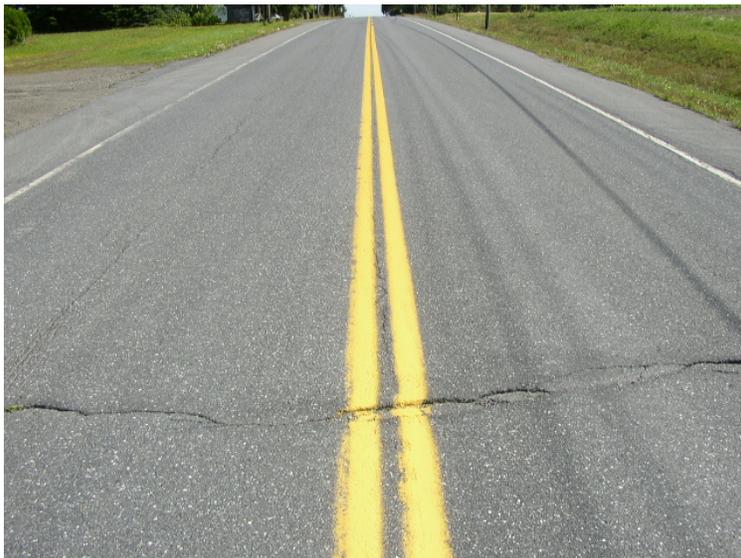
Control Section 6 has very little plow abrasion or rutting and looks very good as depicted in Photo 9.

Photo 9: HMA Section 6; August, 2006.

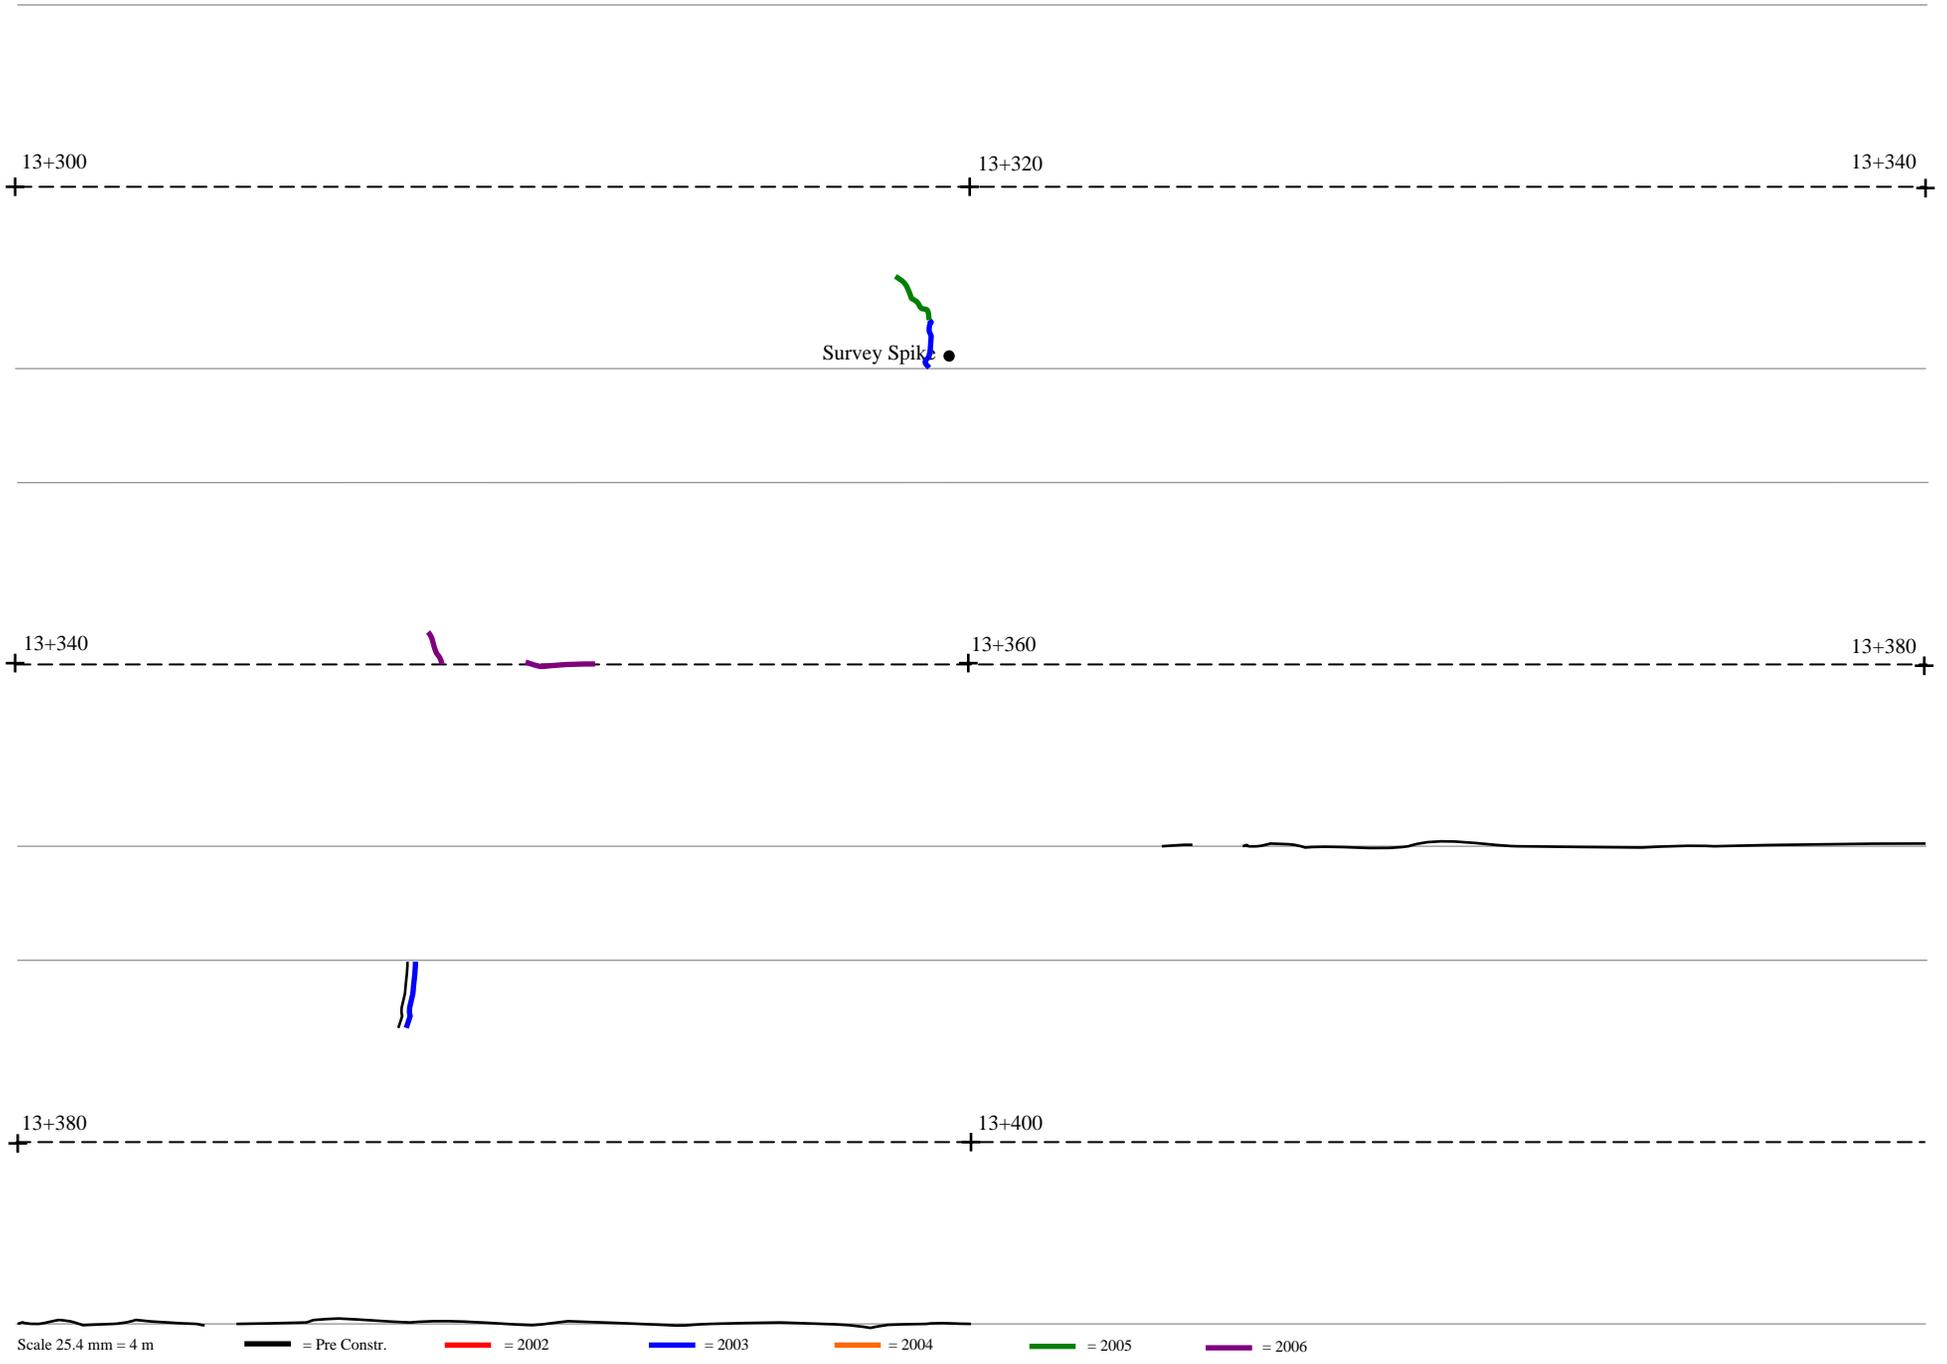
Figure 12. Section 1 Micro-Surface Crack Survey

Figure 12 contains a crack survey of Micro-Surface Section 1. This section had the lowest amount of preconstruction longitudinal cracking and only one partial transverse crack. The partial transverse crack reflected through and a new transverse crack appeared in 2003. No additional cracking was observed in 2004. In 2005 the new transverse crack at station 13+320 extended into the roadway to about midway across the lane. In 2006 a transverse crack was observed running from centerline to the inner wheel path of the left lane at station 13+350 and a centerline joint crack is running from station 13+352 to 13+358.

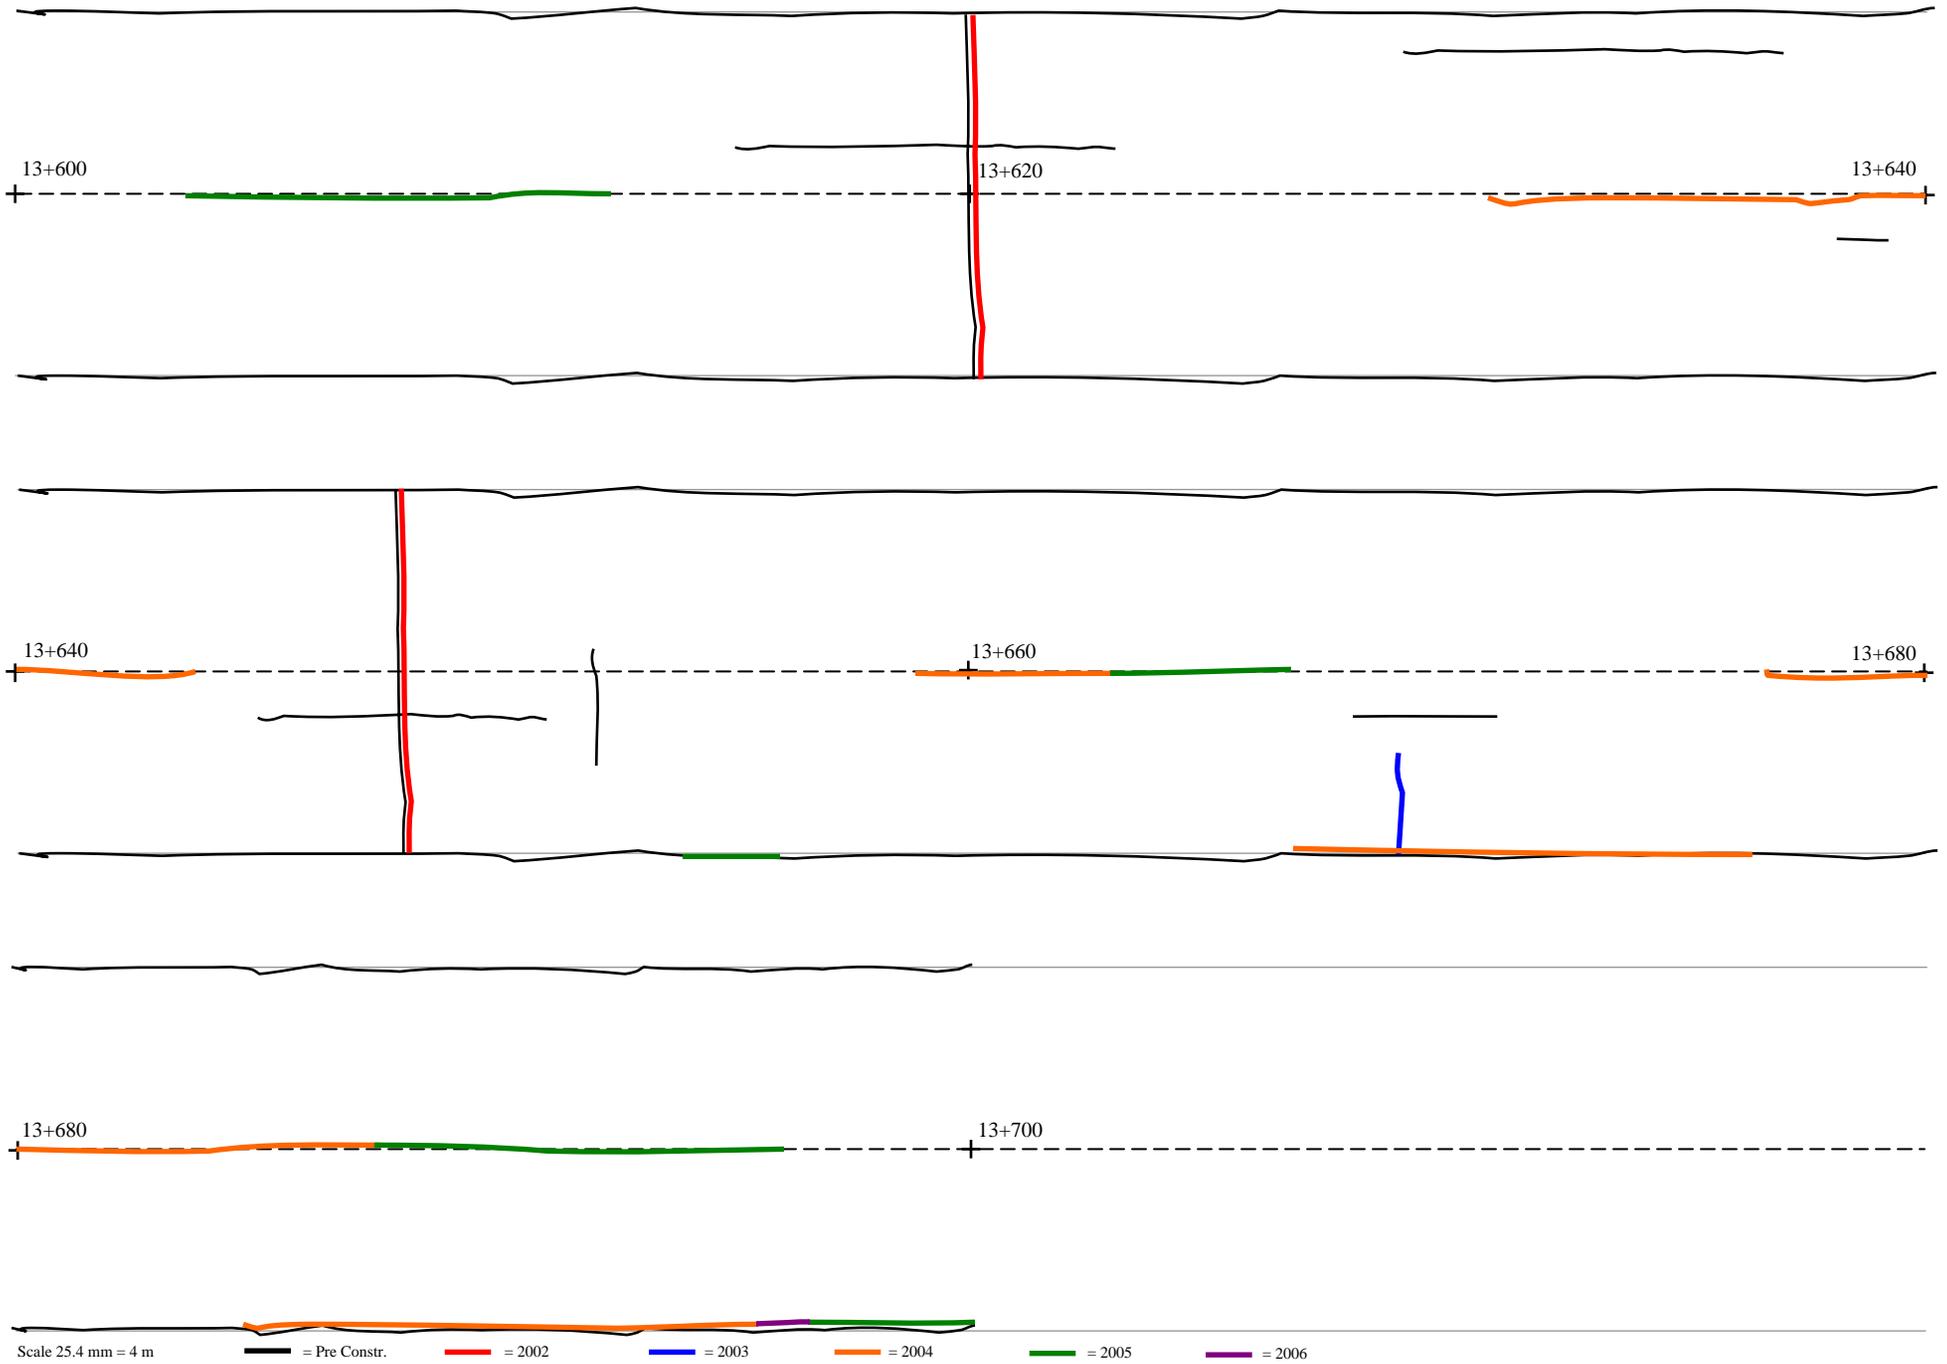
Figure 13. Section 2 Control Crack Survey

Figure 13 contains a crack survey of Control Section 2. After the first year two full width transverse cracks had reflected through. A new transverse crack at station 13+670 was observed in 2003. In 2004 a portion of the shoulder joint had reflected through and new longitudinal cracking was noticed in much of the centerline. Additional centerline and shoulder cracking was noticed in 2005. The only crack observed in 2006 was a small portion of shoulder joint that reflected through at station 13+696.

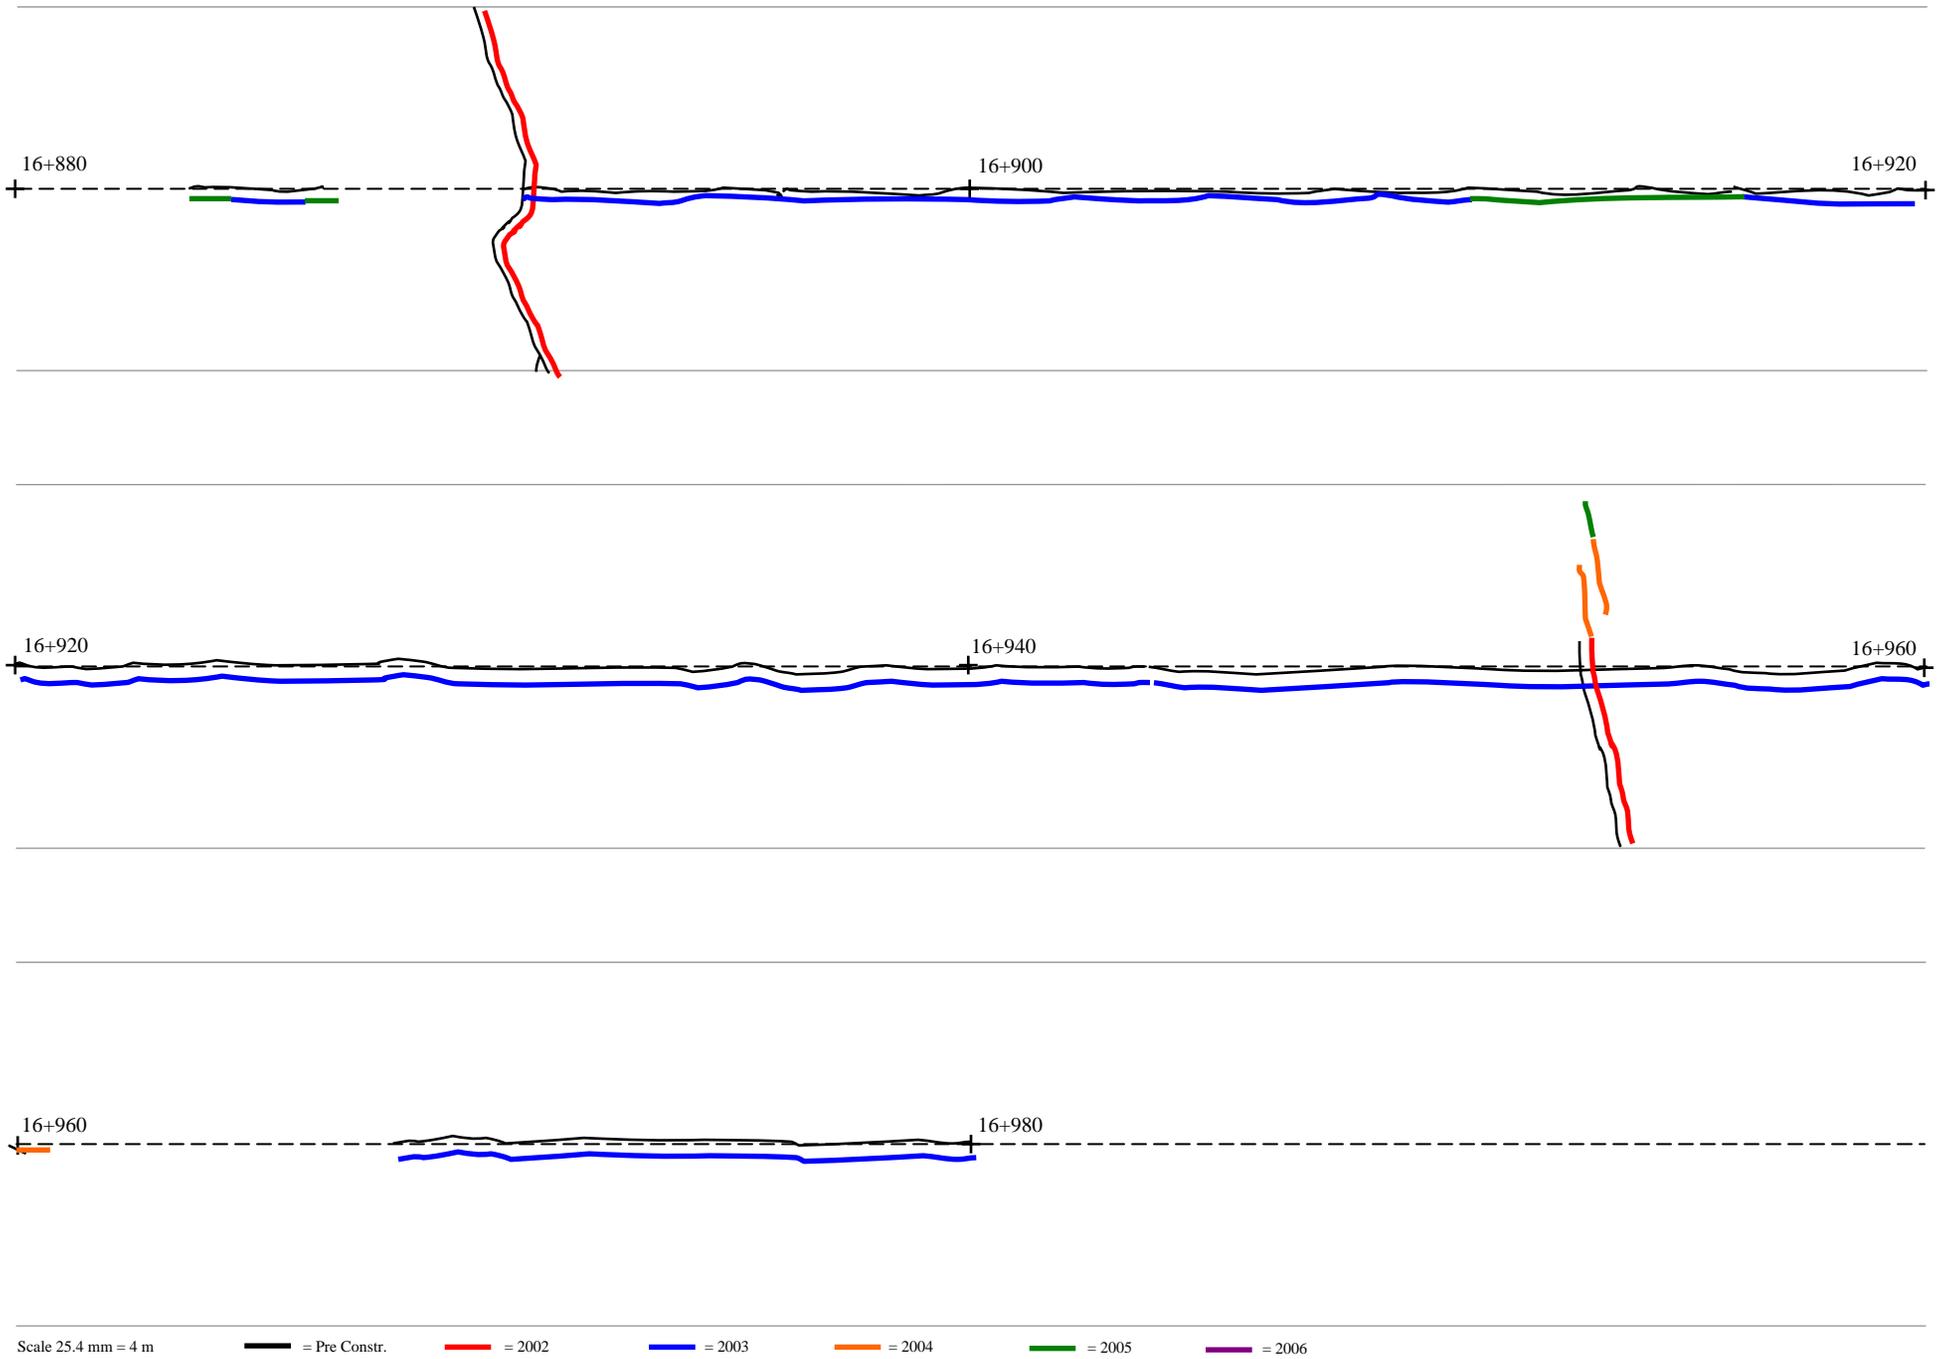
Figure 15. Section 4 Micro-Surface Crack Survey

Figure 15 contains a diagram of Micro-Surfaced Section 4. Two transverse cracks had reflected through in 2002. Most of the original cracks have reflected through by 2003. In 2004 only a small portion of new transverse cracking was observed at station 16+953. By 2005 all of the original cracks have reflected through and the transverse crack at station 16+593 has extended close to the left shoulder. No additional cracking was observed in 2006.
