Maine Department of
Transportation
**Transportation Research
Division**

Technical Report 02-3
*The Use of Micro-Surfacing for Pavement
Preservation*

Final Report - April, 2009

The Use of Micro-Surfacing for Pavement Preservation

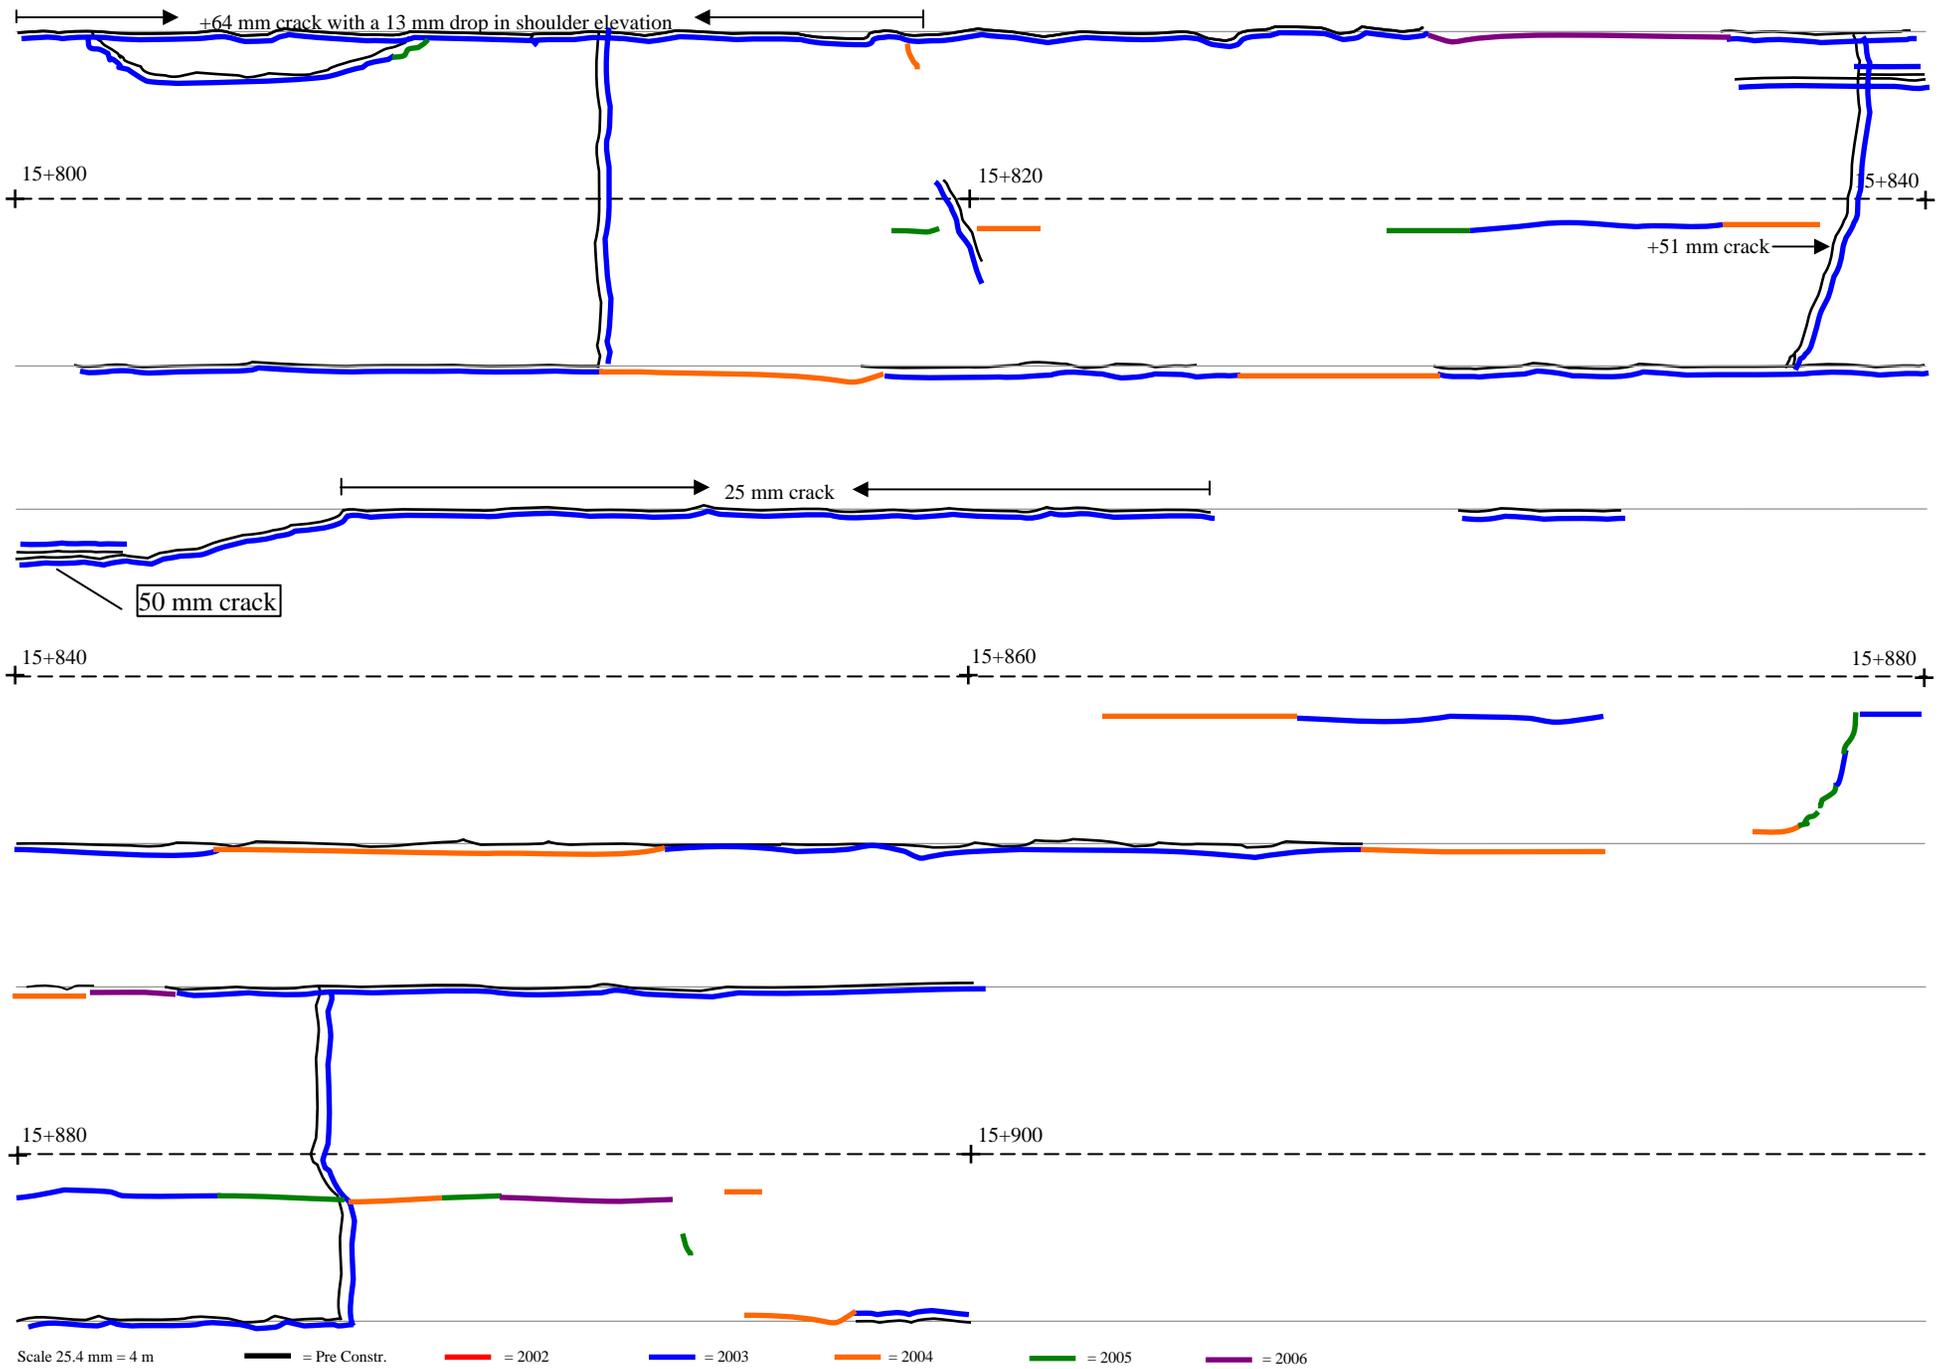
Figure 16. Section 5 Micro-Surface Crack Survey

Micro-Surfaced Section 5 is displayed in Figure 16. There were no cracks observed in 2002. A majority of the original cracks reflected through in 2003 with a number of small areas of initial load cracking. By 2004 nearly all of the original cracks were visible and the initial load cracks were extending. A few small areas of initial load cracking and transverse cracks were observed in 2005. Initial load cracking continues to migrate in the wheel path in 2006 and a small amount of new longitudinal cracking was observed at station 15+860. The inner wheel path load crack at station 15+840 right has increased in width to 50 mm (2 in).

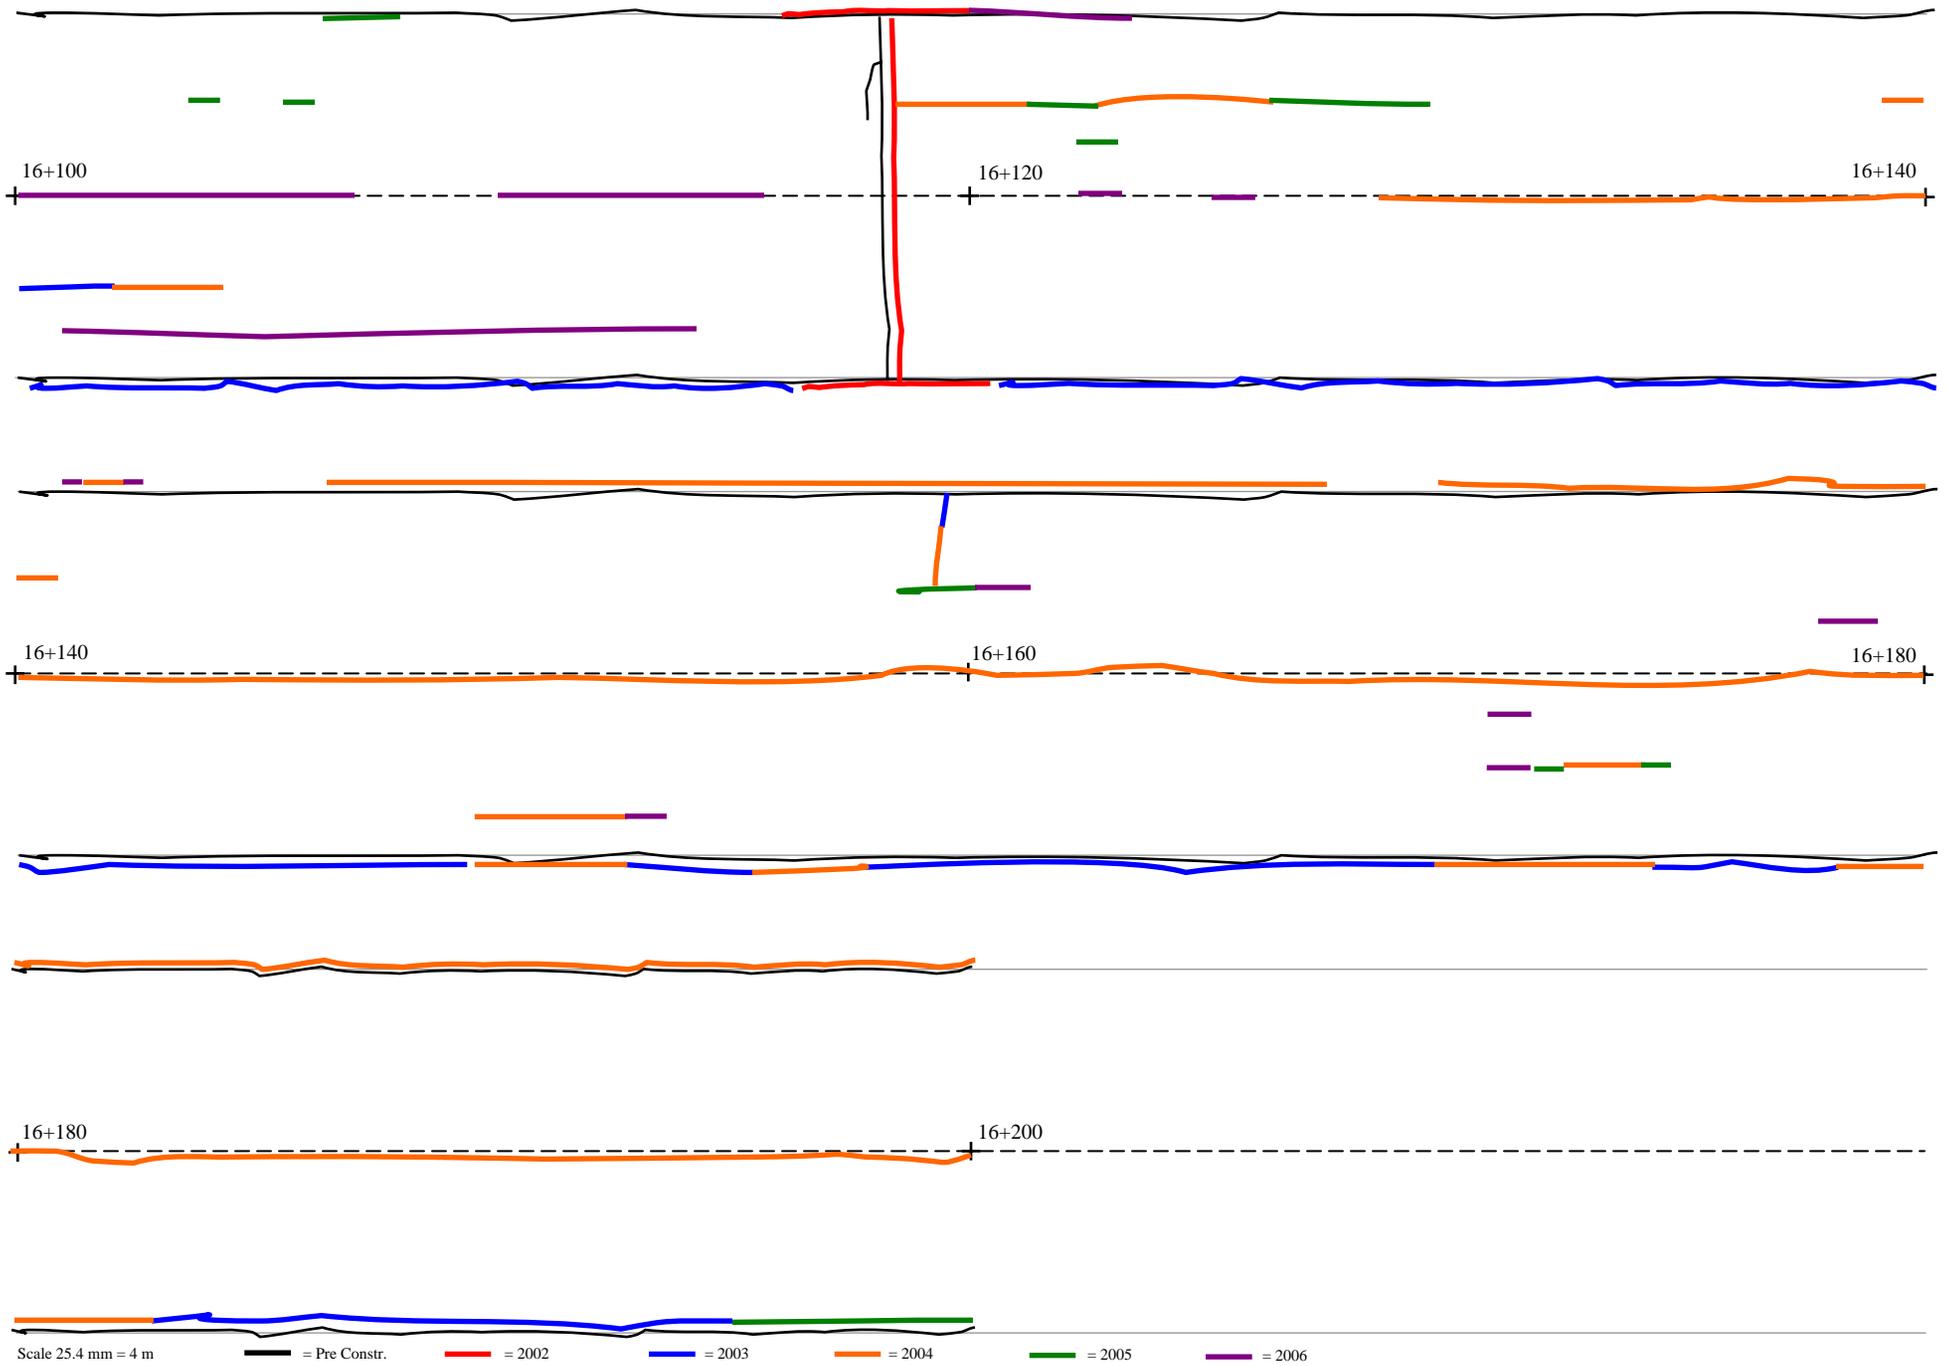
Figure 17. Section 6 Control Crack Survey

A crack survey for Control Section 6 is exhibited in Figure 17. In 2002 the only crack observed was the longitudinal and shoulder cracks at station 16+118. In 2003 roughly a third of the shoulder joint has cracked and a transverse crack has begun to cross the roadway at station 16+159. By 2004 nearly three quarters of the shoulder and centerline joint has cracked and a few small areas of longitudinal cracking were observed between wheel paths and in the outer wheel path. The transverse crack at station 16+159

has extended to the quarter point. In 2005 there was a small increase of cracking at the shoulder joint and additional cracking between wheel paths and in the wheel path. In 2006 a small amount of shoulder crack and centerline cracking was observed between stations 16+100 and 16+125. A small amount of initial load cracking on the inner wheel path at station 16+172 and 16+178 is visible and the load crack at 16+150 right has extended to station 16+155.
