Technical Report 03 - 1

Bridge Deck Resurfacing Using Rosphalt 50

*Interim Report - Second, Third, and Fourth Year
October 2006*

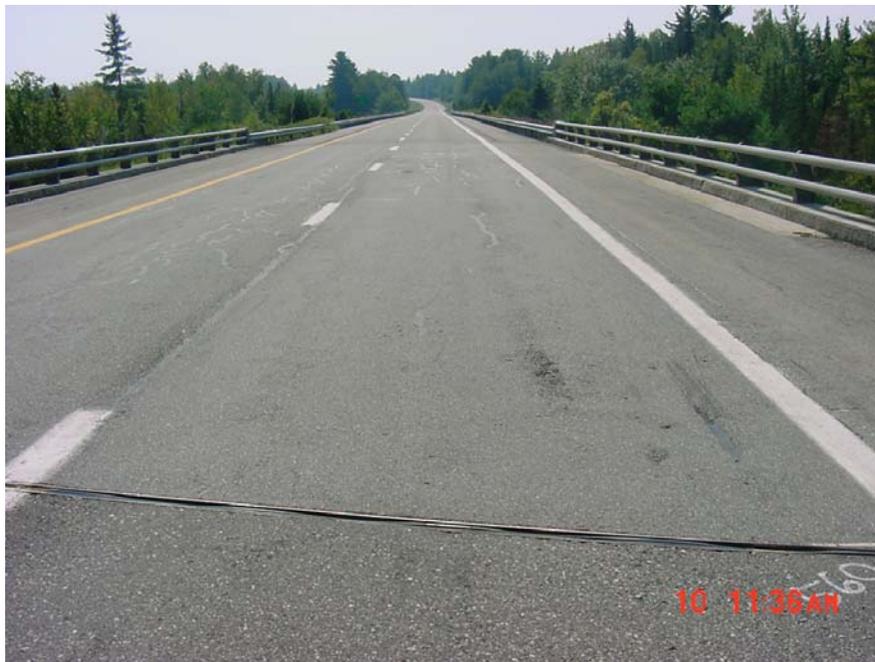
Two bridges are located in the town of Howland (Figure 1). Bridge number 6070 is on the southbound lane of Interstate 95 and crosses Seboeis Road. This bridge is 41 meters (136 ft) in length and 14 meters (47 ft) wide with a 2001 AADT of 3980. The wearing surface was in poor condition and needed replacement (Photo 1). Bridge number 6069 is also on the southbound lane of Interstate 95 and crosses the Piscataquis River. This bridge is 163 meters (536 ft) long, 11 meters (36 ft) wide with a 2001 AADT of 3980. The wearing surface on this bridge was also in poor condition (Photo 2).

Photo 1: Bridge #6070 wearing surface

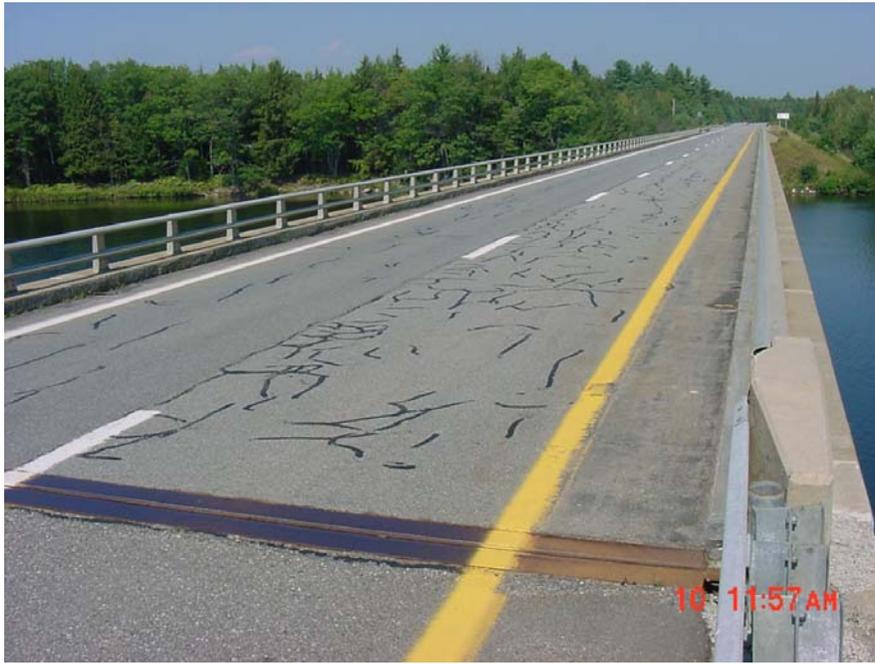
Photo 2: Bridge #6069 wearing surface

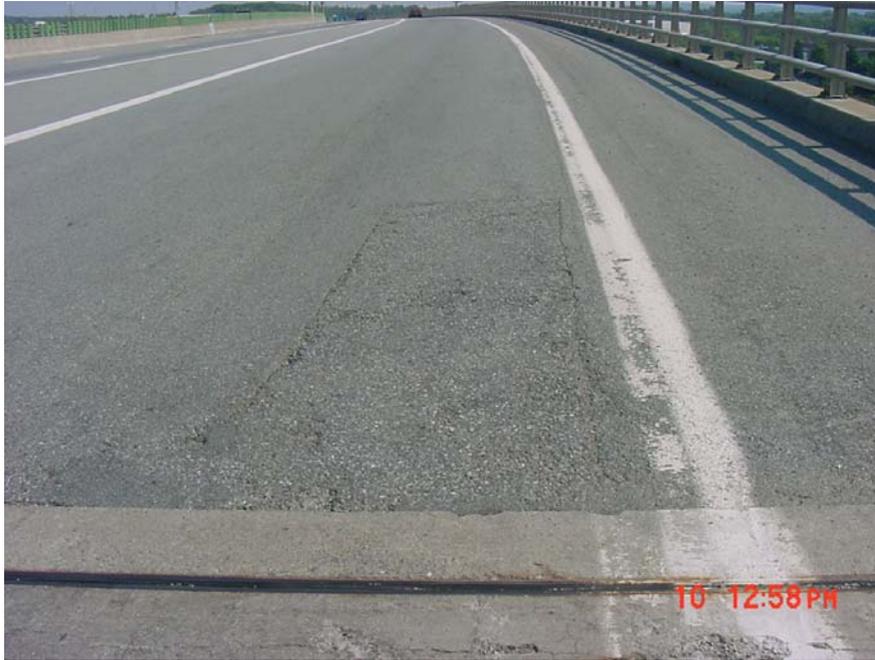
Although the wearing surface was in fair condition, there were areas of shoving that have been repaired over the past five years (Photos 3 & 4). The problem areas are located on the accelerating lane of each entrance ramp and decelerating lane of each exit ramp.

Photo 3: Bridge # 1558 patch area on entrance ramp

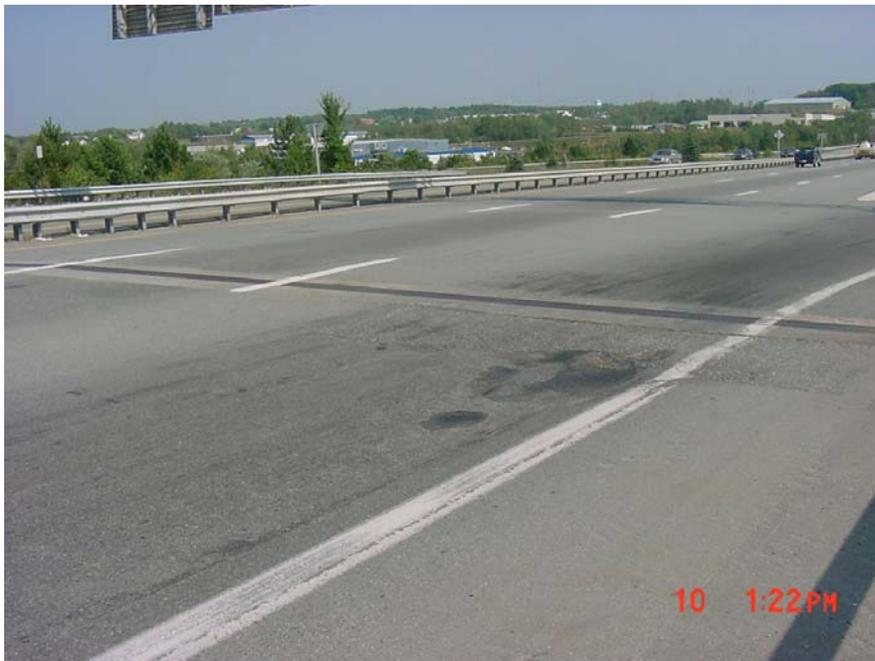
Photo 4: Bridge # 1558 patch area on exit ramp

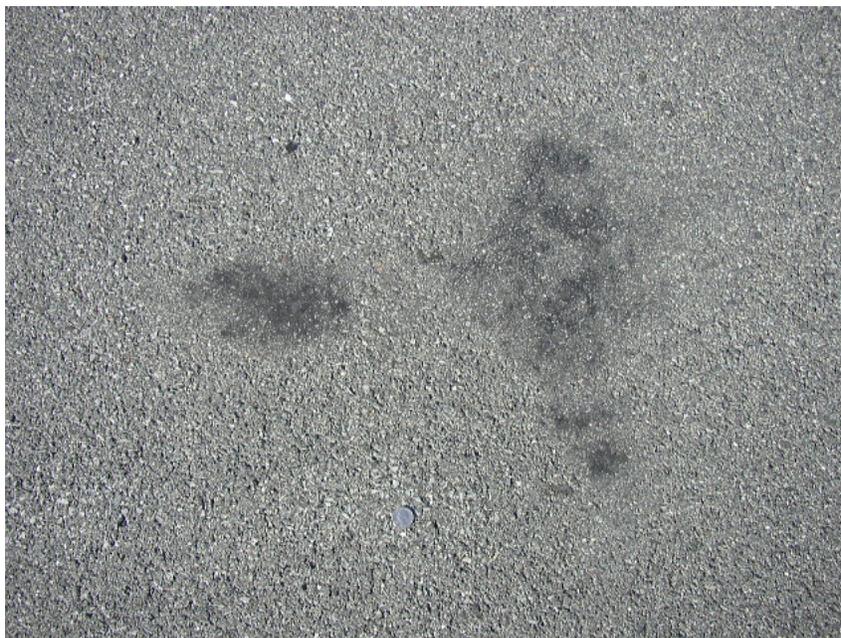
In 2004 a spot of concentrated asphalt was observed at station 0+028 as is displayed in Photo 5. The spot is 0.5 meters (1.6 ft) long and 0.25 meters (0.8 ft) wide. There is no ravel or separation from the mat and its condition has not changed from 2004 to 2006.

Photo 5: Bridge # 6070 Surface Defect

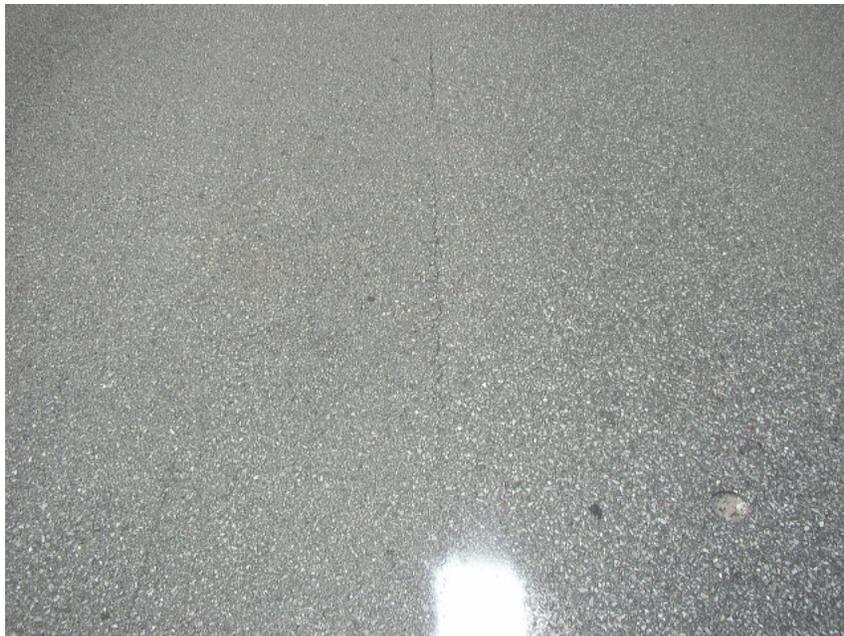
In 2004 a 2.2 meter (7.2 ft) portion of centerline joint near the south end of the bridge has separated. In 2006 the same centerline crack has increased in length to 14 meters (46 feet) and a width between 1 and 2 mm (0.04 and 0.08 in) as displayed in Photo 6. Normally this type of defect is of concern because it allows winter maintenance chemicals to penetrate and contaminate the RPCC bridge deck. In this case the bridge deck membrane was left intact when the original surface mix was milled then Rosphalt 50 was placed over the membrane. Unless the membrane is compromised the RPCC bridge deck should be protected.

Photo 6: Bridge # 6069 Centerline Separation

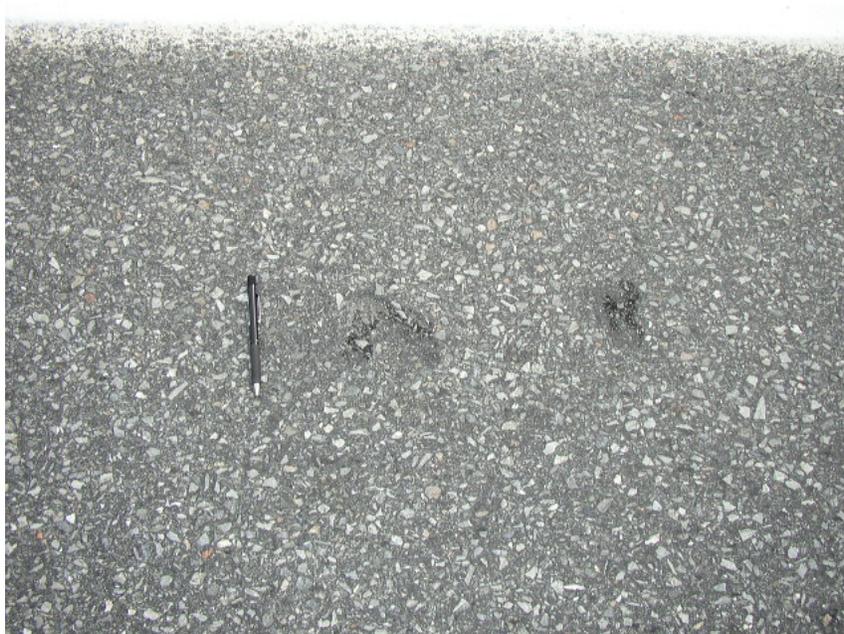
There are roughly 30 areas of concentrated Rosphalt 50 that range in size from a quarter to a softball. The larger spots have begun to ravel to a depth of 12 mm (0.5 in) as displayed in Photo 7.

Photo 7: Bridge # 6069 Surface Defect

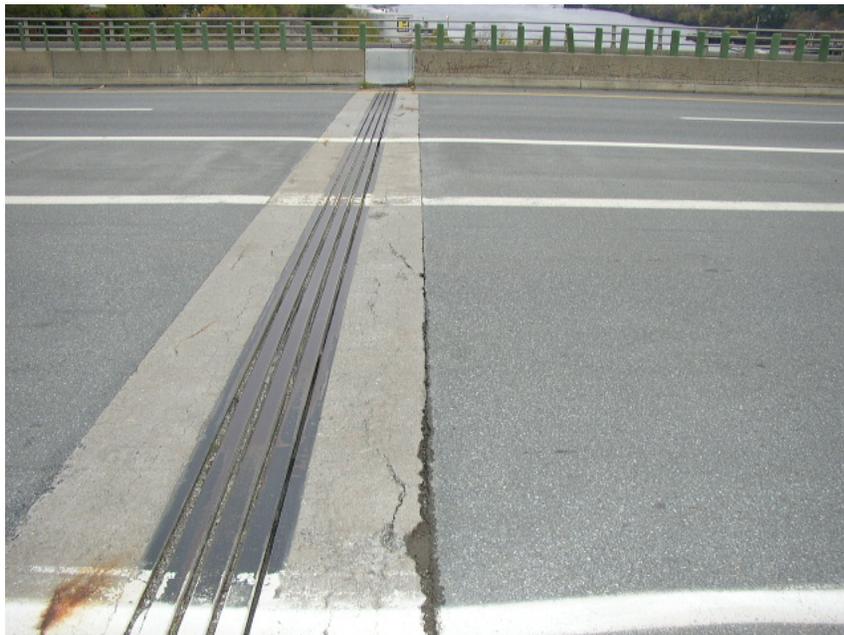
Rosphalt 50 has begun to separate near the expansion joint in a number of areas. In 2004 about 10 percent of the bridge deck between the railroad and main bridge expansion joint in the east bound lane has separated to a width of 3mm (0.12 in). In 2006 about 50 percent of the same area has separated to a width of 6 mm (0.25 in) and as much as 10 mm (0.4 in) in a few areas as displayed in Photo 8. The east end of the bridge deck in the west bound lane started showing signs of separation in 2004. By 2006 90 percent of this area has opened up to a width of 3 to 4 mm (0.12 to 0.25 in). The west end of the bridge deck was well sealed in 2004; by 2006 there was slight separation in the passing lane only.

Photo 8: Bridge # 1558 EBL Expansion Joint Separation

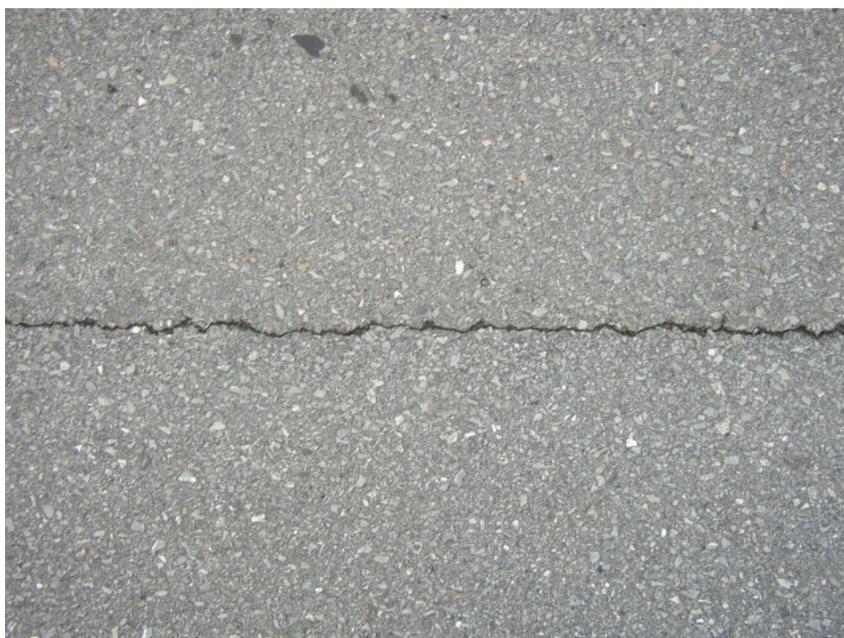
Photo 9 displays a portion of a 36 meter (118 foot) long section of centerline joint between the west bound travel and pass lanes that has opened up to a width of 3 mm (0.12 in). This would normally be a concern if the deck was surfaced with one layer of Rosphalt 50 but this bridge was surfaced with two 36 mm (1.5 in) lifts of Rosphalt 50 with an offset centerline. The first lift of material should protect the deck from winter chemicals unless the centerline crack penetrates both layers. The crack appears to be a result of poor construction.

Photo 9: Bridge # 1558 Centerline Separation

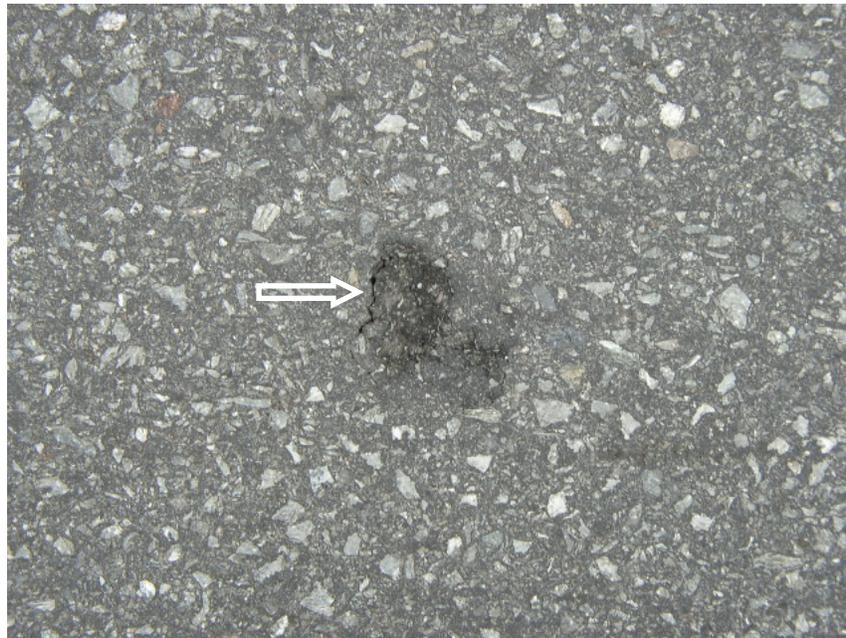
There are a number of concentrated Rosphalt 50 areas in both lanes ranging in size from a quarter to a softball. The larger sized areas have raveled to a depth of 12 mm (0.5 in) in 2004 and remained the same in 2006 as depicted in Photo 10. Note also that the material is beginning to separate from the mat.

Photo 10: Bridge # 1558 Surface Defect
