STATE OF MAINE DEPARTMENT OF TRANSPORTATION

FEDERAL EXPERIMENTAL REPORT 96-2

LONGITUDINAL JOINT STUDY

FINAL REPORT

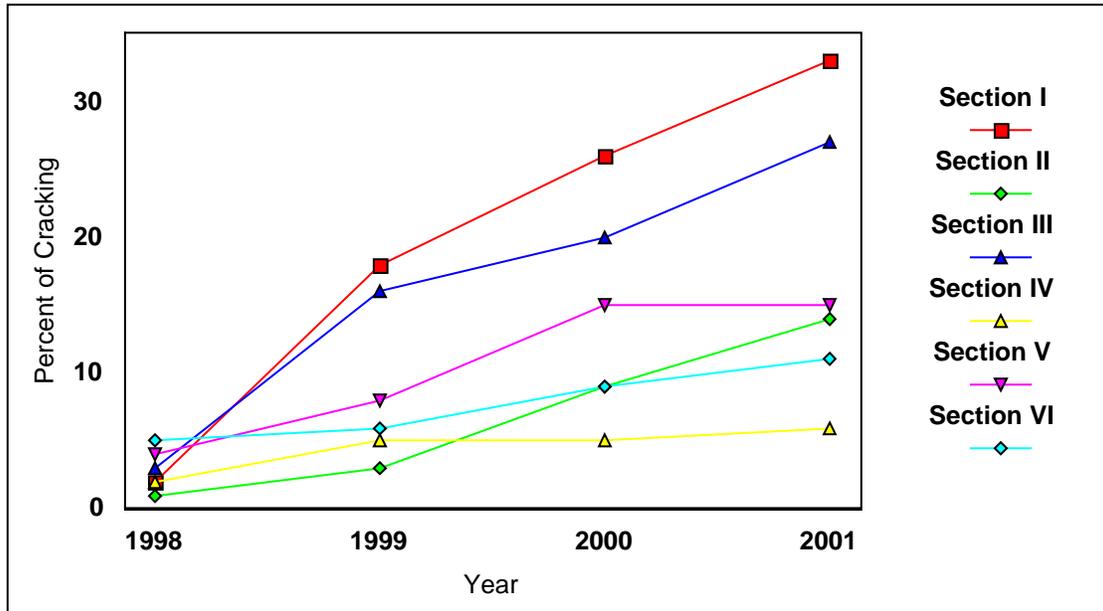
FIGURE I.
CENTERLINE JOINT CRACK SUMMARY

A visual evaluation was conducted on August 7, 2001. Joint wear and raveling has not increased since the 2000 evaluation. Figure I illustrates the amount of centerline cracking that has occurred in each Section over the five-year study period. Table II contains crack severities for the 2001 field evaluation and photos of each Section are attached to the end of this report.

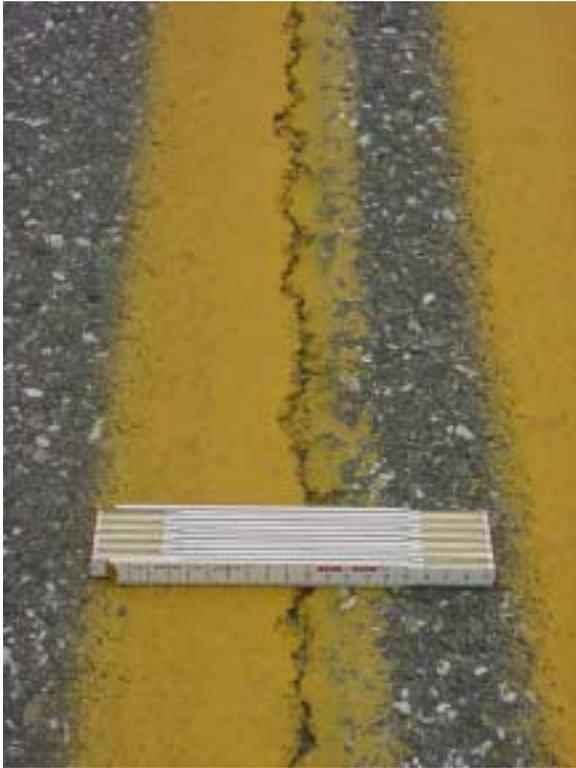
PHOTO 4.
SECTION I

Section I had the greatest amount of cracking at 33%. All of the cracking occurred in the first half of this Section suggesting adjustment of the Kicker Plate and Edge Follower, as mentioned in the Construction Report, may have interfered

with correct placement of mix along the joint. The remaining centerline joint is very tight and difficult to see.

Section I using the Joint Maker had the highest amount of joint separation due to adjustments of the equipment but did precompact the mix prior to rolling producing a higher density on the first mat at an offset of 63 mm (2.5 in) left. Using the Joint Maker combined with Section II rolling technique could produce a very tight and stable centerline joint. It should be noted when this project was paved in 1996 the department used Hveem designed Grade "C" mix we now use Superpave type mix. C mix is finer than Superpave making it easier for the Joint Maker to precompact. Trans Tech has had difficulty precompacting Superpave mix using the Joint Maker and is working on developing a Joint Maker for Superpave mix.

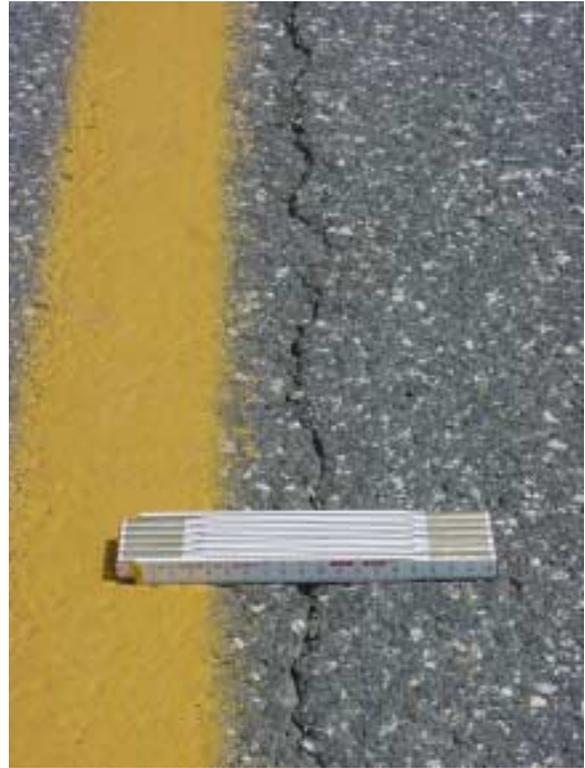
PHOTO 5.
SECTION II

Section II had 14% of joint separation, an increase of 5%, most of it being less than 6 mm (0.25 in) in width. The joint looks very tight with little ravel. Section V had 15% joint separation with no increase from last year. There was 21 m (69 ft) of cracking in the 13 to 19 mm (0.5 to 0.75 in) range. The remaining joint is slightly visible and worn from winter plowing.

Section II (control section rolling from low to high side of mat pinching the last 150 mm (6 in) of centerline joint) had the third lowest amount of cracking and the second lowest severity of cracking. This method of compaction combined with a conscientious paving crew should also be used to prevent premature joint separation.

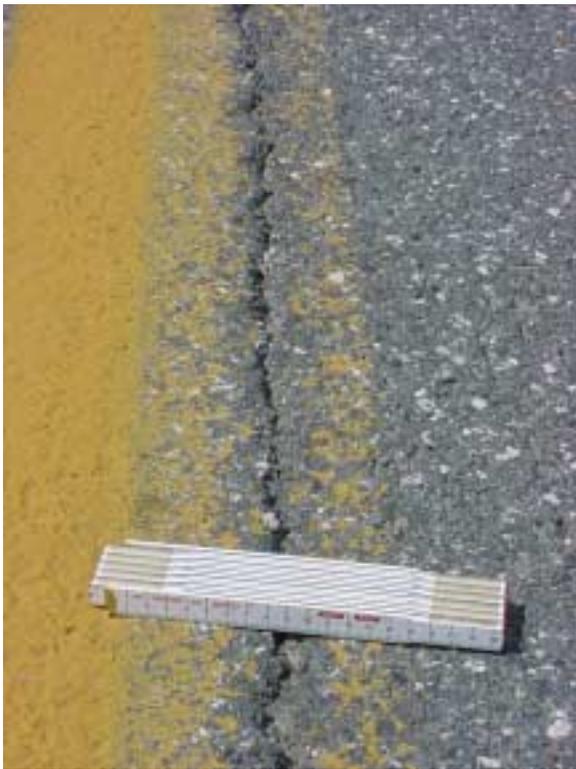
PHOTO 6.
SECTION III

Section III has cracked throughout 27% of the section with the majority of cracking in the less than 6 mm (0.25 in) range. Portions of this section have raveled.

Section III is also not recommended as an alternative rolling technique due to the amount of time necessary to smooth the ridge created at the center of the mat and the amount of cracking in this Section.

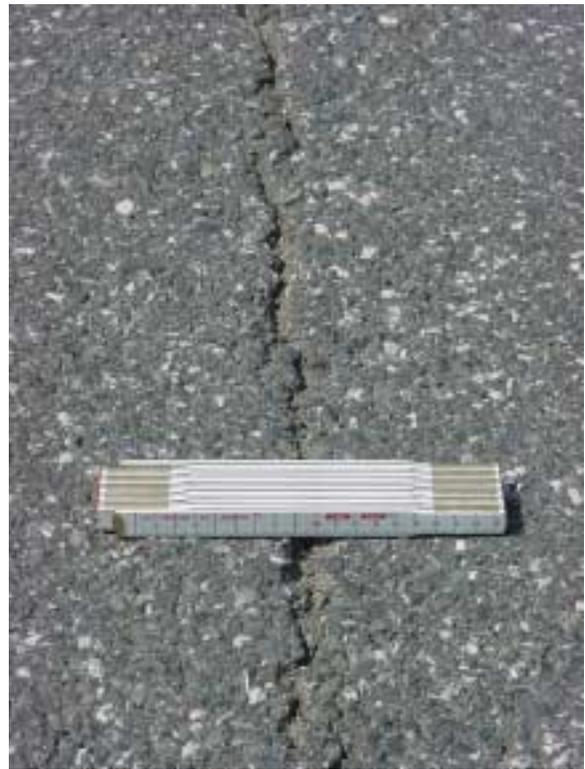
PHOTO 7.
SECTION IV

Section IV had no increase in cracking from the last evaluation and has the lowest amount of cracking at 6%. The centerline joint looks very good and the severity of cracking is limited to 13 mm (0.5 in) or less.

Section IV (first pass of roller in the static mode from the cold mat with a 150 mm (6 in) overlap on the hot mat) had the lowest amount and severity of cracking. This rolling technique appears to sufficiently compact the centerline joint and could be used as a standard rolling technique to reduce the amount of centerline cracking.

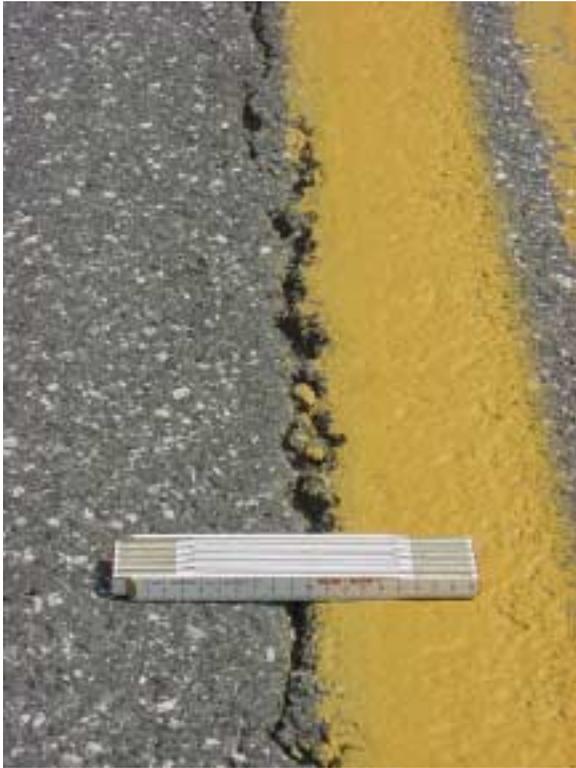
PHOTO 8.
SECTION V

Section V (first pass 150 mm (6 in) from the joint second pass pinching the joint) is very similar to the rolling technique of Section II and has produced nearly the same results. This method is very time consuming for the knockdown roller to roll the entire mat and is not suggested as an alternative rolling technique.

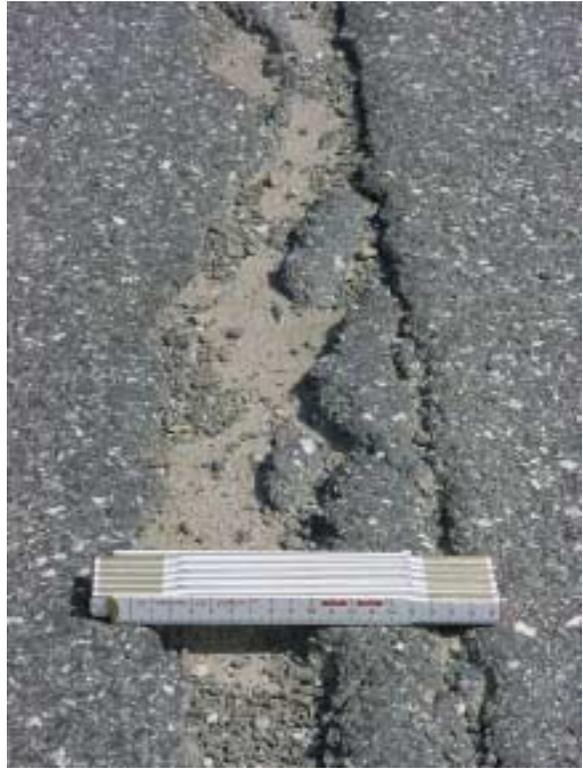
PHOTO 9.
SECTION VI

Eleven percent of Section VI has cracked with an increase of 2% from last year. Although this Section has the second lowest amount of cracking it has the greatest severity of cracking with a 17 m (56 ft) section that is greater than 25 mm (1 in) wide (see Photo 9). A number of reasons may have caused this cracking, poor placement of mix on the second mat (not enough overlap), the higher density edge of pavement on the first mat bridging the knockdown roller reducing density of the second mat or a poor joint on the existing pavement may have reflected through in this area. Tack is visible along 90% of the joint

Section VI (edge trim) is not recommended as an alternative unless the paving crew pays close attention to placing the mix. When trimming the edge of the first mat, it was difficult to keep a straight edge on the mat. This makes it difficult for the paver operator to follow the edge for proper mix placement resulting in premature joint separation.
