Maine Department of
Transportation
**Transportation Research
Division**

Technical Report 96-25 and 97-19
*Experimental Use of Sawed and Sealed Joints to
Minimize Thermal Cracking*

Interim Report - Fourth Year, June 2002

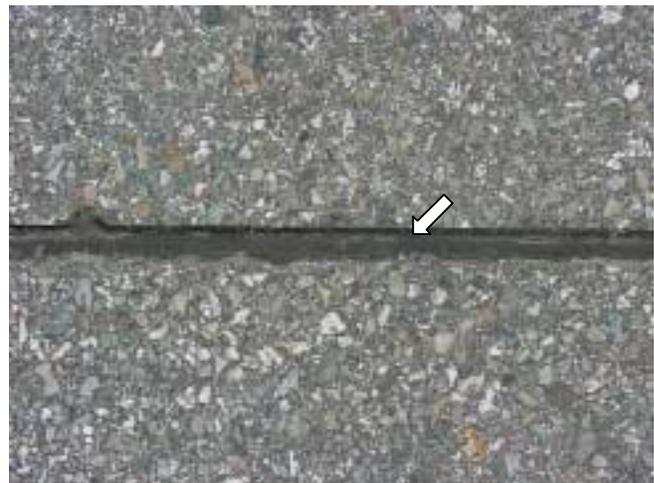
Sealant is pliable and adherence is good except at the roadway centerline (see photo at right) where it has separated from the sidewall along many of the joints.

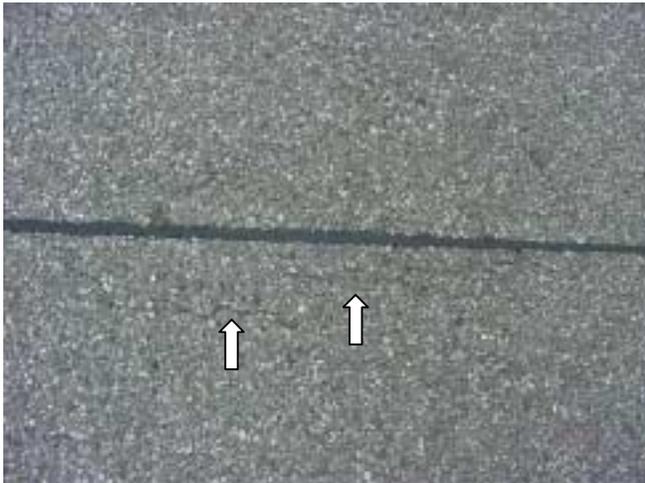
There are no transverse cracks. Centerline and edge joints have cracked throughout the length of the section. There are small areas of initial longitudinal cracking in the travel lane between wheel paths. Three sawed joints have cracks parallel to the sawed joint (see photo at left) in each wheel path of the

Of concern are the parallel cracks on the T1R6 - Sherman project. These areas will be examined closely to monitor the extent and severity of this type of cracking. One possible reason for the cracking is “tenting” of the joints during the winter months. During this time, each side of the sawed joint rose to form a small

“tent”. The extent of the tenting could be felt as you drive over the joints. This tenting could be weakening the pavement causing load cracks parallel to the sawed joint. It is uncertain what is causing this tenting effect. One theory is that since the DOT went to salt priority for winter snow control, the salt brine may be seeping into and under the sawed joint. When this brine freezes, the pressure may be causing the HMA to rise on each side of the sawed joint. This action may be weakening the HMA making it vulnerable to cracking.

The experimental sections will be evaluated in the fall of 2002 and a Final Report will be written with a detailed evaluation of the end and parallel cracking as well as a summary of the performance of the sawed joints.

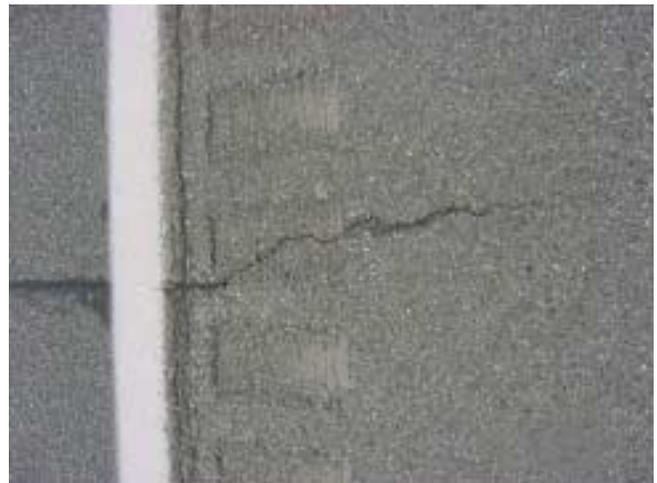
travel lane. Cracks have extended into the shoulder on at least one end of each sealed joint (see photo below).

Another concern is cracking at the end of the sawed joint. These cracks have been extending further into the shoulder and may migrate to the other side of the shoulder over time. There are more end cracks on the T1R6 - Sherman project due to the saw cut ending at the shoulder joint, because of rumble strips at the edge of the travel and passing lane, and not extending into the shoulder as on the Beddington project.
