Maine Department of
Transportation
**Transportation Research
Division**

Technical Report 99-11

*Innovative Solutions to Buried Portland
Cement Concrete Roadways – Rt. 100
Benton – Clinton & Rt. 2 Veazie*

Interim Report - Fourth Year, March 2004

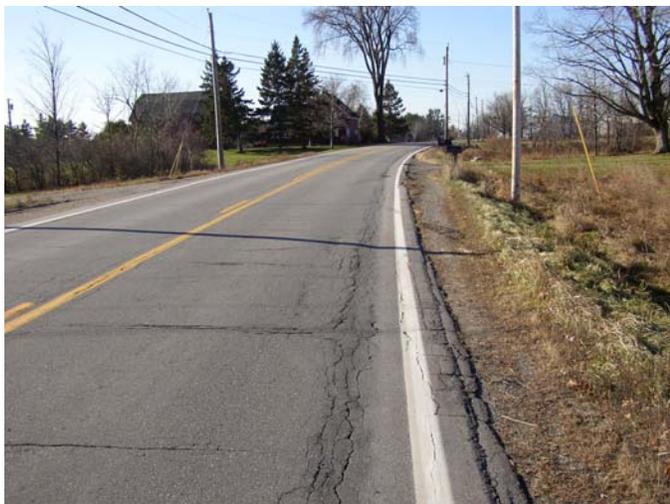
Photo 3. Control Section

Rut depths have increased in severity throughout this section. Three percent of the section had rut depths less than 6 mm (0.25 in), forty two percent were in the range of 6 to 13 mm (0.25 to 0.5 in), and fifty five percent are greater than 13 mm in depth, this is an increase of forty five percent in one year.

The centerline joint has no ravel and joint separation has increased from 51.4 to 65.2 percent.

The number of transverse cracks between the wheel path has decreased from last year. Many of these cracks have developed into full or half roadway transverse cracks resulting in an increase of half and full roadway transverse cracks.

Ninety nine percent of PCC edge related cracking has reflected thru the pavement (see Photo 3) and the shoulder elevation has dropped 4 to 12 mm (0.2 to 0.5 in) below roadway elevation.

The Control Section has failed in all categories and should not be used to support shoulder extensions on composite roadways.

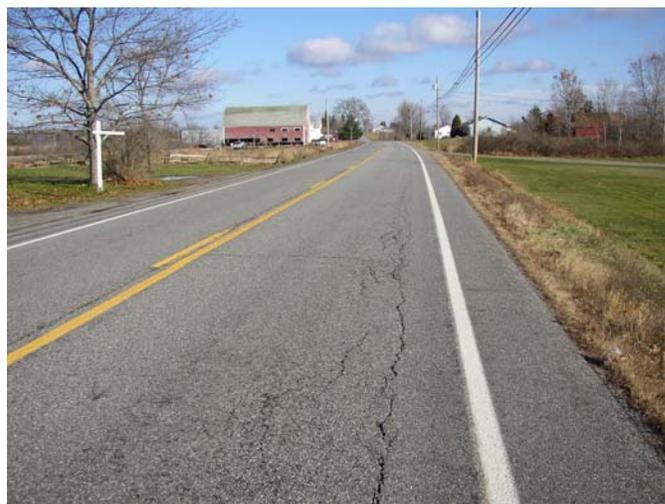
Photo 4. Section 1

PCC related longitudinal cracking has increased dramatically from 28.5 to 71.2 percent (see Photo 4). This is the greatest amount of this type of cracking among the experimental sections.

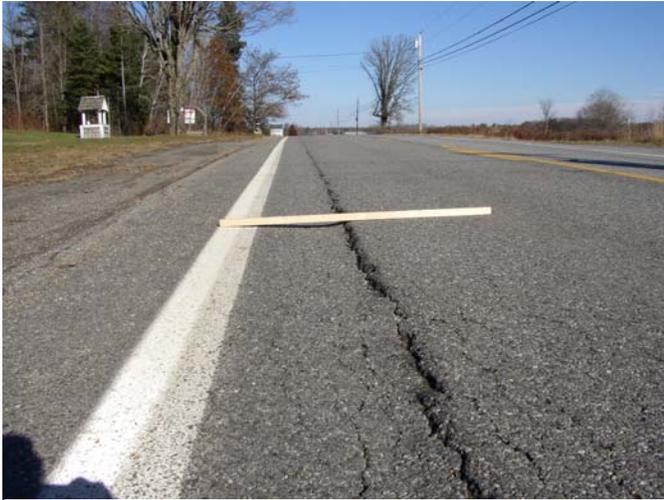
Photo 5. Severe Rutting in Section 2A

The severity of rutting has increased in Section 2A. Rut depths < 6 mm (0.25 in) in depth has decreased from 83.4 to 80 percent of the total section and rutting between 6 and 13 mm (0.25 and 0.5 in) in depth has also decreased from 10.8 to 5 percent while rutting greater than 13 mm (0.5 in) in depth has nearly tripled from 5.8 to 15 percent. There are a few areas in the South bound lane that have ruts at the PCC edge crack that are greater than 38 mm (1.5 in) in depth (see Photo 5).

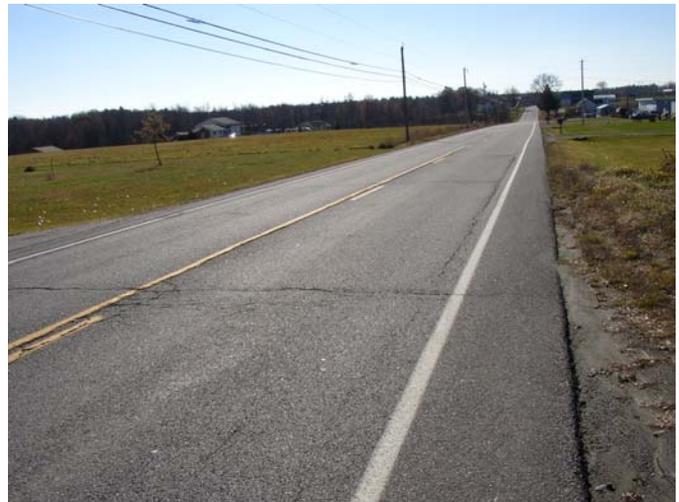
Photo 6. Section 2A

PCC related edge cracking has increased nearly a third from 49.2 to 71.1 percent with no shoulder elevation change (see Photo 6). This is the second highest amount of PCC related edge cracking among the experimental sections.

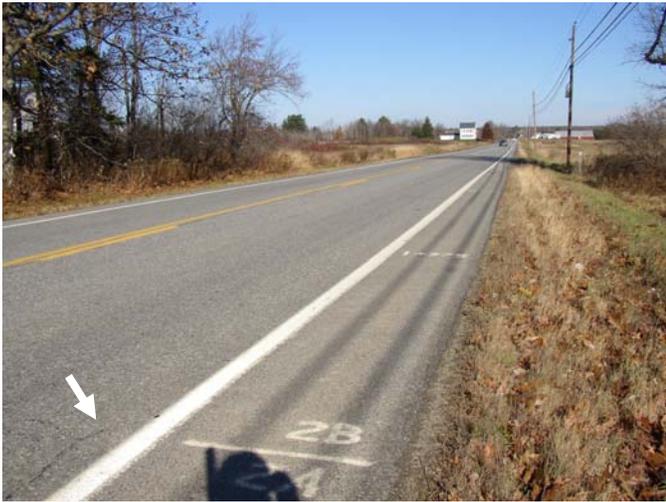
Photo 7. Section 2B

Although Section 2B is short, it continues to outperforming all other experimental sections.

Rut depths have remained the same at < 6 mm (< 0.25 in).

Centerline joint separation increased from 73 to 85.3 percent.

The number of full and half roadway transverse cracks has remained the same at 1 and 0 respectively. One transverse crack has developed between the wheel paths.

There has been a slight increase in PCC related edge cracking from 8.3 to 9.3 percent. This experimental treatment has reduced the amount of PCC related edge cracking better than all other sections. In the lower left hand corner of Photo 7, you can see where PCC edge cracking in Section 2A has stopped at the beginning of Section 2B.

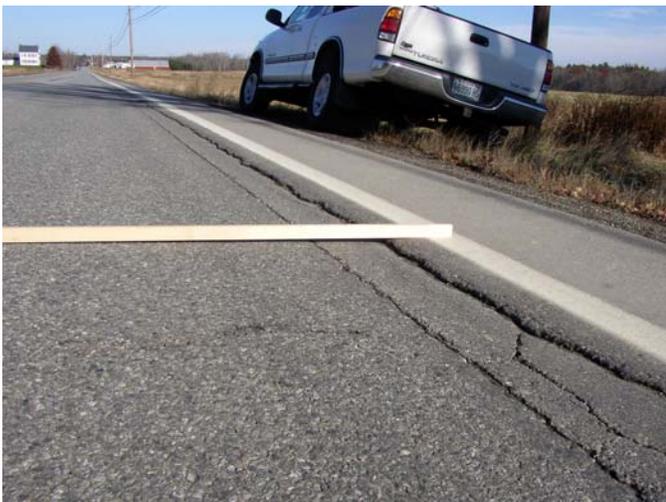
Photo 9. Section 3 Elevation Change

There is a 20 m (66 ft) long area in the North bound lane where the shoulder elevation is higher than the

roadway. Shoulder height has increased from 25 to 30 mm (1 to 1.25 in) over the past year. Photo 9 displays the elevation change. This is the only section where the shoulder elevation is higher than the roadway elevation. Water may be saturating the shoulder subbase by entering thru the bituminous construction joint and PCC edge crack. If the excess water does not have enough time to properly drain from the subbase aggregate before the roadway freezes, frost action in the spring may be raising the shoulder elevation above the roadway.

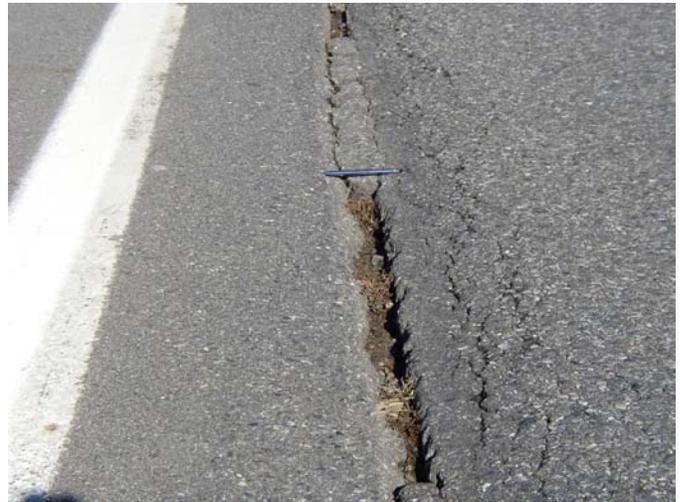
Photo 8. Section 3 Construction Joint

The longitudinal shoulder construction joint, 3 m (10 ft) left and right of centerline, has separated from the roadway throughout 99.7% of this section. The joint is greater than 24 mm (1 in) in width in some areas (see Photo 8).

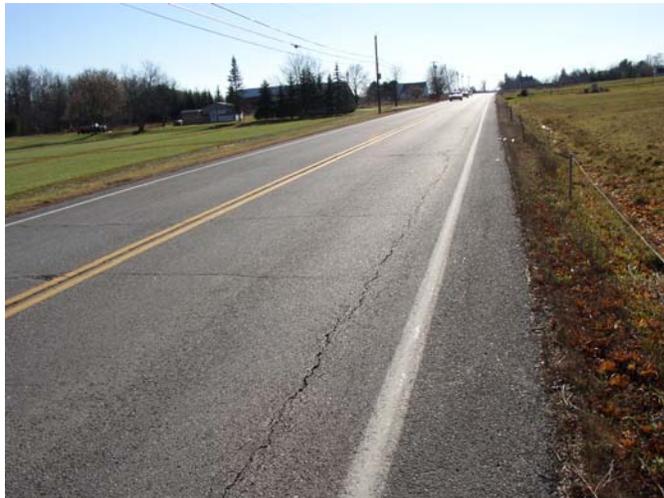
Photo 10. Section 4

PCC related edge cracking has increased from 40.3 to 68.6% (Photo 10). This is significantly less than the Control Section and slightly less than experimental Sections 1 and 2A. Experimental Sections 2B and 3 continue to have less PCC edge cracking.

Section 4 with Heavy Overlay has very high average shoulder deflections as compared to Section 1, 2A, 2B, and 3. The shoulder elevation is even with the roadway but rutting continues to increase in depth. When comparing this section to the Control section the only noticeable improvement is fewer transverse cracks. High shoulder deflections is an indicator of shoulder deterioration in the future and because of this and the severity of rutting this treatment should not be considered to increase the width of composite roadways.

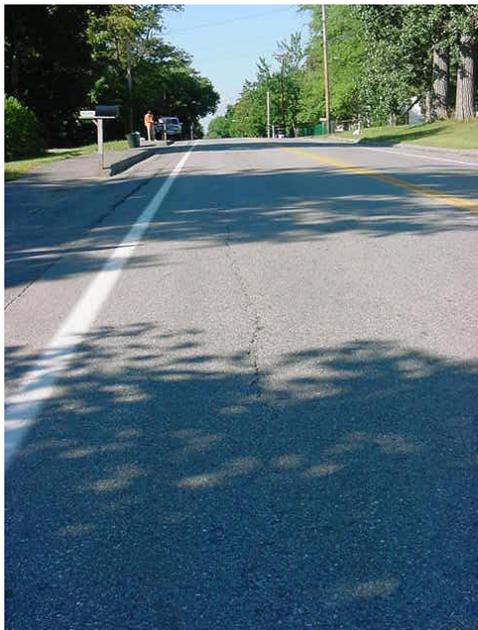
Photo 11. Self Adhesive Mesh

PCC edge related cracking has increased from 5.9 to 16.8 percent (Photo 11). Although this is nearly three times higher than the last evaluation, it is still well below the amount of cracking in the Control Section.

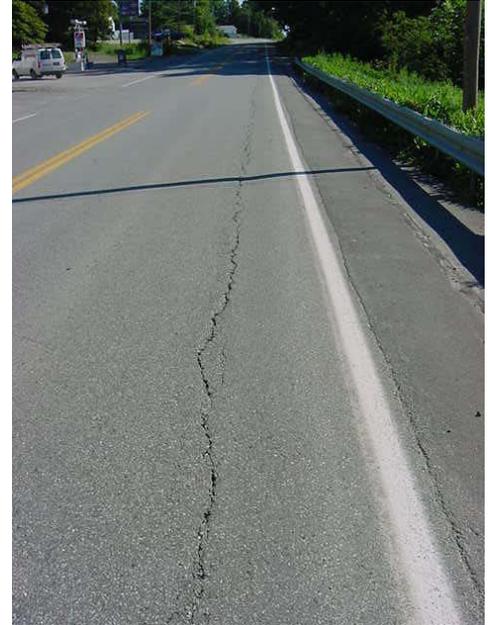
Photo 12. Control Section

PCC edge related cracking has increased somewhat from 33.3 to 36.8% (Photo 12) and shoulder elevation has remained the same at 6 mm (0.25 in) below the roadway.
