Technical Report 15-05

Bridge-in-a-Backpack™

*Task 7: Investigation of Damage and Repairs for
Concrete Filled FRP Tubular Arches*

Final Report – April 2015

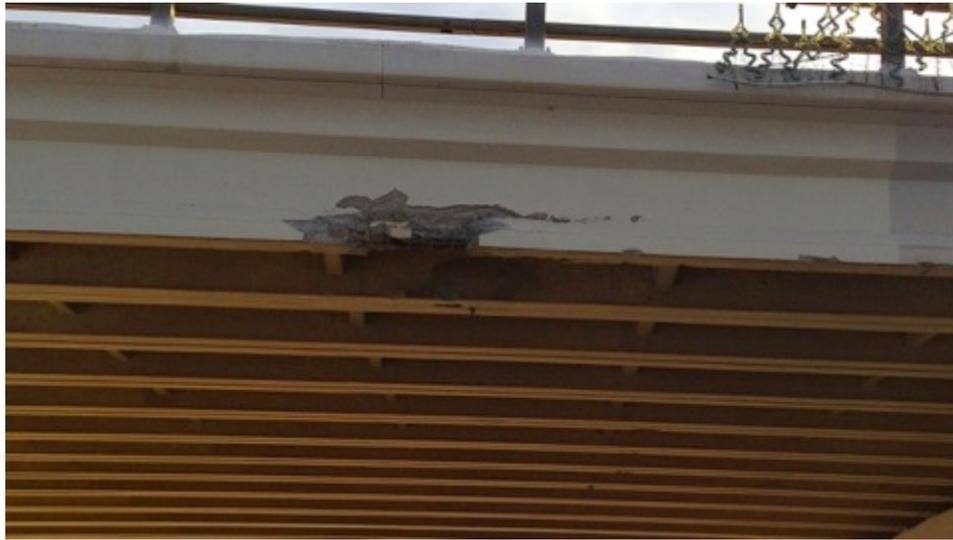
Bridge damage can be caused in many ways such as vehicle or equipment impact where traffic flows under the arch bridge, debris or ice impact for stream or river crossings, or vandalism. An example of collision damage is shown in Figure 1.

Figure 1. Example of collision damage to a reinforced concrete bridge

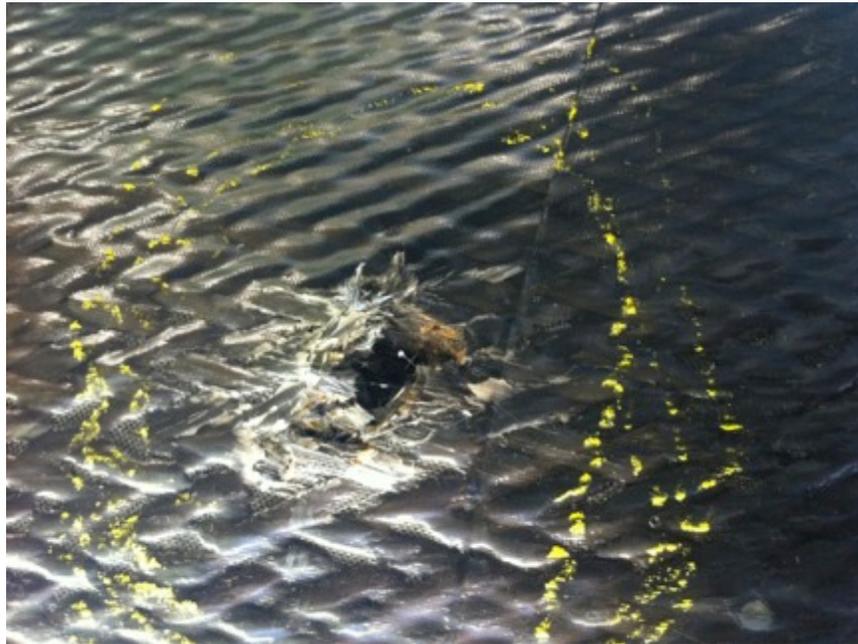
Composite damage could include chips, cuts and cracks, delaminations, fractures, scratches and penetrations. These types of damage and imperfections are defined in ASTM D 2563. Another example of damage is shown in Figure 2 where a penetration is shown through the FRP shell.

Figure 2. Penetration into tube

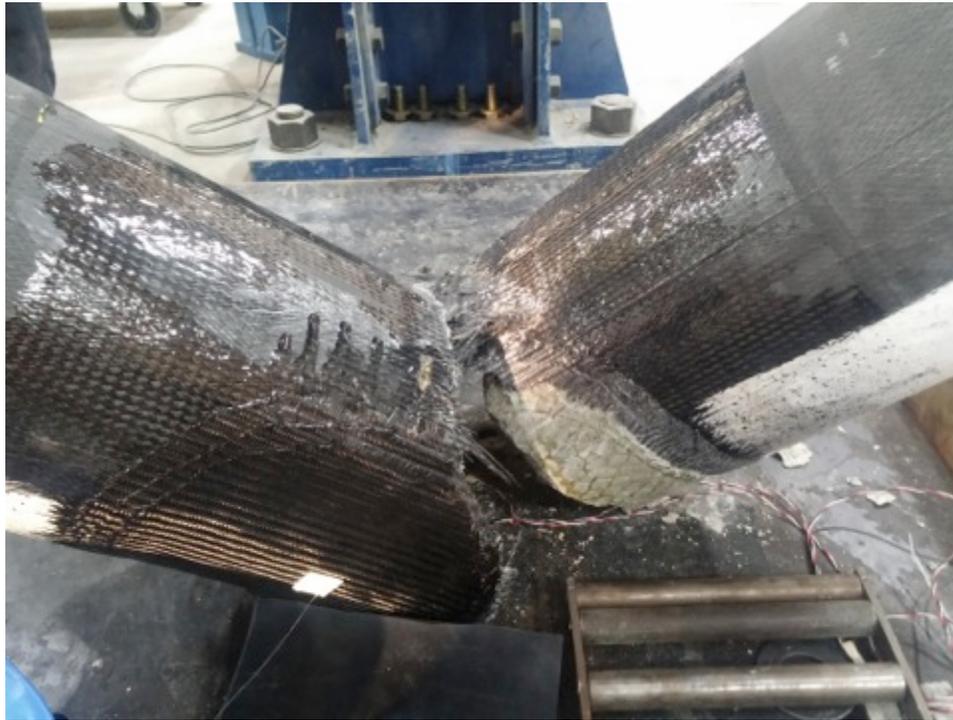
Both beams failed at lower loads than they did in the damaged beam study (17.05 kip and 16.18 kip respectively for beam H & I). A failed beam can be seen in Figure 8 where the patch appeared to fail in or near the bondline. A summary of the resulting loading is given in Table 3.

Figure 8. Failed beam

Upon closer look, the patch fabric for both repaired beams appears to have been bonded with its strongest axis parallel rather than perpendicular to the beam crack, as was intended (Appendix A, step 19). More detailed analysis of the bondline and corrected fiber direction should be included if it's possible to repeat these tests. The process of substrate preparation and secondary bonding is a good example but unfortunately a successful repair was not shown in this test.

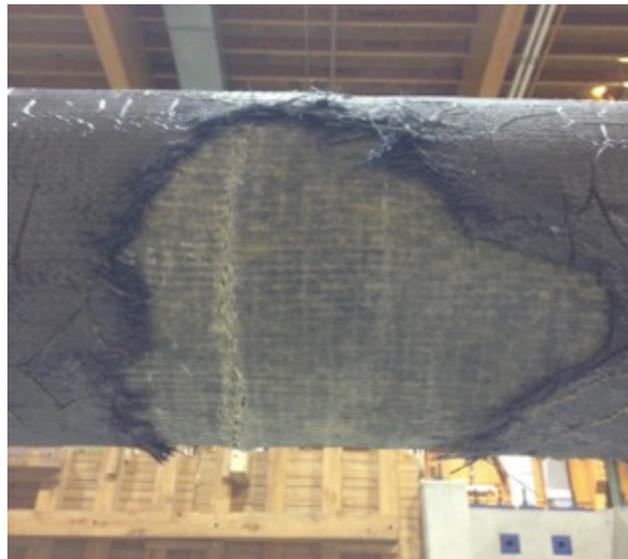
The procedure for repairing the previously failed CFRP arch was begun by cutting away ruptured fibers from the damaged area. The fibers were cut back until only undamaged fibers still adhered to the concrete remained (Figure 10). The exposed area was then cut and shaped to remove any sharp corners, to minimize stress concentrations in the remaining material. The edges of the carbon material were then ground down to a taper of approximately 10:1 (e.g. 1 in. for a 0.1 in layer of carbon). An area 3 in. beyond the repair area was sanded down to remove resin and expose fiber, creating a good bonding surface and establishing the desired profile. The repair area was then thoroughly vacuumed then wiped down with 99.8% isopropyl alcohol wipes.

Figure 10. Damaged arch surface preparation (ruptured carbon FRP removed)

Any cracks, voids, or sharp transitions were filled with KCR structural putty. Once the putty had cured, the area was given a final sanding. The repair area was primed with a light coat of M1002 toughened epoxy resin and allowed to cure until tack free. The area was then wetted with a heavy coat of resin and the first of the 7 layers of the carbon fiber patch were placed. Any entrapped air pockets were pressed out by hand. The 6 subsequent layers were then placed in a similar manner. The patch was allowed to cure at room temperature for 15 hours (Figure 11). Then, the patch was heated to 140°F and held for 8 hours.

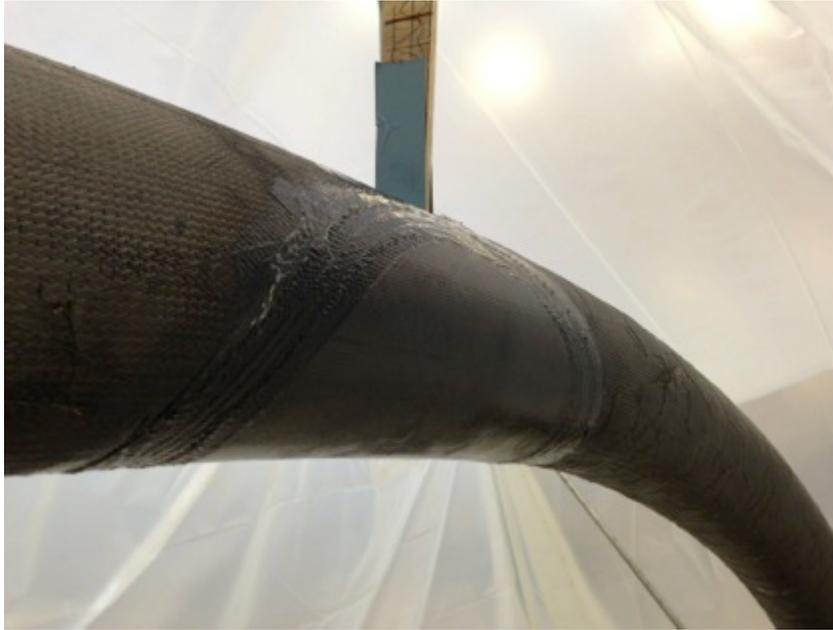
Figure 11. Repaired arch patch

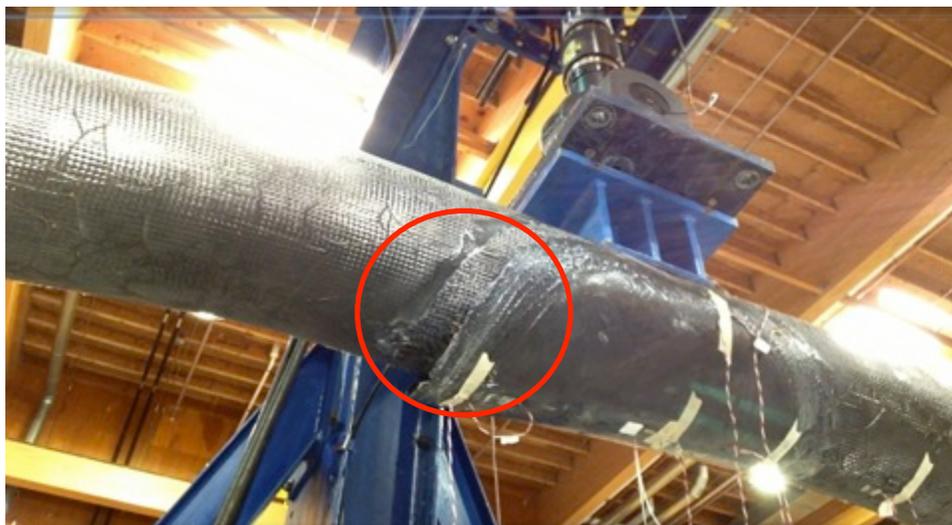
The arch test reached a peak load of 43,041 pounds prior to the repair failure. An ultimate load of 60,321 lbs was seen when the arch shoulder ruptured. The repair failed in the bondline of the patch as seen in Figure 14. Load versus deflection at the crown of the arch can be seen in Figure 155.

Figure 14. Bondline failure of repaired arch

The arch failed at a load lower than the original capacity of the member which was 62.3 kips (Nagy et al 2009). Additional bondline width or strength could be designed in future applications however it is expected that the moment gradients seen in this test with the single point load at the crown contributed to unrealistic peeling stresses for in-service bridges. Repair methods and professionals are available should there be a need for these services.

Among the several available methods of repair, single sided, bonded repairs with scarf joints may be the most aesthetically pleasing. Design methods such as that in Duong and Wang provide reasonable solutions for repairs for many situations, but with limited results for the test specimens here. As the particular repair method used on beams H and I has not been shown to be effective, other potential repair methods for reinforced hybrid concrete beams should be developed and tested. These need to emphasize the bondline design and potentially use additional factors of safety where peeling stresses due to the geometry may be greater than predicted with the linear cross section design. Surface preparation and curing are also very important to the quality of the repair and should be considered and discussed when repairs are needed.
