Automated Track Video Inspection Pilot Project

SEPTEMBER 2013

FTA Report No. 0049
Federal Transit Administration

PREPARED BY
MTA-NYCT

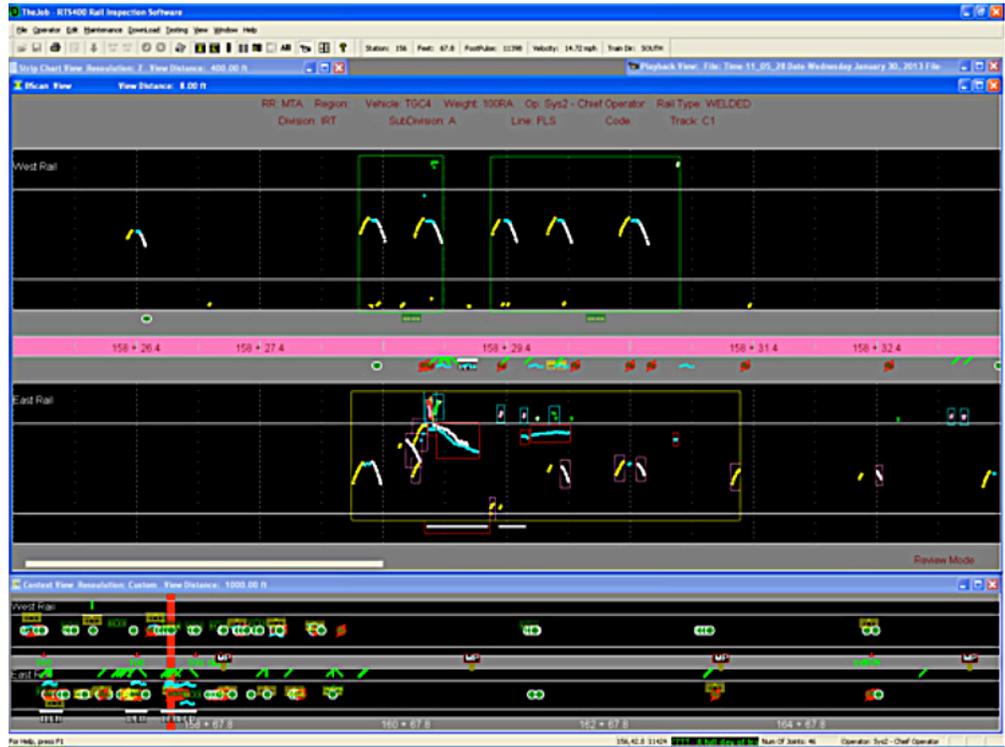
Figure 4-5
B-Scan of detected UT defect on track C1 at station # 158+28

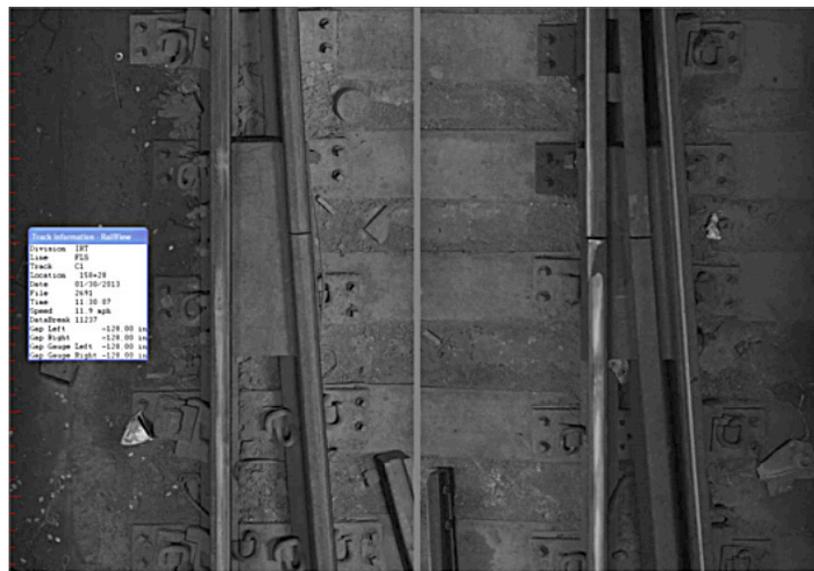
Figure 4-6
Rail View Video picture of UT defect location on track C1 at station # 158+28

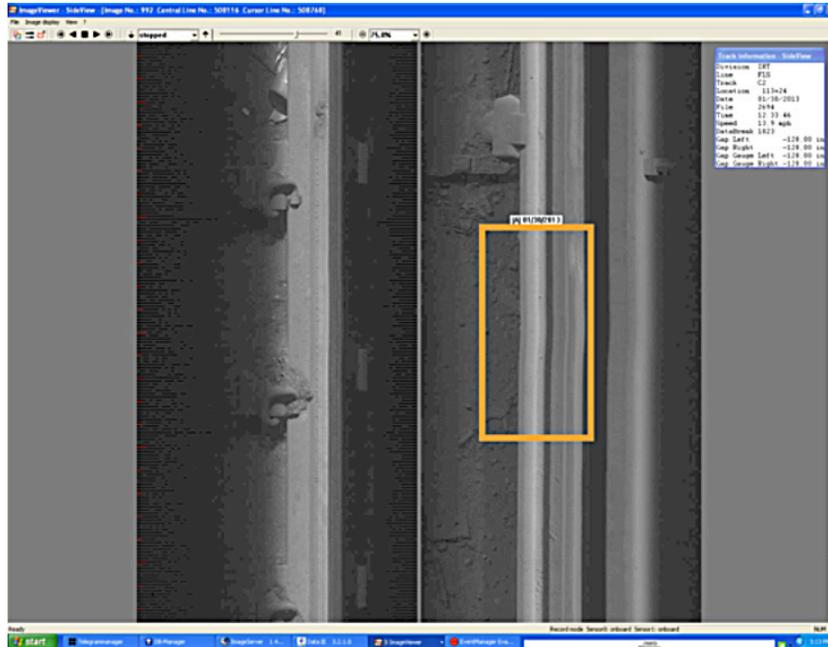
Marquee (right image) showing condition detected with Power Rail View video system on track C2, run of 1/30/2013

No third rail or cover board defects were observed with the new Power Rail View video system. Defects detected with the Third Rail KLD system that were further analyzed with the Power Rail View video system appeared to be distinguished most of the time. Only one condition was detected with the Power Rail View video system on the third rail, and it was classified as Power Rail View Video defect #TRVideo01, consisting of a slight gouge on the contact rail surface, as determined by the reviewer.

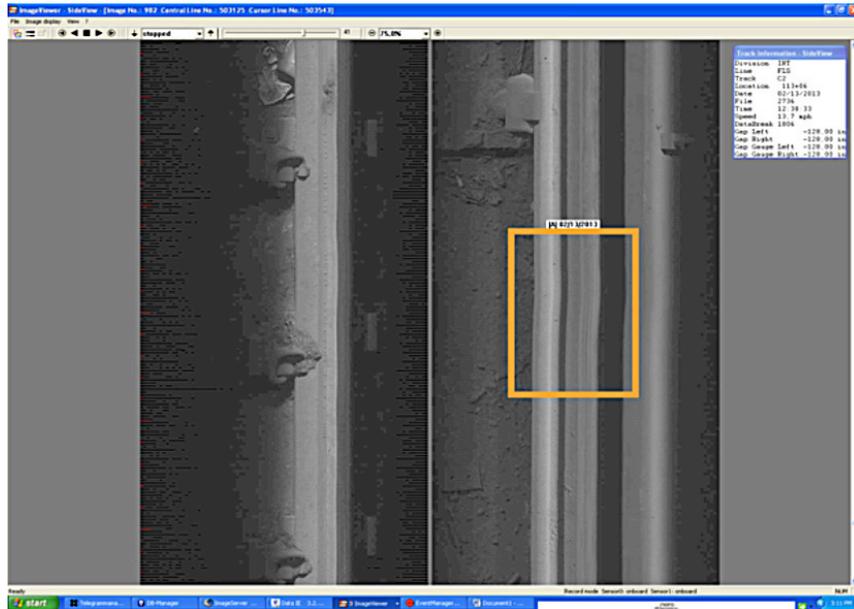
Figure 4-23
Marquee (right image) showing condition detected with Power Rail View Video System on Track C2 – run of 2/13/2013

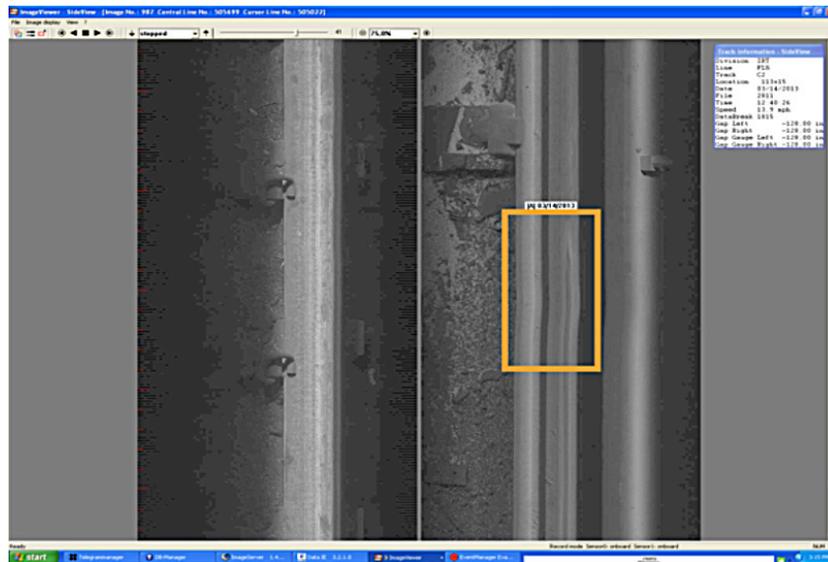
Marquee (right image) showing condition detected with Power Rail View video system on 3/14/2013 inspection run

No new third rail or cover board defects were detected in the video files analyzed and reviewed with the Power Rail View video system, except for the one condition detected in previous inspections and classified as a “slight gouge” on the contact rail (defect ID TRVideo01).

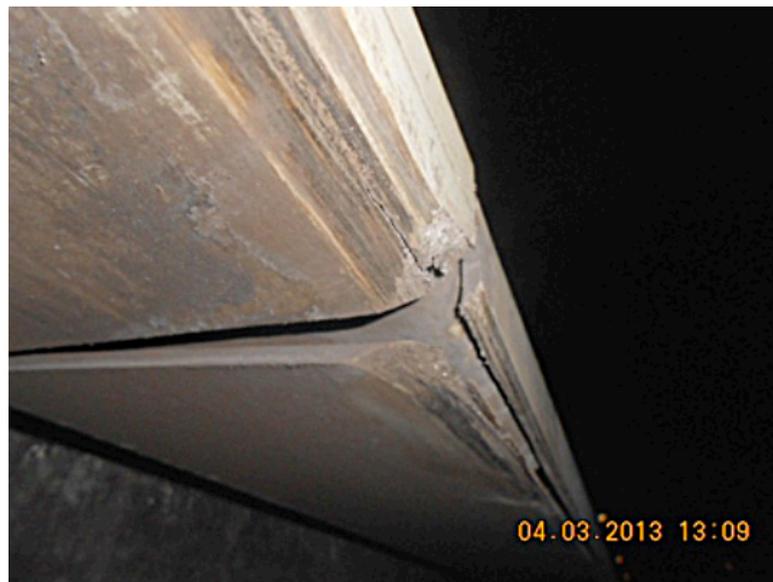
Underside of cover board rubbed by third rail shoe of passenger cars (field supervisor picture)

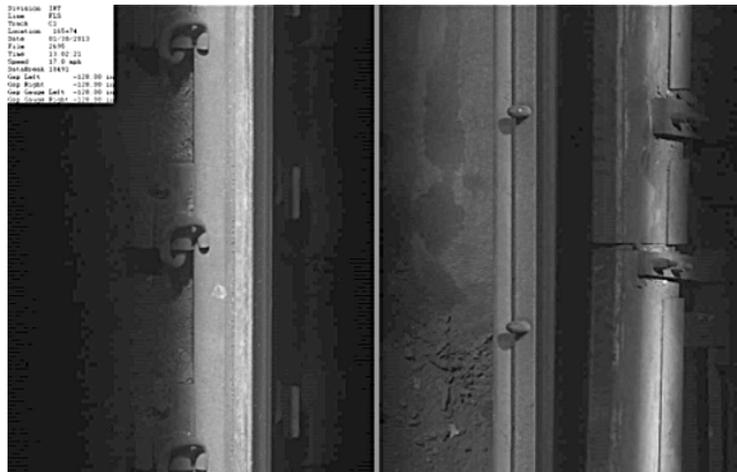
Figure 4-31
Cover board viewed
in TGC4 Power
Rail View video
system of 1/30/2013
inspection run

The limitations regarding the angle of the Power Rail View video camera, the levels of illumination, the position of the lights, and the lack of color in the images did not allow the reviewer to realize that there were rubbing marks on the underside of the cover board.

- The Power Rail View video system camera and illumination should ideally be placed in a lower position to allow viewing of conditions under the power rail's cover board. The Power Rail View video system, as it was installed in the TGC4, was not able to detect rubbing marks on the underside of the cover board because of the camera position and the lack of optimal illumination.

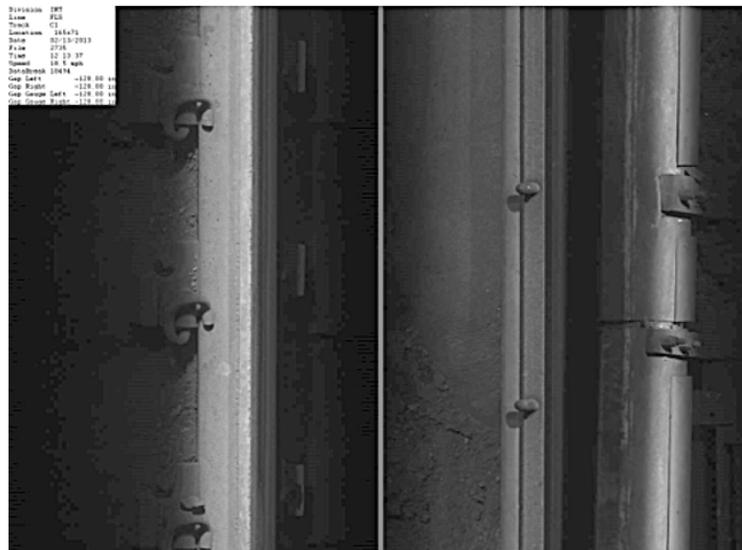
Figure 4-32
Cover board viewed
in TGC4 Power
Rail View video
system of 2/13/2013
inspection run

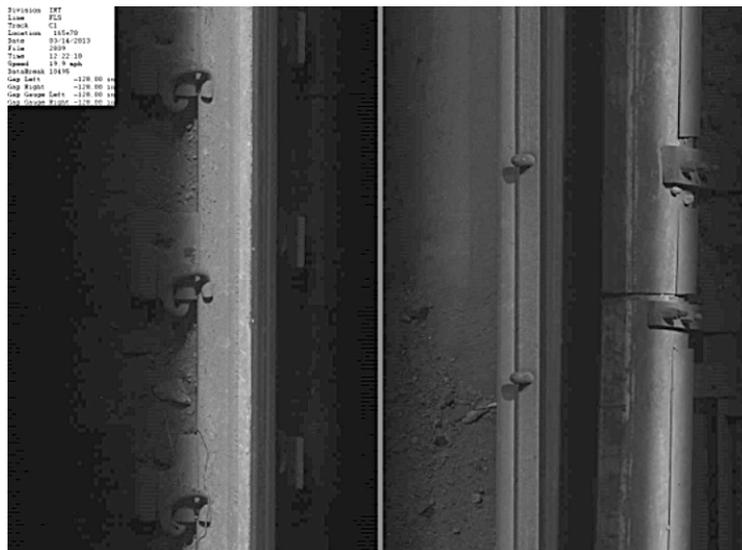
Figure 4-33
Cover board viewed
in TGC4 Power
Rail View video
system of 3/14/2013
inspection run

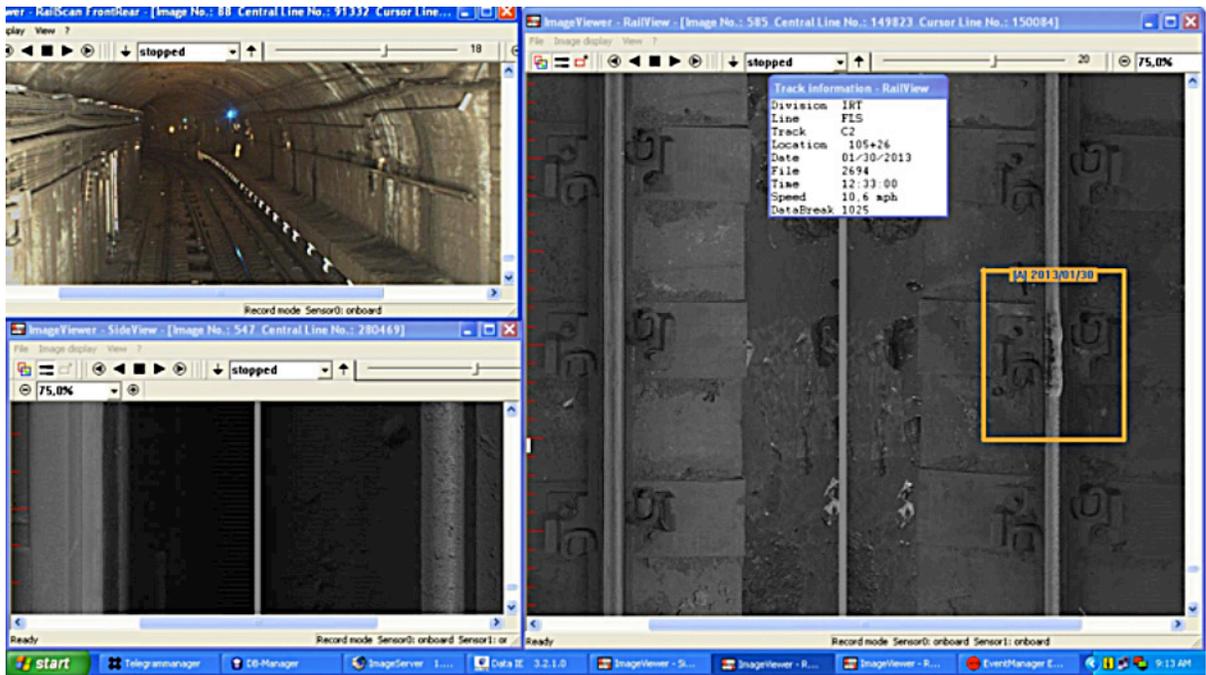
Figure 4-35
Rail View defect detected and marked in 1/30/2013 inspection run

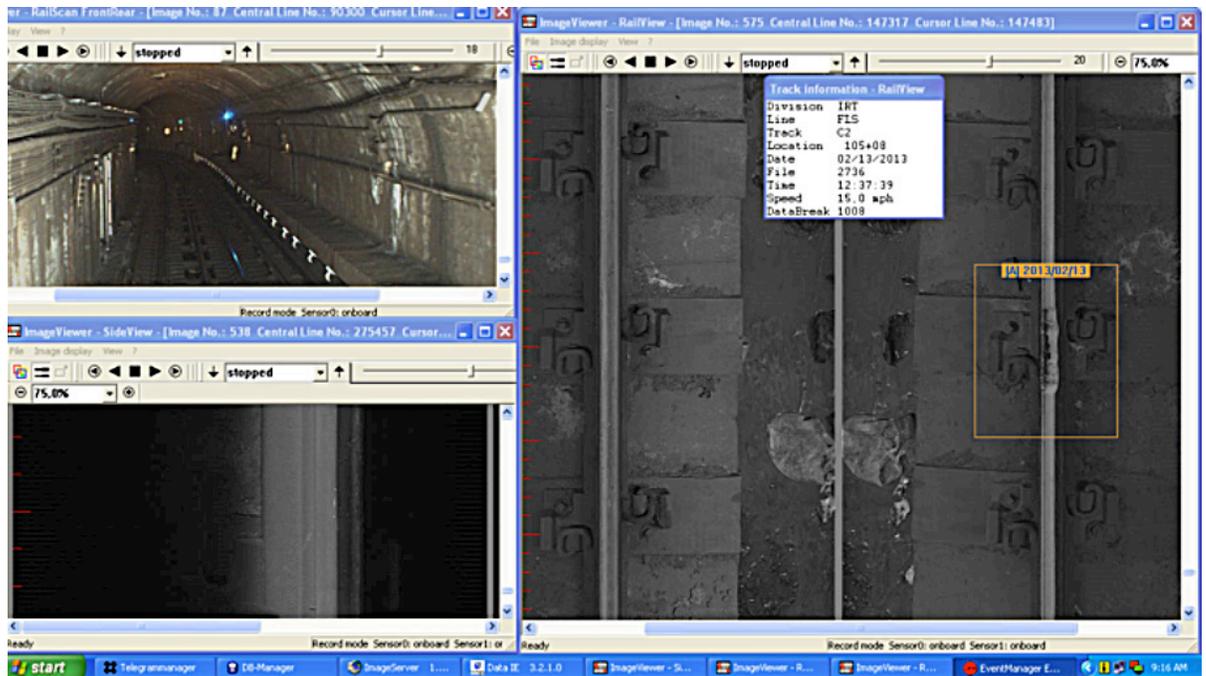
Figure 4-36
Same Rail View defect detected and marked in 2/13/2013 inspection run
