Evaluation of Stay-in-Place Metal Forms

for the
Ohio Department of Transportation
Office of Research and Development

State Job Number 134155

Final Report
FHWA/OH – 2006/13
May 2006

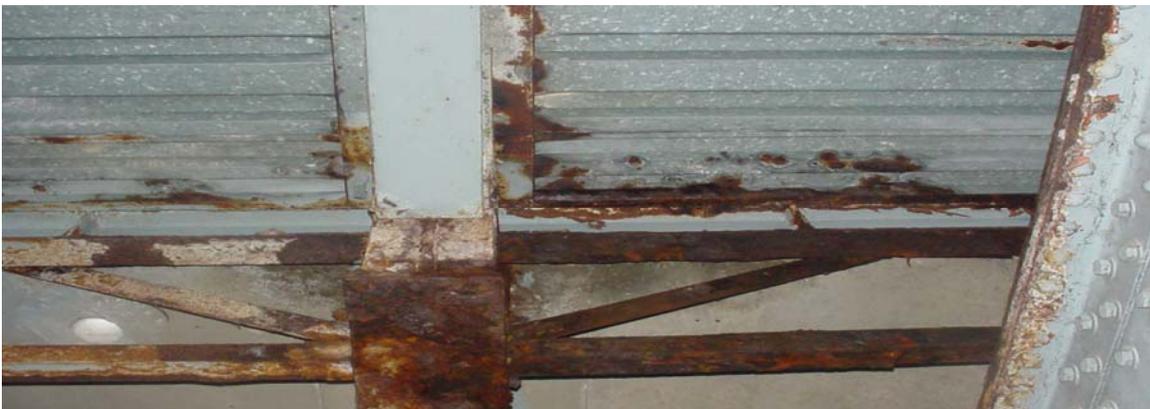
Overall, the bridge was in fairly good condition except for a few areas. One noticeable problem area was along the first expansion joint. This expansion joint, where the SIPMF area meets the non-SIPMF area, showed an excessive amount of rust. Because of this, a few core samples were extracted from this area to determine the properties of the concrete in this area. Figure 1.3 provides a picture of this problem area.

Figure 1.3. LOR-57-18.18 Excessive Rust at First Expansion Joints

SIPMF near expansion joints and SIPMF with holes in it experienced localized rusting near these water sources. It is recommended the number of holes be minimized and steps be taken to prevent water from flowing around the edges of the SIPMF. It has also been reported that SIPMF on underpasses in urban areas experienced deterioration from water being continually thrown on the bottom of the bridge.

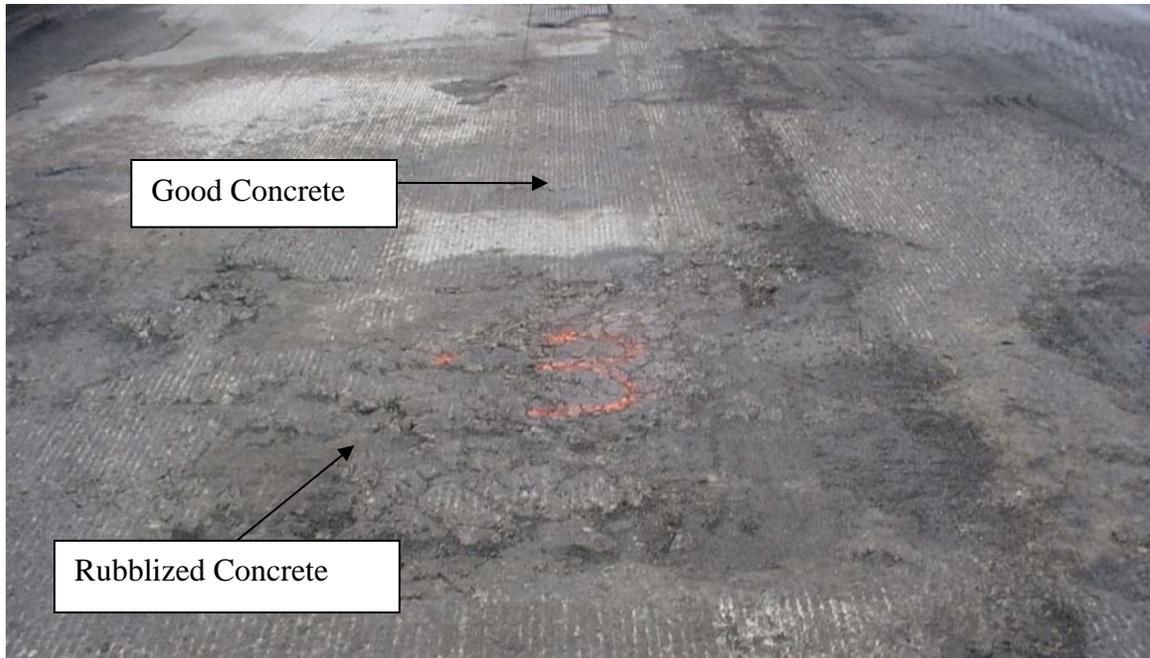
Another area of concern was the bridge deck. The deck showed a few areas in which the surface concrete was totally rubblized. This is illustrated in Figure 1.4.

Figure 1.4. LOR-57-18.18 Rubblized Deck

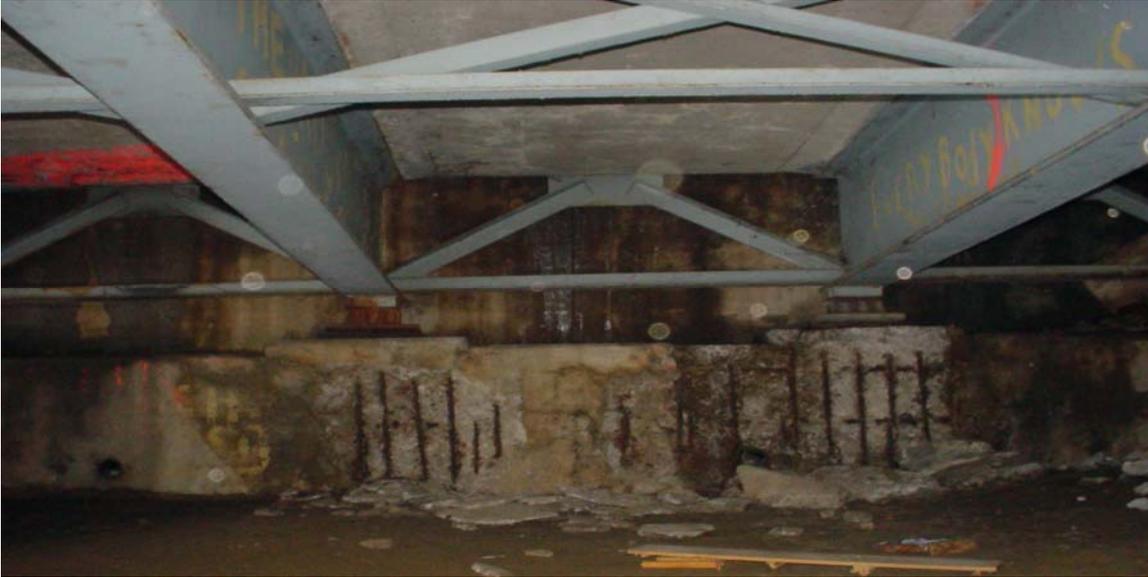
Lastly, the area along the joint between the approach slab and the first span also showed an excessive amount of rust. The expansion joint at this area was totally deteriorated and water was found settled in the joint. This problem was magnified due to the fact that the drainage on bridge was not working properly. All the drains were clogged with debris, which caused the water to collect along this joint. This problem is shown in Figure 1.5.

Figure 1.5. Excessive Rust at Joint Between Approach Slab and First Span

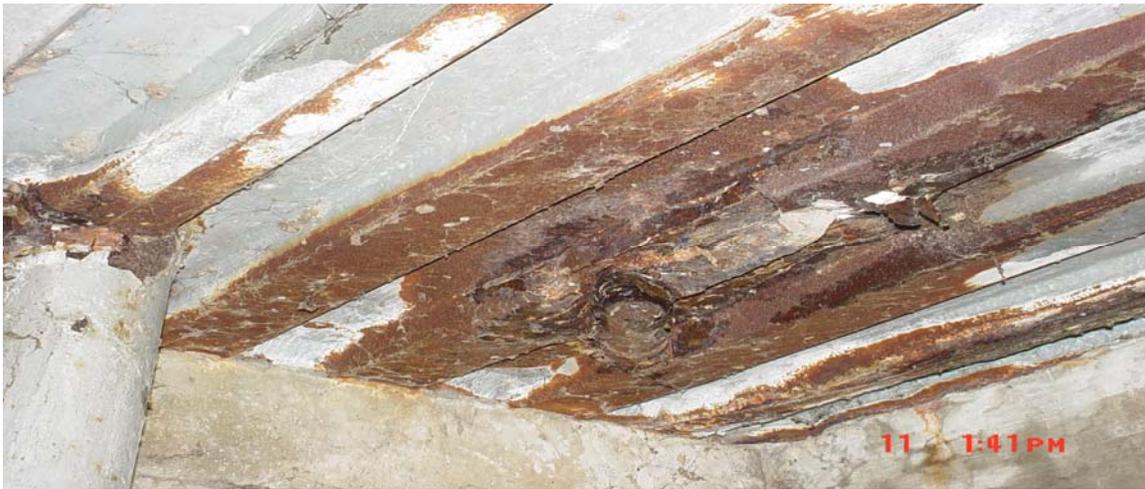
The one noticeable problem area was along the area where the approach slab meets the deck. This area showed an excessive amount of rust on the SIPMF. This problem originated because that the drains on the bridge were extremely clogged with debris causing the water to collect in this area. Figure 1.9 shows the heavy amount of rust on the SIPMF.

Figure 1.9. OTT-2-28.41 Excessive Rust of SIPMF

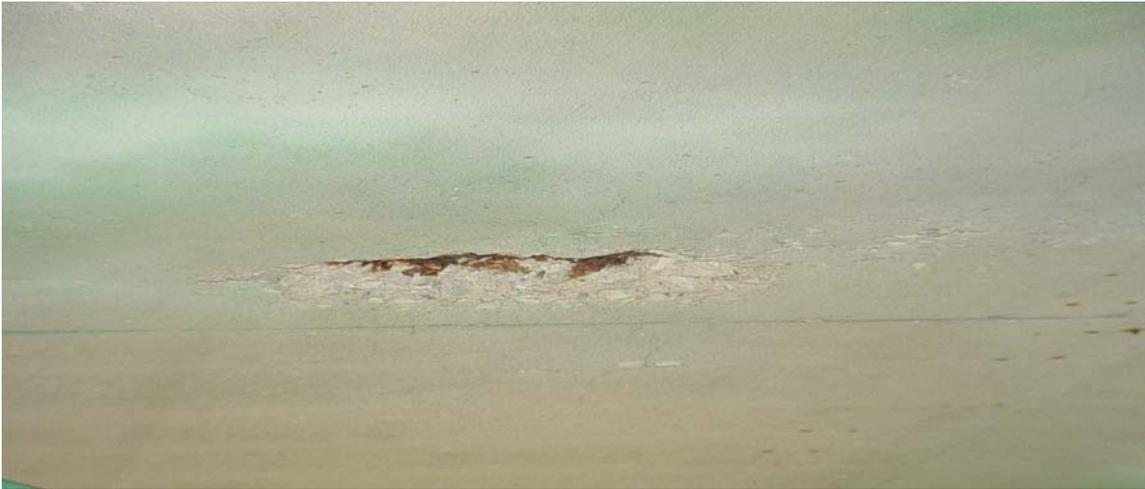
The overall condition of the bridge was good. The SIPMF were in good condition. They showed no signs of rust. The deck also appeared to be intact. It showed very little transverse or longitudinal cracks from our initial inspection. However, the bridge did show some areas of concern. The bottom of the deck had a few areas where the concrete had begun to spall. This is illustrated in Figure 1.12.

Figure 1.12. LAK-90-23.42 Spalling of Deck Bottom

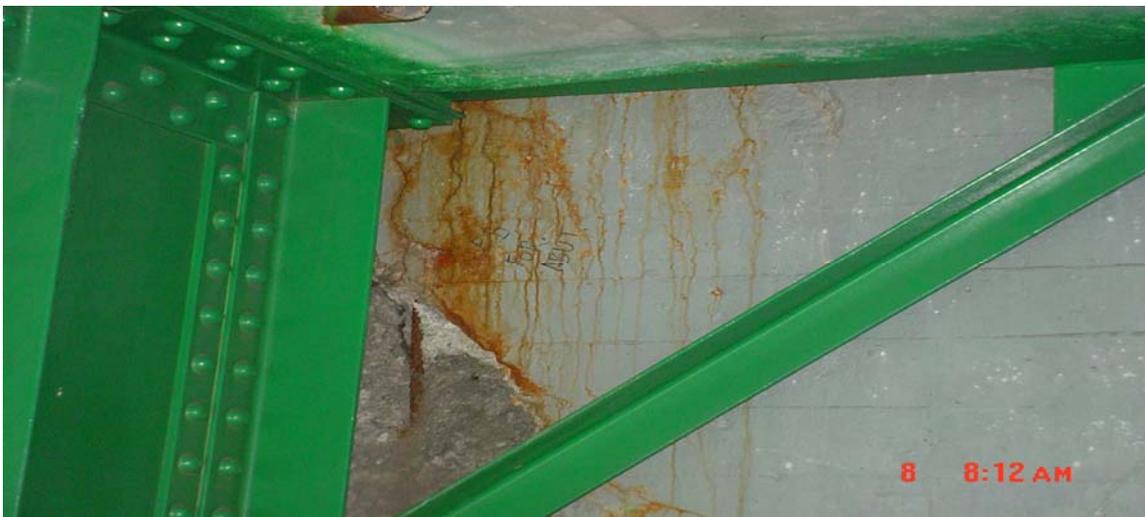
Another area of concern was along the expansion joints. The expansion joint located between the approach slab and first span showed some signs of rust. The other expansion joints also exhibited signs of rust. Once again, this problem can be attributed to the poor drainage on the bridge. All the drains on the bridge deck were clogged with debris causing the water to collect in the expansion joints. Figure 1.13 shows the rust present at the expansion joint located between the approach slab and the first span.

Figure 1.13. LAK-90-23.42 Rust at Expansion Joint

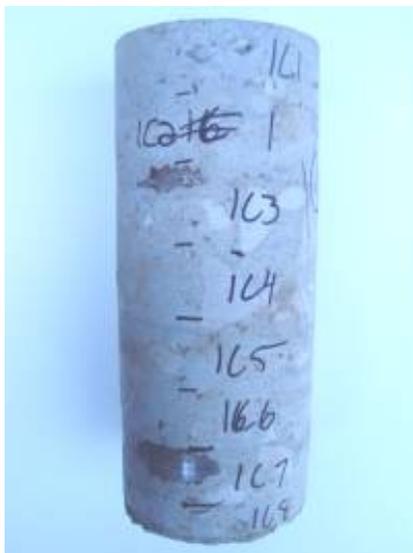
- 9.25 in.(228.6 mm) height.
- 2 reinforcement bars, non-epoxy coated located at 2.75 in. (69.85 mm) and 7.75 in. (196.9 mm) from top surface.
- Some rust traces on bars.
- Voids located at 1.25 in. (31.75 mm), 7 in. (177.8 mm) , and 8.5 in. (215.6 mm) from the top surface.

Figure 7.2. Core 1C shows rust traces

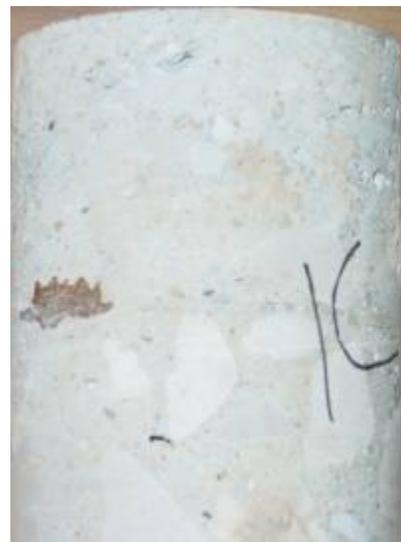
Figure 7.3. Core 1C shows small voids

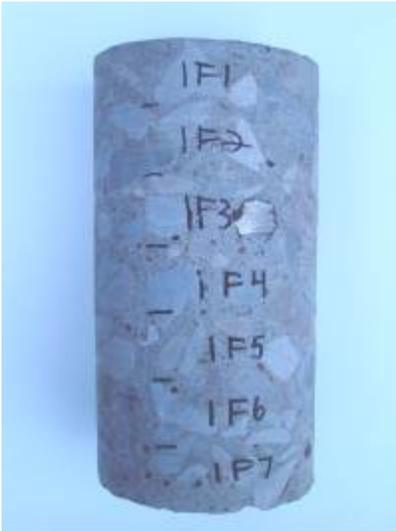
- 8.75 in. (222.3mm) height.
- Regions of small to moderate voids.
- 1 reinforcing bar, non-epoxy coated, located at 3.5 in. (88.9 mm) from top surface.
- Some rust existed at edges of reinforcement bar.
- 1 horizontal crack located at 2.5 in. (63.5 mm) from top surface.

Figure 7.4. Core 1F shows rust traces

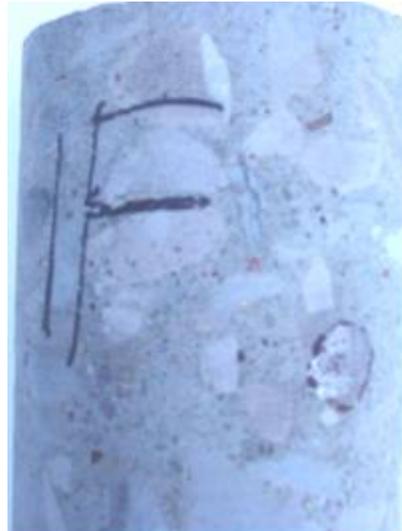
Figure 7.5. Core 1F shows small voids

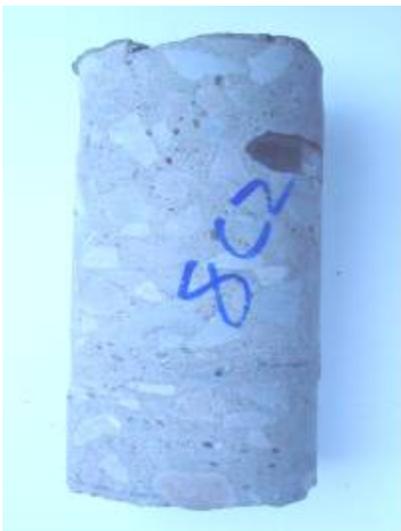
- 9 in. (228.6 mm) height.
- 3 reinforcement bars located at 2.5 in. (63.5 mm), 6.75 in. (171.5 mm), and 7.75 in. (196.9 mm) from the top surface.
- Bars are not coated and show slight signs of rust.

Figure 7.10. Core 8C2 shows rust in steel reinforcement

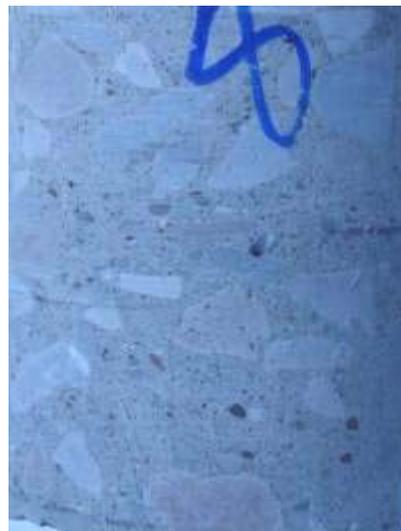
Figure 7.11. Core 8C2 shows small voids

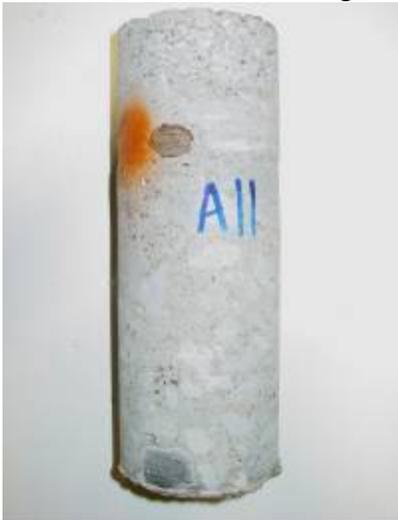
- 10.75 in. (273.1 mm) height.
- Regions of moderate to large voids located at 7 in. (177.8 mm) from top surface.
- 2 reinforcing bar, non-epoxy coated located at 3 in. (76.2 mm) and 4 in. (101.6 mm) from top surface.
- The bars show severe rusting.

Figure 7.19. Core A11 shows uncoated bars

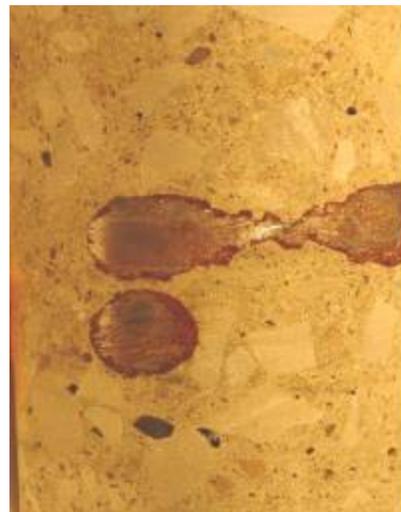
Figure 7.20. Core A11 shows severe rusting

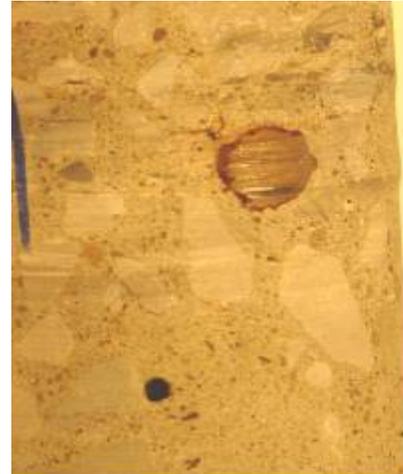
Figure 7.26. Core A9 shows severe rusting

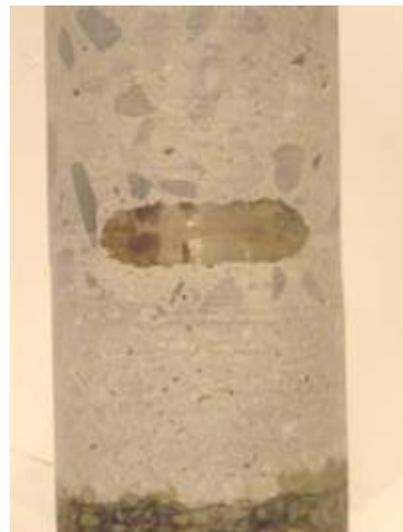
Figure 7.33. Bars show some rusting

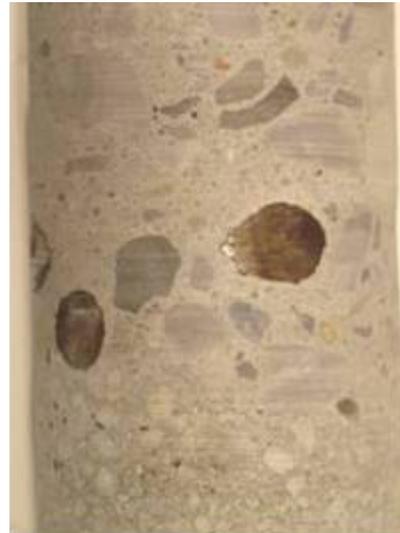
Figure 7.35. Bars show some rusting

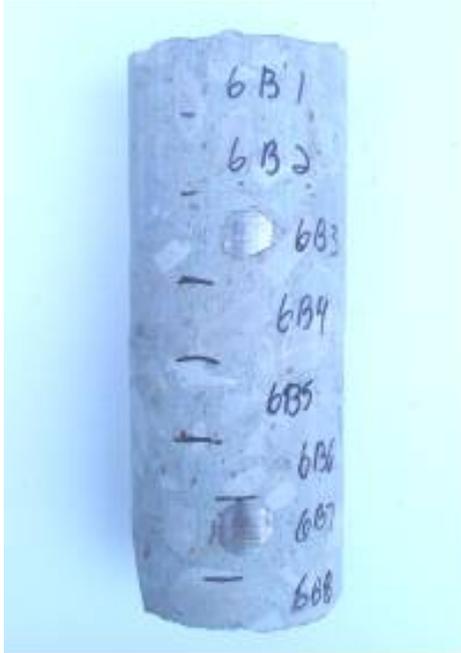
- 7.875 in. (200 mm) height (9.75 in. (247.7 mm) with the concrete in the region of the valley of the SIPMF).
- 2 reinforcement bars located at 3 in. (76.2 mm) and 7.5 in. (190.5 mm) from top.
- Bars are not coated and show some rust traces.
- Small region of honeycombing at 3 in. (76.2 mm) from the top surface.
- Concrete broken in region of SIPMF.

Figure 7.47. Core 6B shows small region of honeycombing

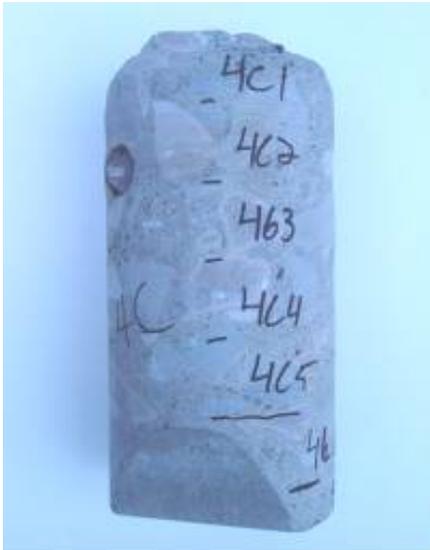
- 6.625 in. (168.3 mm) height (8.25 in. (209.6 mm) with the concrete in the region of the valley of the SIPMF).
- Concrete broken at the top.
- 3 reinforcing bars located at 2 in. (50.8 mm), 6 in. (152.4 mm), and 7 in. (177.8 mm), from bottom surface.
- Bars are not coated and show severe rusting
- Region of voids at 6 in. (152.4 mm) from bottom.

Figure 7.49. Broken concrete at top of core 4C

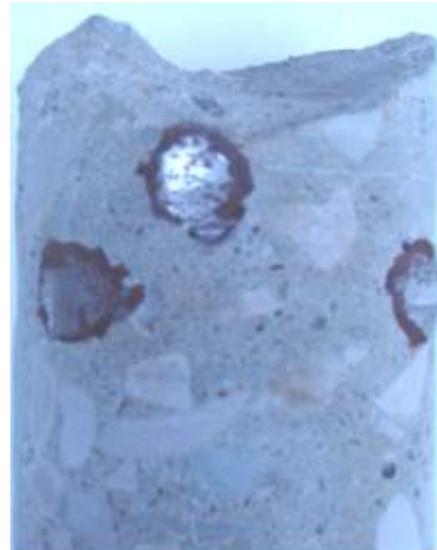
Figure 7.50. Core 4C shows rust in steel reinforcement

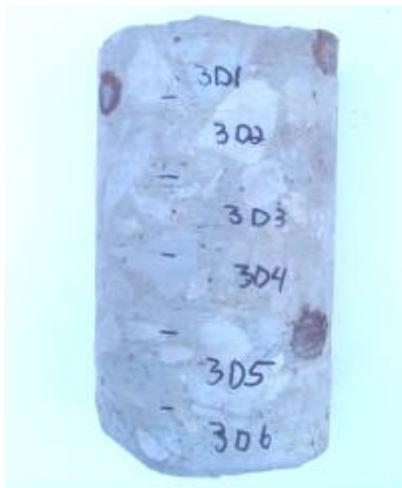
- 6.25 in. (158.8 mm) height (7.5 in. (190.5 mm) with the concrete in the region of the valley of the SIPMF).
- Top of core is broken.
- 3 reinforcement bars located at 2.25 in. (57.15 mm), 6.25 in. (158.8 mm), and 7.0 in. (177.8 mm), from bottom surface.
- Bars are not coated and show severe rusting.
- Area of honeycombing at 5.5 in. (139.7 mm) from bottom surface.

Figure 7.53. Core 3D shows small voids

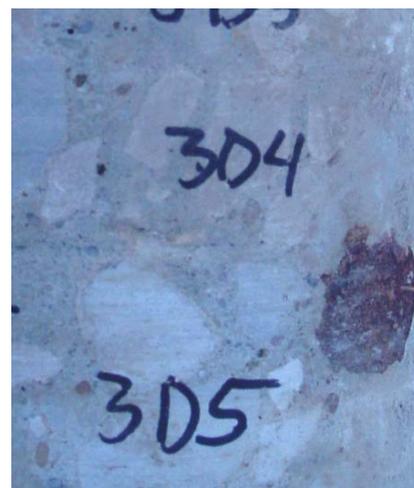
Figure 7.54. Core 3D shows rust in steel reinforcement

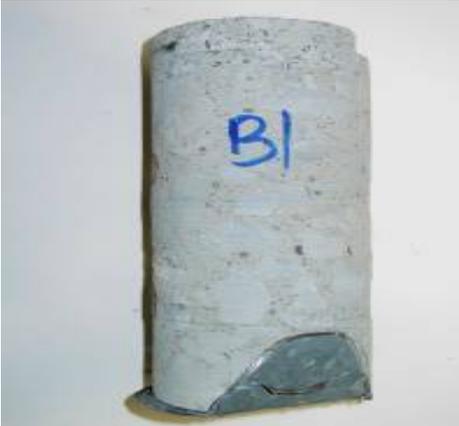
- 7.25 in. (184.2 mm) height (9.25 in. (235 mm) with the concrete in the region of the valley of the SIPMF).
- 2 reinforcement bars located at 3.5 in. (88.9 mm) and 6.5 in. (165.1 mm) from top.
- Small region of honeycombing at 2.5 in. (63.5 mm) from top surface.
- Bars are not coated and show some rust.

Figure 7.62. Core B1 shows some rust traces

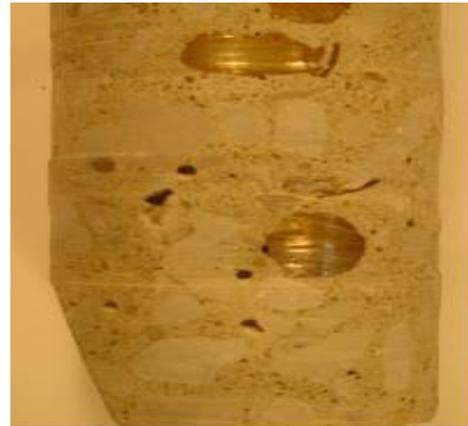
Figure 7.63. Core B1 shows region of honeycombing

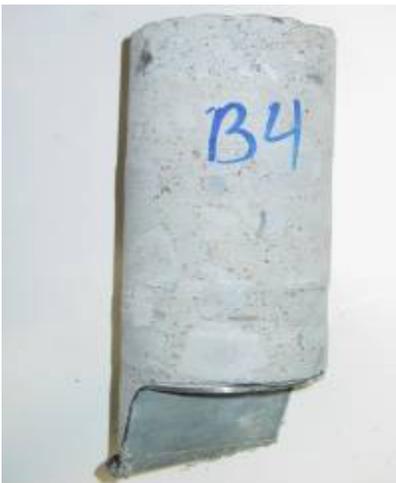
- 7 in. (177.8 mm) height (9 in. (228.6 mm) with the concrete in the region of the valley of the SIPMF).
- Regions of small voids.
- 2 reinforcing bars located at 1 in. (25.4 mm) and 3 in. (76.2 mm) from bottom surface, and show some rust traces.
- Brown and white traces on the SIPMF.
- Region of honeycombing at 6 in. (152.4 mm) from bottom.

Figure 7.64. Core B4 shows regions of small voids

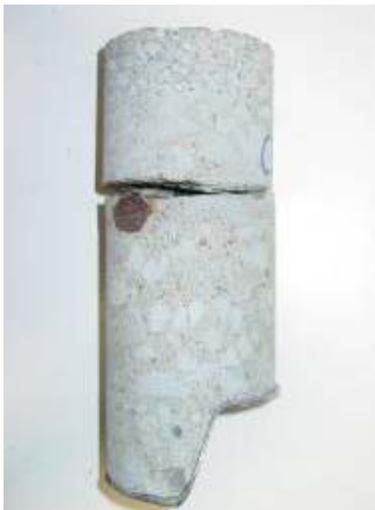
- 7.5 in (190.5 mm) height (9.5 in. (241.3 mm) with the concrete in the region of the valley of the SIPMF).
- Core is broken into two parts.
- 1 reinforcement bars located at 3.75 in. (95.25 mm) from bottom surface.
- Bar is not coated and shows severe rusting.
- Brown and white traces on the SIPMF.

Figure 7.68. Core C3 is broken into two pieces

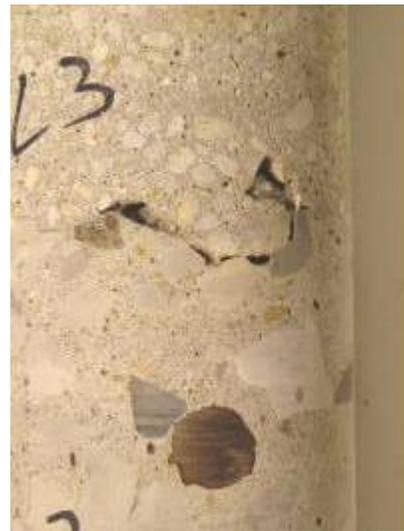
Figure 7.78. Regions of cracks and honeycombing

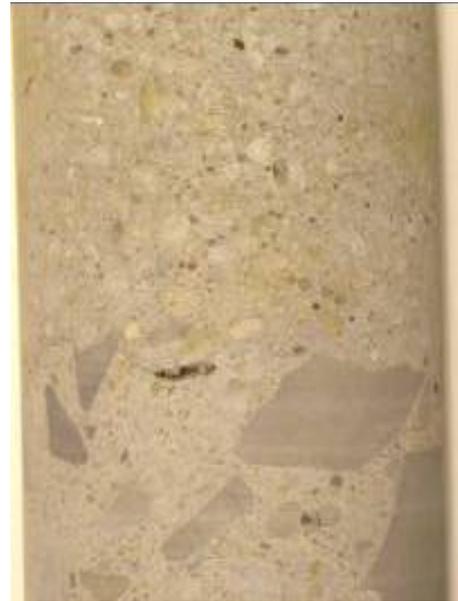
Figure 7.80. Voids region

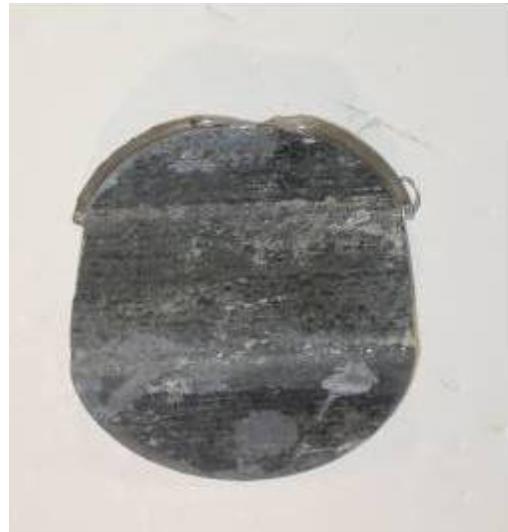
Figure 7.86. White traces on SIPMF

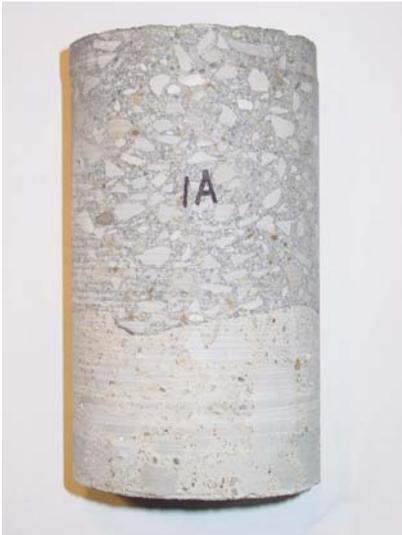
- 6.88 in. (174.8 mm) height.
- 3.75 in. (95.25 mm) thickness of wearing surface.
- The concrete in the region of the valley of the SIPMF was broken.
- Fine aggregates were in the wearing surface and coarse aggregates in the remaining thickness.
- More porosity in the wearing surface.
- Honey combing in the wearing surface of 0.2 in (5.08 mm).
- Some rust and salt traces on the bottom of the core.
- The concrete in the region of the valley of the SIPMF was broken.

Figure 9.30. Large Depth of wearing surface

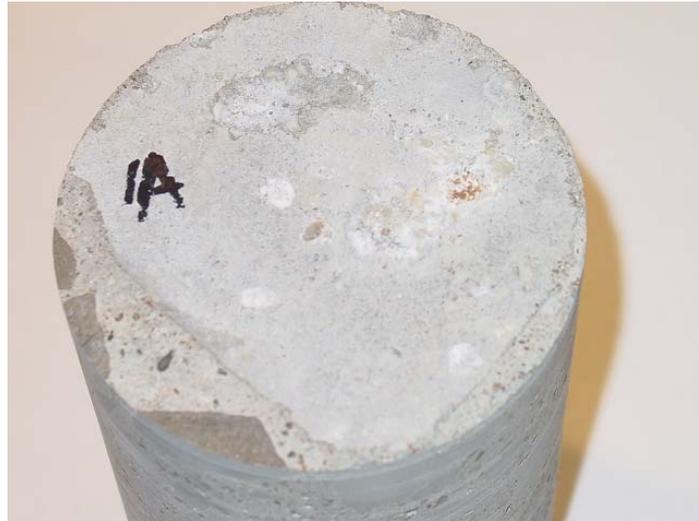
Figure 9.31. Rust and salt traces

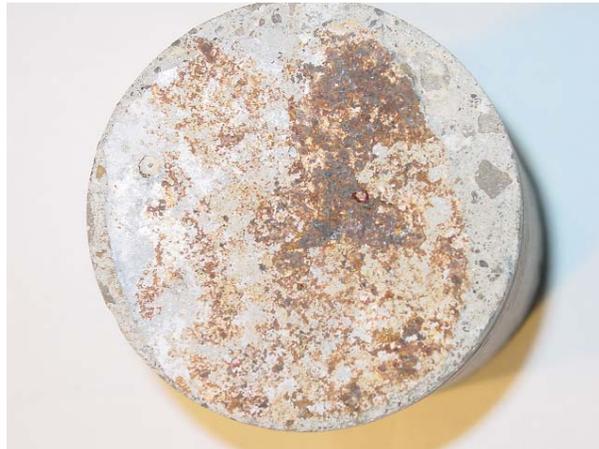
Figure 9.33. Severe rust and salt traces

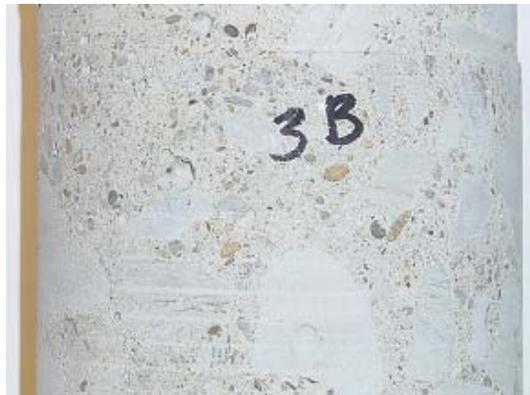
Figure 9.35. Void at 3.75 in.

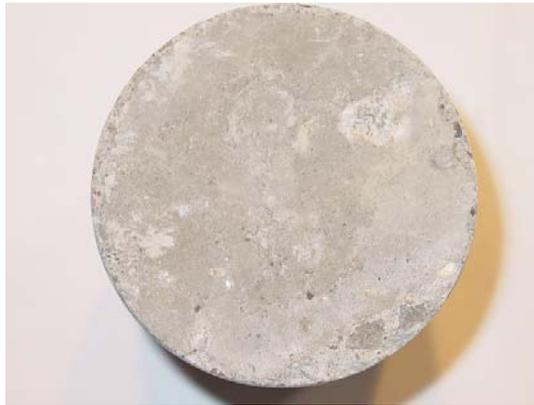
Figure 9.38. Small traces of salt at the bottom of Core 7B

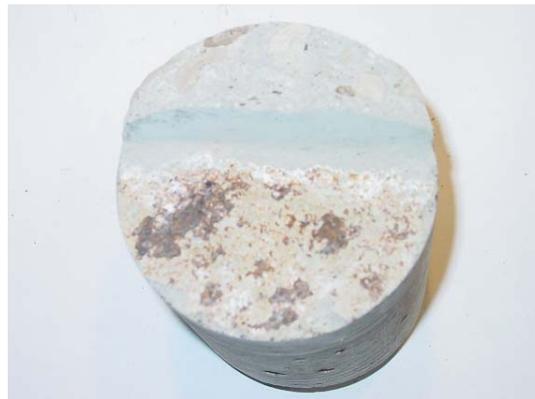
Figure 9.40. Rust traces at the bottom

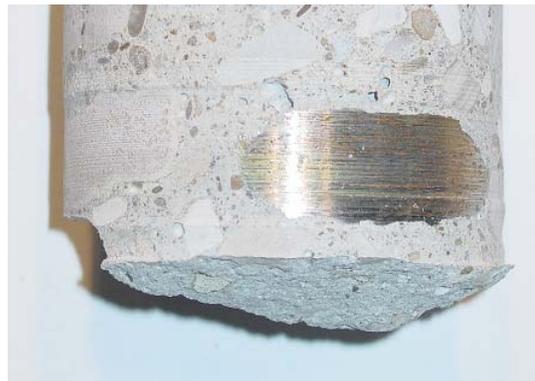
Figure 9.42. Some rust traces on reinforcement
