The Ohio Department of Transportation Office of Research & Development Executive Summary Report

Monitoring of Bridge Abutment Walls at SR 33 over East State St. (Athens, Ohio)

Start Date: February 1, 2005
Duration: Approx. 25 months
Completion Date: March 1, 2007
Report Date: March 20, 2007
State Job Number: 505953(0)

Report Number: FHWA-OH-2007/02

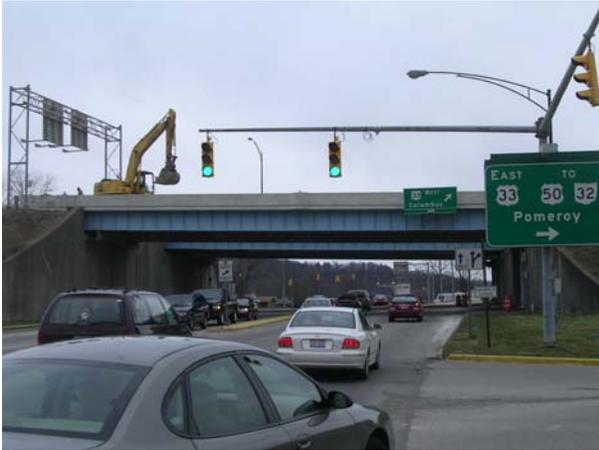
Figure 1: General View of Project Site

ODOT District 10 personnel noticed signs of on-going problems (cracks, backfill washout) on the bridge abutment walls existing at the SR 33 bridge over E. State St. in Athens, Ohio (shown in Figure 1).

Visual Inspections At the beginning of the project, one or two major vertical hairline cracks were detected on each abutment wall panel, in addition to signs of backfill soil washout at their joints. No horizontal hairline cracks were observed anywhere. The visual inspection conducted a mid way through and at the end of the project detected no changes in the conditions of the abutment wall structures.

The initial site visit identified one or two major cracks running vertically on each panel, and signs of soil infiltration were also noted at some wall joint sections on the north side of East State St.

The site conditions observed during the first year of the project suggested the following remedial actions to be taken by ODOT: water-proving the abutment wall front faces; complete reconstruction of the end sections of the bridge deck; installation of upgraded drainage system under each end section of the bridge deck; complete reconstruction of

the sidewalk on the north side of East State Street; installation of drain gutter along the edge of the sidewalk on the north side of East State Street; and filling of the joint gaps existing between abutment wall panels. Most of these remedial actions were taken during the actual rehabilitation project, which lasted from March to September of 2006.

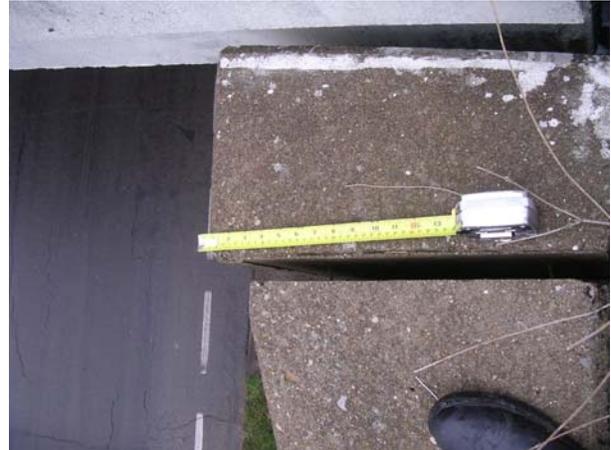
Figure 4: Manual Measurements Taken at Top of Abutment Walls

In addition to the tilt measurements taken by the sensor, a set of manual measurements were taken at the top of the abutment walls (shown in Figure 4) to detect joint movements taking place within the upper sections.

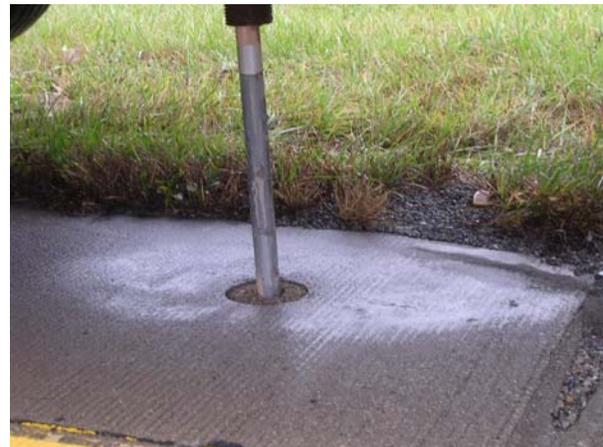
Figure 5: CPT Sounding of Highway Embankment Fill

CPT sounding (seen in Figure 5) was conducted in October 2004 to collect high-resolution subsurface exploration (including tip resistance, sleeve friction, and pore water pressure) data for the highway embankment fill material at three locations behind the north abutment wall.

CPT Soundings CPT sounding of the highway embankment fill material was performed at three (3) locations behind the north abutment wall. No apparent shear failure planes or zones of seepage flow were detected during the CPT sounding.

The high-resolution CPT soundings data collected on Oct. 20, 2004 identified mostly dry silty clay soil in CPT Hole #1 and relatively soft and wet soils in CPT Holes #2 and #3.

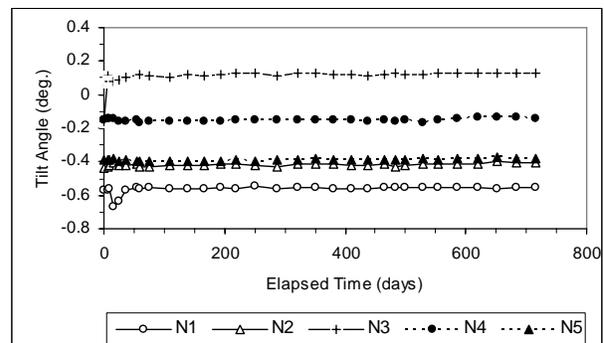
Figure 6: Tilt Angle vs. Time for Abutment Wall Panels on North Side

Tilt Angle Measurements Tilting of the ten (10) abutment wall panels was monitored using the Digi-Tilt system. The collected data showed that most of the abutment wall panels remained stable during the two-year monitoring period (see Figure 6). Only the wall panels N-1, N-3, and S-1 experienced small rotational movements during the early stage of the project. The manual measurements taken at the top of the abutment wall panels confirmed the outcome reflected in the tilt angle measurements.

The tilt-meter readings collected during the project showed that most of the abutment wall panels had remained stable over the two-year period. Only the abutment wall panels N-1, N-3, and S-1 experienced small rotational movements initially. The manual measurements taken at the top of the abutment walls suggested that the abutment wall panels N-1, N-5, S-1, and S-5 might have moved slightly during the initial period. The visual inspections conducted on April 25 and Aug. 16, 2006 identified no new cracks on the abutment wall panels at the site. These facts point out that these bridge abutment walls have been very stable during the life of the current project (which also included the abutment wall performance in the post-rehabilitation work period).

- There is no need to perform major reconstruction or rehabilitation work on the abutment walls.
- Additional horizontal drains may need to be integrated into the existing embankment structure. The horizontal drains installed during the summer of 2006 appear to have very limited capability to drain the embankment soils.
- The gap existing between the wall panels should be filled with suitable durable joint material to prevent further loss of backfill soil.
- There will be no need to keep monitoring the movements of the abutment walls with tilt-meter system in the future. The bridge and wall structures should be inspected occasionally by the ODOT District personnel. The sensor monitoring should be resurrected only if additional signs of possible wall movements are detected.
