Report No. KS-07-5
FINAL REPORT

FINITE ELEMENT ANALYSIS OF FATIGUE PRONE DETAILS OF THE TUTTLE CREEK BRIDGE

November 2007

KANSAS DEPARTMENT OF TRANSPORTATION

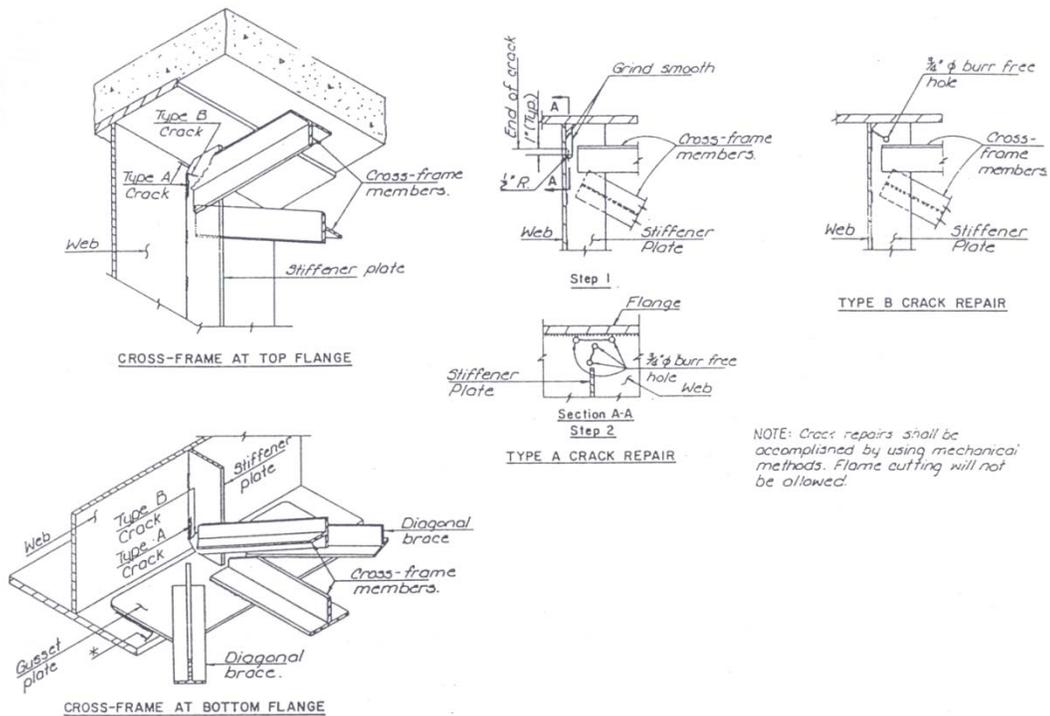
In 1986, KDOT performed retrofits at all the transverse connection plates as shown in Figure 1.6. In this fix, the high constraint web gap region was made flexible by cutting back the connection plate by 4 in. and providing a smooth transition of 0.5 in radius fillet. Burr free holes were also drilled at all the crack tips. The repair was, however, not effective and fatigue critical inspections in 2000 reported continuous crack growth at the end of stiffener plate and reinitiation from stop holes, as shown in Figures 1.8 and 1.9.

Figure 1.6: Pre-1986 Web Gap Crack Patterns and Repair Procedure

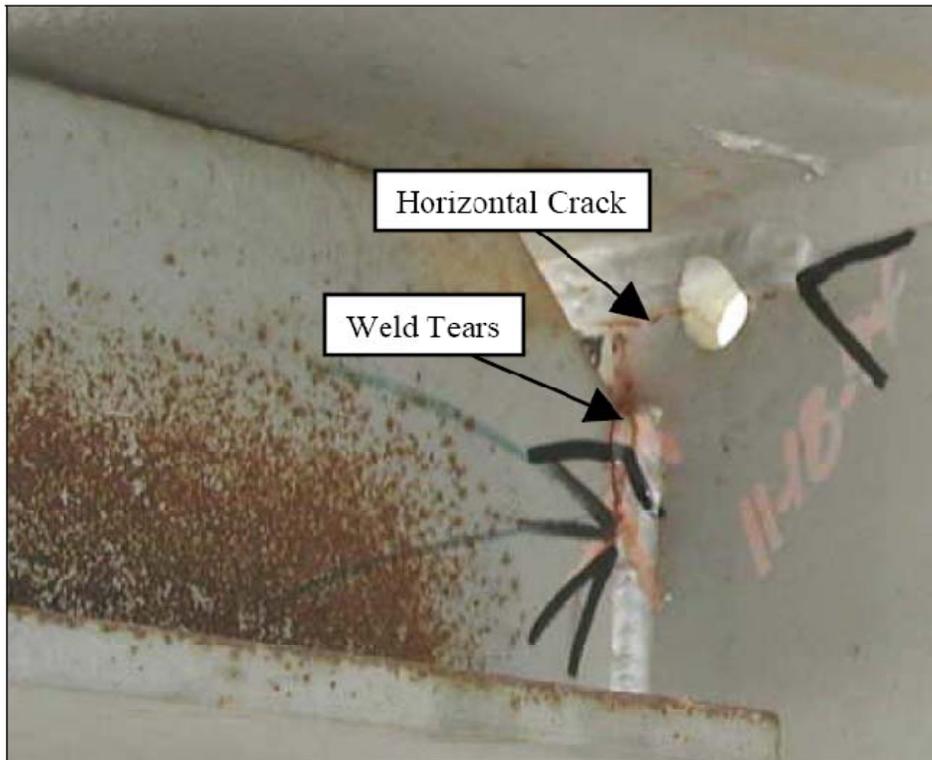
shown in Figure 1.5. This out-of-plane distortion creates high secondary stresses at the connection plate end leading to fatigue cracking. Cracks developed at both the web-to-flange and web-to-connection plate fillet welds, typically as horizontal or horseshoe cracks, as indicated in Figure 1.5. Cracks are mostly located in the positive moment regions because of large differential girder deflections occur at the mid spans. Cracks are more frequent at the girder top flanges. This is because the top flange is restrained to rotation and lateral movement by the concrete deck. The bottom flanges are relatively much less constrained and are therefore less susceptible to distortion-induced fatigue cracking. Figures 1.6 and 1.7 show the two distinct crack patterns, Type A horizontal cracks and Type B horseshoe cracks, observed on the bridge in the top web gap. A total of 379 horseshoe type cracks and 291 horizontal type cracks were found on the bridge [Marshall et. al., 2005].

Figure 1.7: Horizontal and Horseshoe Type Cracks, [Marshall et.al., 2005]

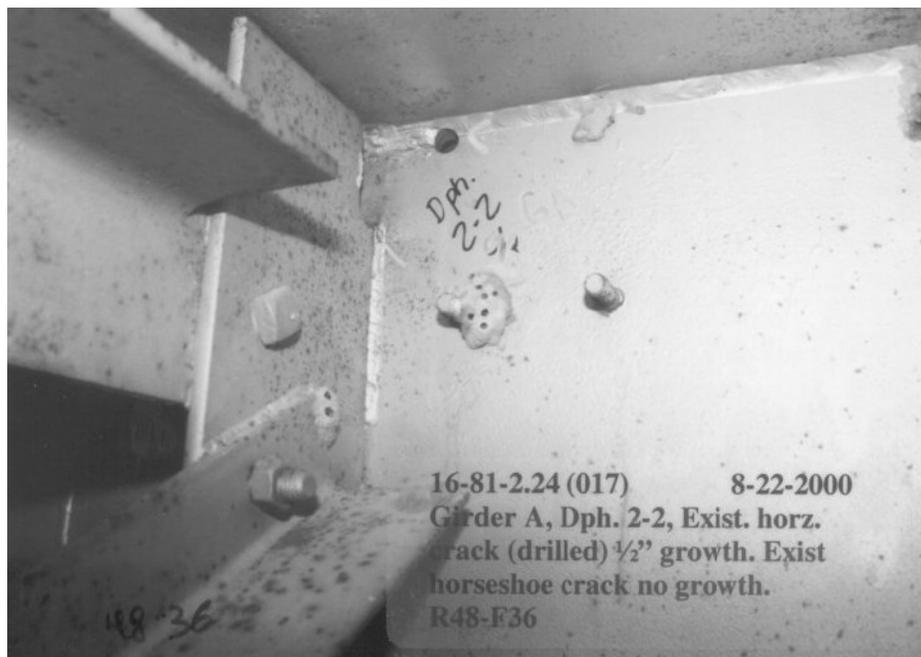
Figure 1.8: Post-1986 Retrofit Horizontal Crack Growth

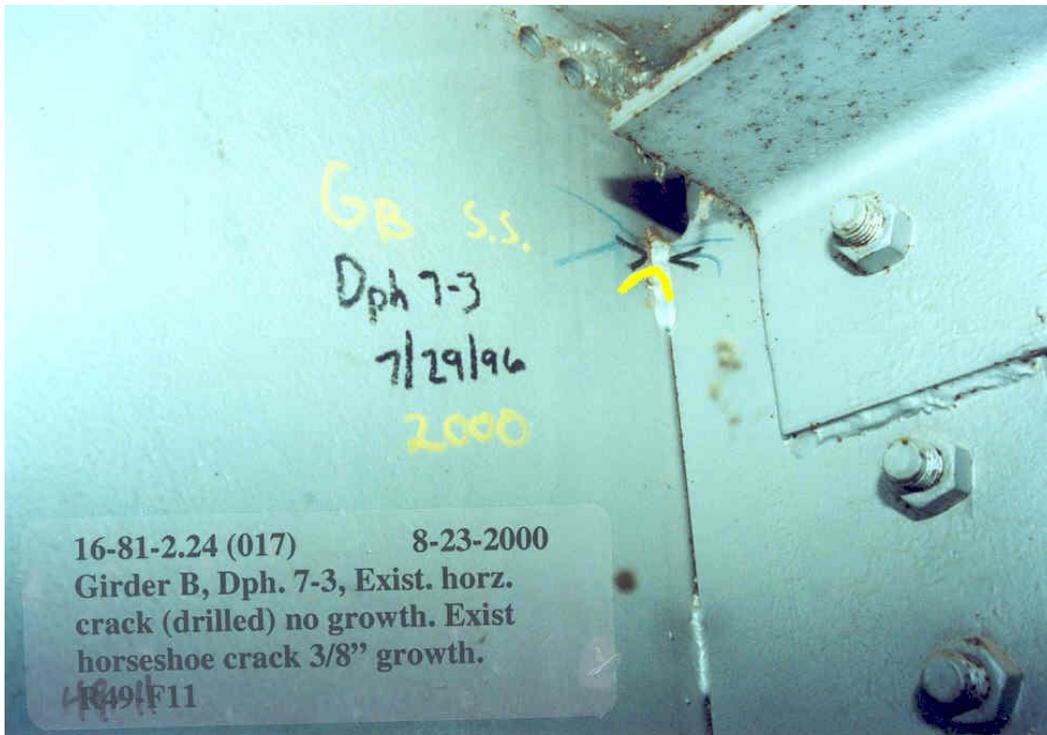
Figure 1.9: Post-1986 Retrofit Horseshoe Crack Growth

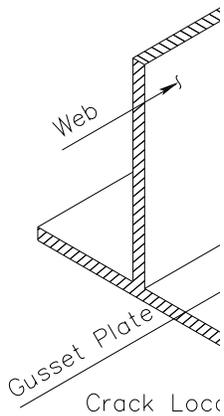
flange fillet welds perpendicular to the girder and the tack welds parallel to the girder. The two crack patterns are shown Figures 1.10 and 1.11. Both the types of cracks were only weld tears and did not propagate into the girder flange. The first type of crack was found mostly at weld terminations along the sides of the gusset plate. The second type was in the tack weld placed on the underside of the gusset plate. The cracks are believed to be caused by the prying action of the bracing members under the action of traffic loads.

Figure 1.10: Gusset Plate Crack Patterns

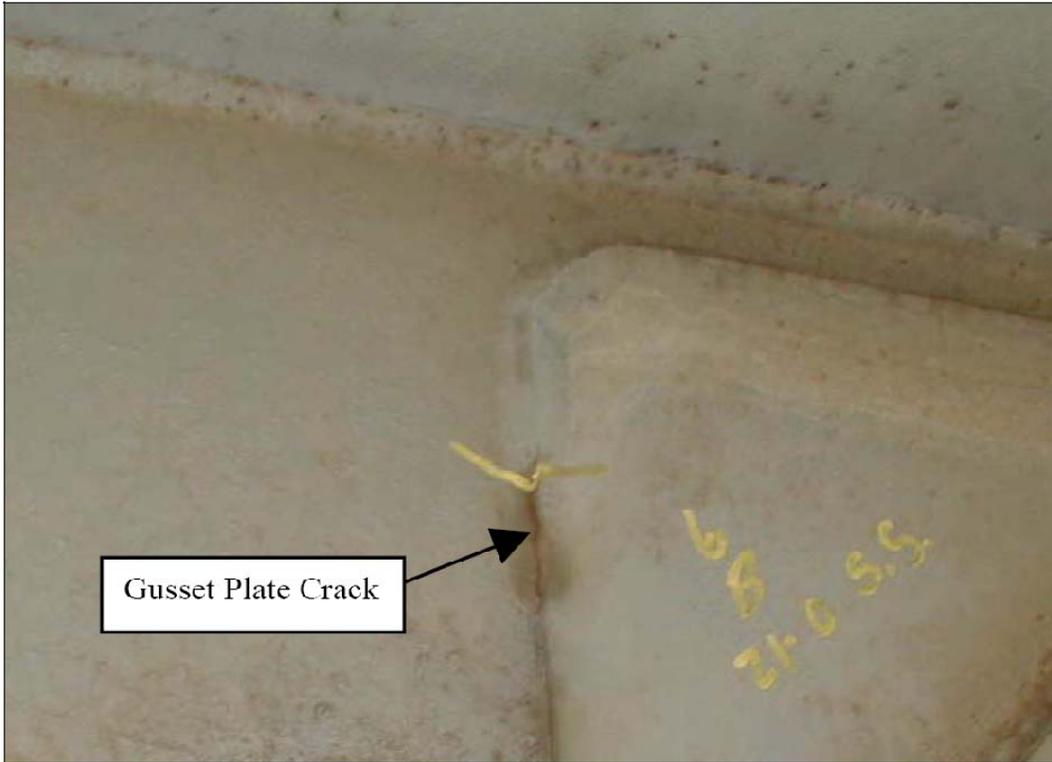
Figure 1.11: Gusset Plate Weld Tear, [Marshall et.al., 2005]

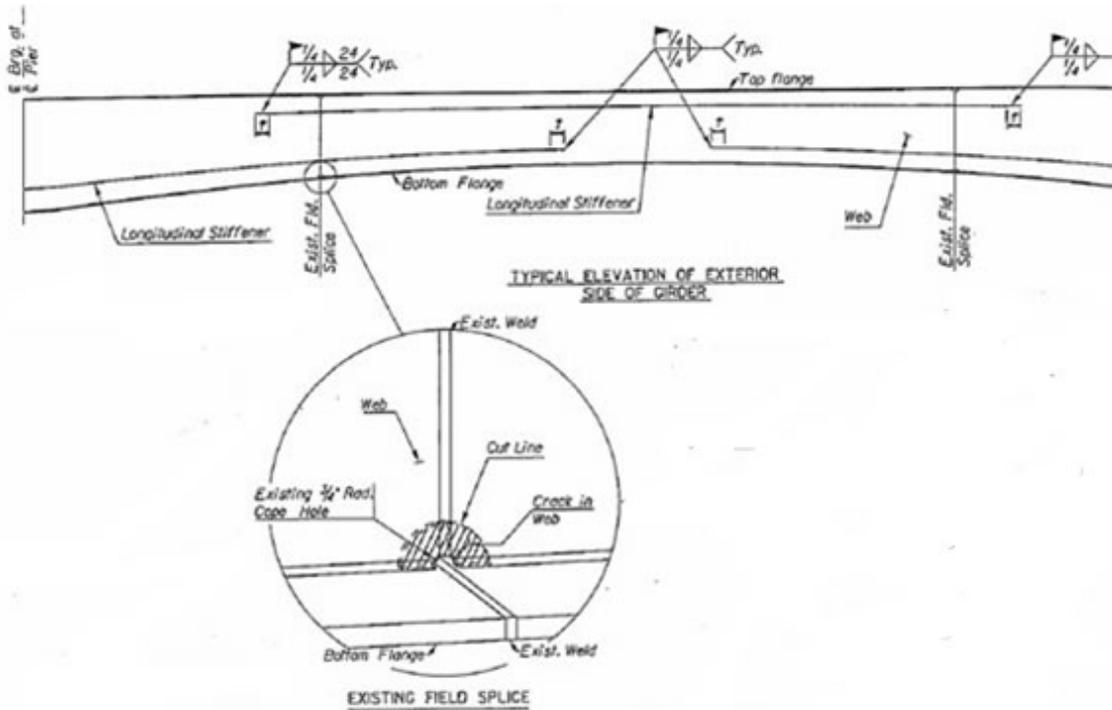
Cracks were found at the rim of weld access holes present on the bridge at the field splices, see Figure 1.12. The cracks originated from the splice weld and they propagated into the girder web plate. As discussed later in this report, the cope hole is located in a low stress field region. Initial defect at the weld is the most likely cause of this crack. Detailed analysis of a typical cope hole is presented in Chapter 6.

Figure 1.12: Cope Hole Crack Patterns

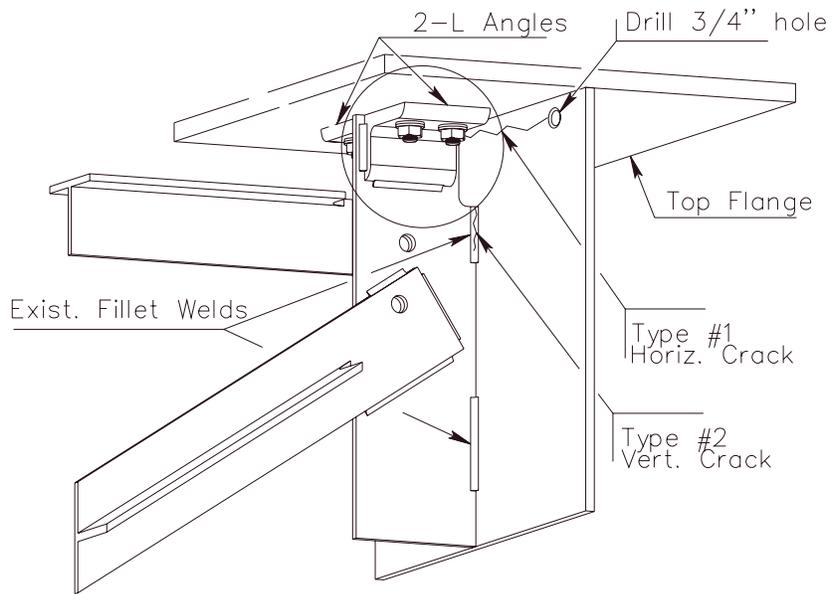
(b) Angles Welded to Stiffener

Figure 4.14: Type 'A' Repair for Top Flange Connection

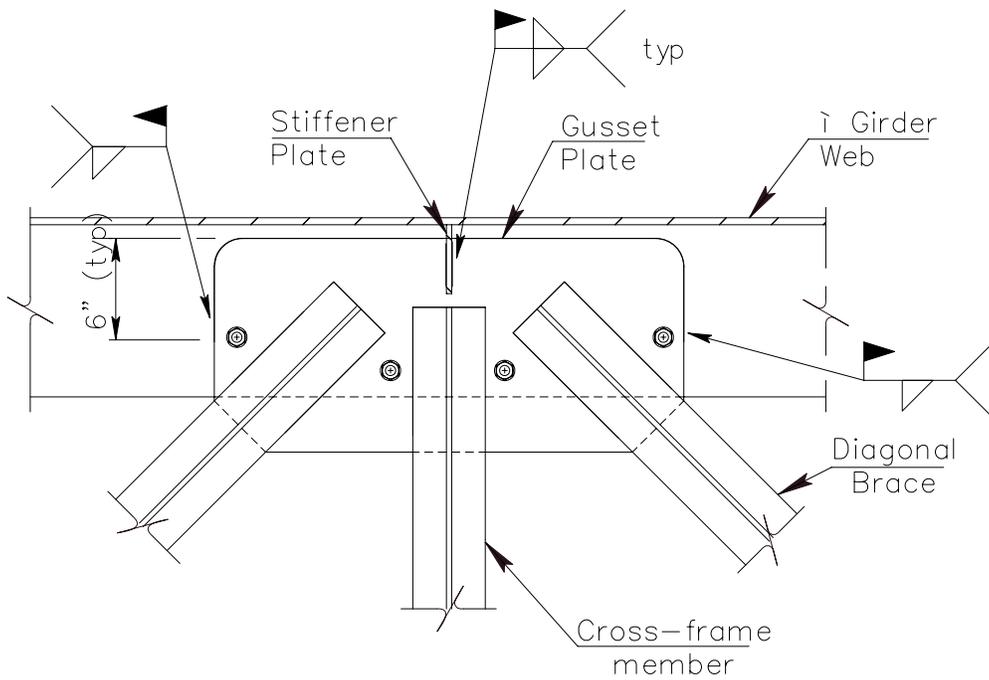
Figure 5.8: Type 'B' Repair for Bottom Flange Connection

The analysis results from model BR match well with the field test data and demonstrates the effectiveness of the Type 'B' repairs. Before retrofit, the stresses developed in the bottom flange web gap are much lower than those developed in the top flange web gap, which explains the field observation that no cracks were found in the lower web gap. The newly installed retrofit further reduces the stresses and so no fatigue cracks are expected to initiate in the lower web gap. The analysis shows that prior to the retrofit, peak stresses develop near the weld terminations at the flange-to-gusset connection, but after the retrofit the stress distribution is more uniform and there is no stress concentration at the connection. This indicates that the retrofit is effective in reducing the prying action and eliminating the hot-spots on the connection.

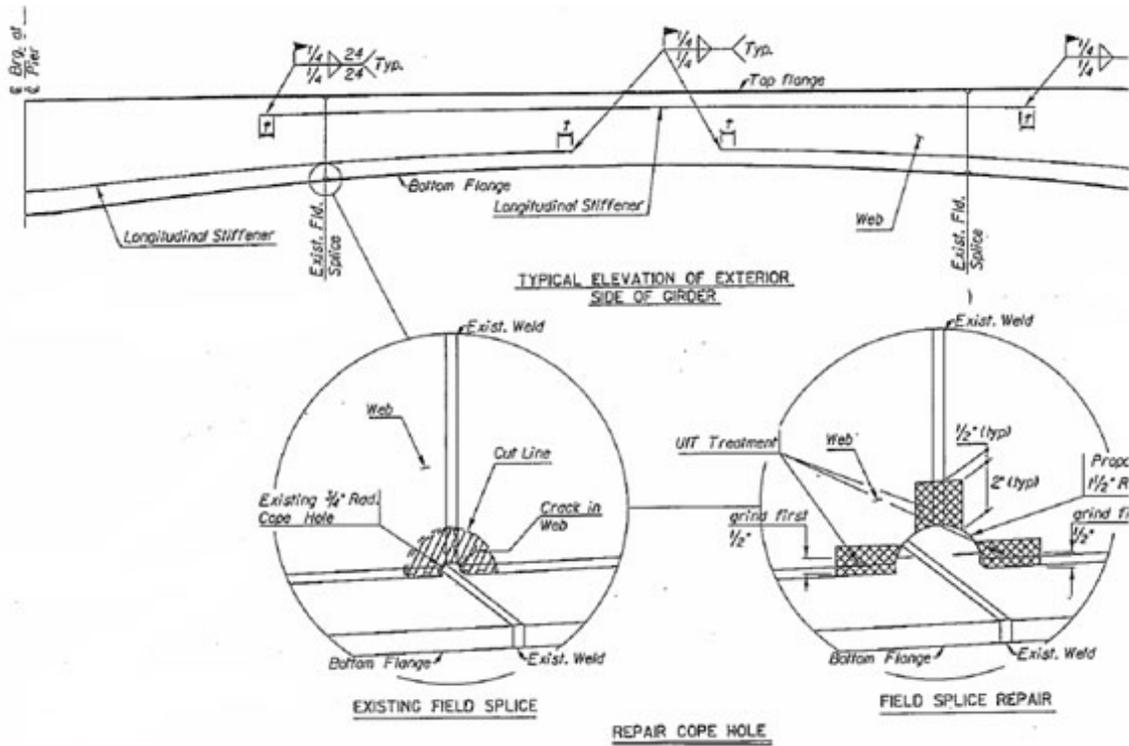
Figure 6.1: Type 'D' Repair

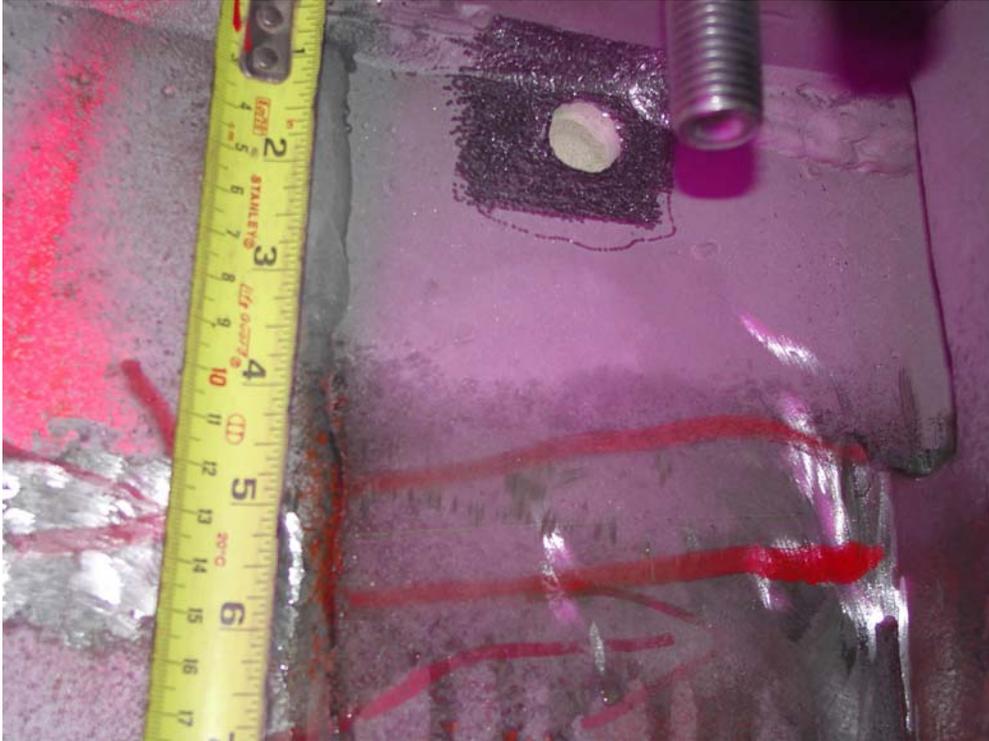
During a site inspection of September 2005 a horizontal crack was found at the fourth cross-frame of span 14. The crack originated at cope end of the stiffener clip. It was not a through thickness crack and was detected by a Magnetic Particle test. The crack is not a typical distortion-induced fatigue crack. It is believed to be originated at a mill flaw. A Detailed analysis of this crack is presented in Chapter 7.

The crack is not a typical distortion-induced fatigue crack. It is believed to be originated at a mill flaw. Type 'A' repair reduces the stresses significantly in the web gap region. The presence of the crack redistributes the hot-spot from the root of the slot to the crack tip. The maximum crack opening stress (SY) at the crack tip is 2.8 ksi is significantly lower than the CAFL (5 ksi). The diameter of the drilled stop hole is one-half times larger than minimum required by Fisher's criterion. Type 'A' repair combined with

Figure 7.1: New Crack Observed in June 2005

drilled stop holes thus provides an effective retrofit and further crack growth in this region is not expected.
