Report No. K-TRAN: KU-04-5  
FINAL REPORT

## **FIELD INSTRUMENTATION AND ANALYSIS OF THE TUTTLE CREEK BRIDGE**

**Br. No. 16-81-2.24 (017)**

Final Report

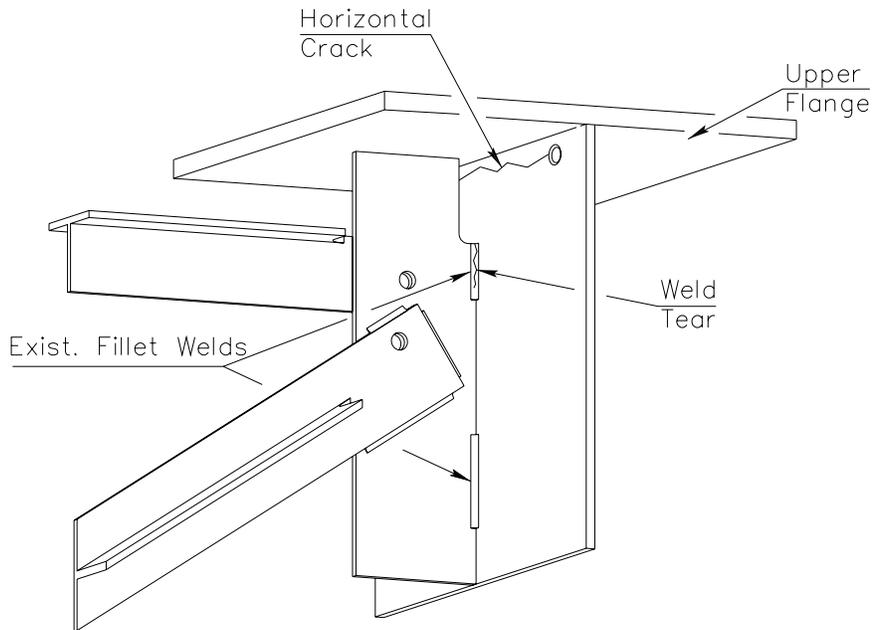
**Figure 2-3 Web-Gap Cracking Patterns**

Two distinct cracking patterns are found in the web-gap region. Figure 2-3 shows a drawing of the cracking patterns, while Figure 2-4 shows an actual picture of the cracking. The

most common cracking pattern is a weld tear. The weld tears begin at the weld connecting the stiffener to the girder web. The stiffener is welded to the primary girder web with 4 in. fillet welds at each end and 6 in. welds spaced at 12 in. between the end welds. The cracks propagate down the top 4 in. weld connecting the upper portion of the stiffener to the web. Some weld tears have tapered off from the fillet weld and into the web of the girder. Many of the 4 in. top intermittent welds on the stiffener have been broken completely by the weld tears. A total of 379 weld tears have been found in the bridge.

Another frequent cracking pattern is horizontal cracking. The horizontal cracks are found at the bottom of the fillet weld connecting the upper flange to the web of the girder. The cracks are located on both the interior and exterior sides of the girders. Exterior horizontal cracks are found less frequently than the similar interior horizontal cracks. Only 13 exterior, horizontal cracks have been found, as opposed to 291 interior, horizontal cracks.

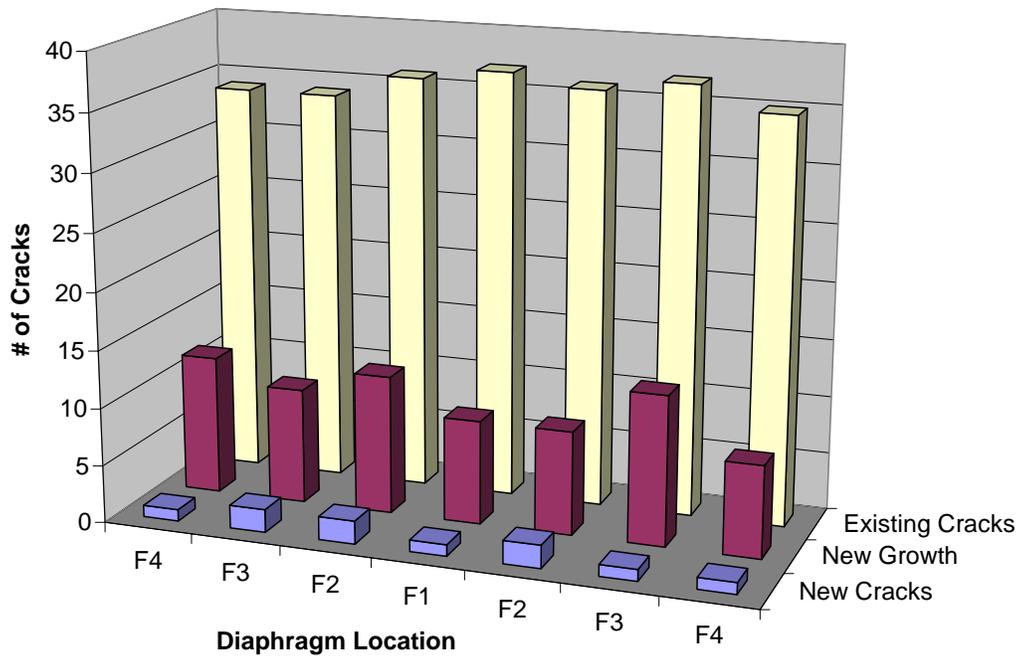
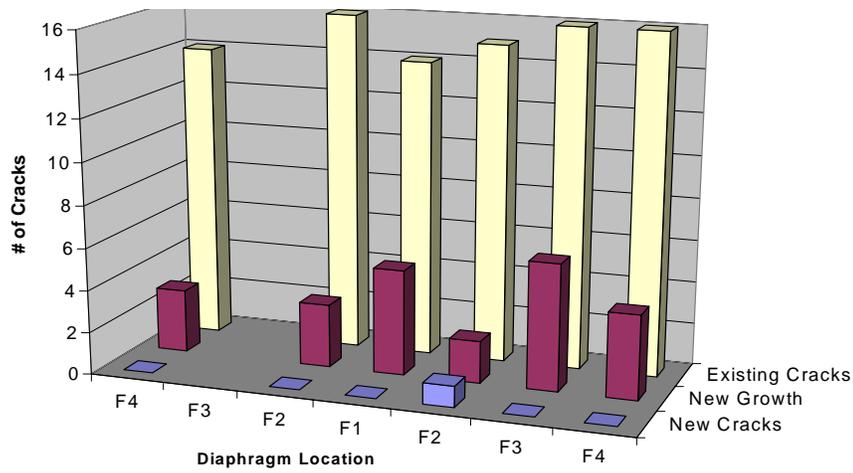
The inspection reports revealed helpful information concerning the web-gap cracking problem. Surveys of each span indicated that web-gap cracks were not more or less abundant for any particular span. Full spans compared to hinged spans did not show any recognizable patterns. However, the comparison of diaphragm locations did indicate patterns for the cracking. Interior horizontal cracks showed a bell-shaped curve distribution, with larger number of cracks appearing in the middle diaphragms, as shown in Figures 2-5 and 2-7. Weld tears displayed a rather constant development regardless of diaphragm location, as shown in Figures 2-6 and 2-8.

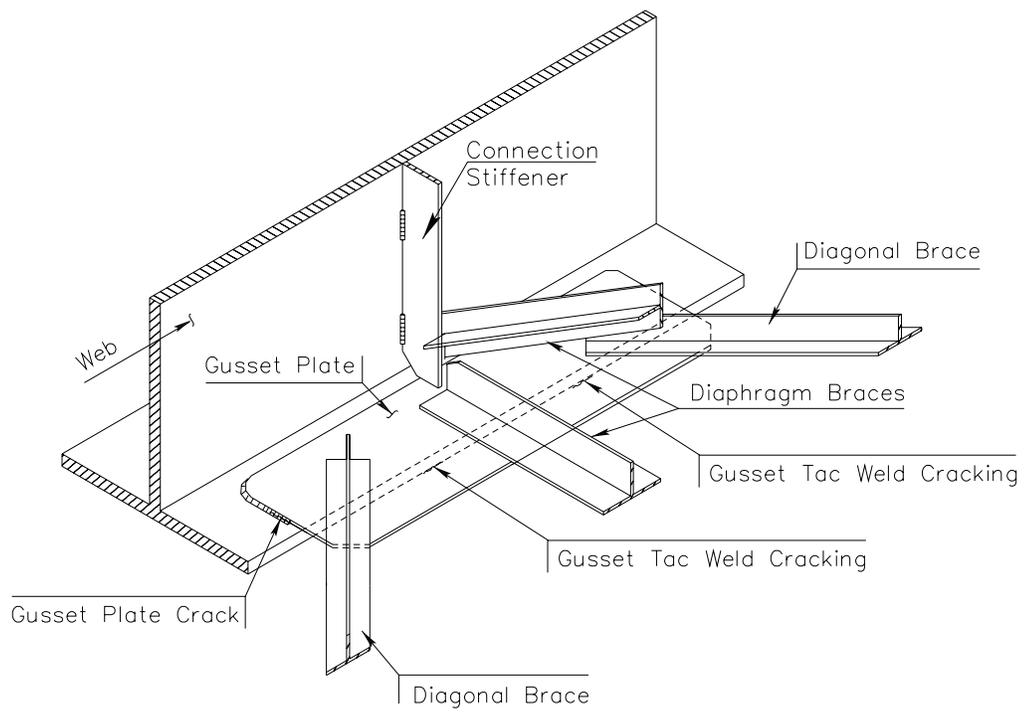
**Figure 2-11 Gusset Plate Cracking Patterns**

Two types of gusset plate cracks have developed: cracking of the fillet weld perpendicular with the girder and tack welds parallel with the girder. Figure 2-11 shows a drawing of the cracking patterns, while Figure 2-12 displays an actual fillet weld crack.

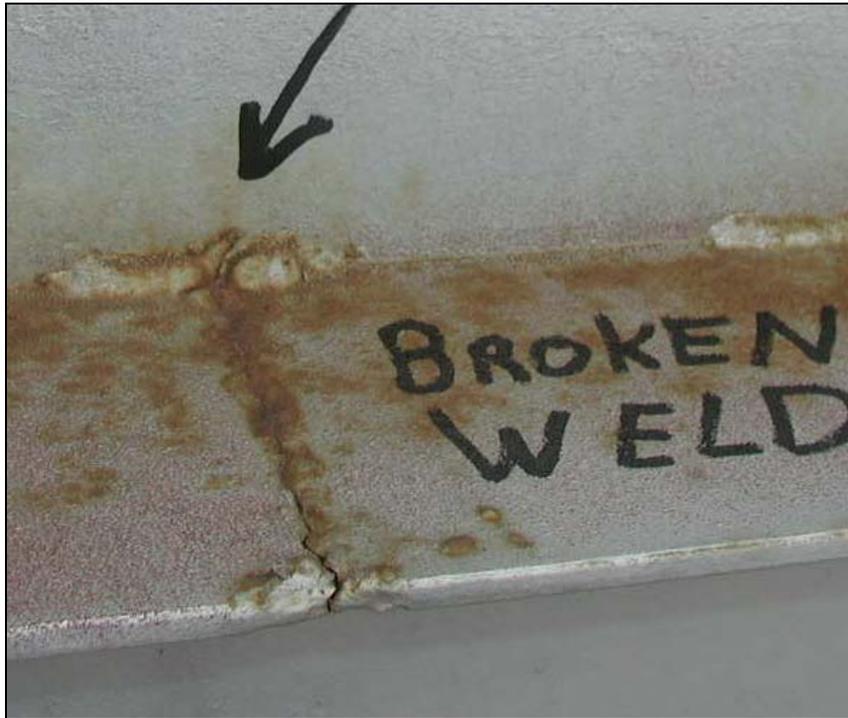
**Figure 2-17 Longitudinal Stiffener Crack**

A defect in the weld was the probable source of crack initiation in the stiffener. Stress cycles in the stiffener due to bending of the girder propagated the crack. Even during compression stress cycles, residual stresses would transform the stress cycles from compressive to tensile. The resulting tensile cycles would quickly propagate a crack.

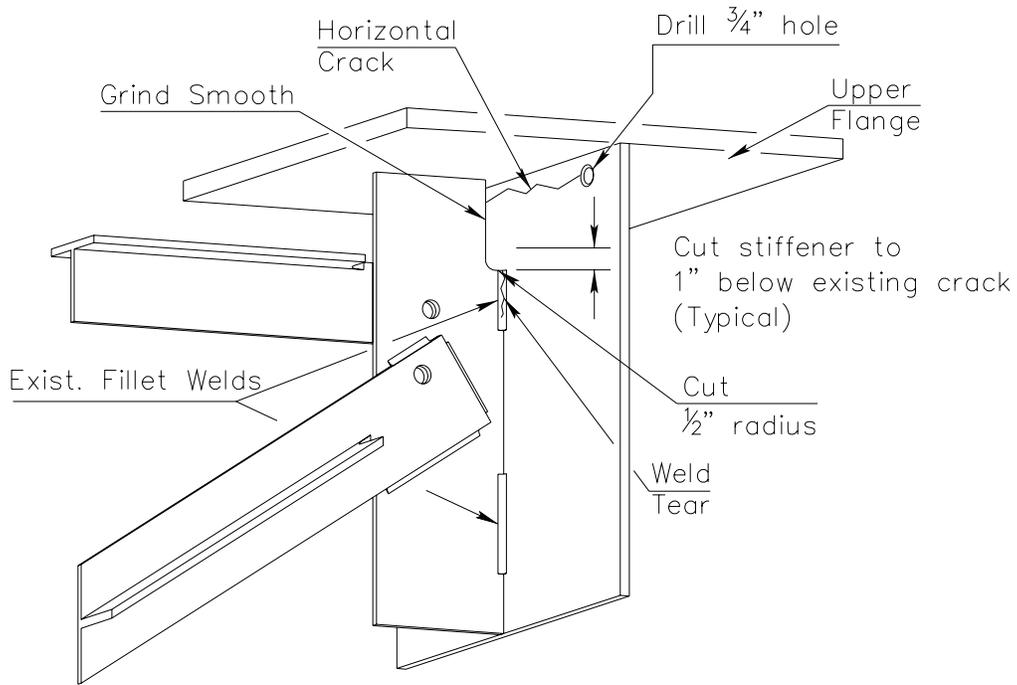
**Figure 5-1 1986 Repair of Upper Web-Gap**

In 1986, a retrofit strategy of increasing the web-gap was performed. For the 1986 repair, the connection stiffeners were cut 1 in. below the termination of the existing weld tears. A 0.5 in. radius was placed at the end of the cut. The radial cut was supposed to reduce stress concentrations from initiating a new crack, however, cracks continued to grow in this region.

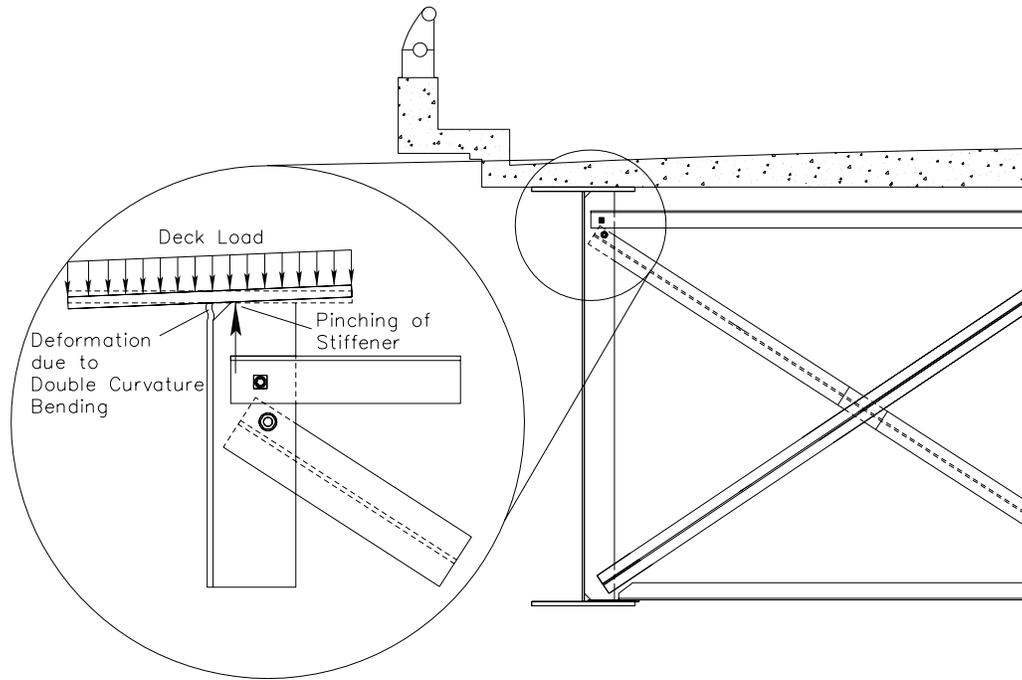
**Figure 5-12 Cracking Theory (Binding of the Stiffener)**

Another theory would be binding of the connection stiffener. The connection stiffeners, found only on the interior side, were designed to be the same height as the web at the diaphragm locations. Although designed as a secondary-loaded member, the connection stiffeners may have inadvertently created stress in the web-gap. When constructed in 1962, the girders were first loaded with the dead weight of the decking. The weight of the decking was transferred directly to the upper flange of the girders. The load may have then transferred to portions of the connection stiffener, which were at the same height as the girder web. Additional deformation of the web-gap, due to double curvature bending from differential deflection of the girders, would cause further load to be applied to the stiffener. Since the stiffener is found only on the interior side, the distributed load from the decking onto the upper flange would be unbalanced. A moment is thus created in the web-gap region, placing the interior side into tension, as shown in Figure 5-12. If the interior side of the web-gap were in tension prior to large live loads, fatigue cracks would be likely to initiate. The live loads producing compressive stress cycles would actually be creating tensile residual stress cycles, thus causing crack initiation.
