Report No. K-TRAN: KU-06-2  
FINAL REPORT

**POST-RETROFIT ANALYSIS OF THE TUTTLE CREEK BRIDGE  
(BRIDGE NO. 16-81-2.24)**

March 2008

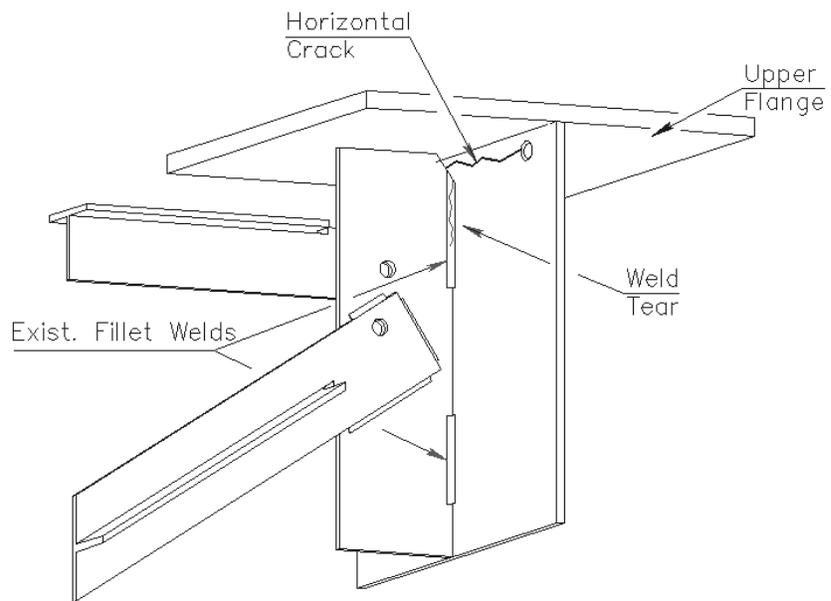
**Figure 2.3: Web-Gap Cracking Patterns Diagram.**

Of the two types of cracking, weld tears were found to be the most common. The weld tears propagated down the 4 inch fillet weld between the upper portion of the

stiffener and the web. Many of the 4 inch top intermittent welds on the stiffener were broken completely by weld tears. In addition, some weld tears propagated from the fillet weld into the web of the girder.

The other cracking pattern found in the web gap region was horizontal cracking. The horizontal cracks occurred at the base of the fillet weld that connects the upper flange to the web. Horizontal cracks were located mainly on the interior side of the girders, but were also found on the exterior side.

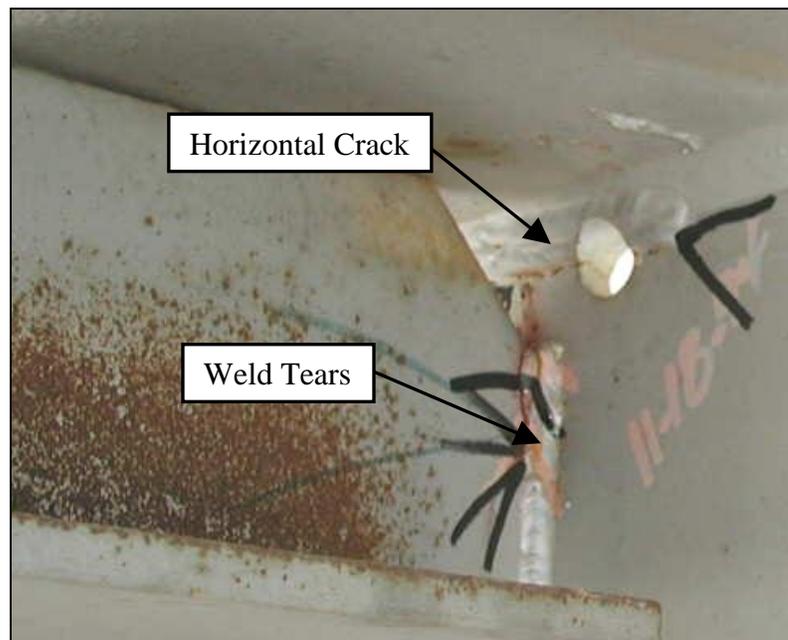
**Figure 2.4: Web-Gap Cracking Patterns Picture.**

The web gap region consisted of a 1"x 1" diagonal cut removed from the top and bottom of the stiffener as shown in Figures 2.1 and 2.2. This cut allowed the fillet weld between the web and flange to be continuous. This gap creates high stress concentrations in the web and creates the potential for fatigue cracks to propagate in this area. Two types of cracks that occurred in the upper web-gap region were designated as either weld tears or horizontal cracks. Figure 2.3 shows the two types of cracks, and Figure 2.4 presents a photograph of actual cracks.

The primary source of fatigue cracking in the Tuttle Creek Bridge was the lack of attachment between the top of the stiffener and the tension flange. The web-gap cracking was the result of differential deflection of the girders. Braces in the diaphragms created a tension force on the stiffener due to the difference in deflections between the two girders. This caused the web-gap to undergo double-curvature bending. Figure 2.5 shows the tension force created by the diaphragms. This type of detail is classified as a category C fatigue detail according to the 2004 AASHTO LFRD specifications.

A previous repair of the web-gap region was implemented in 1986. To repair the weld tears, the joint was “softened” by cutting the stiffeners 1 inch below the termination of the existing cracks. A 0.5-inch radius was placed at the end of the cut. Even though this was supposed to have repaired the problem, weld tears continued to grow in this region. To stop the horizontal cracks, 0.75 inch diameter stop holes were drilled at the tips of existing cracks. However, the horizontal cracks reinitiated after the retrofit.

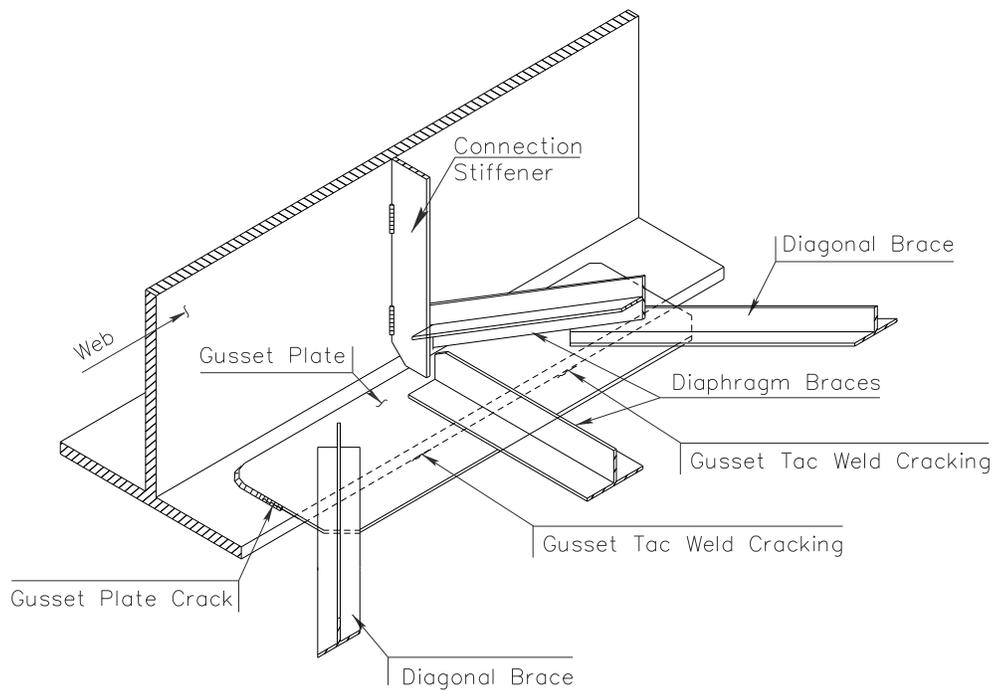
**Figure 2.6: Gusset Plate Cracking Patterns.**

Cracks developed in welds that were both perpendicular and parallel to the gusset plate. Figure 2.6 shows a drawing of the cracking patterns, while Figure 2.7 displays an actual fillet weld crack.

The more common of the two was the cracking of the fillet weld perpendicular to the gusset plate. The fillet welds extended symmetrically across the back six inches along the sides of the gusset plate. This type of detail is classified as a Category E detail according to the 2004 AASHTO Bridge Specifications. The cracks are found at the end of the weld along the sides of the plate. The cracks were assumed to be only in the weld material, but could potentially propagate into the lower tension flange.

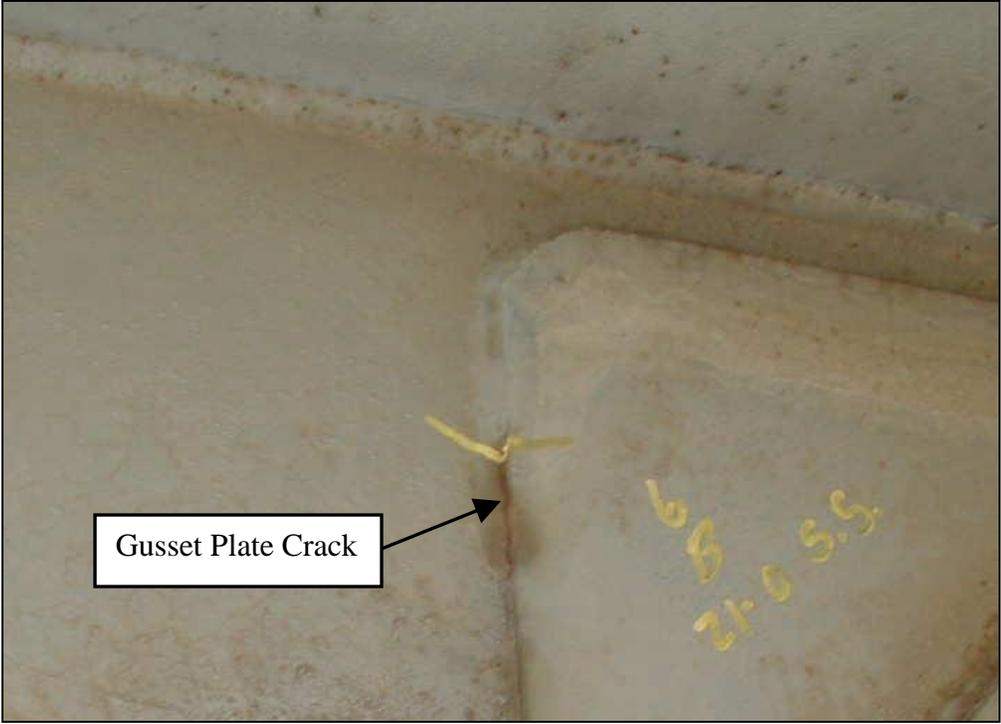
Figure 2.7: Gusset Plate Cracking Patterns (Picture).

Fatigue cracking also occurred in the fillet weld between the gusset plate and the lower flange of the girder. Gusset plates connect the girders to the lateral bracing of the girders. As shown in Figure 2.7, three structural tees enter the connection. Loads imposed by the lateral bracing caused cracking of the gusset plate connection.

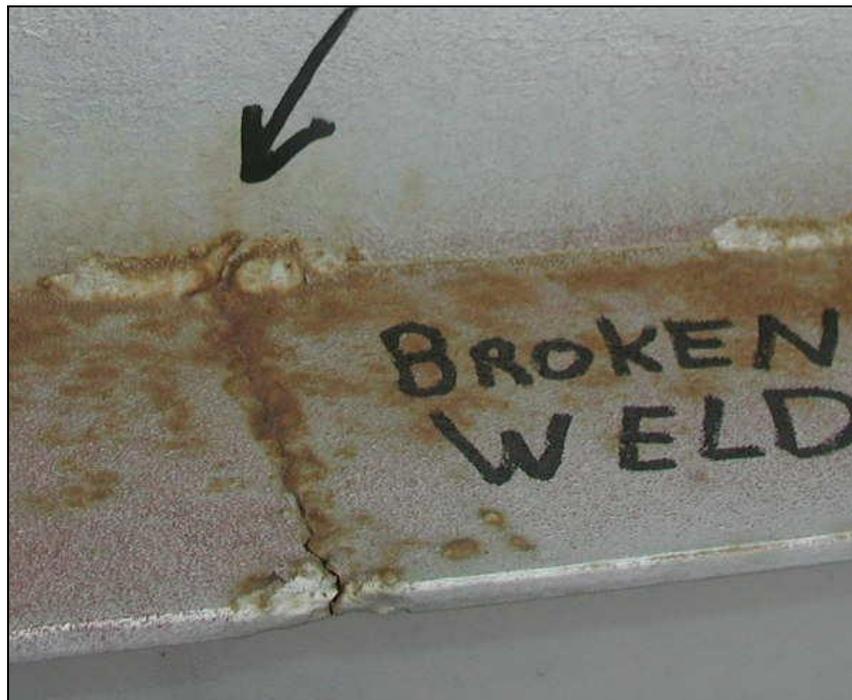
**Figure 2.12: Longitudinal Stiffener Crack.**

Cracks had developed in the butt welds of the stiffener splices. The cracks are found only in the weld material. Figure 2.12 shows a crack in the longitudinal stiffener.

The crack was probably generated from a defect in the weld. Due to the bending of the girder, stress cycles occurred within the stiffener. These cycles propagated the crack in the stiffener.

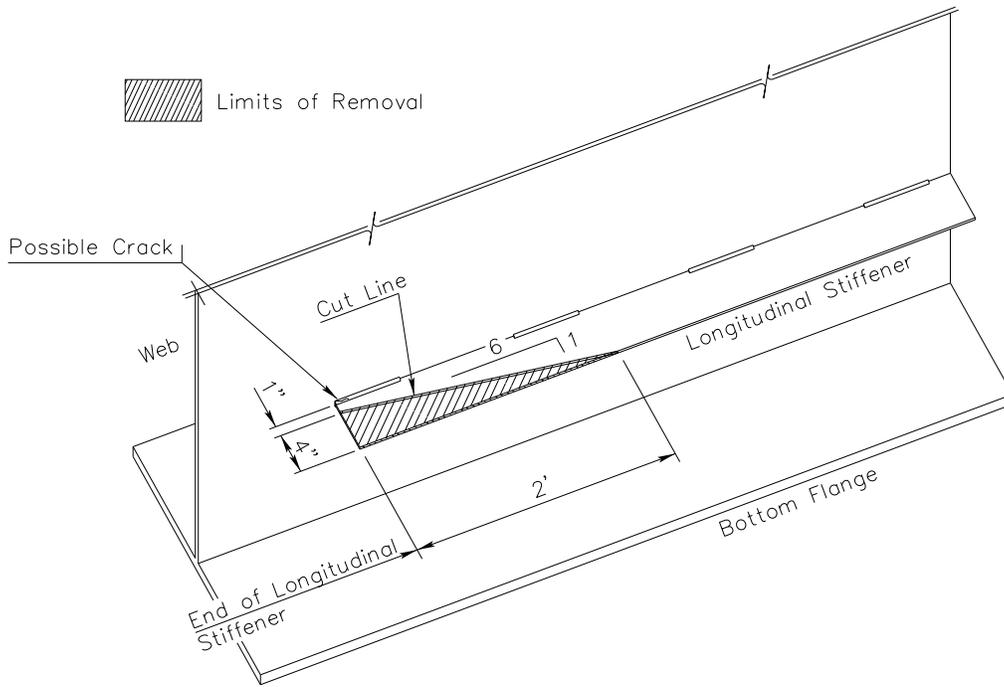
**Figure 7.1: Completed Longitudinal Stiffener Repair.**

Comparison of the data can be found in Table 7.1. According to the data, there was a slight decrease in average stress at the gage location. The data obtained was not sufficient to determine the effectiveness of the repair.
