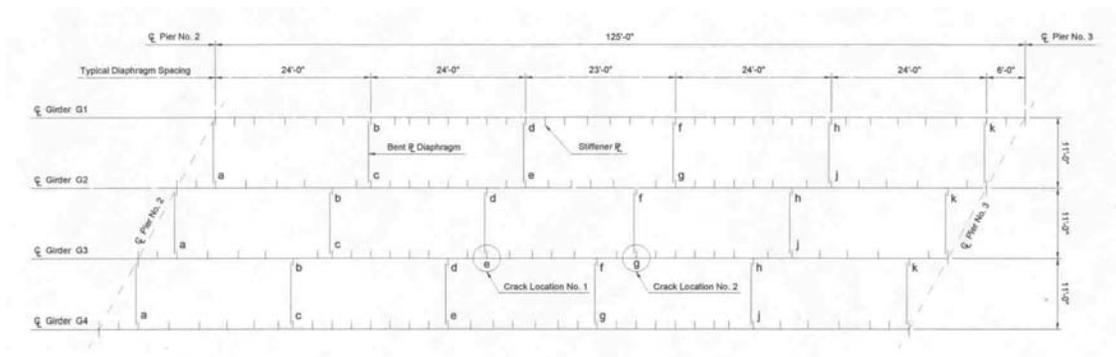
During the 1996 bridge inspection, web gap fatigue cracks were observed at two diaphragm-girder connections in Span No. 3 of the northbound bridge. The framing plan (Figure 7-2) has a staggered diaphragm arrangement. Both Crack Location No. 1 and 2 were located in the mid-span of Girder G3 close to the bottom flange and were thus subjected to high magnitude of both in-plane and out-of-plane bending moments. The connection stiffeners used at these two locations were welded to the top flange, but not to the bottom flange, so cracks were not seen at the top flange web gaps. Figure 7-3 shows the crack exposure on web surfaces at Location No. 1 using dye penetrant. Figure 7-4 shows schematically the observed crack shape and size of the same detail. Both the horseshoe and the horizontal cracks were identified to have gone through the web thickness. Since the cracks were developed at the stiffener to bottom flange connections and at the mid of the longest span of the bridge, the affected web gap areas were exposed to high tensile flexural stresses which could cause the cracks to propagate continuously upward through the girder depth. The cracking condition of this bridge is thus more severe than those found near the girder top flanges such as seen in the Westgate Bridge.

FIGURE 7-2: Span No. 3 Framing Plan and Crack Locations of the Northbound Winfield Bridge

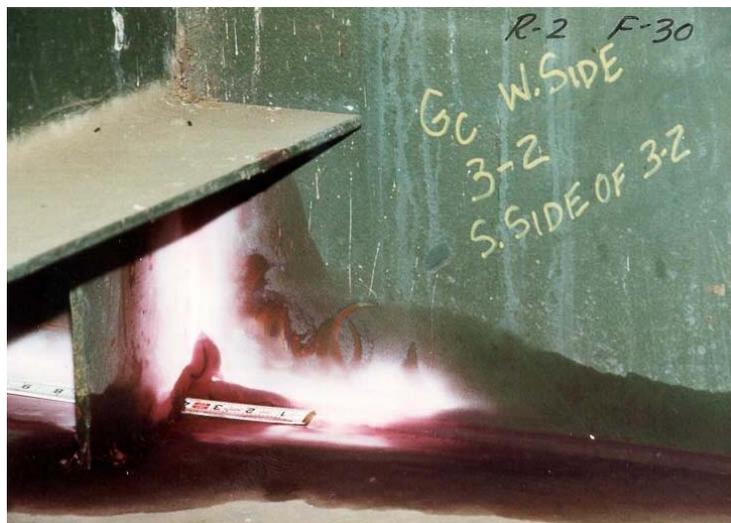
(a) cracks on the interior girder web side

(b) cracks on the exterior girder web side

FIGURE 7-3: Inspection Pictures of Crack Location No. 1

The two crack locations were repaired by KDOT in 1998 using a reinforcing detail shown in Figure 7-6. The complete repair procedure for Girder G3 was carried out as follows:

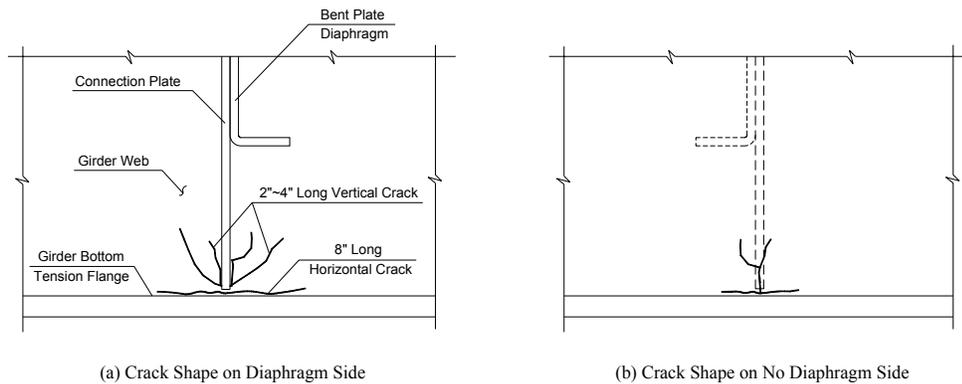
FIGURE 7-4: Crack Shape and Size Observed at Location No. 1

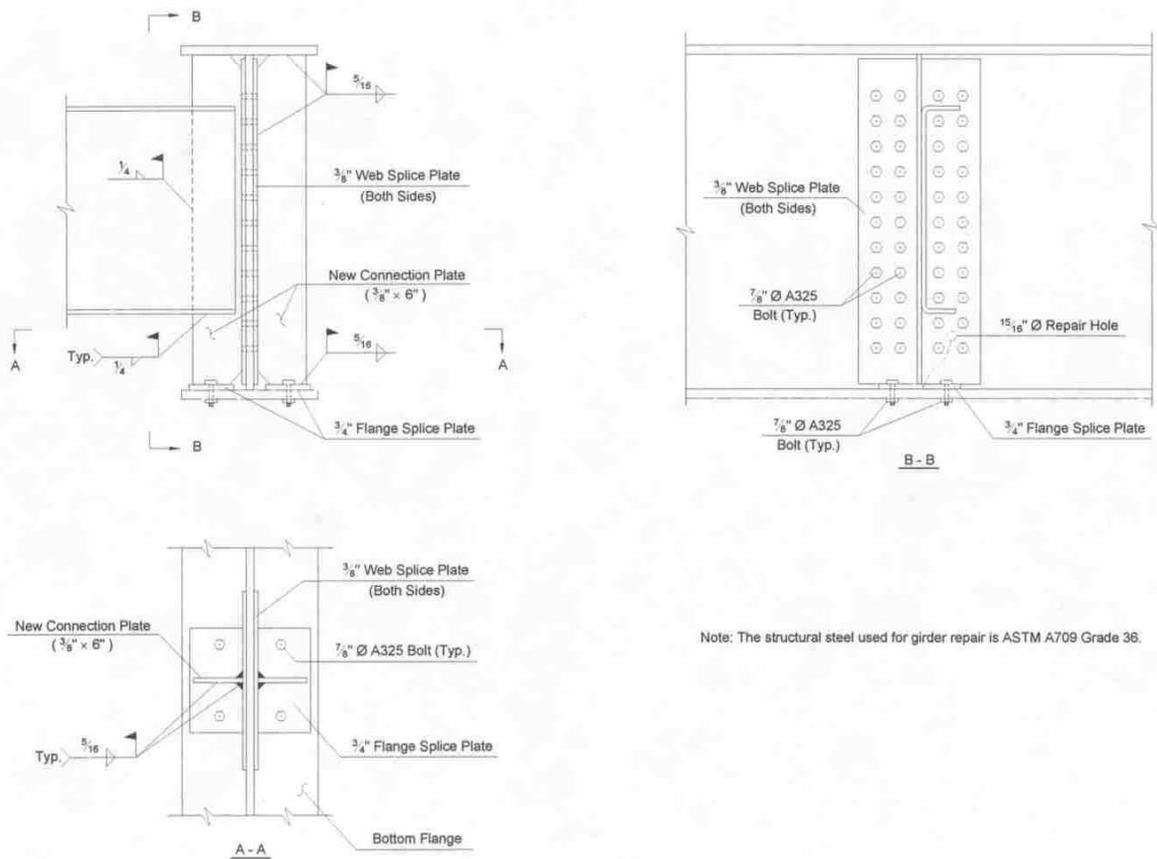
Unlike the original A36 steel used in the bridge, the newly fabricated splice and stiffener plates used for the girder repair are made of ASTM A709 Grade 36 steel. This repair method not only enhanced the girder cross section and stiffened the web gap area at the crack locations, but provided fatigue resistance of Detail Category B to the web and bottom flange using bolted connections. Chances of crack reinitiation at these two locations are very little with such a conservative repair. In fact, to some extent the repaired girder sections could be considered as overly strengthened, as the stiffener installed on the no-diaphragm side is apparently not necessary. The one used on the other web side for diaphragm connection has already been required to be welded to both girder flanges, which should have provided sufficient resistance to the out-of-plane distortion for the repaired details.

However, since no structural corrections were made to the other diaphragm-girder connections that have the same unstiffened web gap details, those areas are still exposed to high cyclic fatigue stresses and remain as potential sites for future crack development. The repair method proposed by Figure 7-6 is expensive if applied to every diaphragm-girder connections. Therefore, it is necessary that certain preventive measures be taken at those intact but crack-prone details before fatigue cracking finally develops.

FIGURE 7-6: Crack Repair Details of the Winfield Bridge

1. Remove and salvage the bent plate diaphragm for reattachment by detaching the diaphragm to stiffener welds. Remove the existing connection stiffener and grind the remaining weld material from web and top flange.
2. Drill a $\frac{15}{16}$ in. diameter repair hole through the web plate at the end of each horseshoe crack.
3. Drill $\frac{15}{16}$ in. diameter bolt holes in web and bottom flange using the web and flange splice plates as templates. Remove all paint from the existing girder surfaces at the web and bottom flange splice locations. Paint these areas with organic zinc primer. Also paint the contact surfaces of the web and flange splice plates with organic zinc primer.
4. Install new splice plates to girder web and bottom flange. Weld new stiffeners to girder web, top flange, and bottom flange splice plates.
5. Weld the existing diaphragm back to the new connection stiffener.

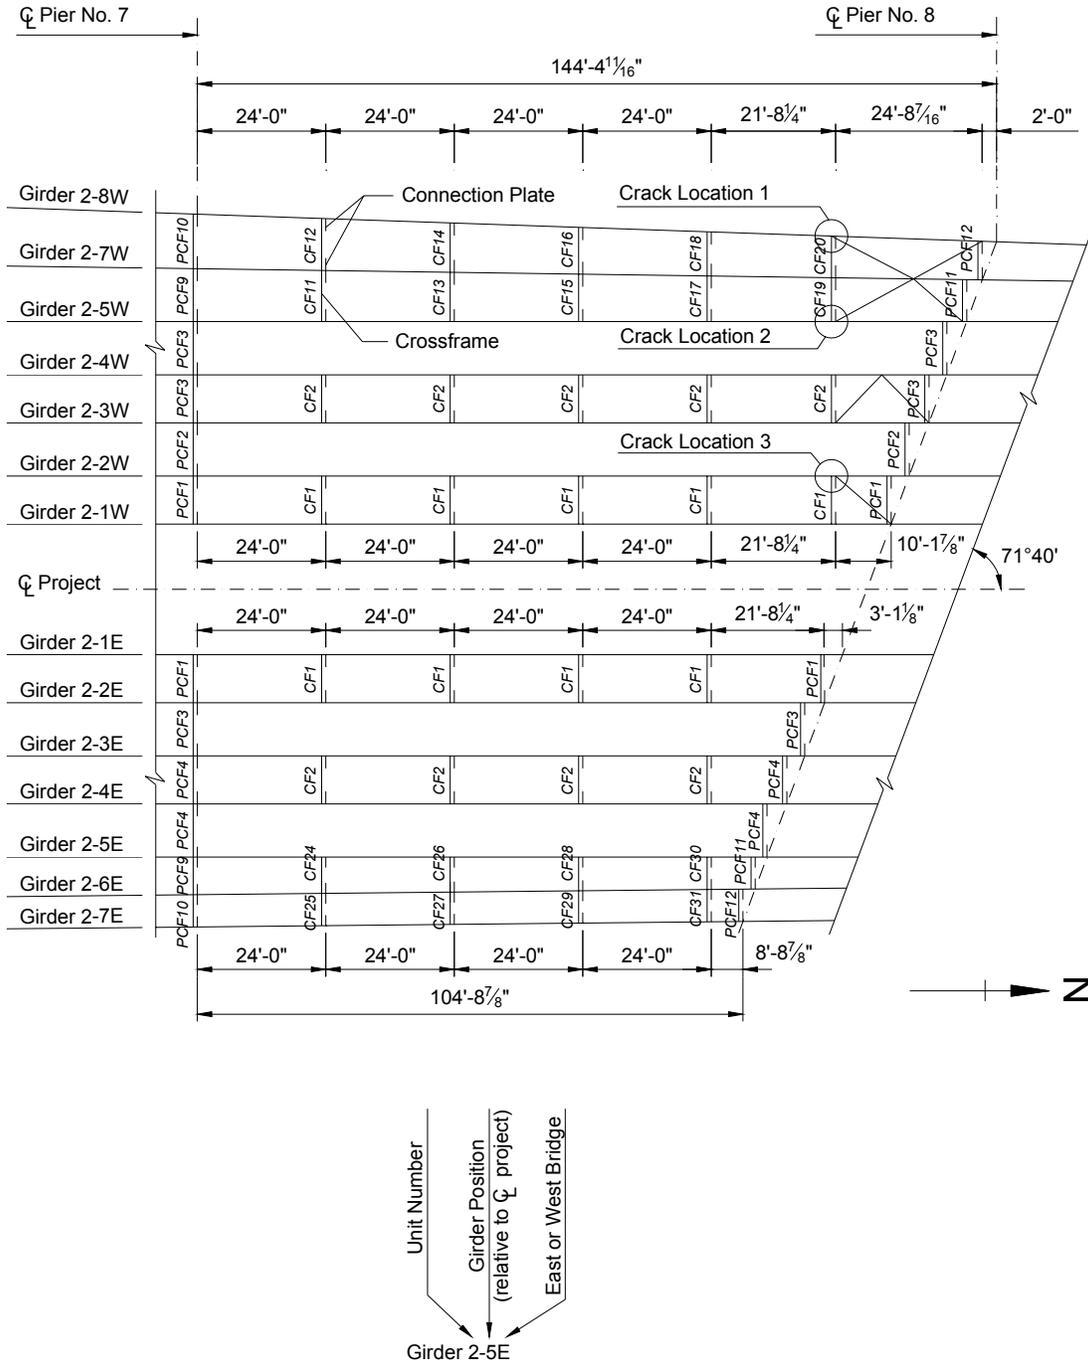
During the 1997 bridge inspection, fatigue cracks were first observed in Span No. 8 of the west bridge at three cross-frame to girder connections. As shown in Figure 8-1, the cracks were identified at the negative moment region close to Pier No. 8 in Girders 2-2W, 2-5W, and 2-8W. All the cracks were found at the small web gaps close to the girder bottom flanges and had propagated through the web thickness. Figure 8-3 shows the inspection pictures of the three locations with the cracks marked by arrows pointing toward the crack tips. The yellow (greyer) arrows were placed during the 1997 inspection. The white (brighter) arrows were placed during a later inspection in 2000. Fatigue crack growth between these two inspections can be noticed clearly by the distance between the ends of the two sets of arrows.

FIGURE 8-1: Steel Framing Plan and Crack Locations of the Hump Yard Bridge Span No. 8

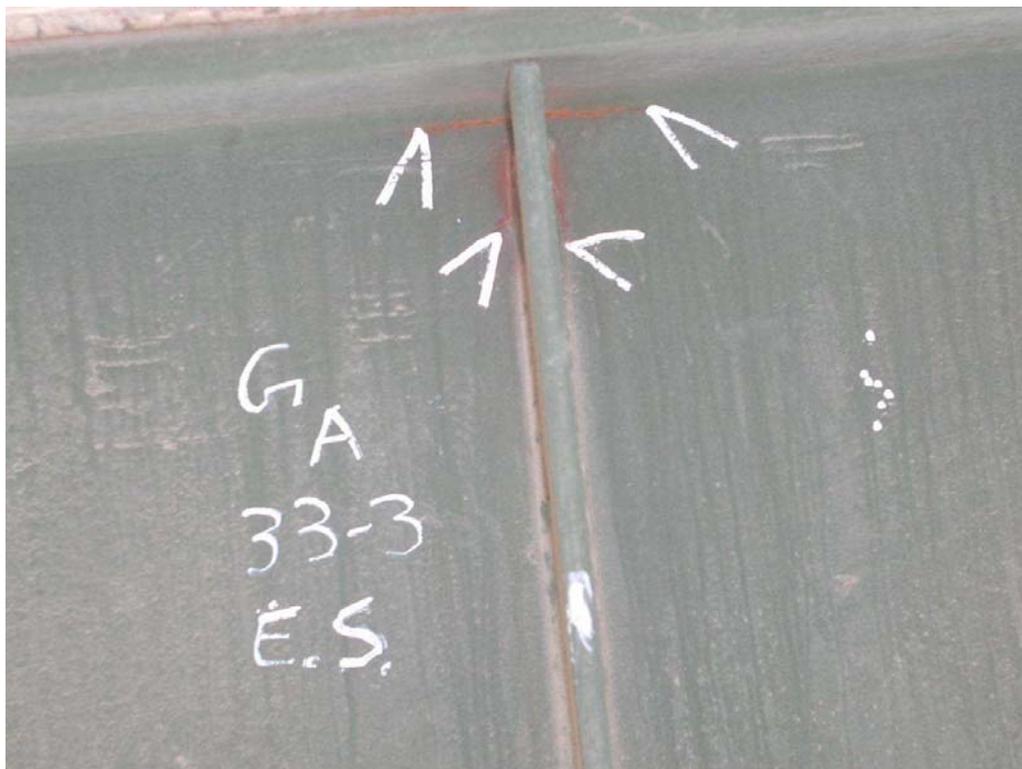
FIGURE 8-5: Top Flange Web Gap Cracks Developed in Span No. 33

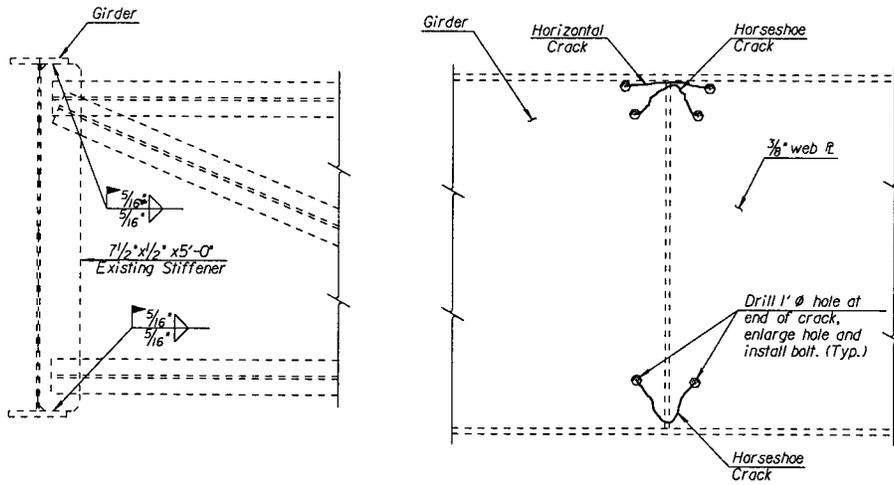
FIGURE 8-6: Type A Repair for Web Gap Cracks

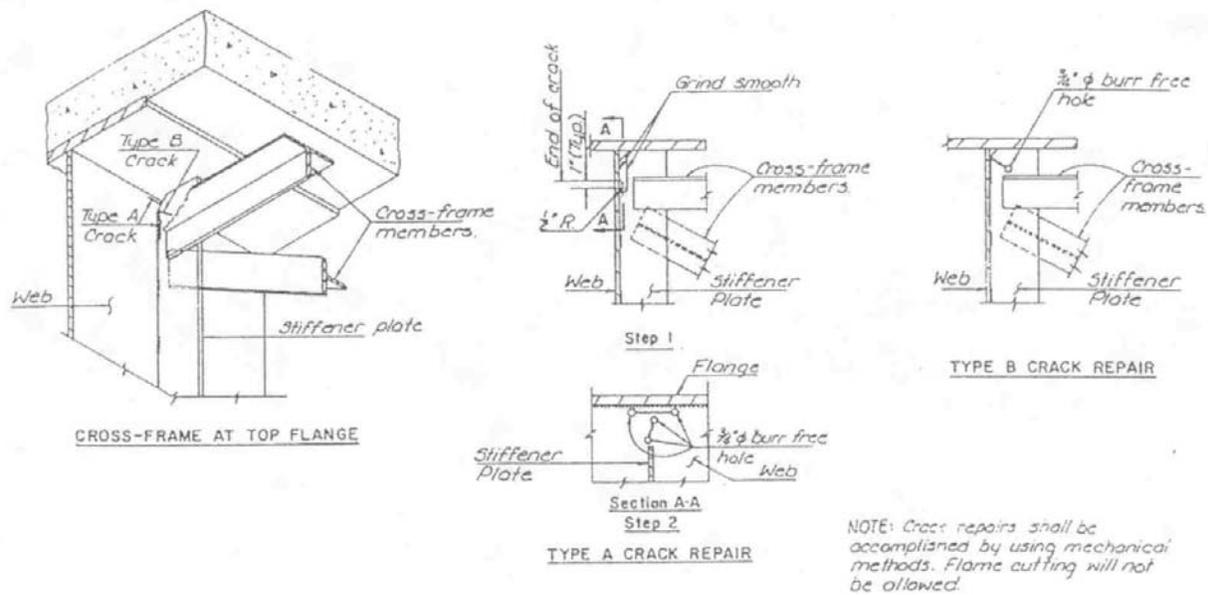
FIGURE 9-5: Crack Repair Detail Used in 1986 Bridge Retrofit

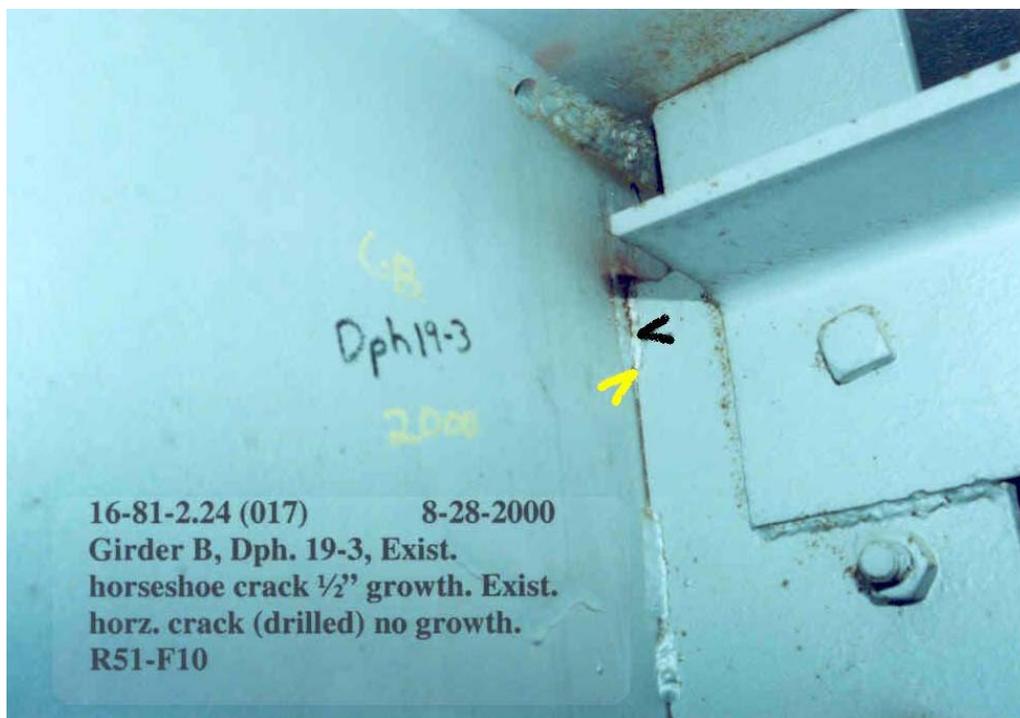
details and 75 of the previously identified crack locations have been found with crack growth. To date, none of the inspections have reported crack formation at the bottom flange web gaps.

FIGURE 9-6: Crack Growth along the Vertical Stiffener-to-Web Welds

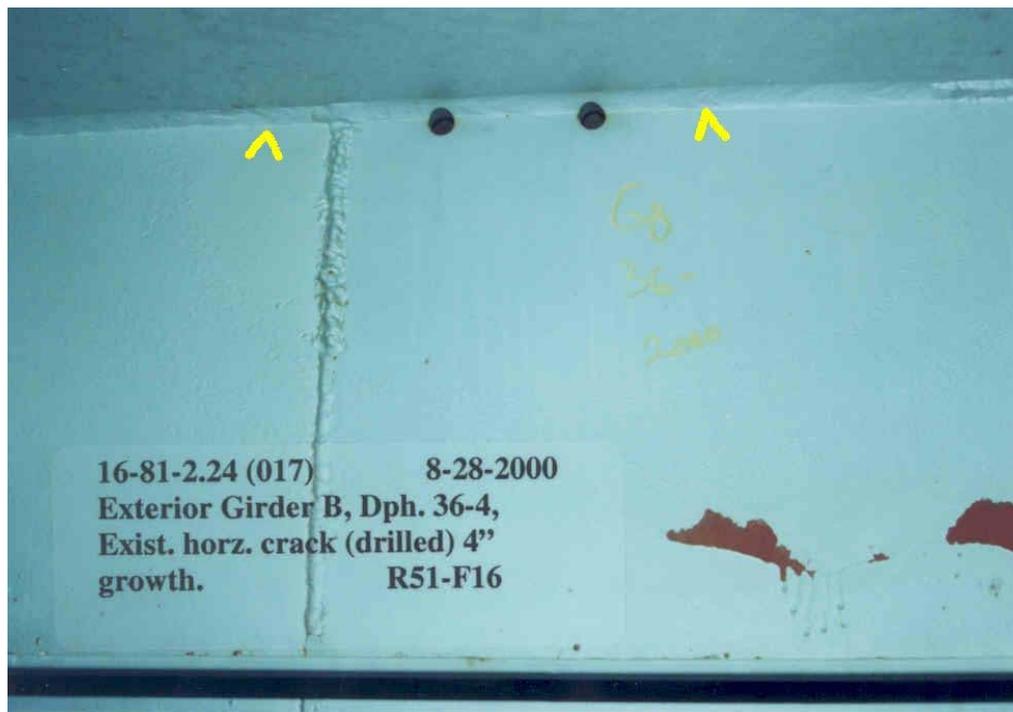
FIGURE 9-7: Crack Growth along the Horizontal Flange-to-Web Welds
