Acoustic Emission Non-Destructive Integrity Assessment of Intermodal Transportation Infrastructure Asset Interactions

Final Report

Multimodal Transportation & Infrastructure
Consortium

January 2016

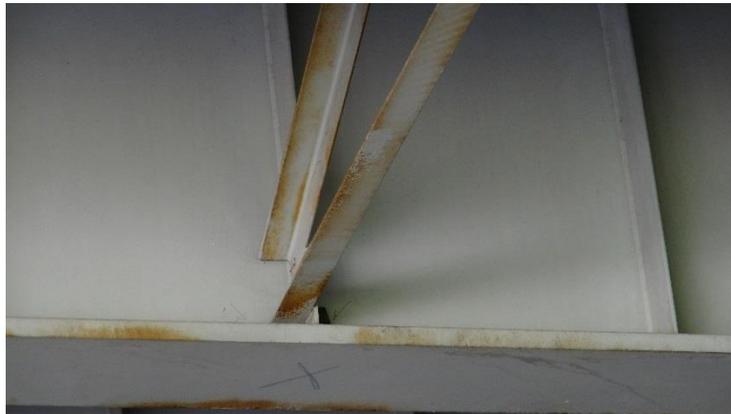
Figure 6: Visually identified crack in the girder #7 connection to cross-brace (location marked with "X" by VDOT, span 2)

The bridge under investigation has three spans. The middle span (span 2) was identified to carry a defect (crack) in the girder #7 girder-to-cross-brace connection. The AE tests, carried out in the suspected area, indicated that there is no active defect in this girder, meaning that the material around the visible crack would have plastically deformed and does not pose any further threat to the integrity of the structure.

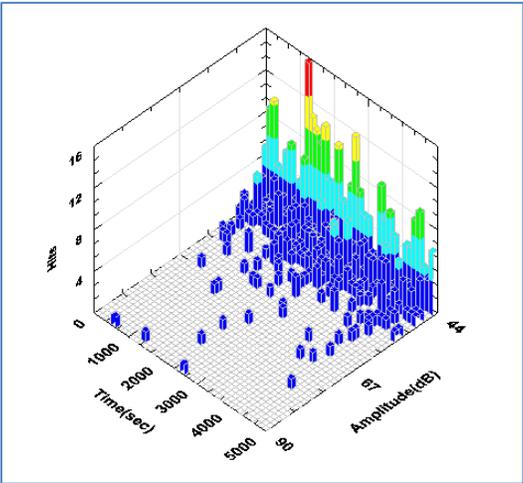
Preliminary tests that were carried out in the year 2013, over a period of four months, indicated that no appreciable increase in AE activity was found during that time, in that there was no active crack propagation. Since the AE activity varies in accordance with the traffic situation on the bridge, we have additionally conducted two experiments over a period of 5,000 seconds at 10:00 AM in the morning during the busy traffic hour. Figs. 9 and 10 show AE signals measured under these conditions. We did not notice any significant increase in the AE activity during the second experiment as compared to the first one. Therefore, the

measurements taken over a period of one year showed that there was no significant increase in the levels of AE emission. It is expected that an active crack will show increasing rates of AE activity as the defect grows. Since there was no increase in the AE activity over the period of one year, it is concluded that the visible crack is inactive, in that the material around the crack does not encounter any appreciable stress concentration and there is no need to take any further action.

Figure 9: AE activity result measured in January 2014 for a period of 5,000 seconds during the busy road traffic hour.

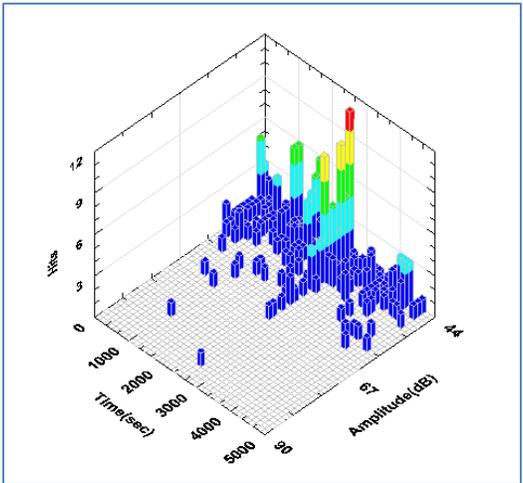
Figure 10: Subsequent AE activity measurement result to confirm the level of AE under the similar road conditions.

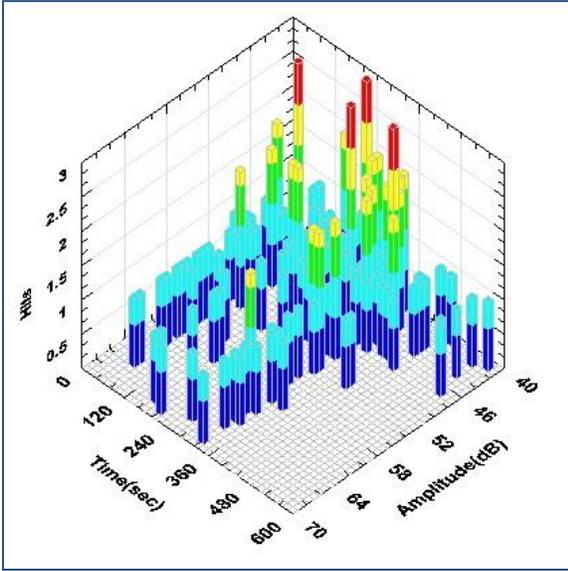
Fig. 12.9: Girder #9 (300 kHz, 40dB)

This bridge has four travel lanes with two shoulders. It has been observed in all measurements that the AE activity is always greater in the central portion of the road surface. The AE activity is the lowest in the girders #1 and #10, while girders #4, #5, and #6 exhibit more severe AE. This trend has been observed with measurements conducted with both 300 kHz as well as with 150 kHz AE transducers. AE hits acquired from the 300 kHz sensors (Channels 2 and 4) in the ten girders are given in the Fig. 14. Fig. 15 illustrates the same information as a summary, where it is very clear that the AE activity is greater in the middle of the road. However, it can be seen that girder #9 produces much higher level of AE activity, indicating that there is a possibility that this beam may have an active crack. It is

The northern span (span 1) is also supported by ten steel girders with I-sections. AE tests carried out on these 10 girders showed AE activity levels with distinctly higher AE occurring in girder #9. This girder is very close to the side of the bridge, where the load conditions normally are not that severe, compared to the central region, where girders #4, #5, and #6 support the road. It is therefore possible that girder #9 may have an active crack source which emits strong AE signals when subjected to normal traffic loads. It is advised to carry out further NDT tests on the girder #9 to check for the integrity of the structure. Visual examinations, dye penetrant tests, and ultrasonic tests can be carried out to locate the source of the defect, if any.

recommended to carry out further detailed studies using visual examination, dye penetrant tests, and ultrasonic tests to check for the presence of defects.

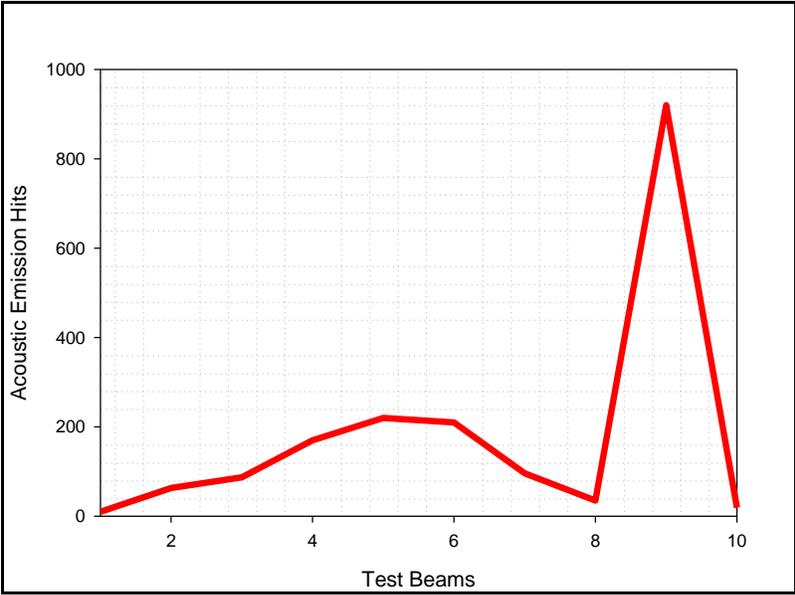
Figure 15: Plot of AE hits acquired in the ten girders.
