REPORT NOS. DOT-TSC-NHTSA-79-48

//  
COMPARISON OF PRE AND POST ROAD TEST  
ULTRASONIC INSPECTION RESULTS ON  
134 PASSENGER TIRES

George Berube

FINAL REPORT

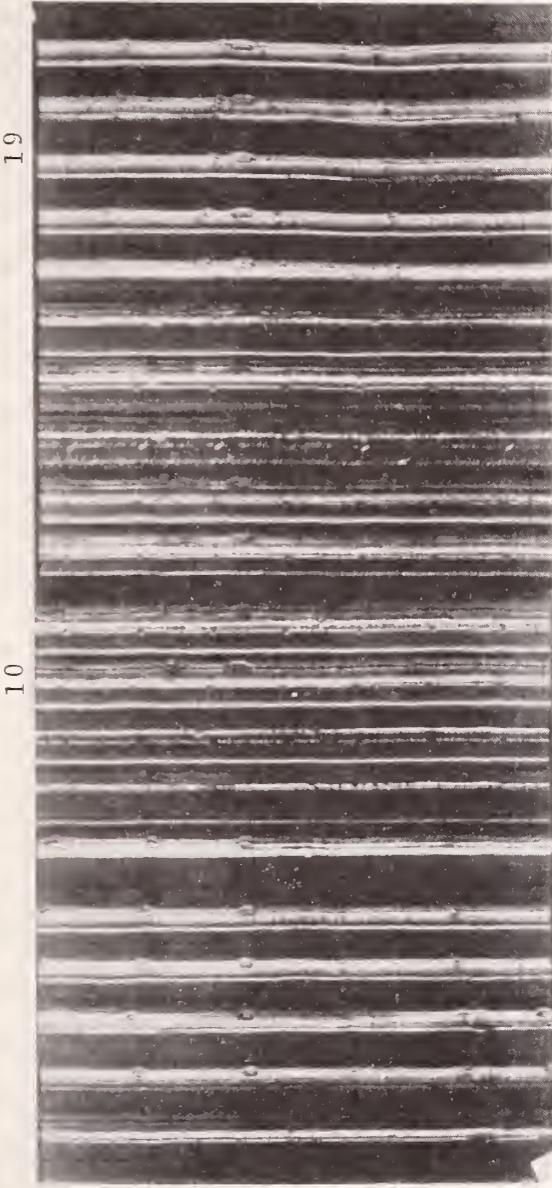
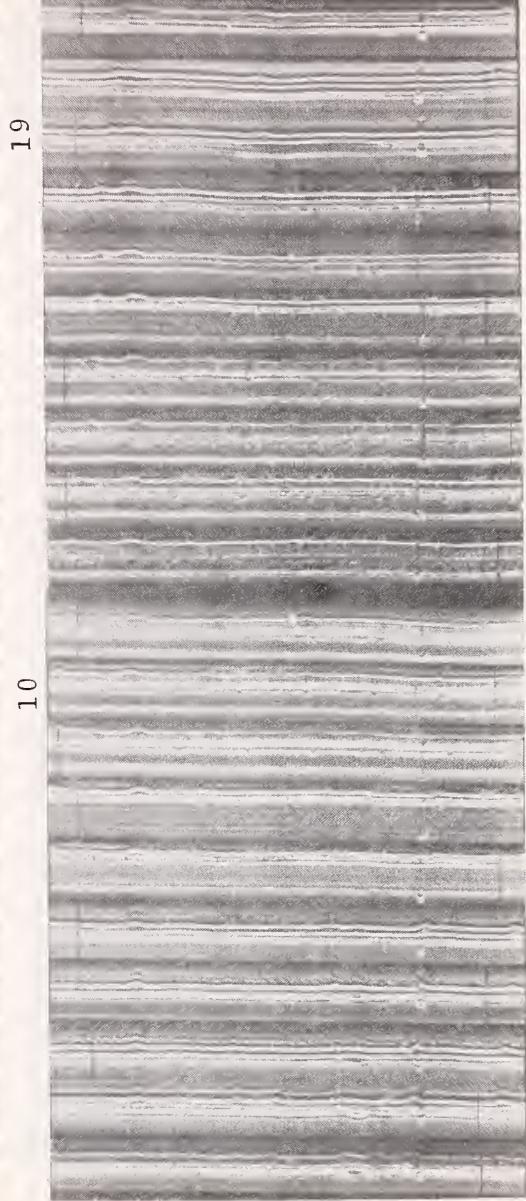
T8X  
2119

FIGURE 6-1. GOODRICH CUSTOM LONG-MILER ——— RADIAL RUNOUT IN CHANNEL 10. IT DID NOT APPEAR BEFORE ROAD TEST. POSSIBLE SEPARATION ? CHANNEL 19 ALSO HAS SOME SHAPE DISCONTINUITIES, BULGING OF OUTER SURFACE. DOES NOT APPEAR IN NEIGHBORING CHANNELS. POSSIBILITY OF EXCESS RUBBER.

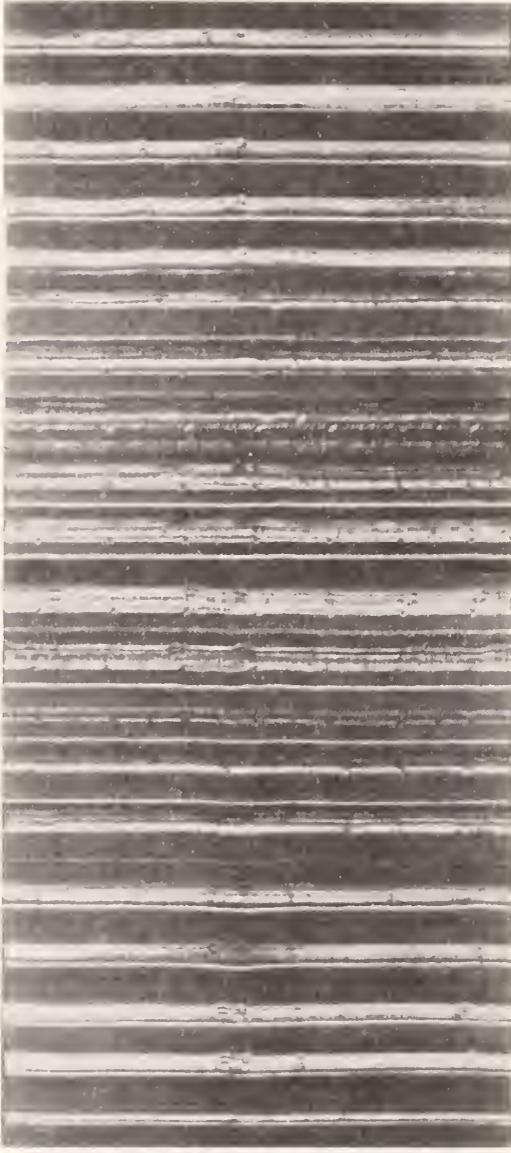
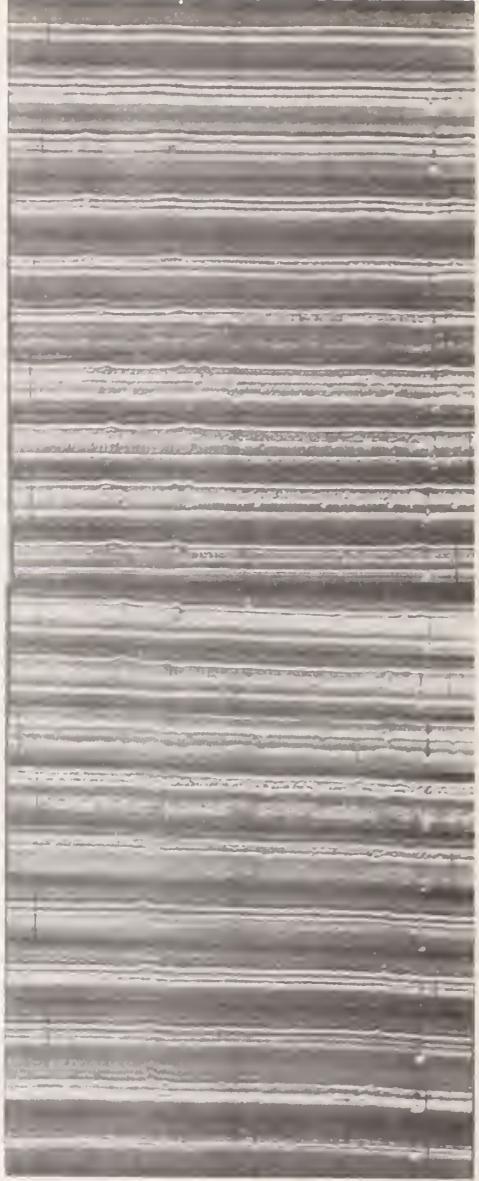
T8X  
2122

FIGURE 6-2. GOODRICH CUSTOM LONG-MILER --- APPARENT TREADWEAR IN SHOULDER AREA. DARK LINER TRACES IN CHANNEL 9 ARE SUSPICIOUS. PELTS SPERM TO HAVE SHIFTED SLIGHTLY IN CHANNELS 9, 10, and 11.

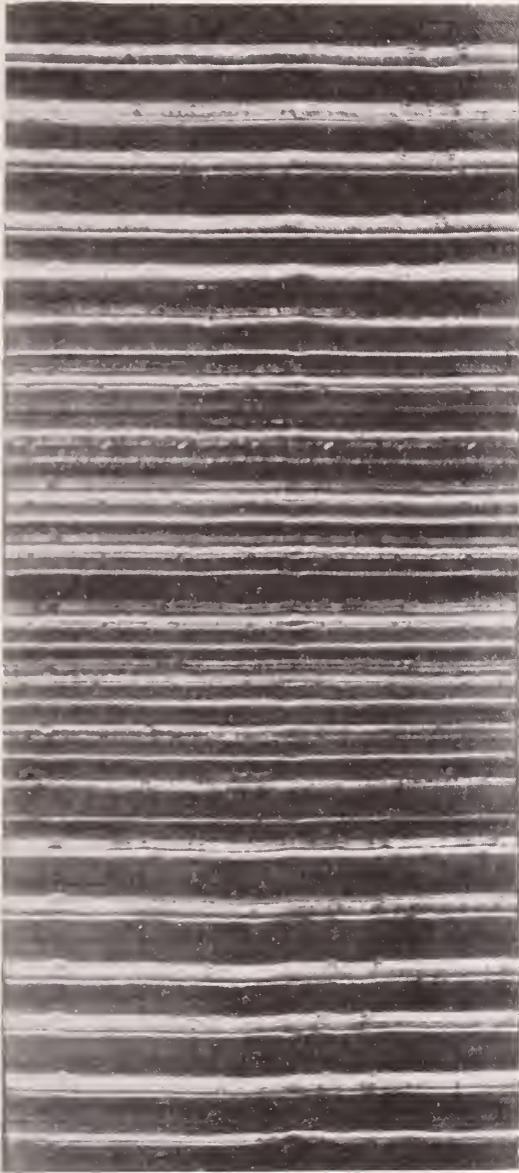
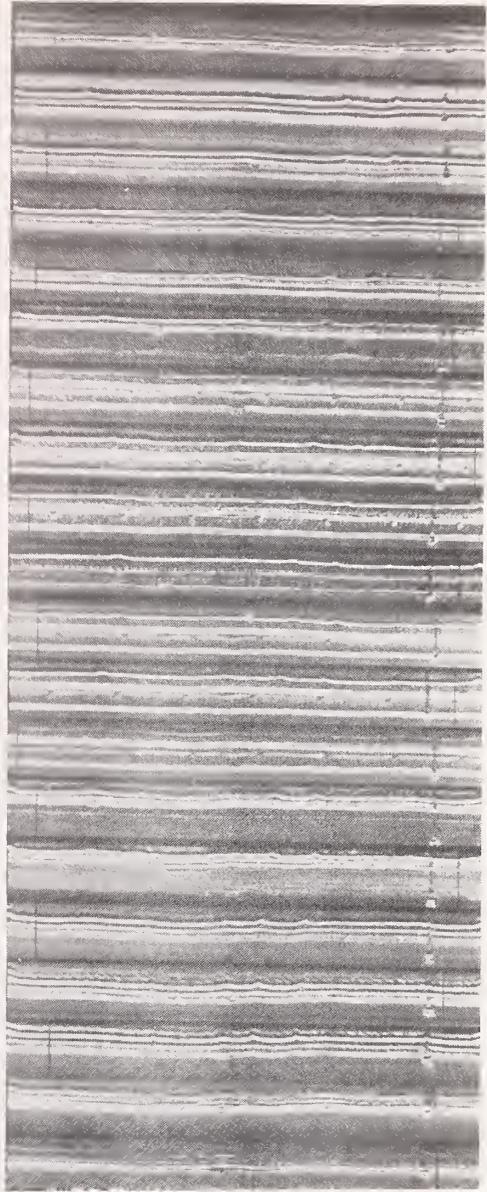
T8 X  
21 23

FIGURE 6-3. GOODRICH CUSTOM LONG-MILER --- SOME TREAD MODULATION; MAY OR MAY NOT BE SPURIOUS. BELTS ARE NOT EVEN, SOME LATERAL RUNOUT INDICATED.

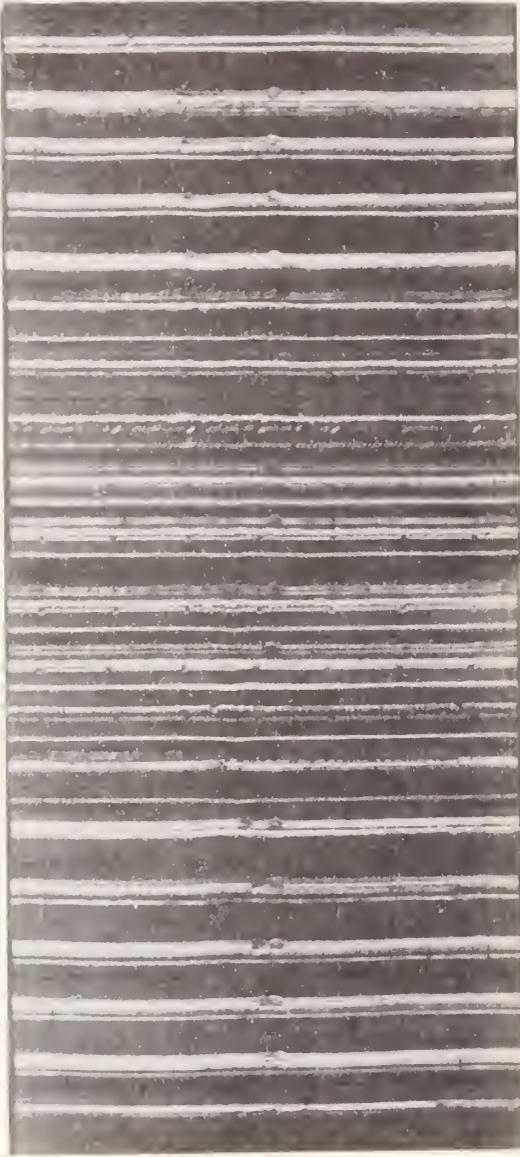
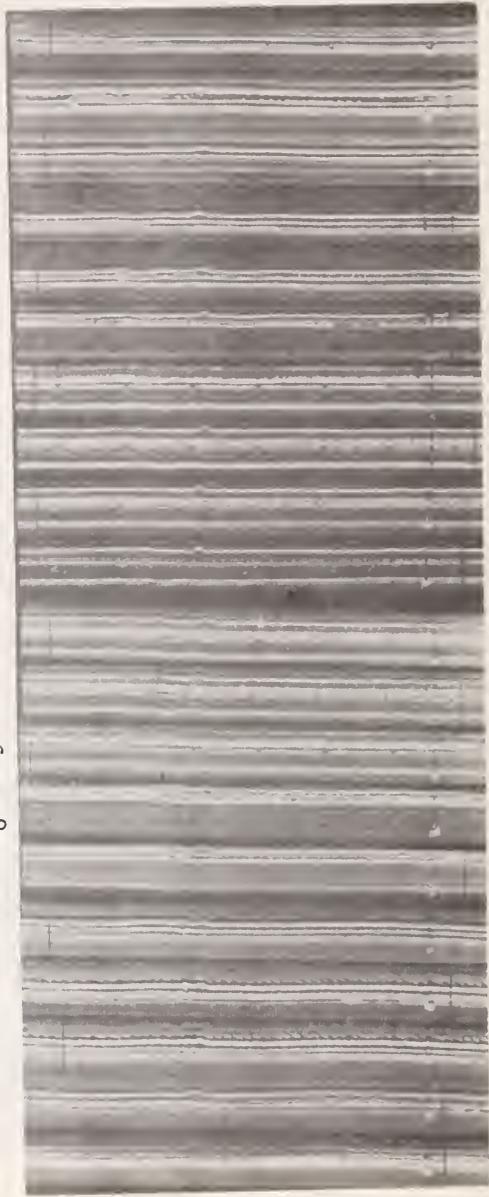
TSX  
2124

FIGURE 6-4. GOODRICH CUSTOM LONG-MILER --- HEAVY SPLICE IN CHANNELS 8&9 CAUSING BULGING EFFECT ON SURFACE OF SHOULDER. THIS CAUSES OUT-OF-POUNDNESS AND IRREGULAR WEAR. SPLICE APPEARS TO BE MORE SEPARATED AFTER ROAD TEST.

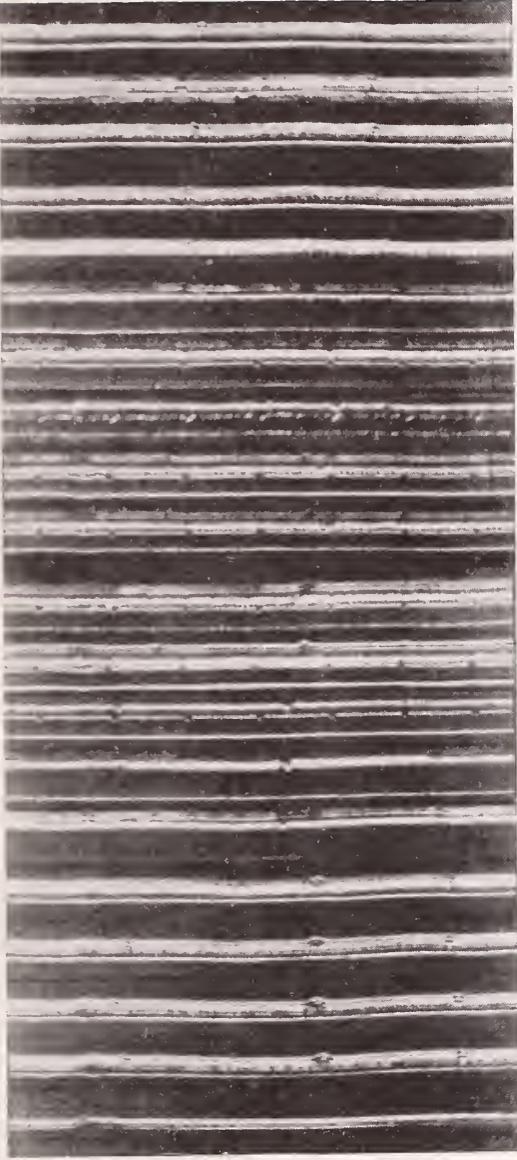
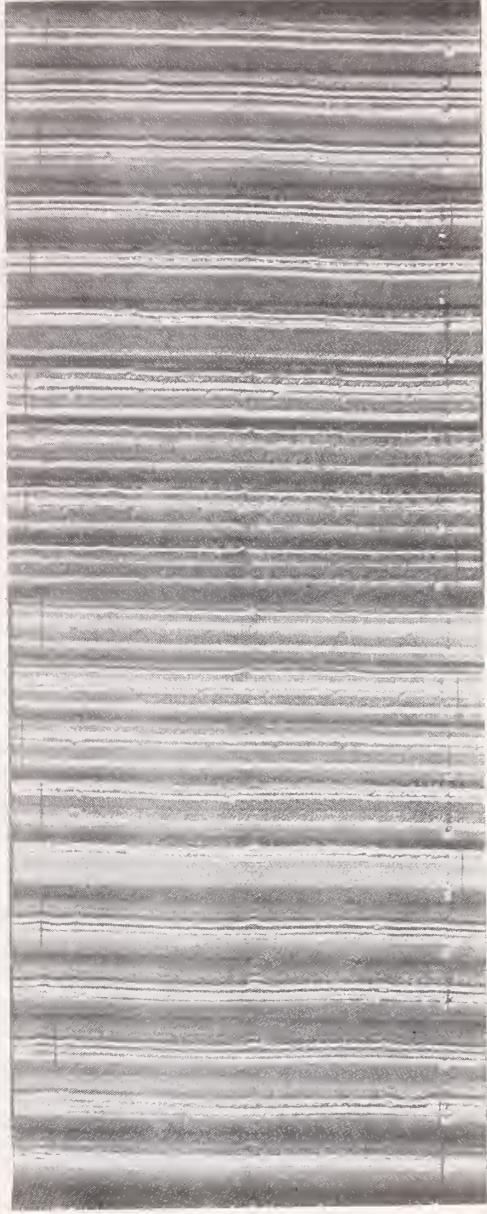
T8X  
2125

FIGURE 6-5. GOODRICH CUSTOM LONG-MILER — BULGING OF OUTER SURFACE DUE TO BELT PROBLEM. BELTS IN CHANNEL 15 SEEM TO HAVE DISCONTINUITIES. WOULD SUSPECT A POSSIBLE SEPARATION TO BE PRESENT. UNEVEN BELT SPLICES ARE KNOWN TO CAUSE UNEVEN TREADWEAR.

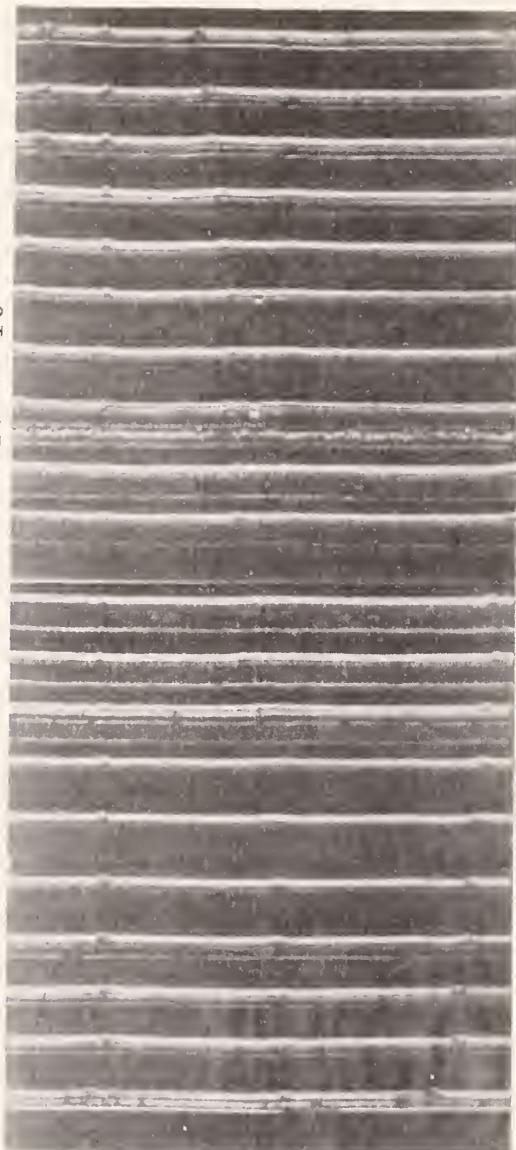
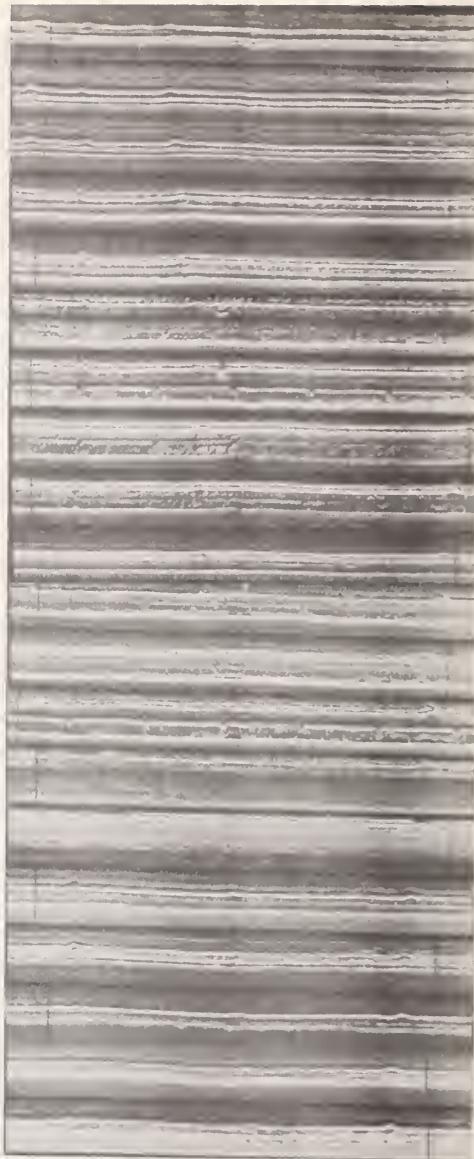
TSX  
2199

FIGURE 6-6. UNIROYAL TIGER PAW INCLUSIONS OBSERVED IN CHANNELS 14 AND 16 BEFORE ROAD TEST ARE OBSERVED IN CHANNELS 15 AND 16 AFTER ROAD TESTS.

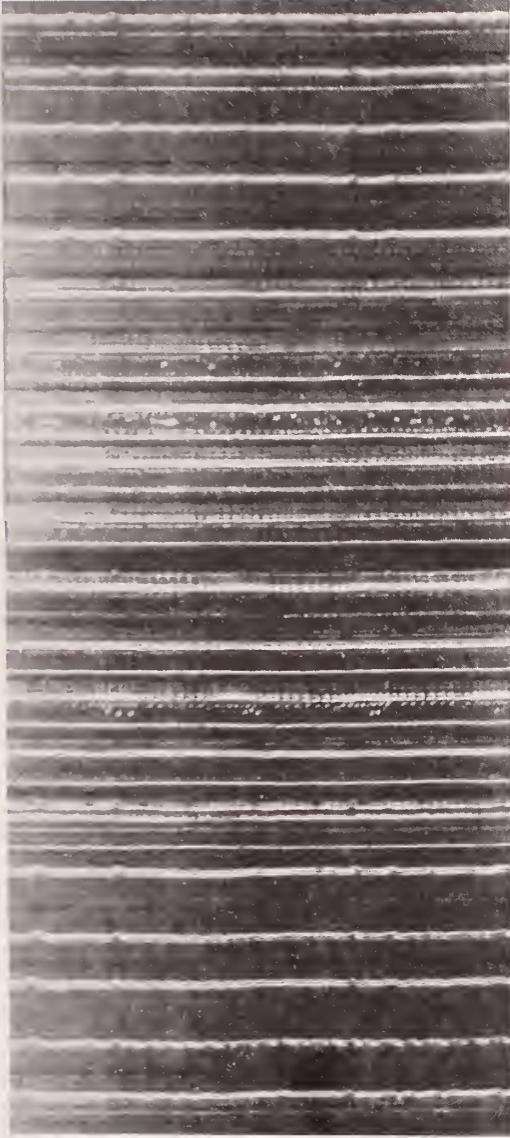
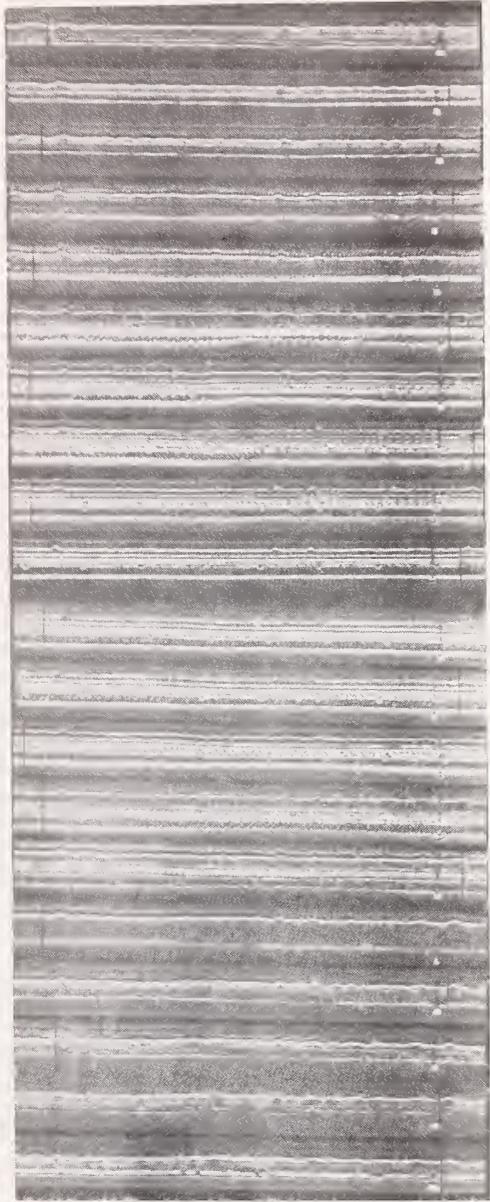
T8X  
2236

FIGURE 6-7. FIRESTONE #500 — DEFINITE CHANGE IN SHAPE IN CHANNELS 15 AND 16. NOTICEABLE TREADWEAR. CAUSE DOES NOT SEEM TO BE ASSOCIATED WITH BELTS OR INNER SURFACE.

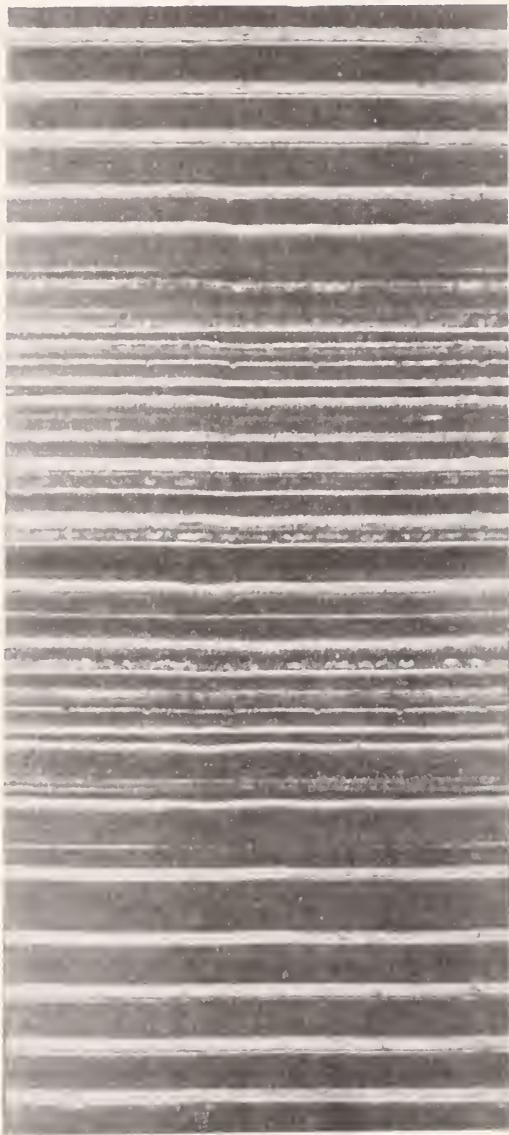
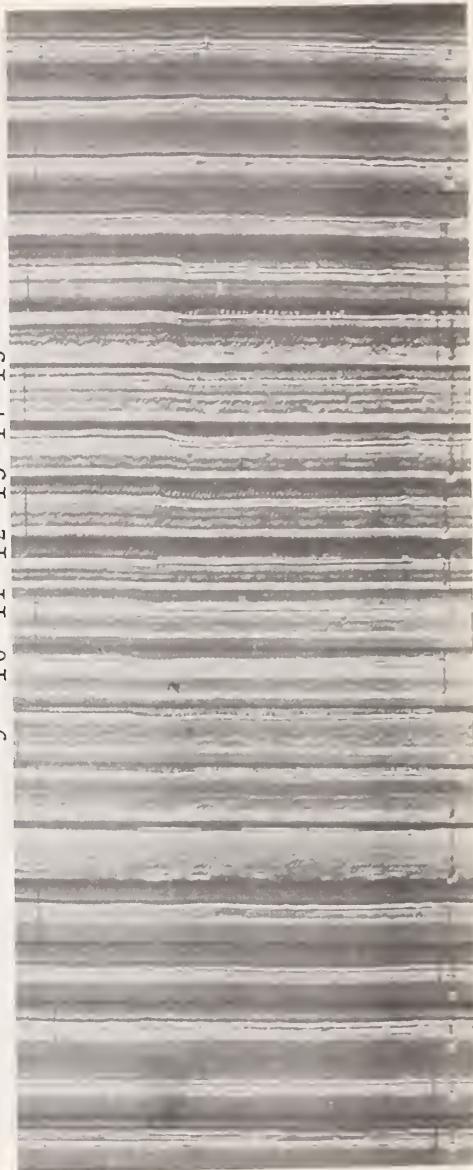
T8X  
2270

FIGURE 6-8. GOODYEAR POWER CUSHION 78 — SEVERE RUNOUT (CHANNELS 9-15). CAUSES CIRCUMFERENTIAL OUT-OF-ROUNDNESS WHICH LEADS TO UNEVEN TREADWEAR.

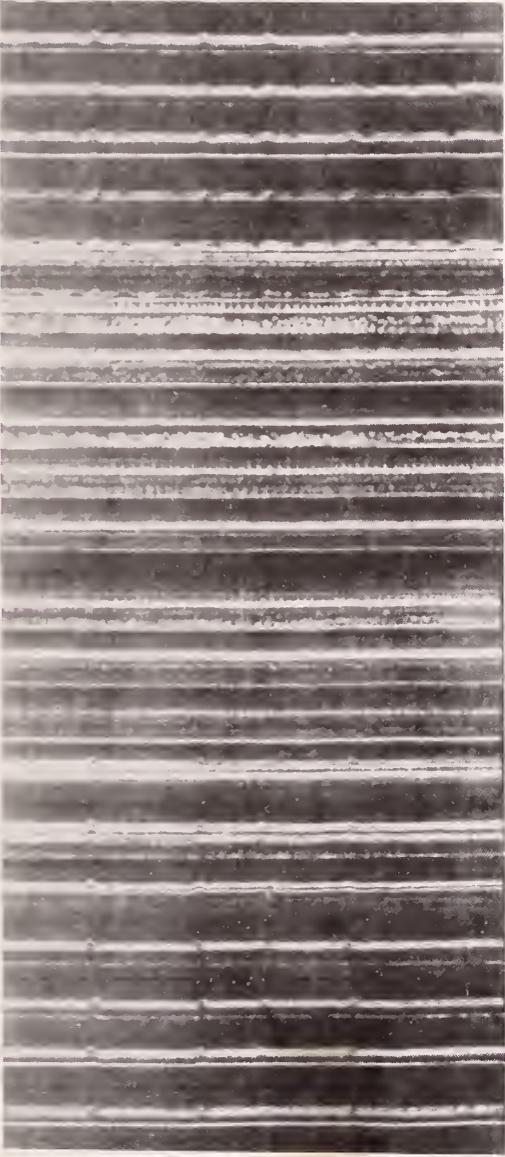
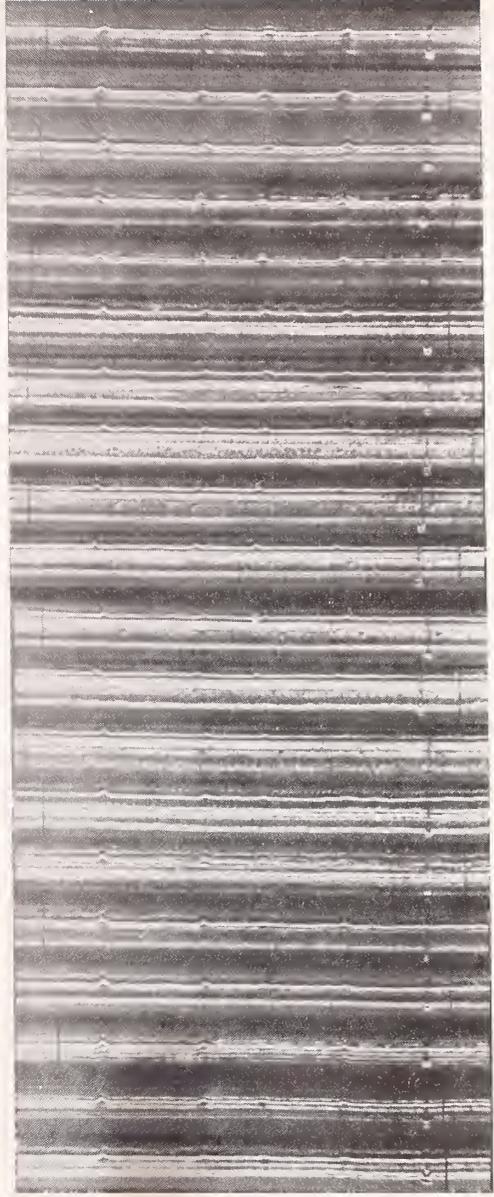
T8X  
2302

FIGURE 6-9. GOODYEAR POLY STEEL RADIAL CHANNEL 15 INDICATES SOME SHAPE DISCONTINUITY AFTER THE ROAD TEST. THIS WAS PROBABLY CAUSED BY A WEAK BOND BETWEEN TREAD AND CARCASS WHICH RESULTS IN HIGH SPOTS ON THE SURFACE.
