REPORT NOS. DOT-TSC-NHTSA-79-51

✓✓
**CORRELATION BETWEEN ULTRASONIC NONDESTRUCTIVE
INSPECTION AND WHEEL TEST OF 34 RETREADED TIRES**

NOVEMBER 1979

FINAL REPORT

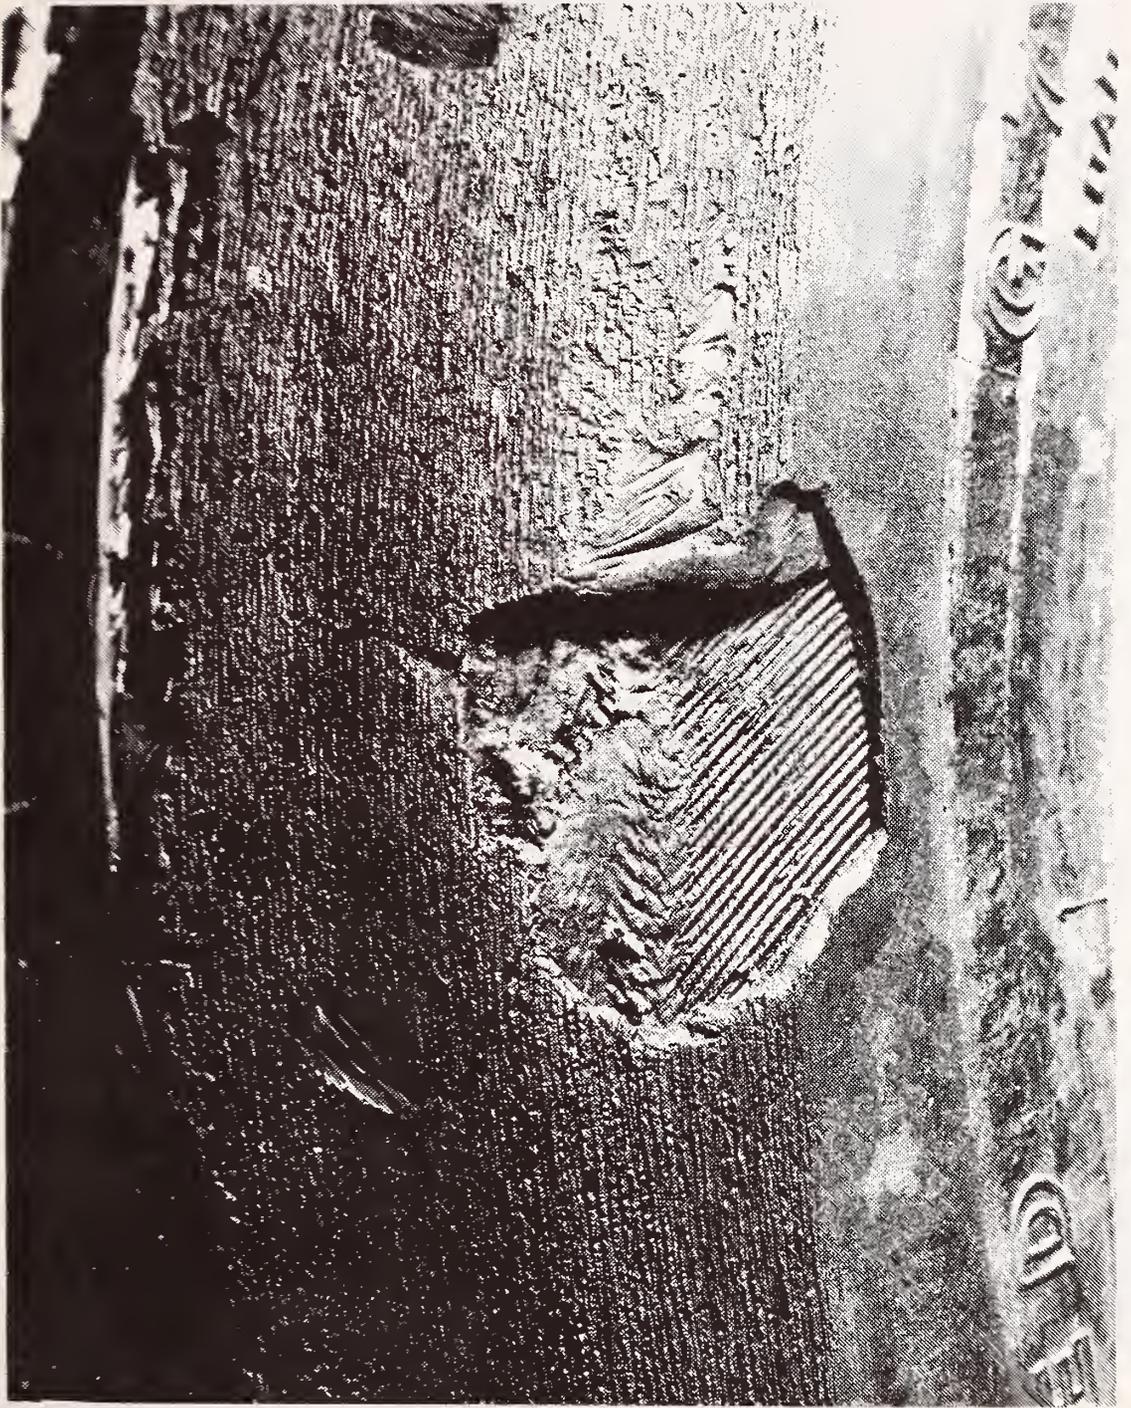
FIGURE 2-1. BUFFED INTERFACE AND BELT EDGE SEPARATION T5X 1223

It is commonly accepted that separations above one-half inch in size, if located at critical sites, will eventually cause failure of a tire. This criterion seems to be true whether the tire is new or retreaded. The rate of degradation of a tire with a separation is highly dependent on the location of the separation and appears to be different for new and retread tires. It is generally thought that belt edge separation is one of the most common and destructive causes of tire failure. These separations seem to occur in most radial tires after a period of service but, if the tire is properly built, they remain small and only achieve accelerated growth toward the end of wear-out. However, for retreaded radial tires, belt edge separations appear to be the principal cause of failure. A typical example of this is shown in Figure 2-1.

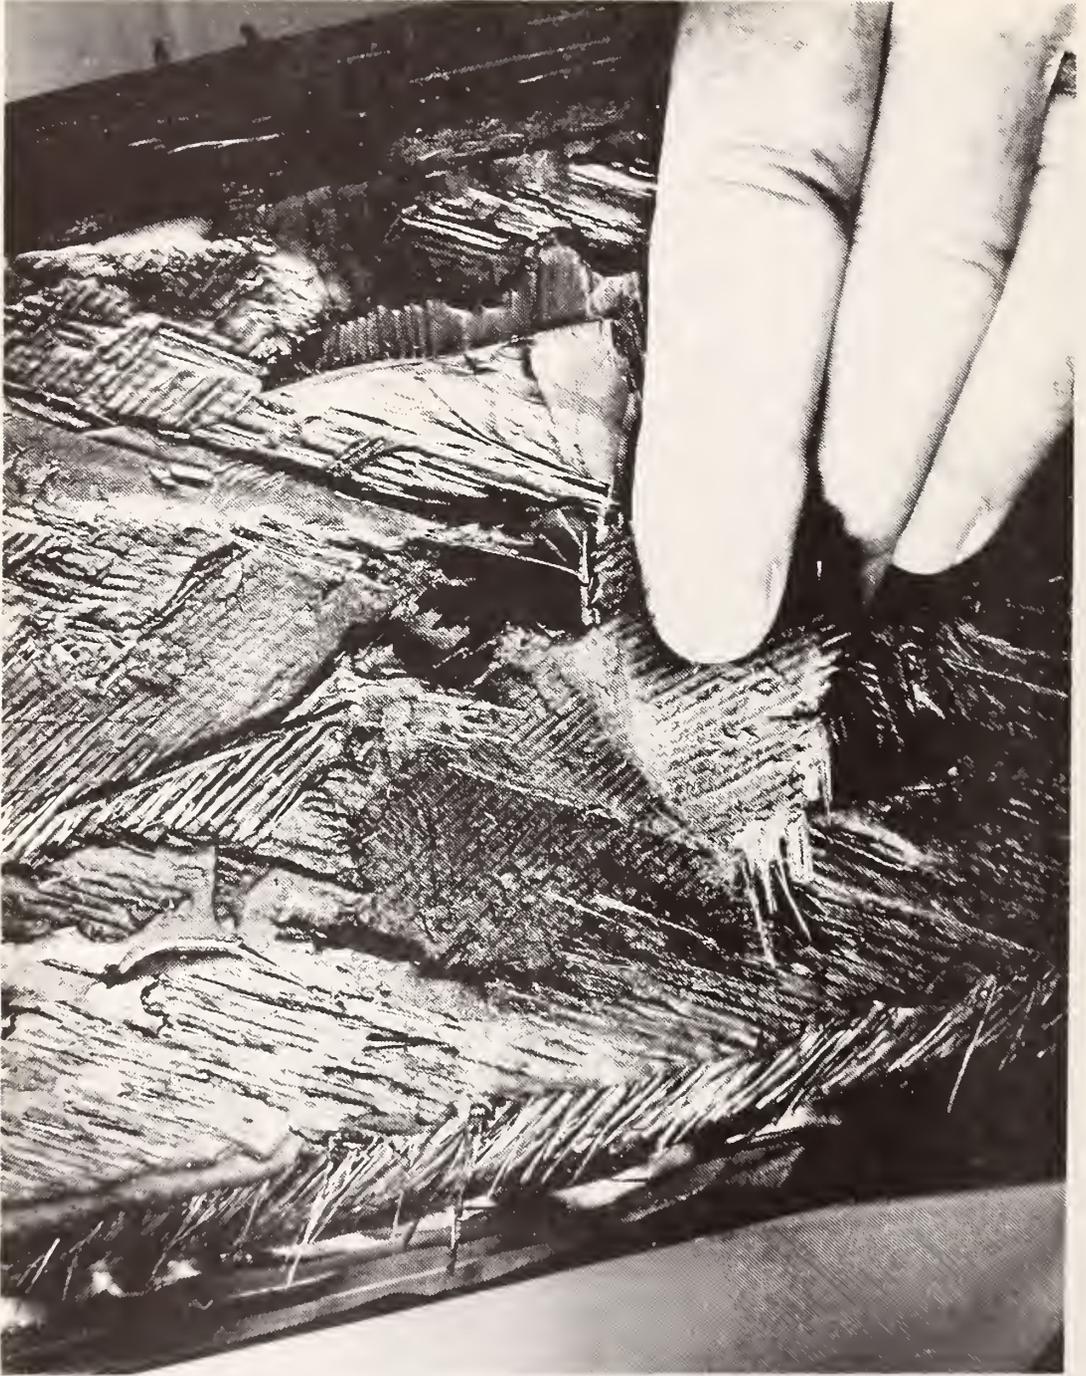
FIGURE 2-2. SEVERE BELT BREAKAGE AND FAILURE AREA T5X 1183

Belt breakage, shown in Figure 2-2, is far more prevalent in retreads than in new tires. Although new green tires are sometimes "trapped" in a mold in such a way that the expanding

mold bag will break the belt during curing, this is a rare phenomenon. Belt breakage usually occurs either as a result of marginal design practice on early glass belted tires, or by abuse or road hazard damage during the service life of the tire.

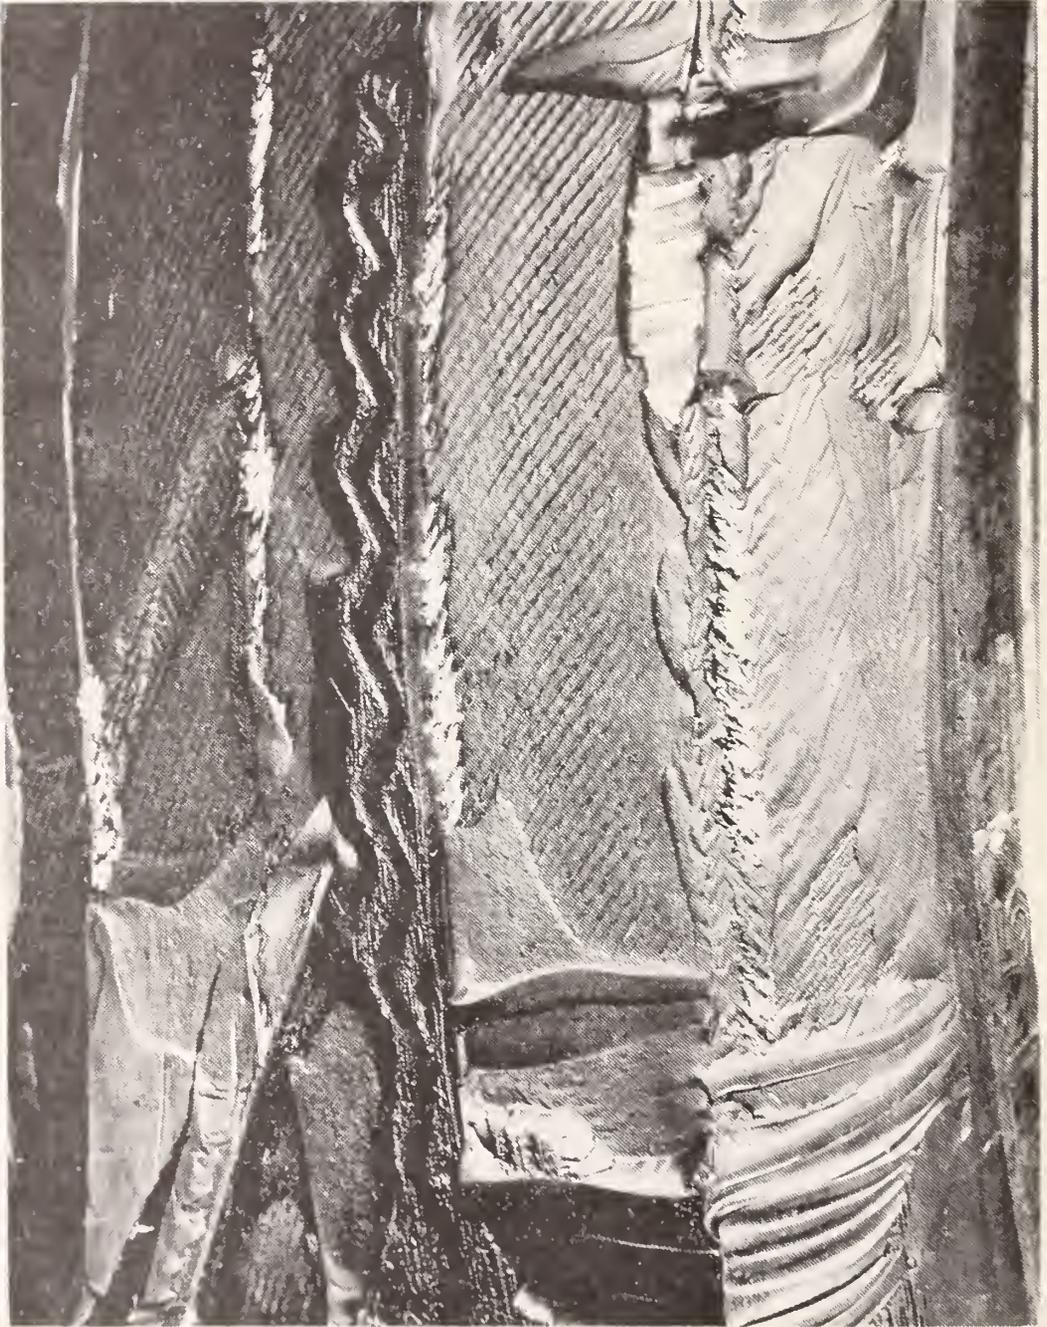
FIGURE 2-3. BURNT MOLD GROOVE LINE T5X 1223

A principal cause of the early failure of retreads and a problem in new tire manufacture is the amount of tread thickness between the groove bottom and the outer ply of the belt. Figure 2-3 is a picture of the condition as found in one of the tires in this study. The groove bottom is nearly in contact with the outside belt and the result is a burned groove bottom and a failed tire.

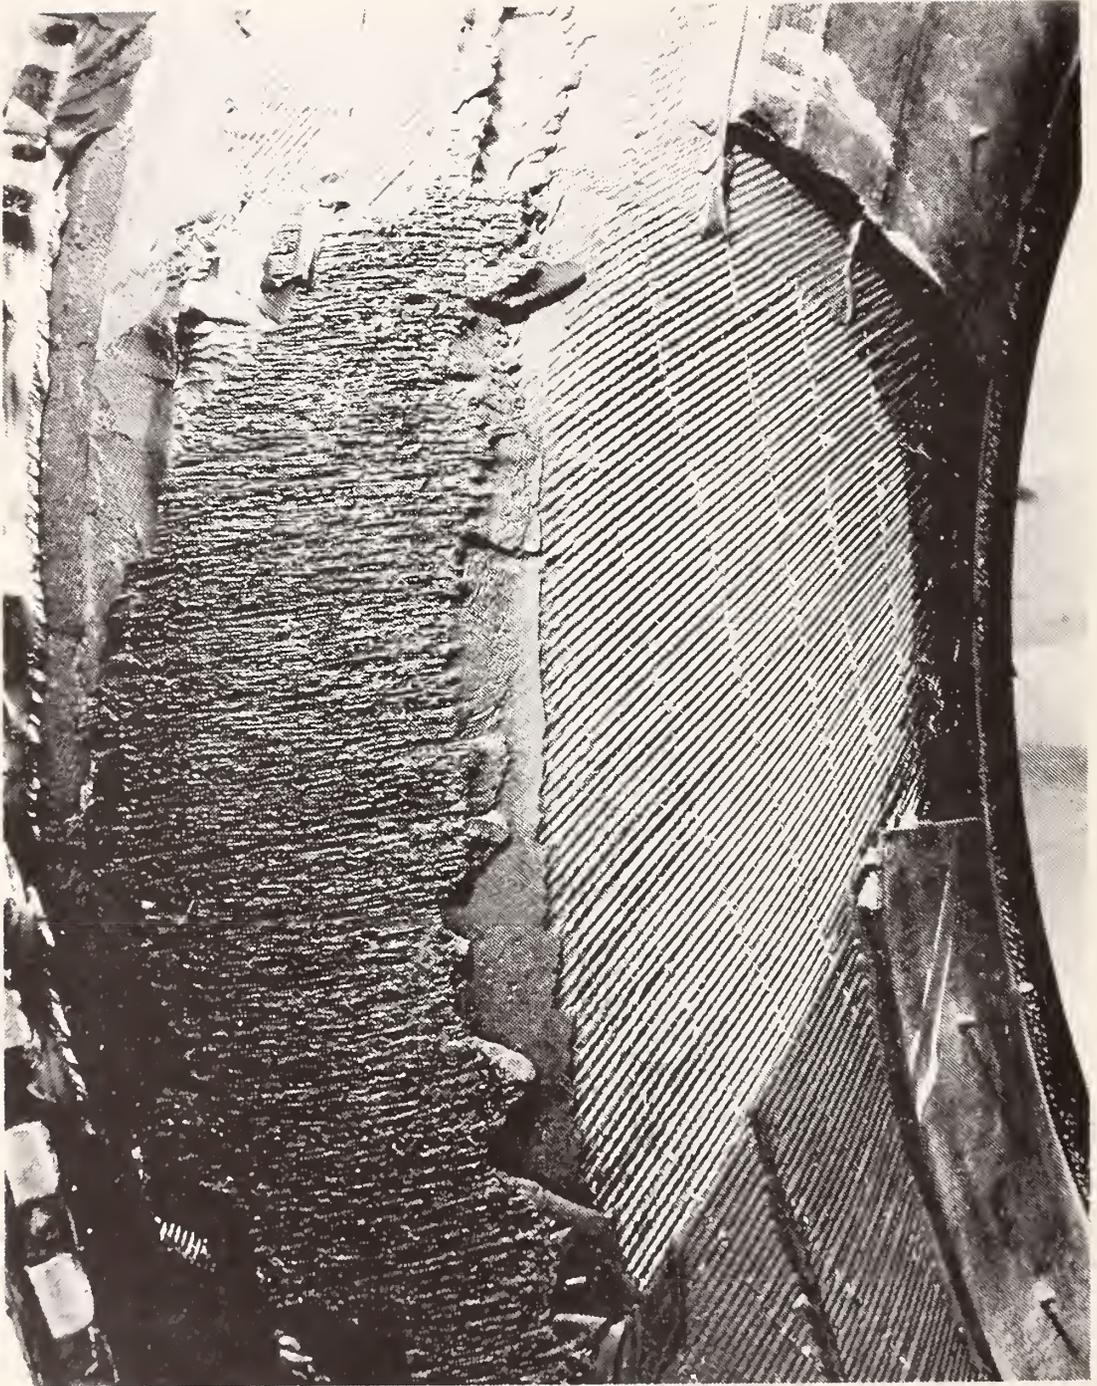
FIGURE 2-4. SIDEWALL SEPARATION AND AREA OF POOR RUBBER ADHESION T5X 1161

the relationship between overbuffing and failure, modern retread practice considers overbuff a harmful condition. Figure 2-4 is a clear representation of many of the major problems of the modern retreader. This casing selected by a casing supplier and inspected several times prior to retreading had in it an area which was in an incipient failure mode, probably from the beginning of the tire's life. Careful use had permitted the tire to run through one service life with an area of poor adhesion in the tread and sidewall. However, when the tire was subjected to the thermal wheel test, the old problem became aggravated, resulting in heat buildup and causing an adhesion failure in the buff line.

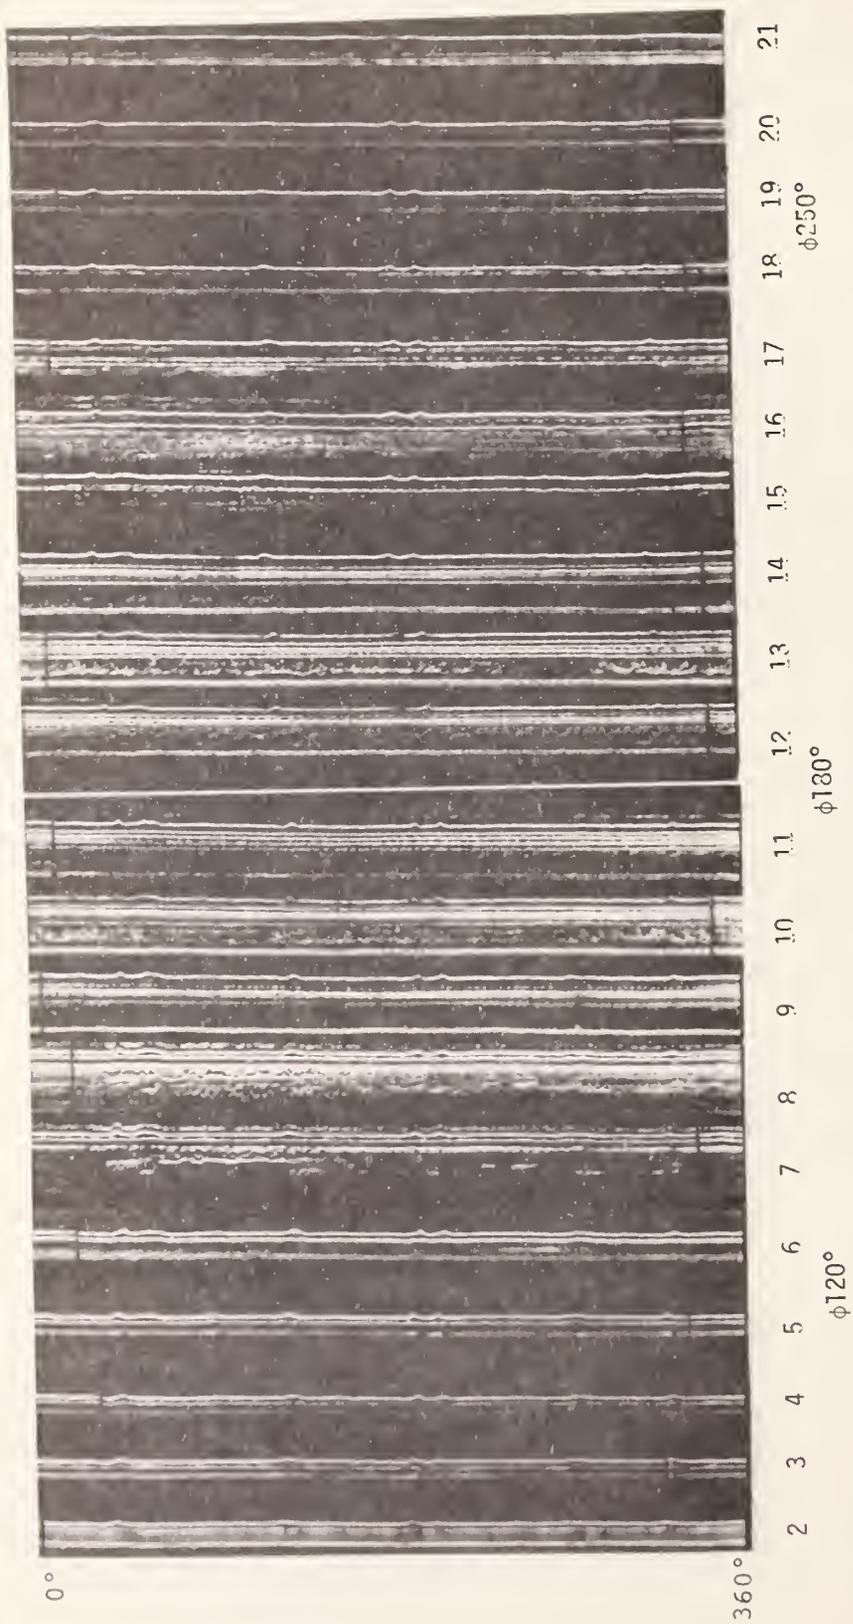
FIGURE 3-1. TIRE T5X 1717

Figure 3-1 is an ultrasonic trace of a good tire. Additional descriptive data concerning ultrasonic inspection may be found in Reference 1 and 4, but a summary is given here to assist in understanding the means by which anomalies are identified. The tire is displayed as if cut at the serial number, opened up and laid out flat. Each channel numbered from 2 to 21 represents a cross-section cut through the tire casing from outside to liner. In each channel, outside is to the left and the liner is to the right. The channels progress from channel 2 which is near the serial side bead to channel 5 near the turnup to channels 8,11,16,18 and 21 which are, respectively, the blackwall or serial shoulder, tread center, the white sidewall shoulder, the white sidewall turnup area and close to the white sidewall bead. In vertical orientation, each channel represents one complete tire rotation, beginning at

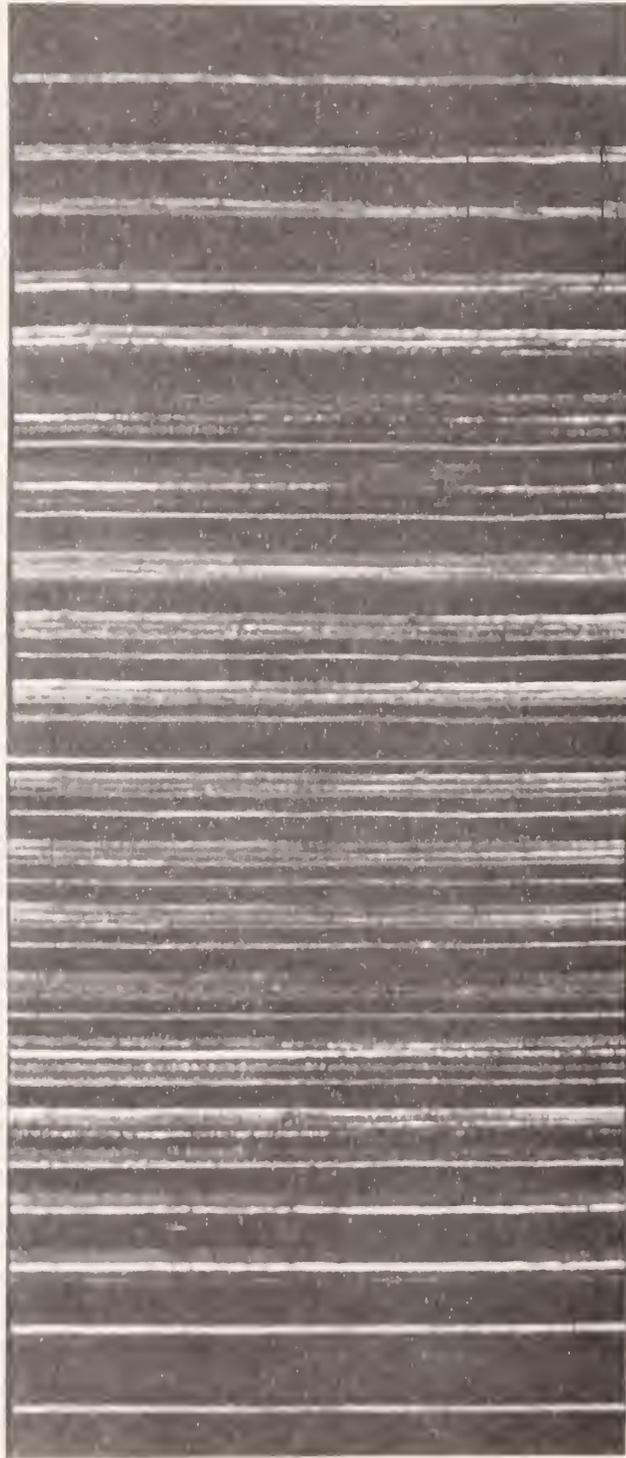
Figure 3-2 is a trace of this tire. The enclosed rectangle shows evidence of a massive separation in an otherwise fairly uniform tire. The separation is accompanied by some dimensional deformation as well as a shadow indicating a high reflection

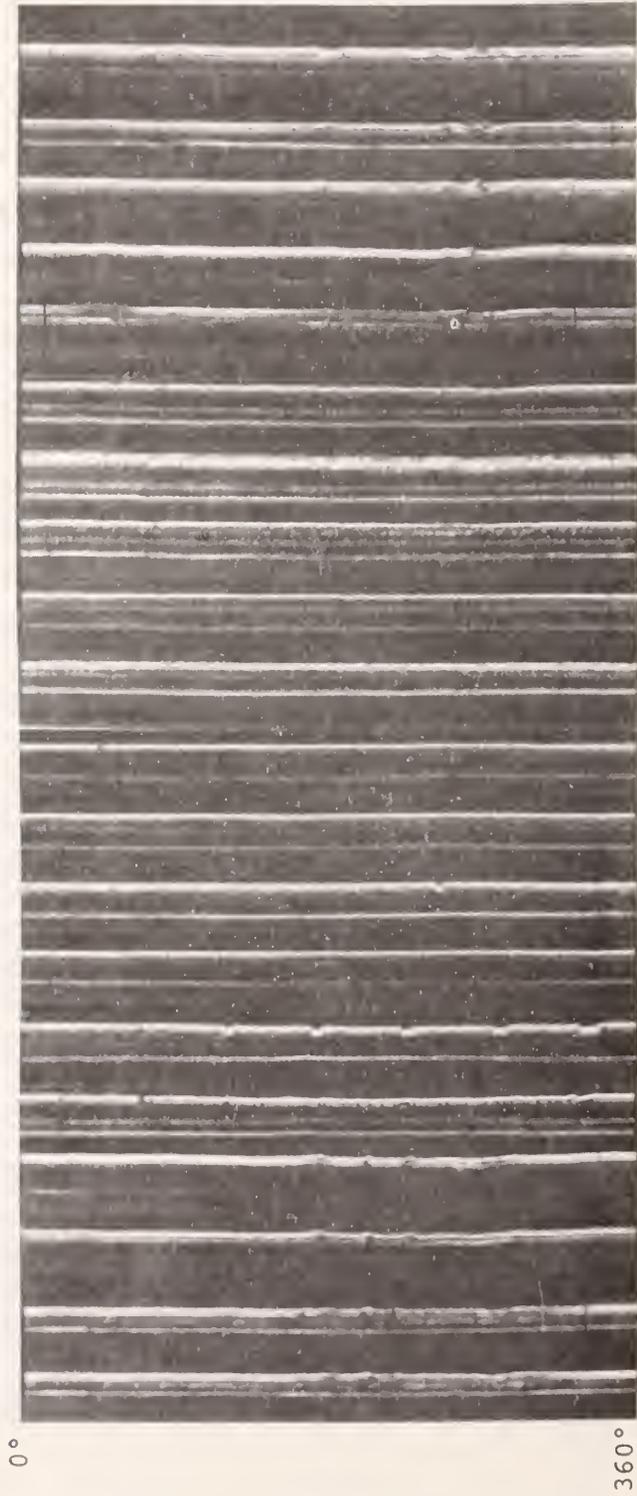
FIGURE 3-3. TIRE T5X 1172R

Although this tire passed the wheel test, Figure 3-3 shows evidence of some abuse in the white sidewall shoulder. Channel 17 (trace in rectangle) is indicative of belt edge separation. The anomalies in channel 7 are generally caused by bagmarks in the liner and are not considered abnormal. The anomaly in Channel 9 would have been considered if it did not look so much like those in channel 7. Inspection of the tire showed nothing that would account for these conditions.

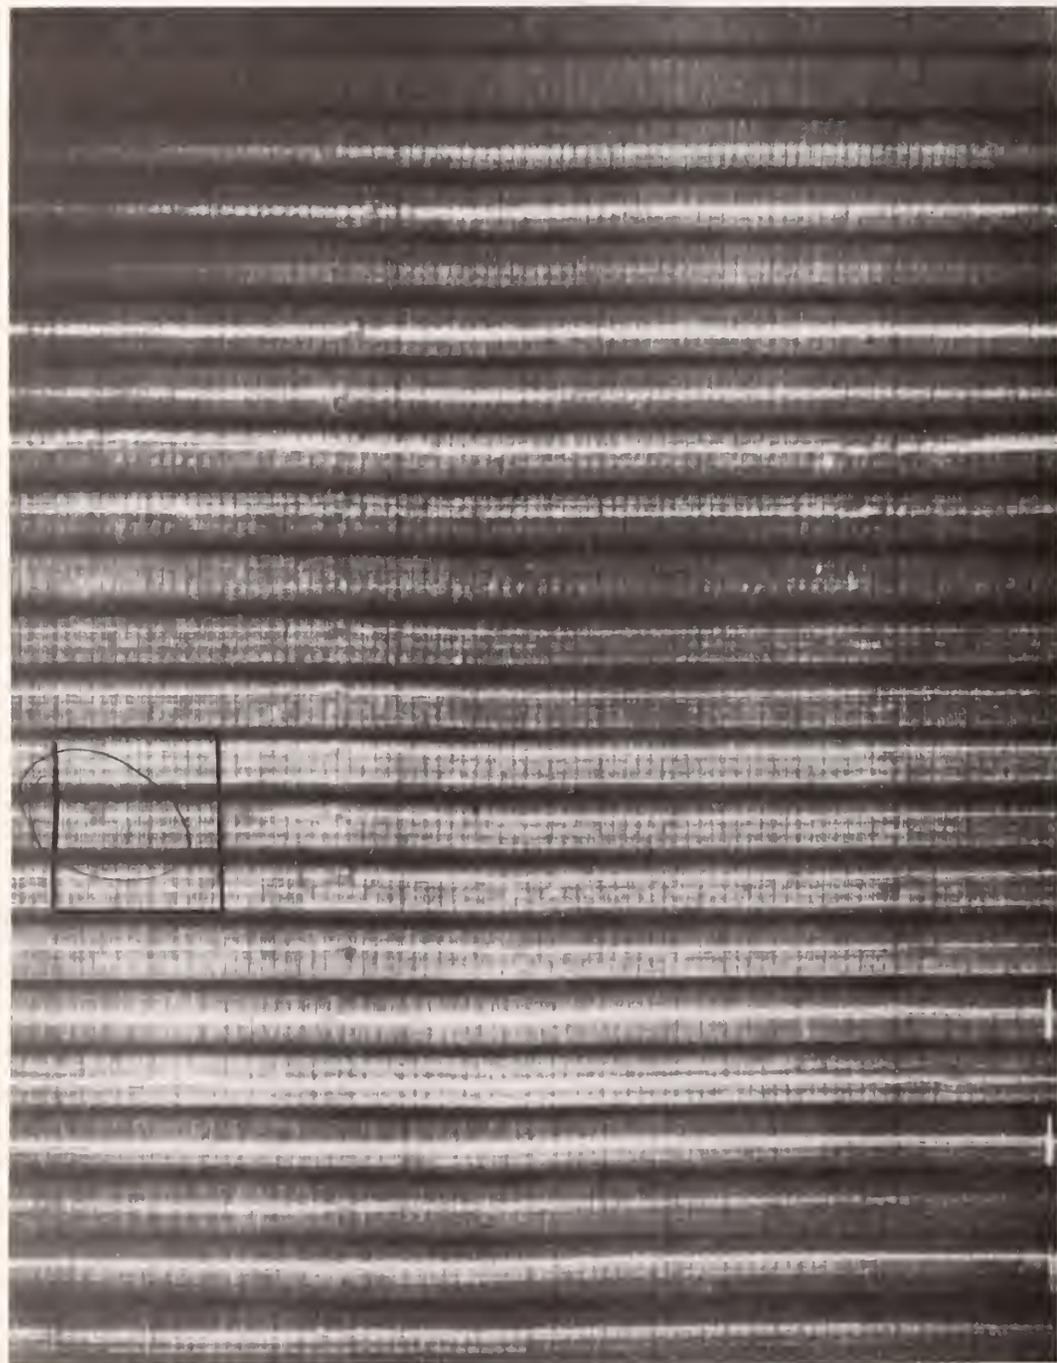
FIGURE 3-5. TIRE TSX 1183R BEFORE RETREADING

This tire failed as a result of a separation in the black sidewall shoulder. The rectangle in Figure 3-5 blocks out a separation in a scan prior to the retreading of the tire. A much smaller but more clearly defined spot is apparent after retreading in Figure 3-6.

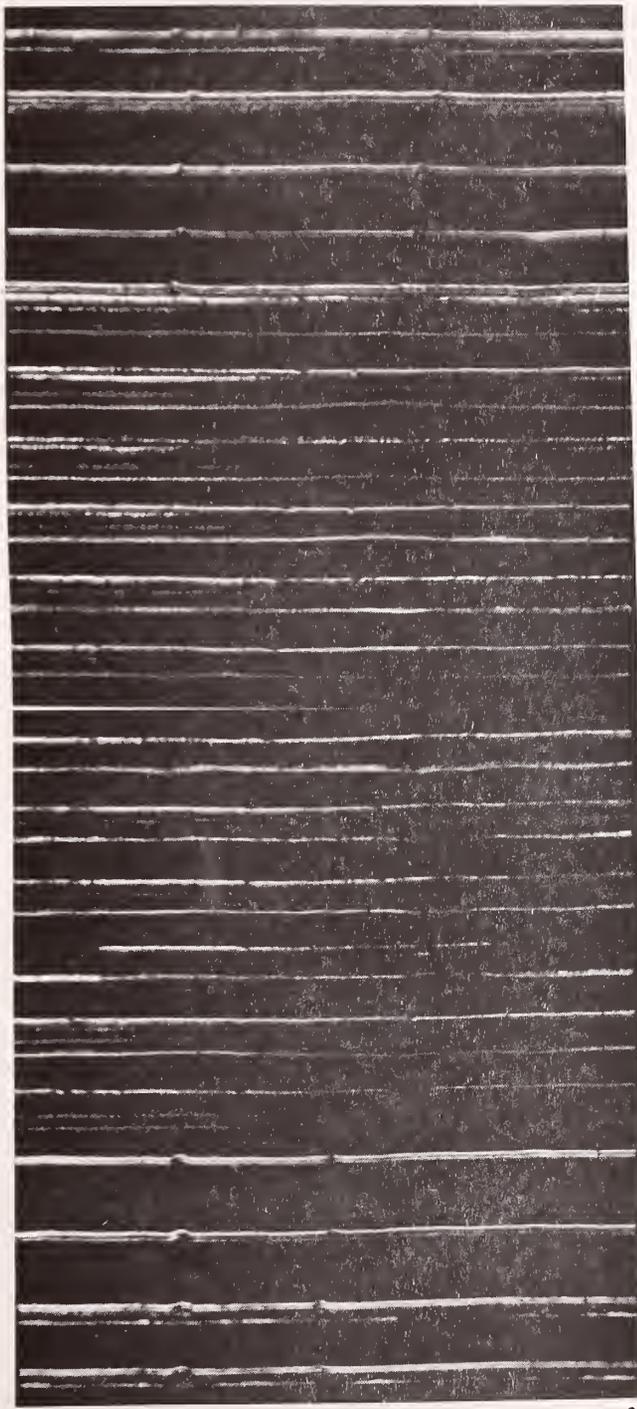
FIGURE 3-7. TIRE TSX 1204

If any of the vertical lines in an ultrasonic trace are not straight, they define runout of the tire in some form. Figure 3-7 is an example of this. The distance of tread surface reflection as measured from the liner reflection is proportional to the thickness of the tire at the point of measurement. This value varies as much as 20 percent in this tire. The tire would therefore be particularly difficult to balance. But the cause of failure in this tire is the separation shown in channel 8.

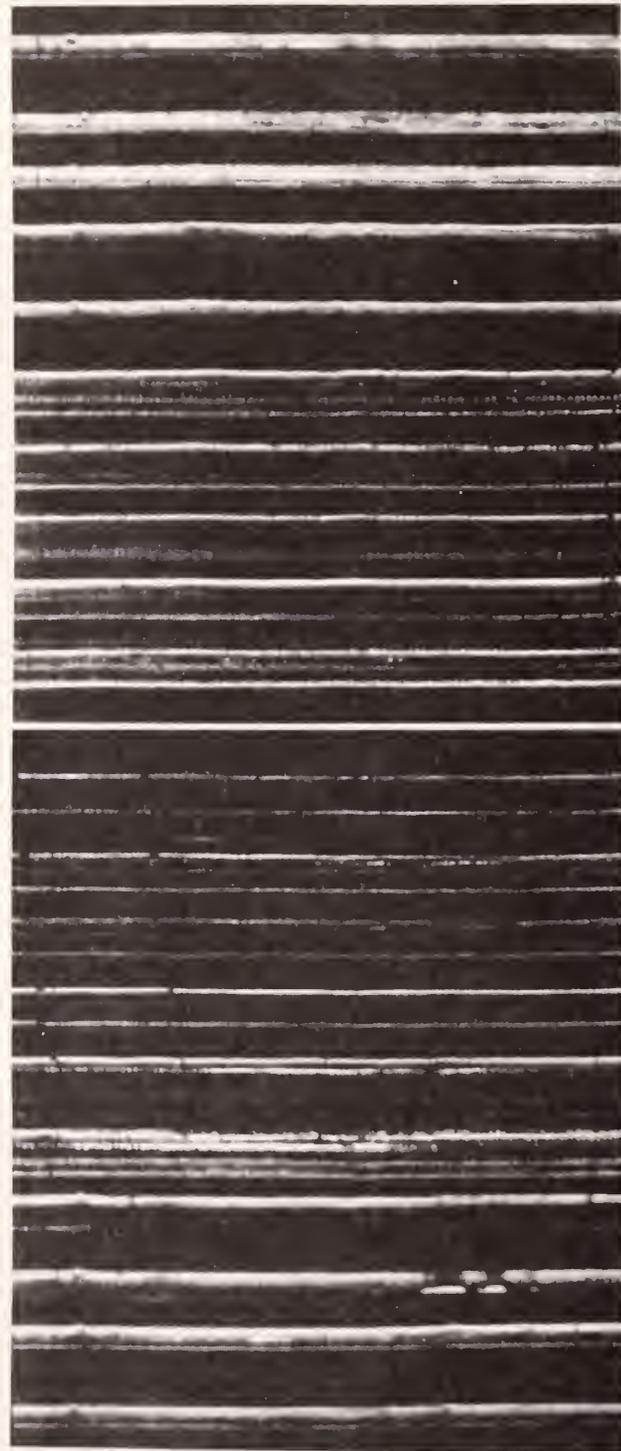
FIGURE 3-8. TIRE T5X 1223R

The location of the conditions are not, however, the same as those at which failure occurred. There is no valid explanation for this from the data. There is a slight possibility that the tire could have been placed backward on the ultrasonic inspection device and this would account for the location difference, but this is conjecture and, therefore, no conclusion can be made.

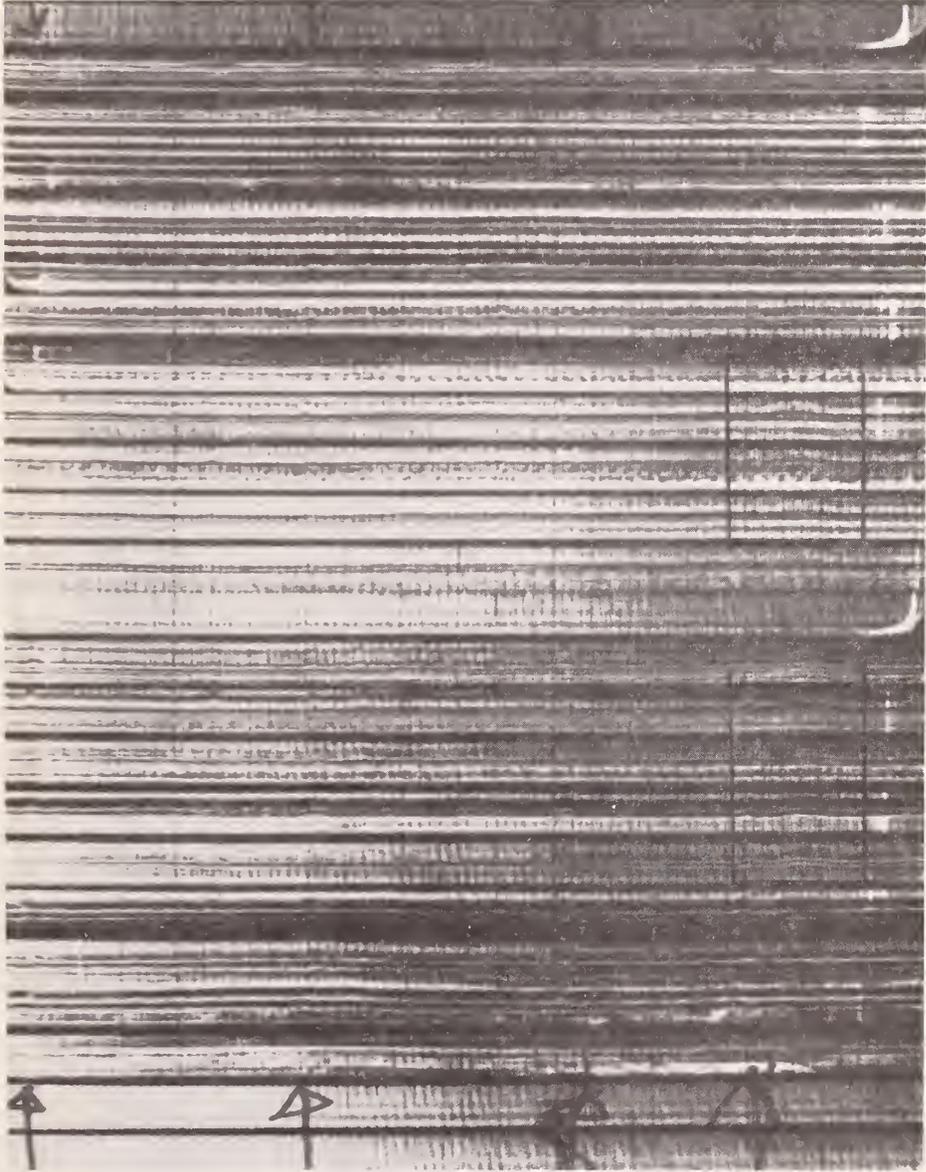
FIGURE 3-9. TIRE T5X 1239 BEFORE RETREADING

It is instructive to review the data from this tire since it is indicative of the types of conditions which can occur. Figure 3-9 is an early reflection trace of the tire prior to retreading. Channels 8,9,10,15 and 16 indicate substantial runout from a heavy splice. This appears only in the liner and

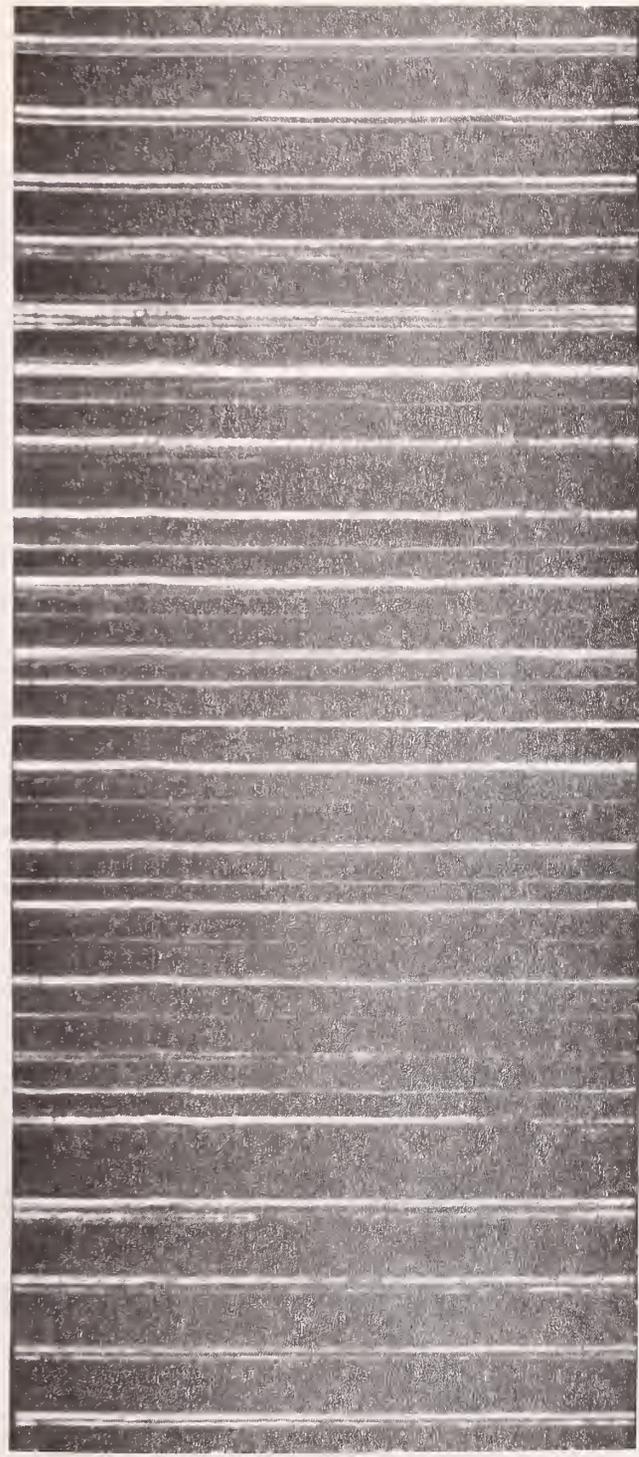
FIGURE 3-10. TIRE T5X 1239R AFTER RETREADING

not on the tread surface. Figure 3-10 is a trace of the tire after retreading. It shows no evidence of this condition and indicates that, in this tire at least, the retreading has helped the balance situation.

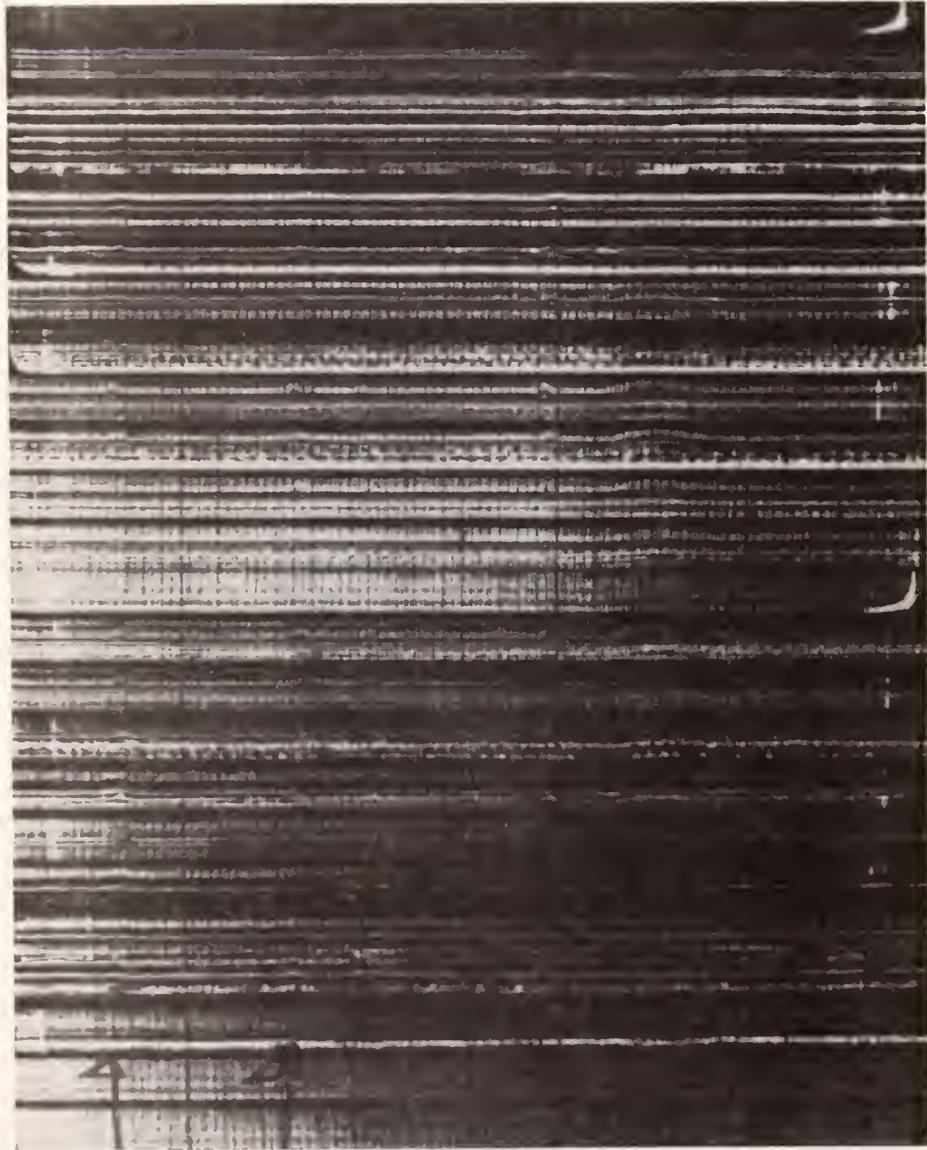
FIGURE 3-11. TIRE TSX 1245R

In this tire, holography indicated a number of belt edge separations. The ultrasonic trace of this tire was of poor quality. It indicated some evidence of belt edge irregularity but the evidence was not conclusive. As in the previous tire a heavy splice condition was also apparent. There is also evidence that channels were transposed in this trace, Figure 3-11, with the result that it is difficult to identify the location of the shoulder.

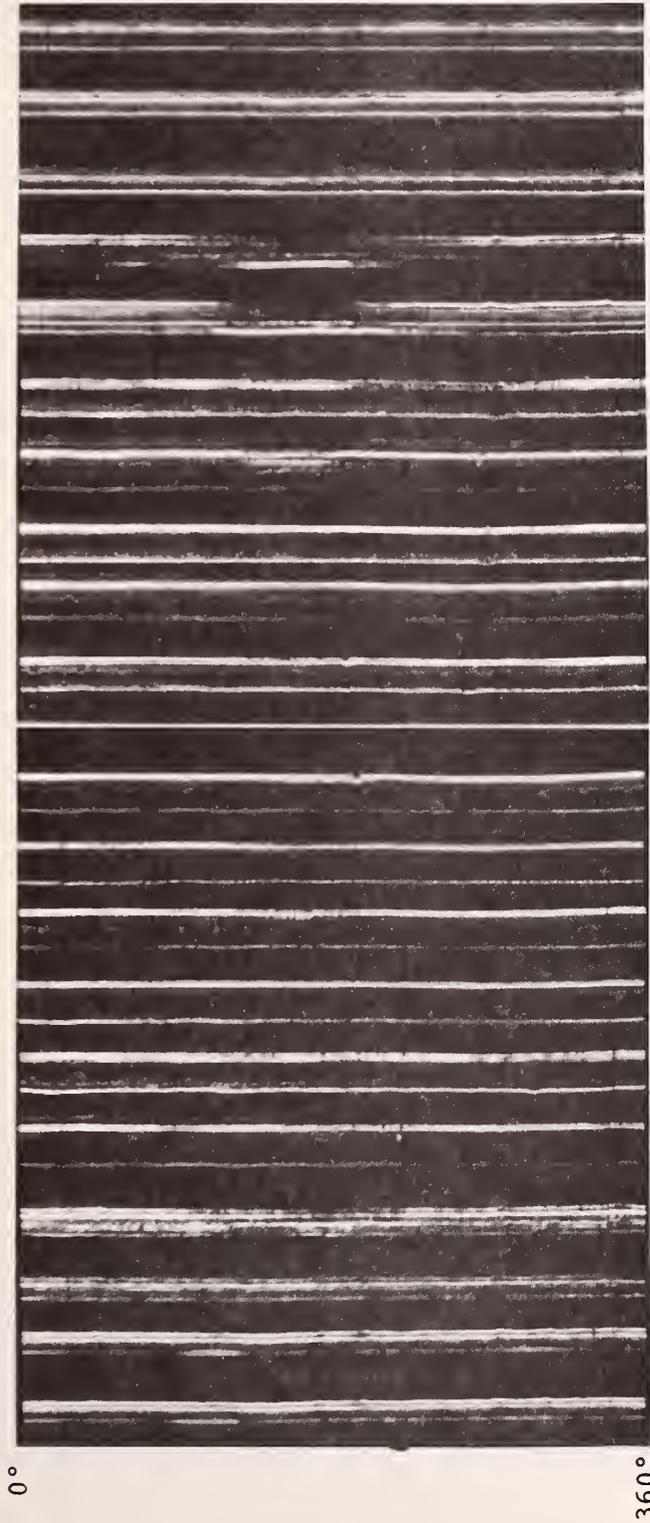
FIGURE 3-12. TIRE T5X 1259R

Although the tire did not fail, there is definite evidence of a small separation at $\theta=190$ on channel 11, at tread center (Figure 3-12). There is also some evidence of irregularity at the shoulders in channel 16 and 5.

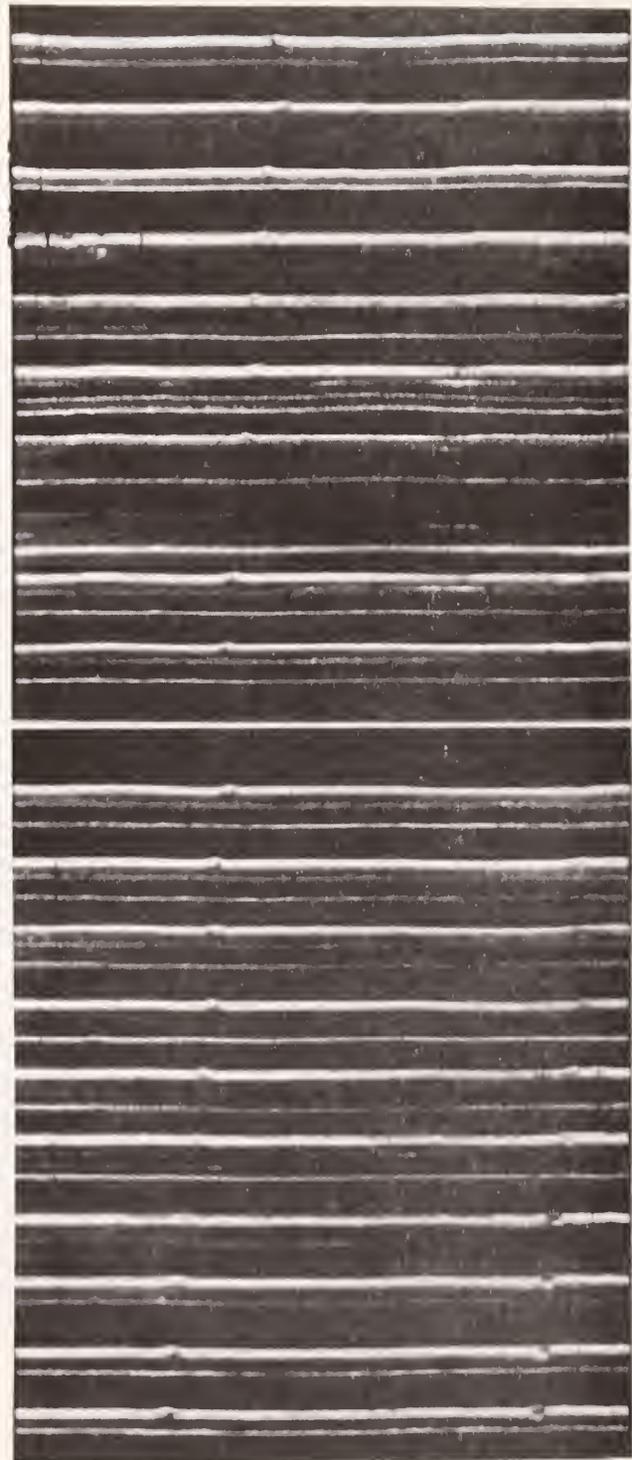
This tire, Figure 3-13, appears to be quite uniform and of good quality. Unfortunately, at one point it had an inclusion or separation in the shoulder. Although this was the site of failure, failure analysis of this tire indicated another reason for failure - poor adhesion in the tread rubber bond line as a result of too much mold heat. It appears that detection of the failure site in this case may have been coincidence.

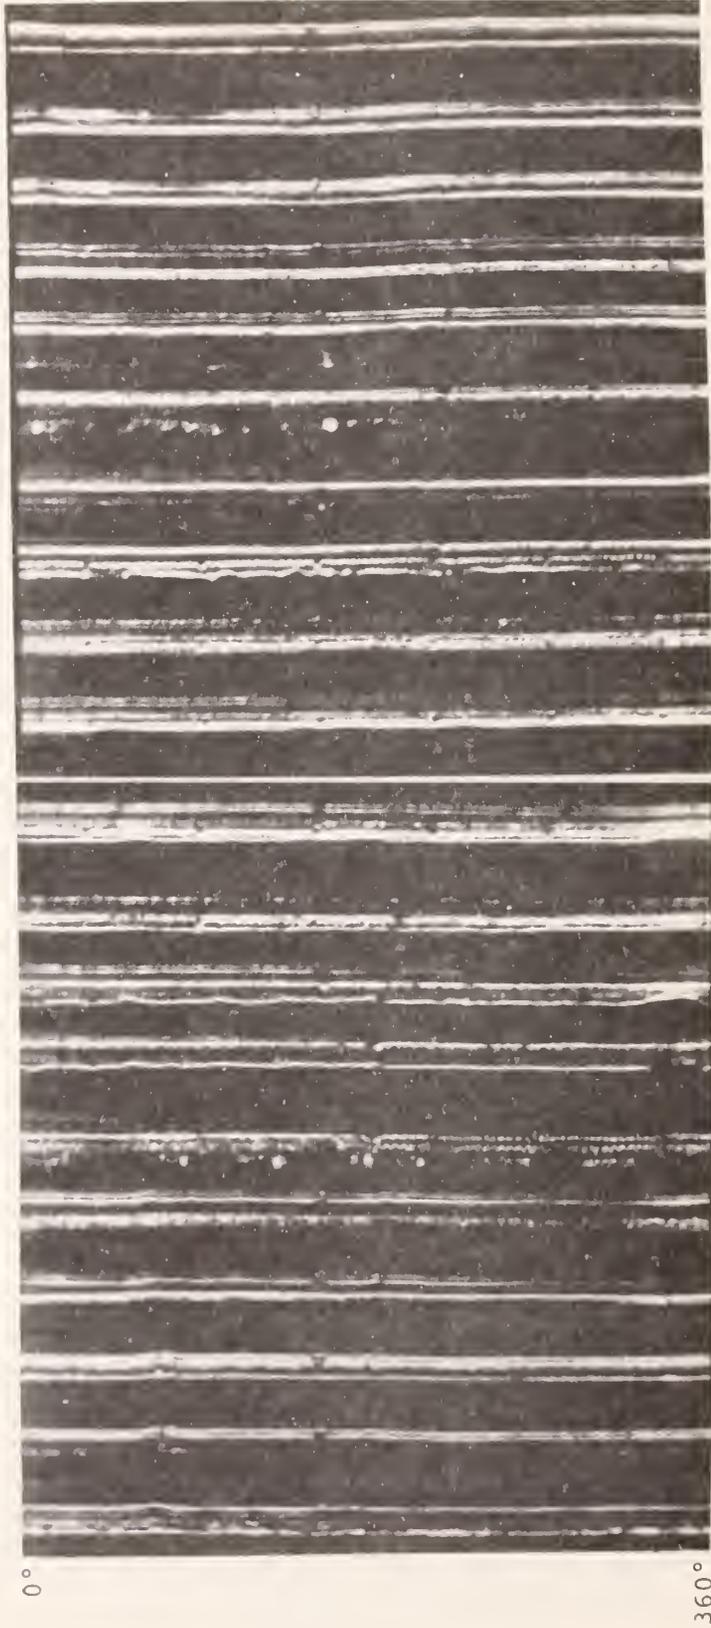
FIGURE 3-14. TIRE T7X 2169R

Channel 11 (Figure 3-14) indicated an area of insufficient rubber. This, coupled with the failure analysis report of insufficient stitching might tend to indicate a short section of camelback. These tires, however, were prepared using an orbitread machine and, barring malfunction, the condition could not have occurred in that way. The difference in tread thickness at this point and at any other point on the tire is .200 of an inch, enough to cause the tire to encounter severe stresses during wheel test. This undoubtedly was a major contributor to failure.

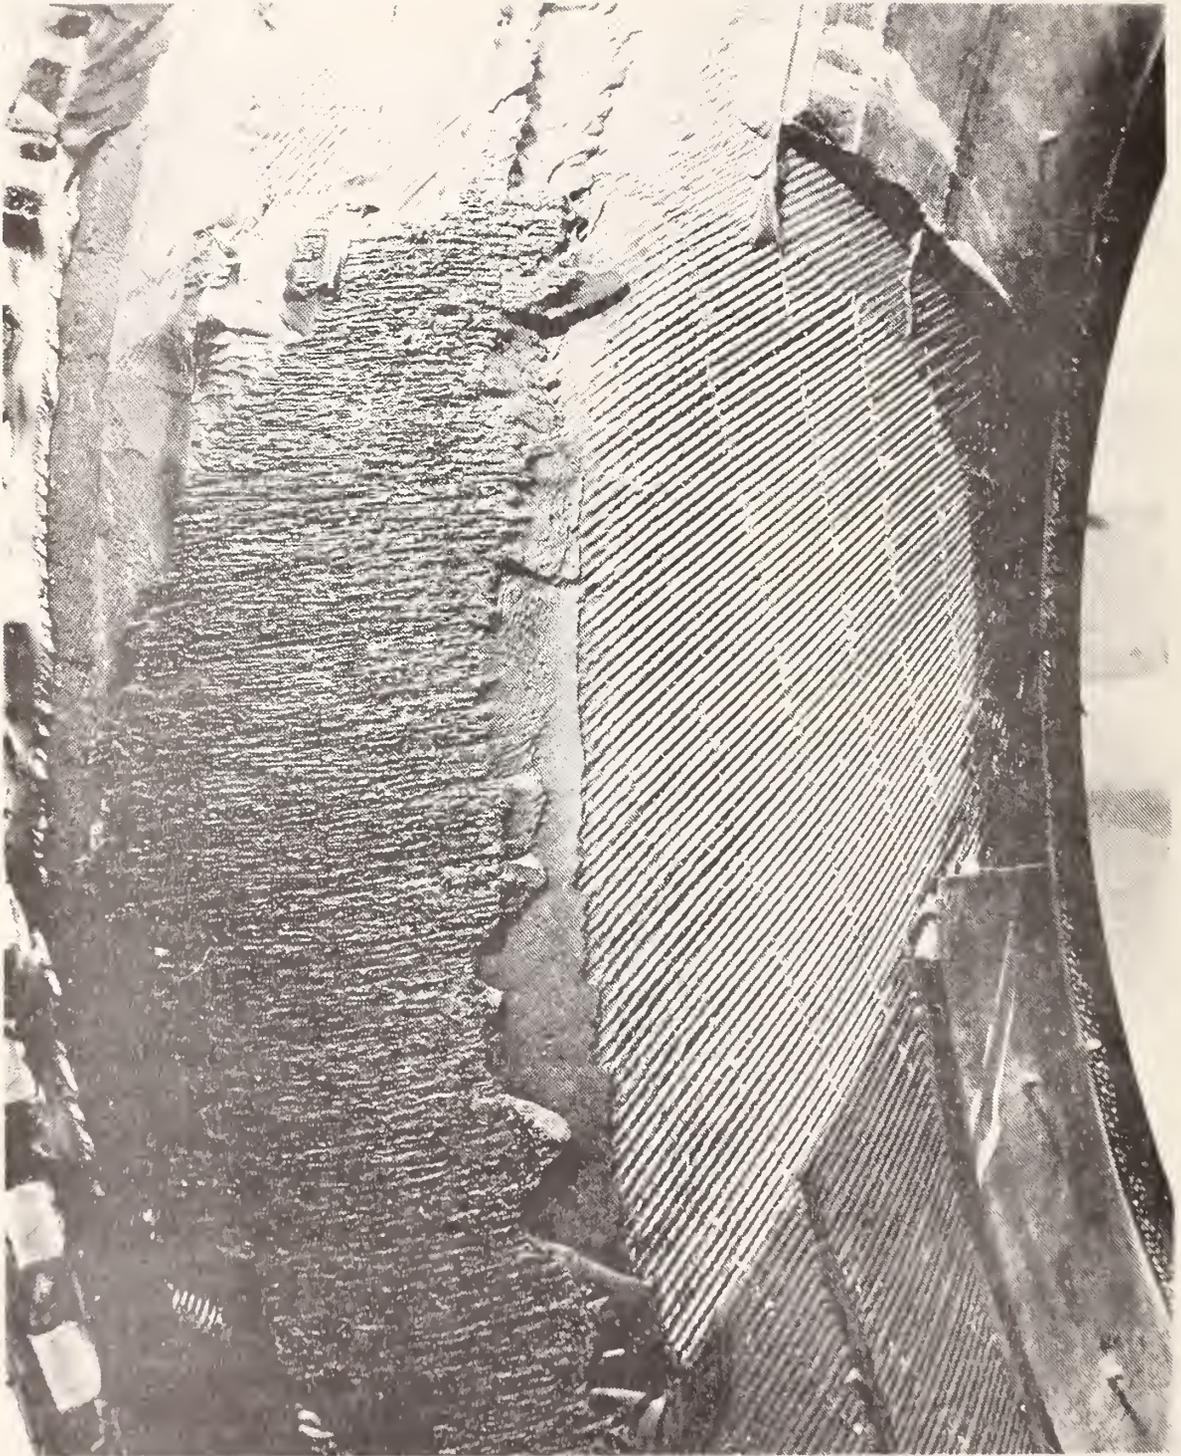
Figure 1 Sidewall Separation and Area of Poor Rubber Adhesion T5X 1161

1. Tire Analysis T5X 1161 - A large separation and bubble centering at $\theta=300$, $\varphi=190-280$ (NDT ultra-sonic inspection had shown separations at both $\theta=270$ and 300 and $\varphi=270$) was the immediate cause of failure. Figure 1 shows the separation area at $\theta=300^\circ$, and especially an area of no rubber adhesion to the sidewall. The ply-cords in this area also contained detritus (black) between individual yarn plies and no cord adhesive remained on the surface of each yarn. The ply-cord surface was not abraded to any degree; thus indicating that the separation or an area of no adhesion was present prior to re-capping. Also the original tire has an aspect ratio of about 83% and was molded in a G78-15 (or 78% aspect ratio) re-cap mold. This situation would cause abnormal sidewall and shoulder distortion in a tire to the point where sidewall buckling is promoted which would very likely cause a separation at any area of weak adhesion between cord ply and carcass rubber.

The separation area at the buffed interface under the re-cap tread is caused from the heat generated from the original separation bubble having been pressurized.

1. The tire was really too old to be subject to re-capping.
2. The tire had a severe separation or area of poor carcass-rubber adhesion that became distorted when the 83% aspect carcass was re-capped and molded in a 78% aspect mold.
3. Failure occurred when the separation became pressurized, bubbled and then generated high heat levels which failed the carcass rubber.
