REPORT NOS. DOT-TSC-NHTSA-79-51

✓✓
**CORRELATION BETWEEN ULTRASONIC NONDESTRUCTIVE
INSPECTION AND WHEEL TEST OF 34 RETREADED TIRES**

NOVEMBER 1979

FINAL REPORT

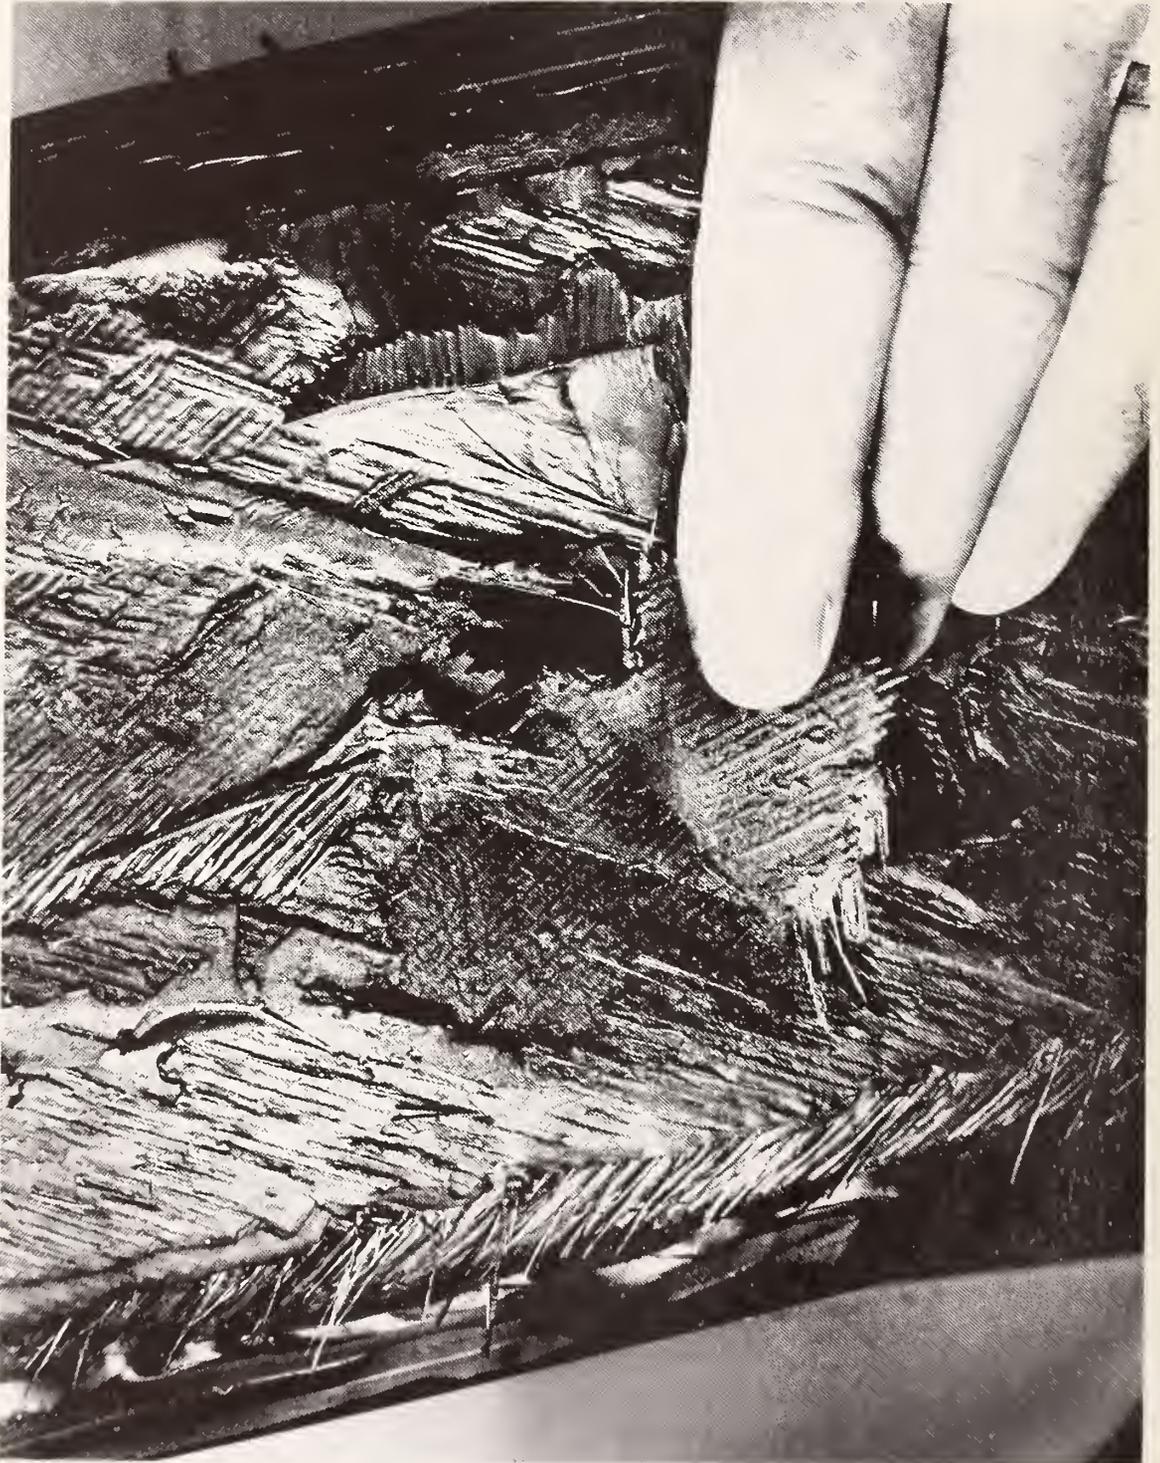
Figure 2. Severe Belt Breakage and Failure Area T5X 1183

2. Tire Analysis T5X 1183 - This glass belted tire had failed when parts of the tread separated. Inspection of the tire under the tread showed massive belt breakage throughout the tire. Actual tire failure was initiated primarily at $\theta=80^\circ$, $\phi=180^\circ$ where there was a large separation in the carcass directly under an area of severe glass belt breakage. Figure 2 shows the area of severe glass belt breakage and the failure separation beneath the belt. Also a larger sidewall separation was found at $\theta=45^\circ$, $\phi=250^\circ$. The sidewall/shoulder rubber had separated from the carcass fabric and the carcass fabric had buckled (reverse curvature). Figure 3 shows this separation and buckle. This buckling is an artifact occurring during the re-capping operation when the tire does not fit the mold very well. With the severe glass belt breakage, the tire was probably considerably over-size in circumference which would cause the sidewall to buckle when the tire was placed in the re-cap mold and there is an area of poor adhesion. The sidewall separation at $\theta=45^\circ$, $\phi=250^\circ$ extends from the bead to well into the shoulder. Also there is another sidewall ply separation at $\theta=50^\circ$. Both glass belts are essentially completely disintegrated from $\theta=70^\circ$ to 120° . There was no evidence that the carcass buffing prior to re-capping had touched or otherwise

damaged the glass belts. Also the broken ends of glass were completely blackened and in some cases covered with burnt rubber, definitely indicating that the tire had been running for a relatively long time with broken glass belt cords.

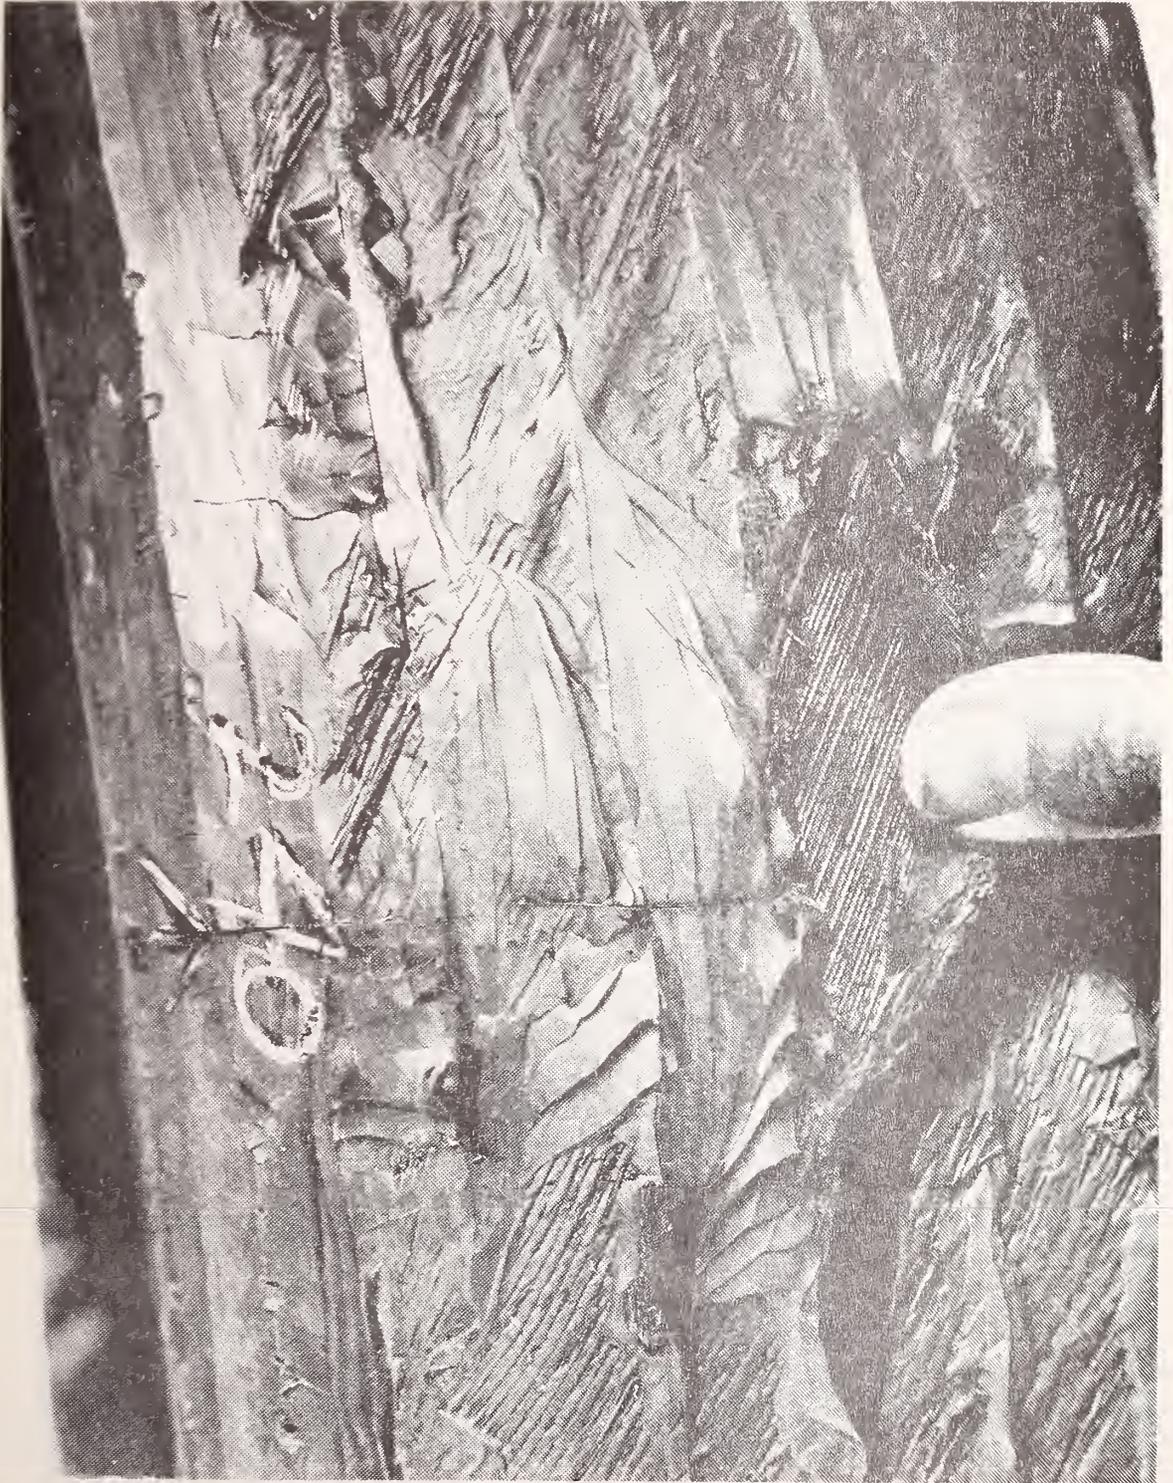
Figure 4. Severe Belt Breakage and Separation in Failure Area T5X 1204

Dissection and inspection of the glass belt showed the glass yarns to be badly broken. Figure 4 is a photo of the failure area showing the severe glass breakage and the separation. The separation also shows a heavy loss of carcass rubber with black detritus having penetrated into the carcass cord, indicating the separation had been present for a long time. The glass belt was badly broken throughout and especially severe breakage was noted at $\theta=200-210^\circ$ and $\theta=270^\circ$, and another belt separation was found at $\theta=270^\circ$. Also a belt edge separation was found at $\theta=220^\circ$, $\phi=250^\circ$. IR scans were made of the pyrolysis products of the tread and liner rubber. Both the tread and liner rubber outside the failure area showed little degradation from either age or heat. The rubber from the failure area was burnt and was oxidized (according to IR analysis) indicating that the tread splitting was caused by excessive heat buildup when the separation became pressurized. Ply-cord adhesion averaged about 4.3 lbs/cord. This adhesion is low for the 3 ply, 3600 denier polyester cord used in this tire. Cord strength was 45.2 lbs which is normal for this cord. The low cord adhesion is probably an accelerated aging effect caused by the tire having been overloaded or underinflated during its earlier life.

Conclusions - T5X 1204 - This tire had severe belt breakage and at least two belt separations at the time of re-capping and was essentially a failed tire prior to re-capping.

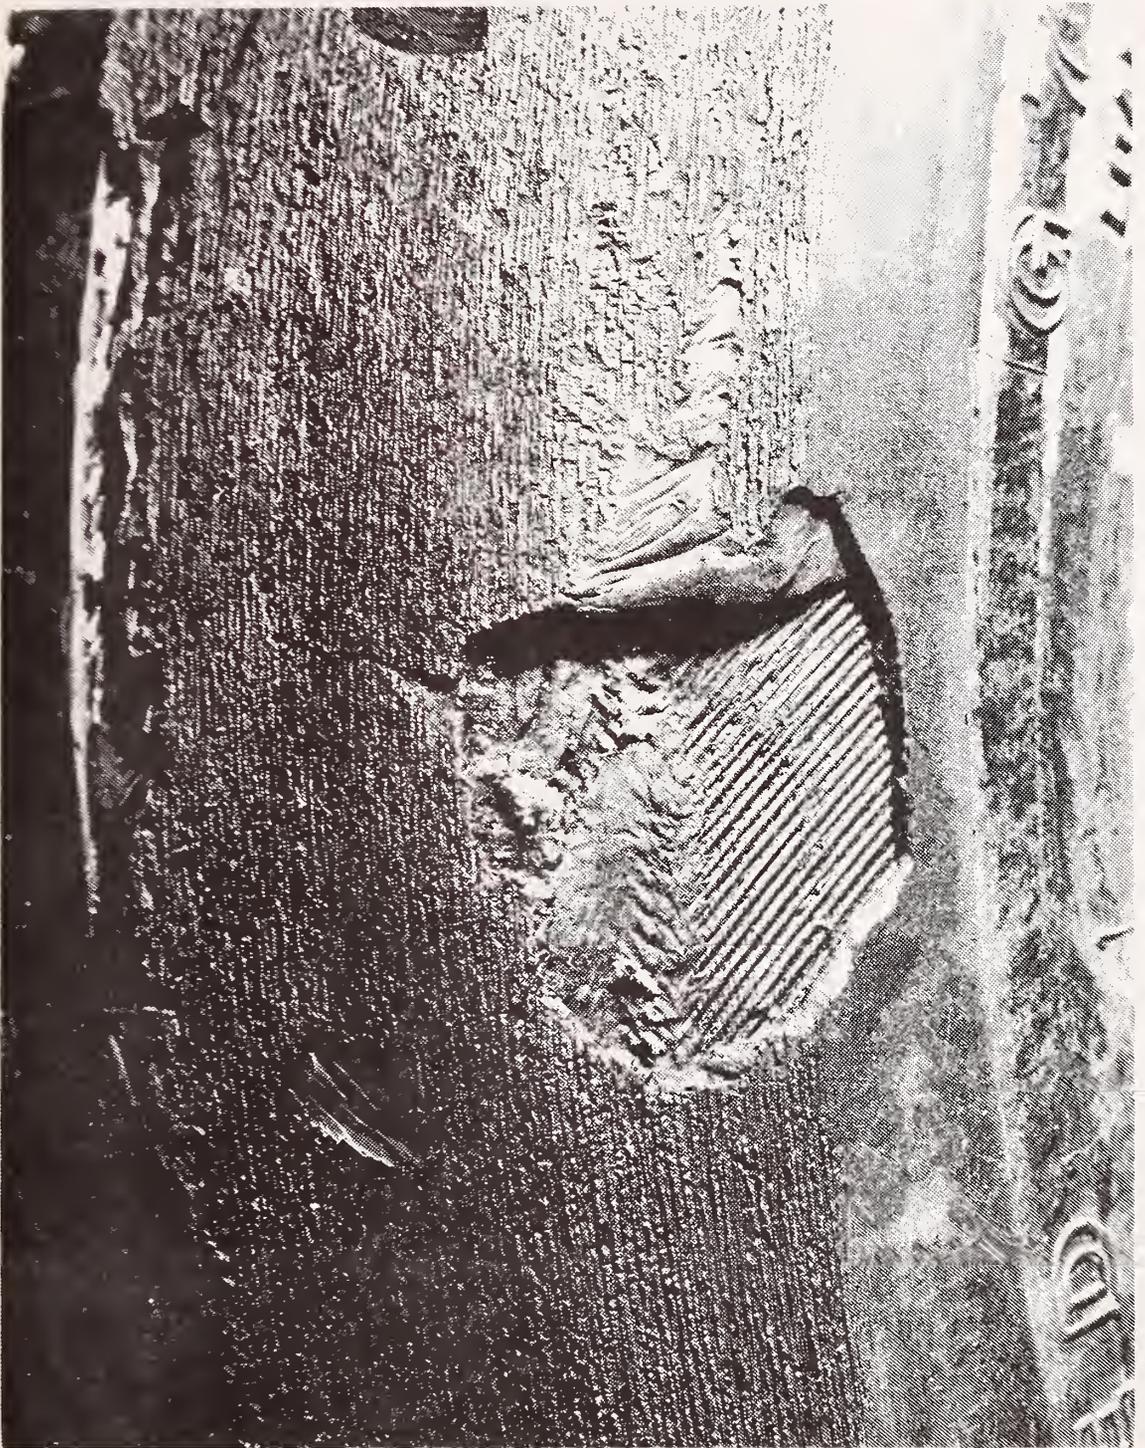
Figure 5. Buffed Interface and Belt Edge Separation T5X 1223

The re-capping was also of poor quality especially along the edges of the re-cap when the stitching was poorly done with many areas of loose edges, one of which was next to the separation at $\theta=270^\circ$.

Conclusions - T5X 1223 - This tire failed because of a re-cap separation present in the tire right after the re-capping. Also the tire became over-heated in the re-cap mold which promoted deterioration. The presence of the belt edge separation at this point also caused local over-heating and a bump in the tire during the wheel testing. Again the tire should not have been re-capped. However, the poor re-capping job and a hot spot in the mold were the immediate cause of failure.
